RE: Chevron USA Incorporated Temporary Pit Application

Cotton Draw 34 27 Federal Com
Section 3 of T25S, R32E, Lea County

**C-144 Permit Package
Cotton Draw 34 27 FEDERAL COM, Temporary Pit
Section 3 of T25S, R32E, Lea County**

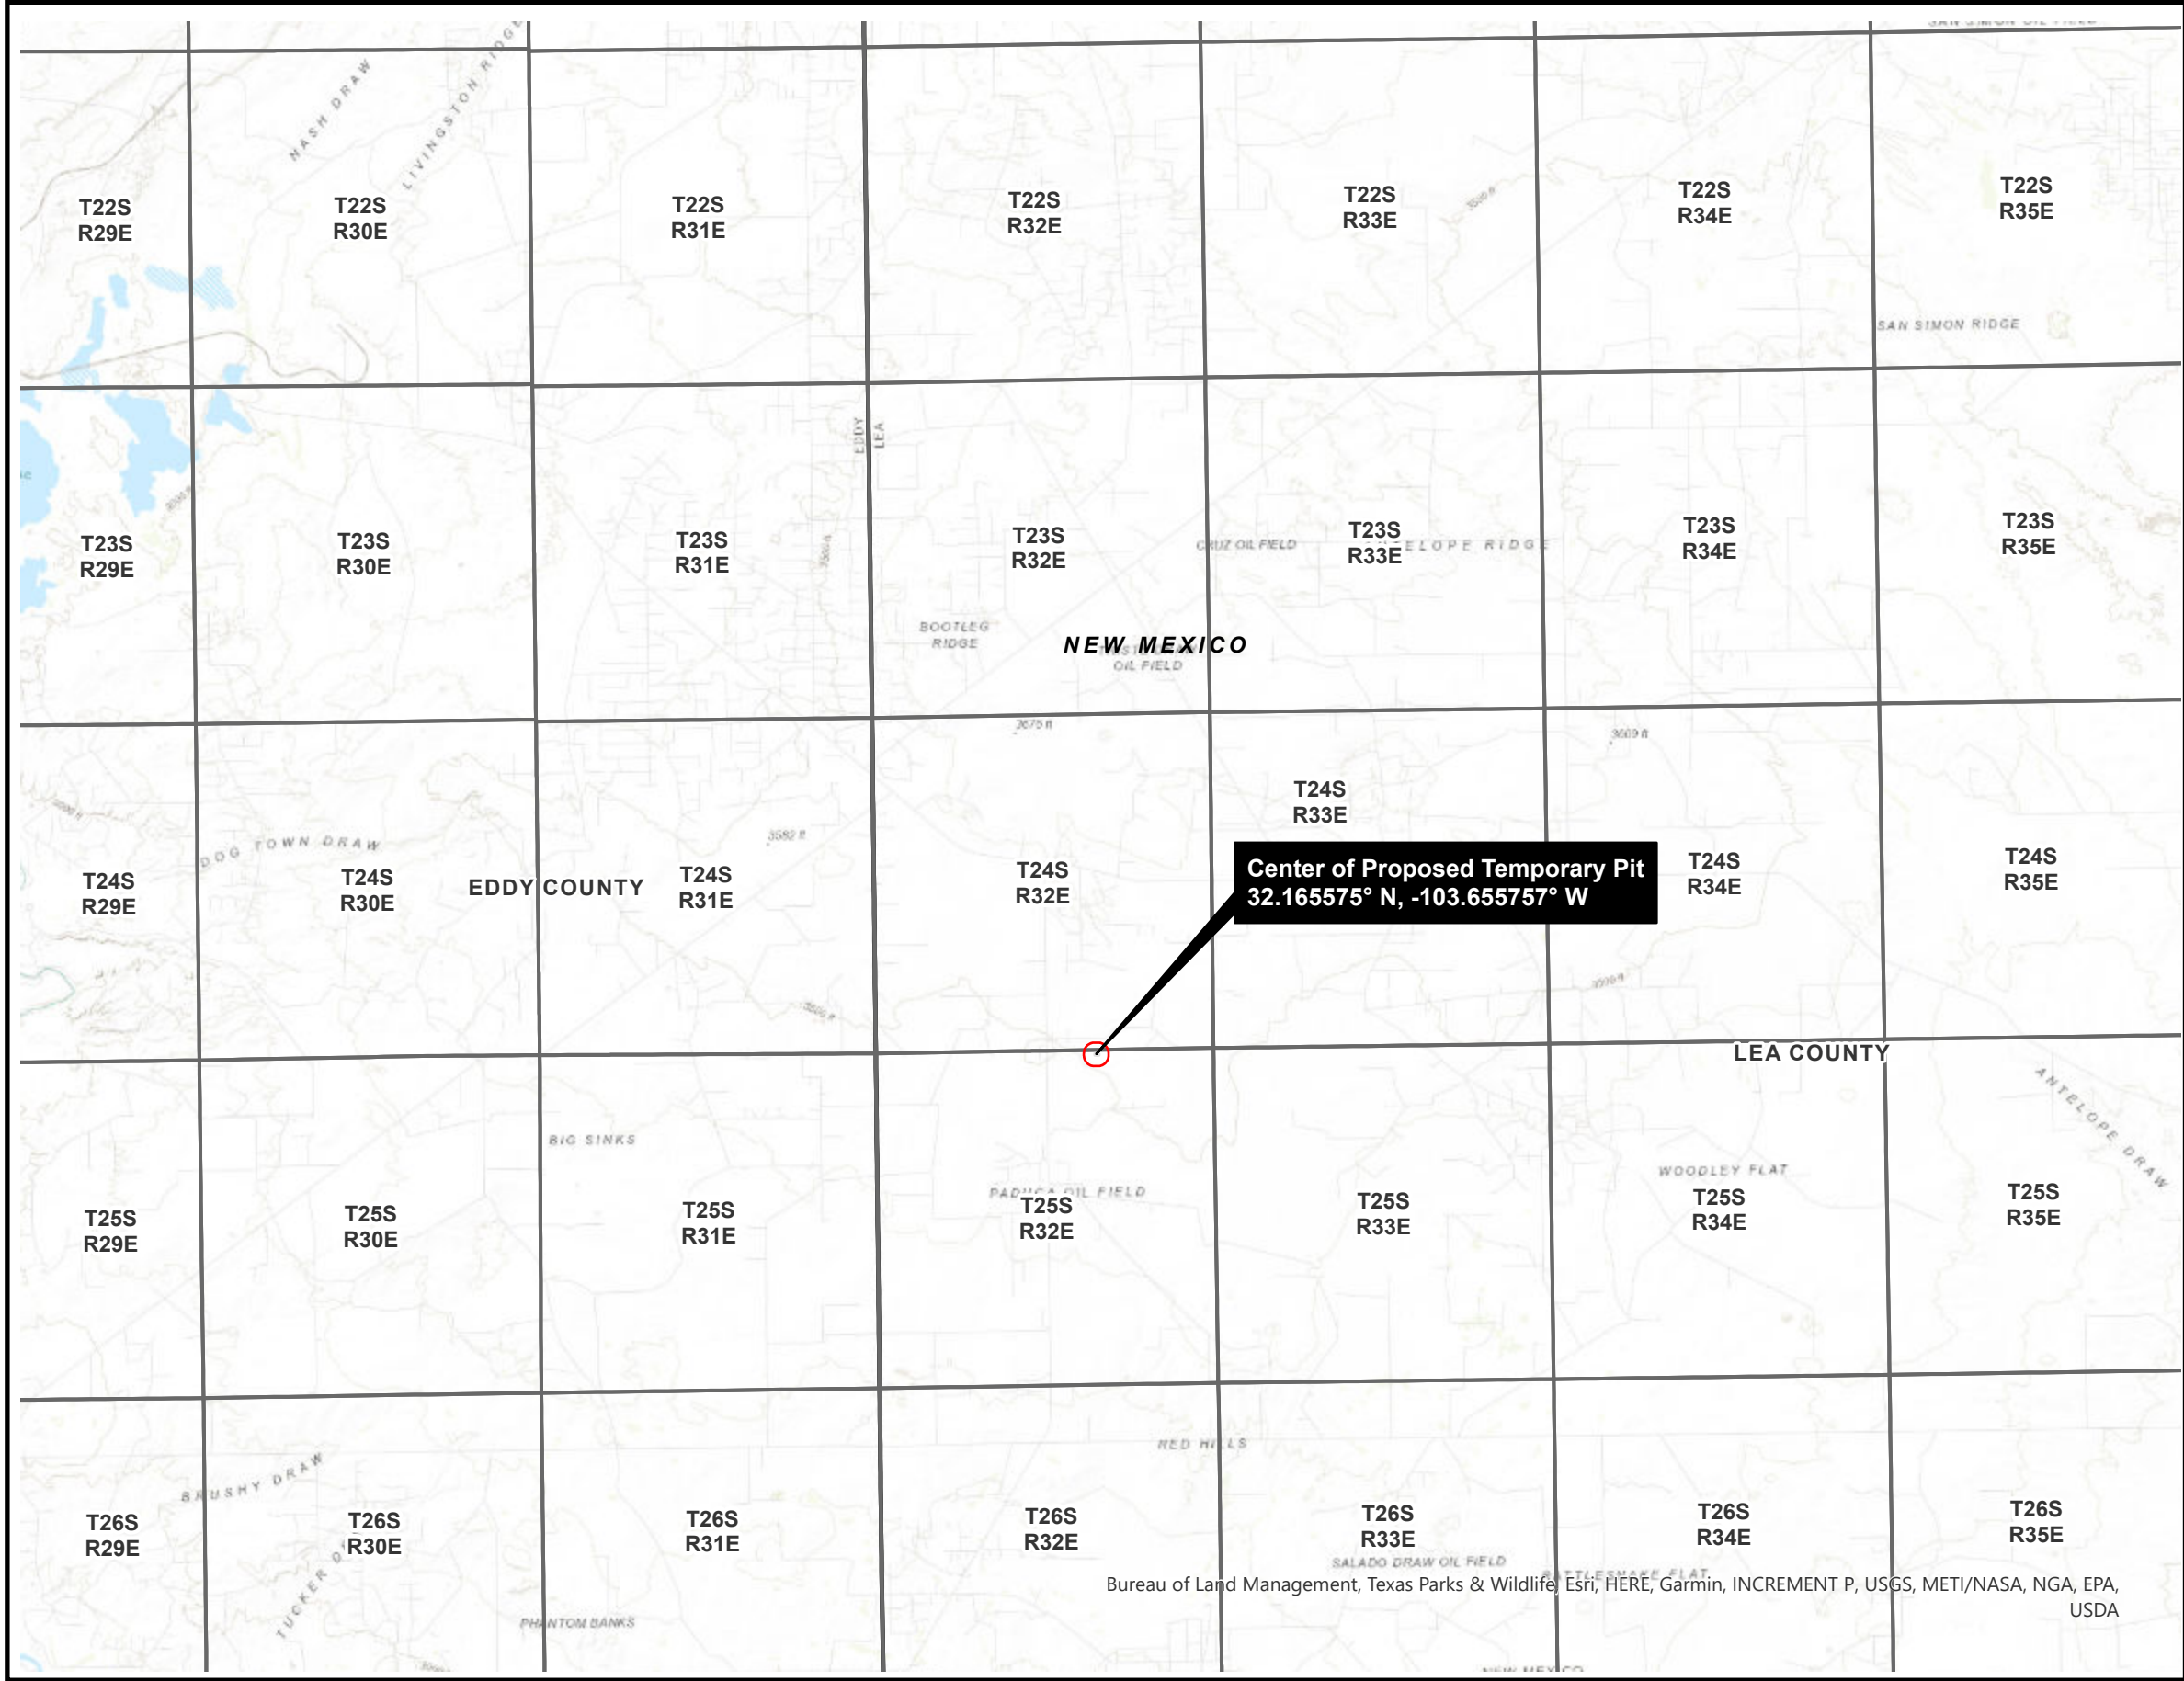
FIGURE
1

VICINITY MAP

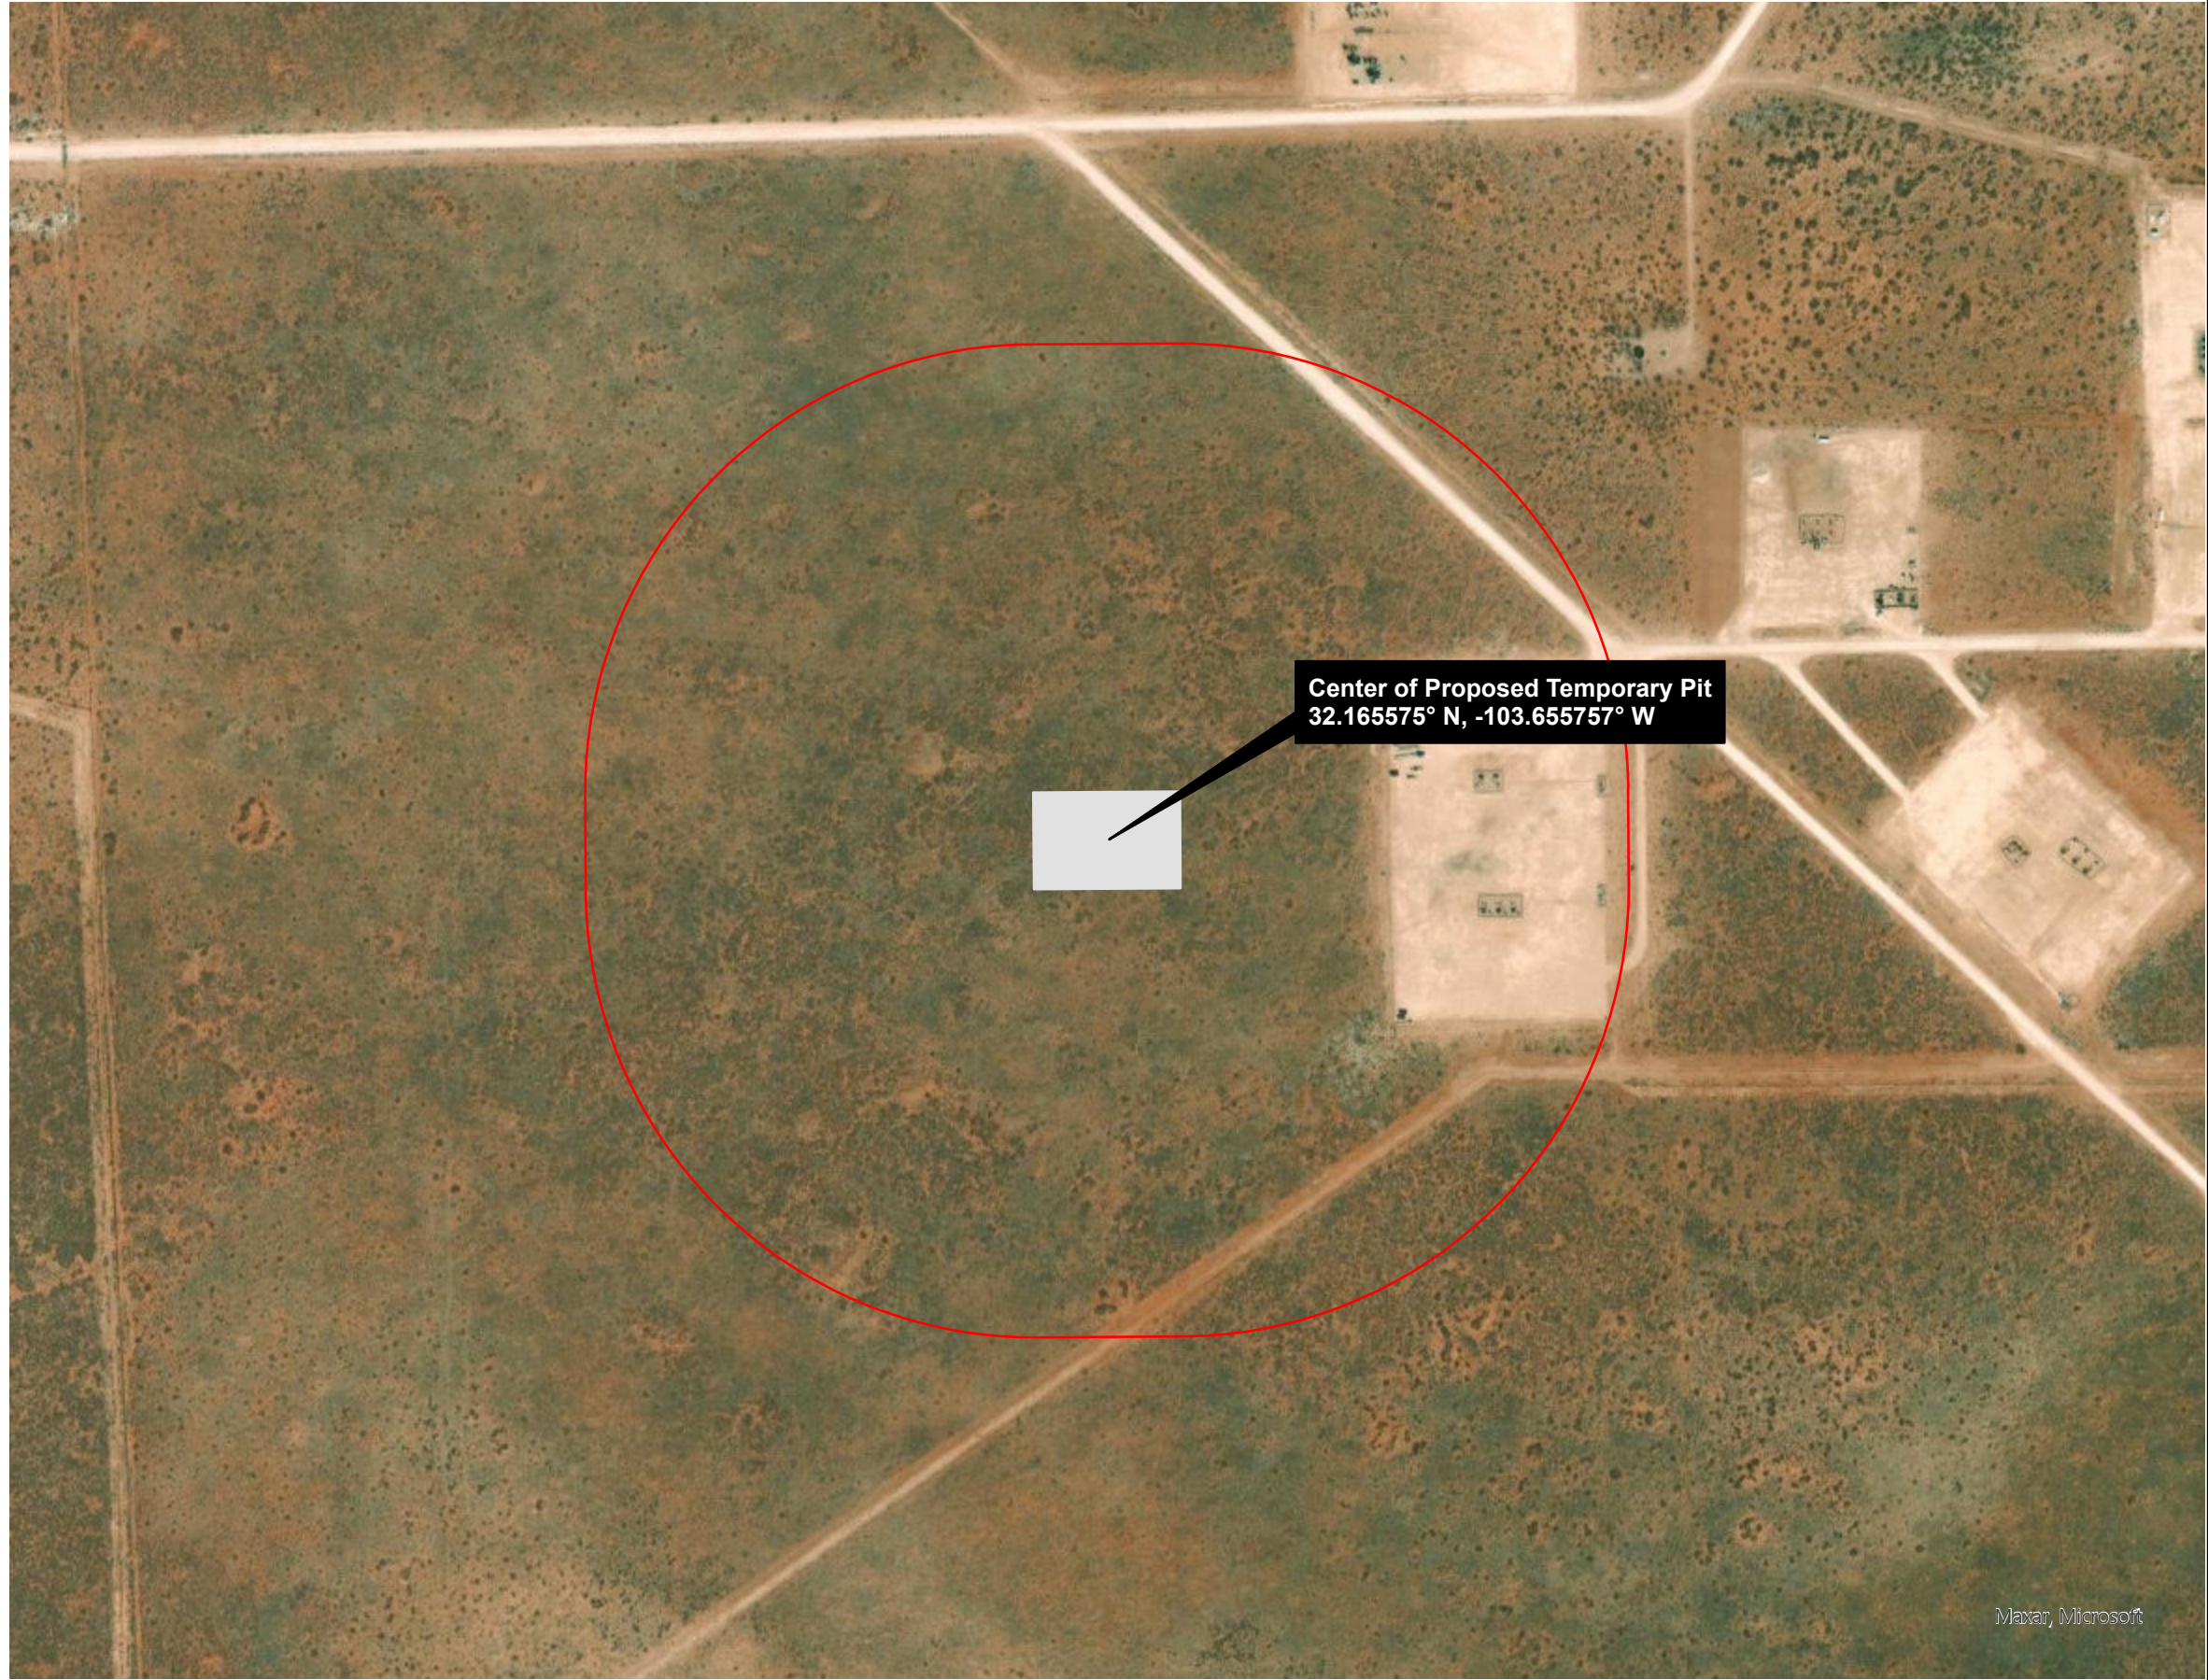
FIGURE
2

SITE OVERVIEW

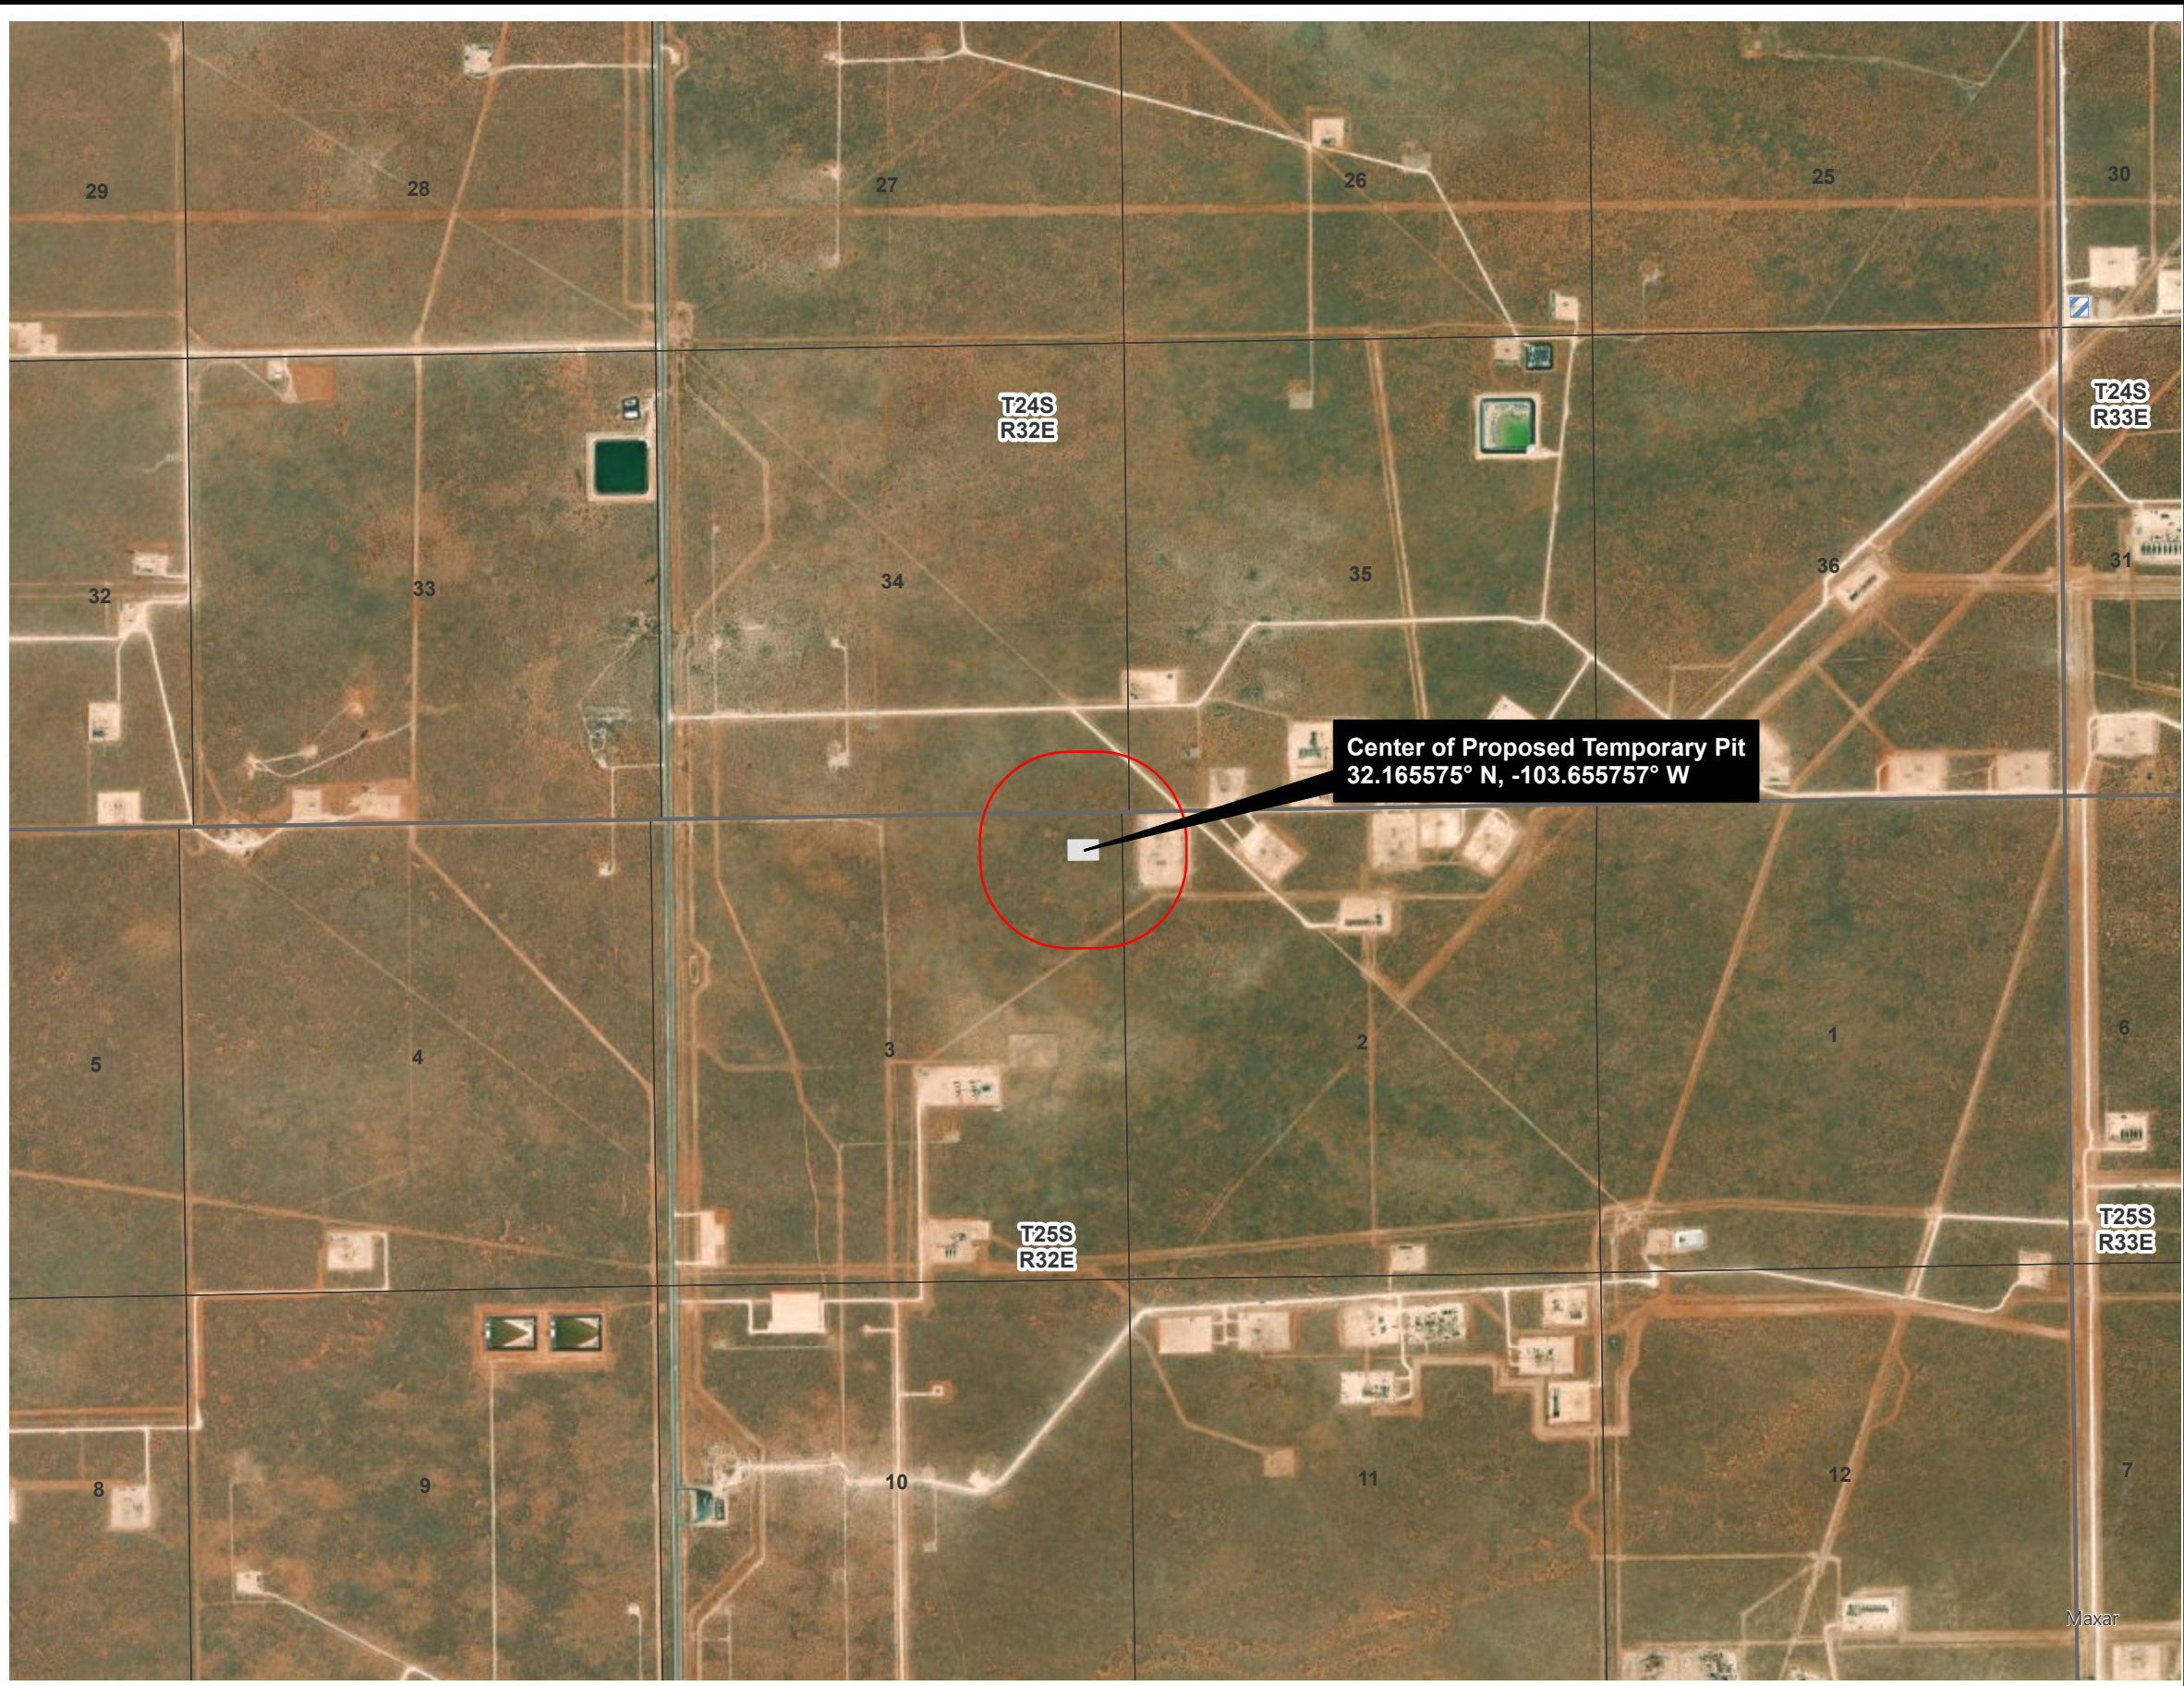
FIGURE
5

WETLANDS MAP

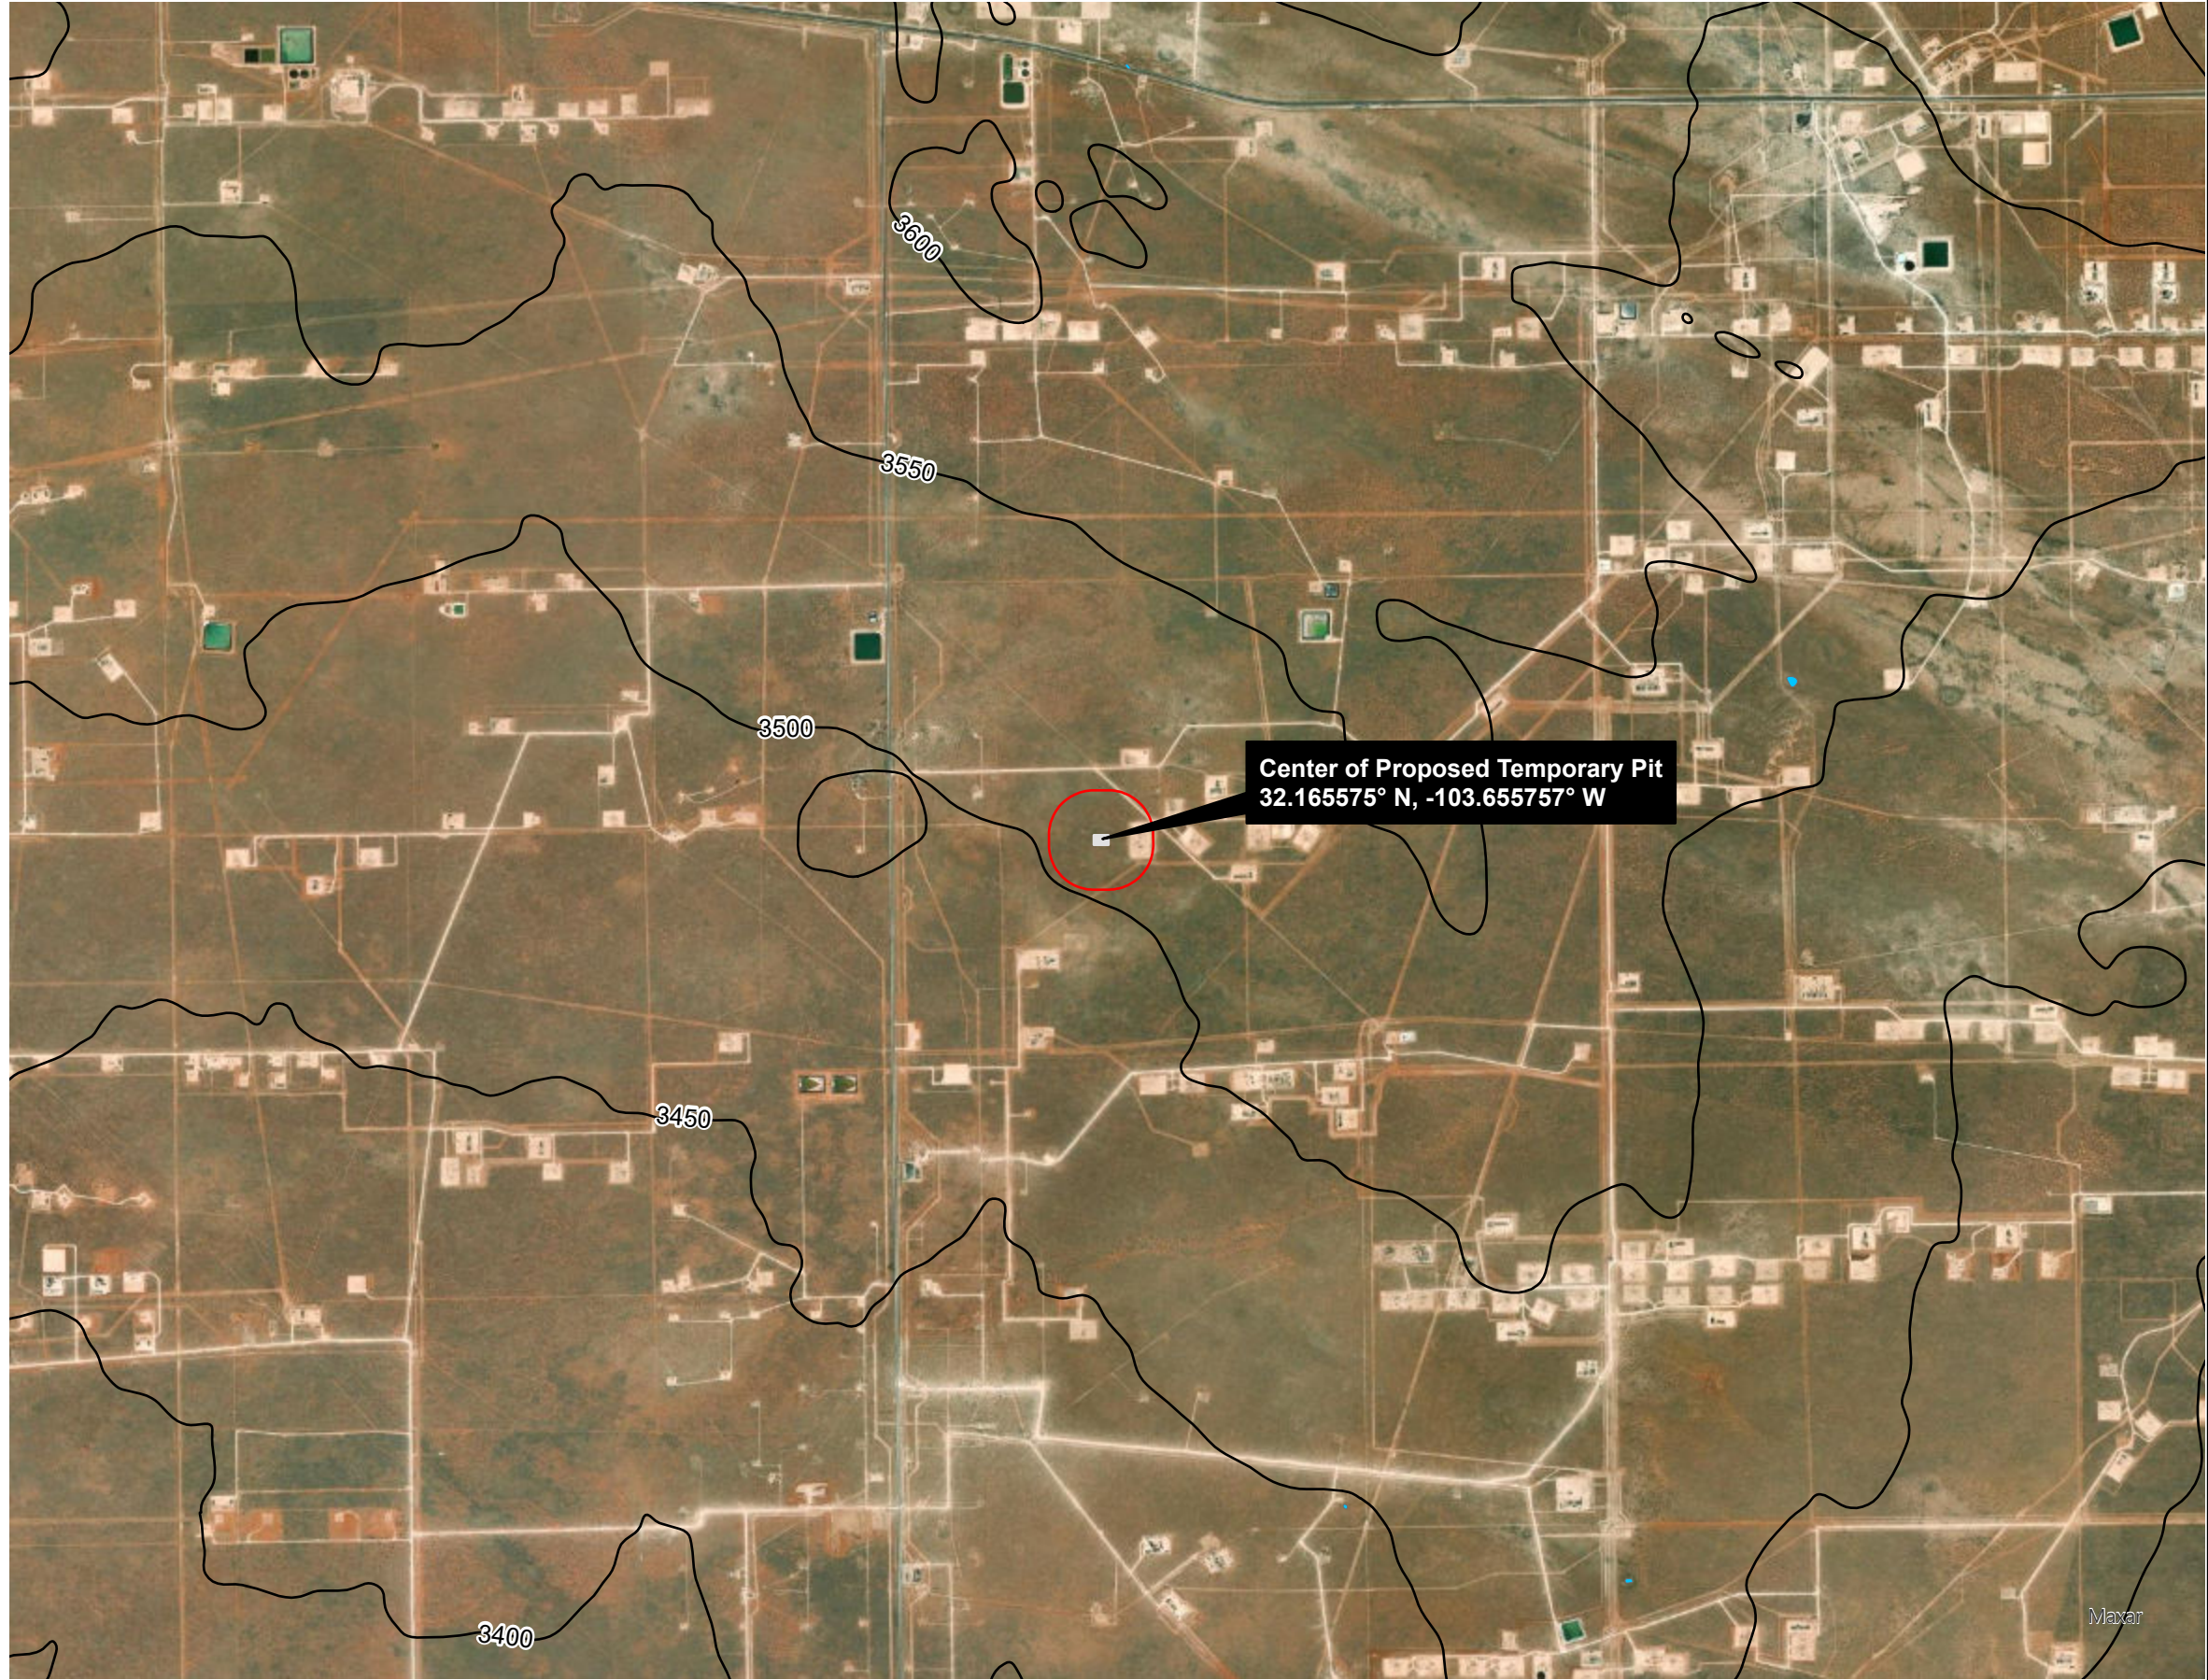
FIGURE
6

ELEVATION CONTOUR & NHD MAP
