No water found to 105 feet in Borehole

"Release Investigation and Remedial Action Plan for Zeus SWD Flowback Line Produced Water Release (1RP-5561). This Remediation Plan is denied for the following: • The Depth to Groundwater has been incorrectly assesses. There are no wells within a ½ mile radius of the release source. The OCD cannot accept the DWG of a well (CP-01701-POD1) that is over 1.5 miles from the release site. Per rule 19.15.29.11 (A)(2) NMAC: "The responsible party must determine the depth to ground water where the release occurred". If Solaris believes that Groundwater is >100', a borehole will need to be drilled onsite at 105' and leave it open for at least 72 hours. If there is no evidence of water after 72 hours, the OCD will accept this as evidence. We will need a copy of the driller's log. For further clarifications regarding the implementation of the spill rule, visit the OCD website: <http://www.emnrd.state.nm.us/OCD/documents/OCDInternalPolicy-SpillRuleClarifications.pdf>".

Re: Solaris Zeus Boring  
Section 36, NENE, T21S-R32E  
Lea County, New Mexico

Solaris Zeus ■ Lea County, New Mexico  
September 10, 2019 ■ Terracon Project No. AR197210

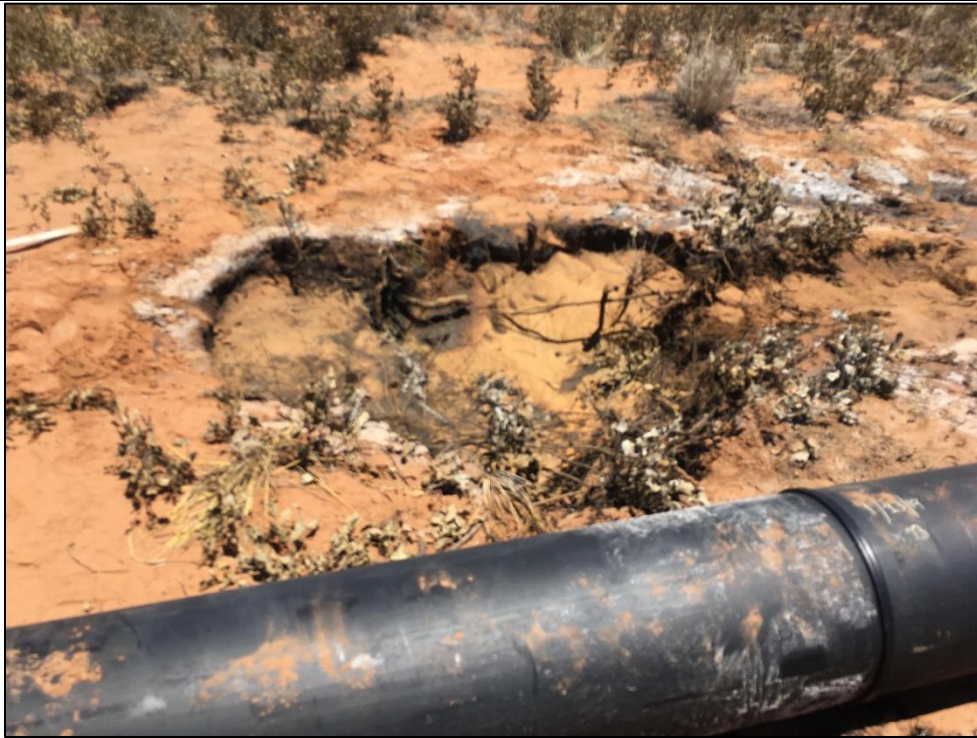
**PHOTO 1:** View of Release Origin, facing East. 6/07/2019

Initial source elimination was accomplished by the Solaris foreman shutting in the leaking line and replacing the failed pipe connection.

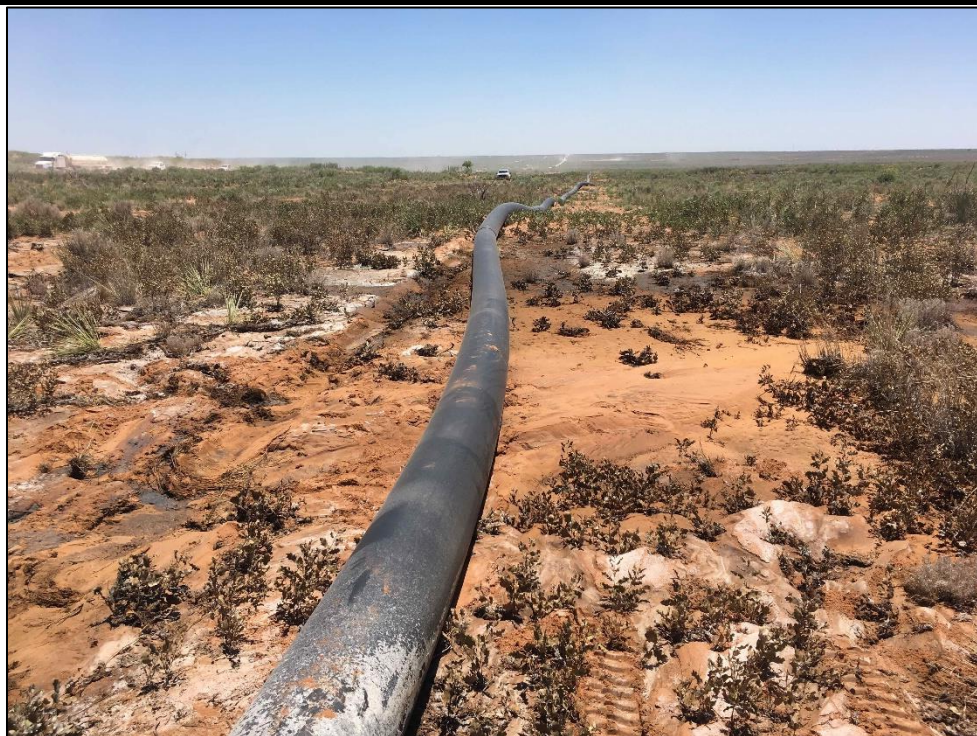
**PHOTO 2:** View of Release Origin, Facing South. 6/07/2019

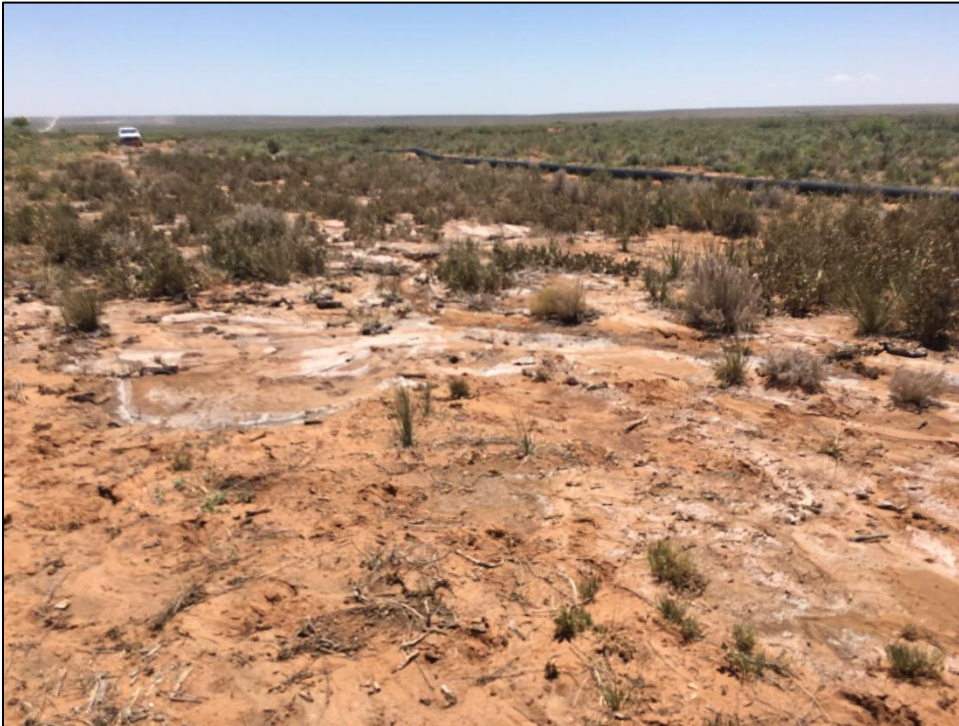
**PHOTO 4:** View of Eastern Edge of Delineation, facing Southwest. 6/07/2019

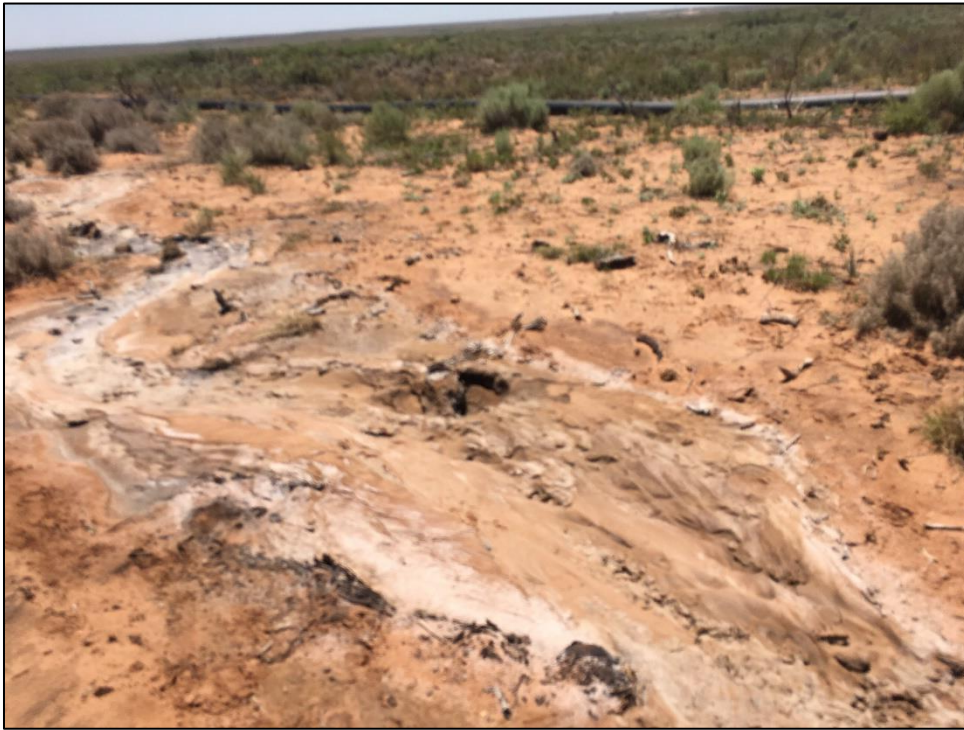
**PHOTO 5:** View of Release Flow Path, facing West. 6/07/2019

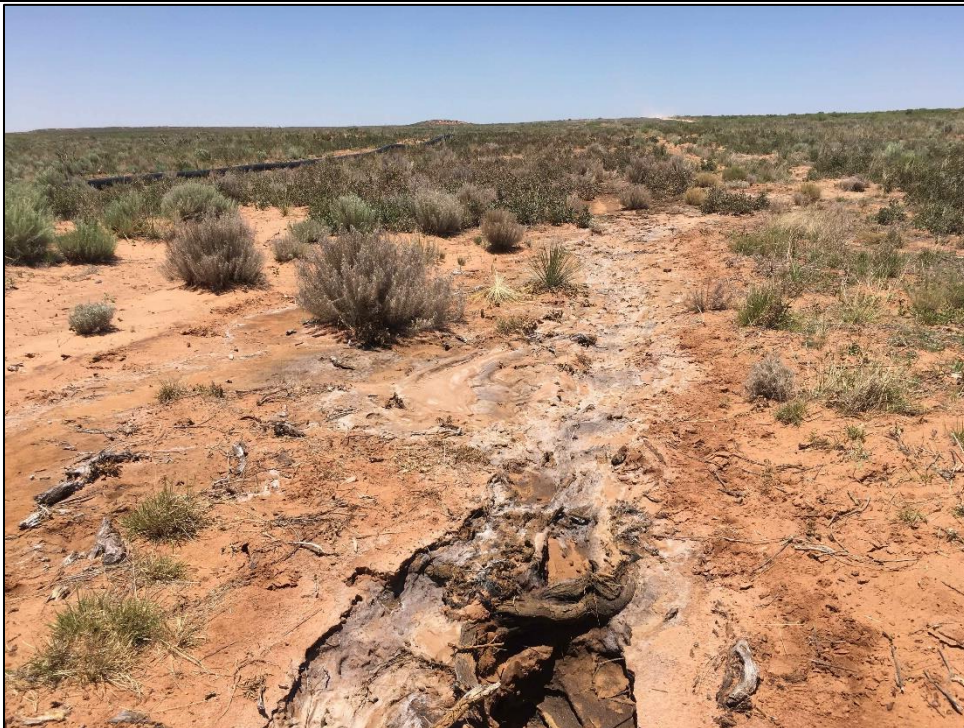
**PHOTO 6:** View of Release Flow Path, Facing North. 6/07/2019

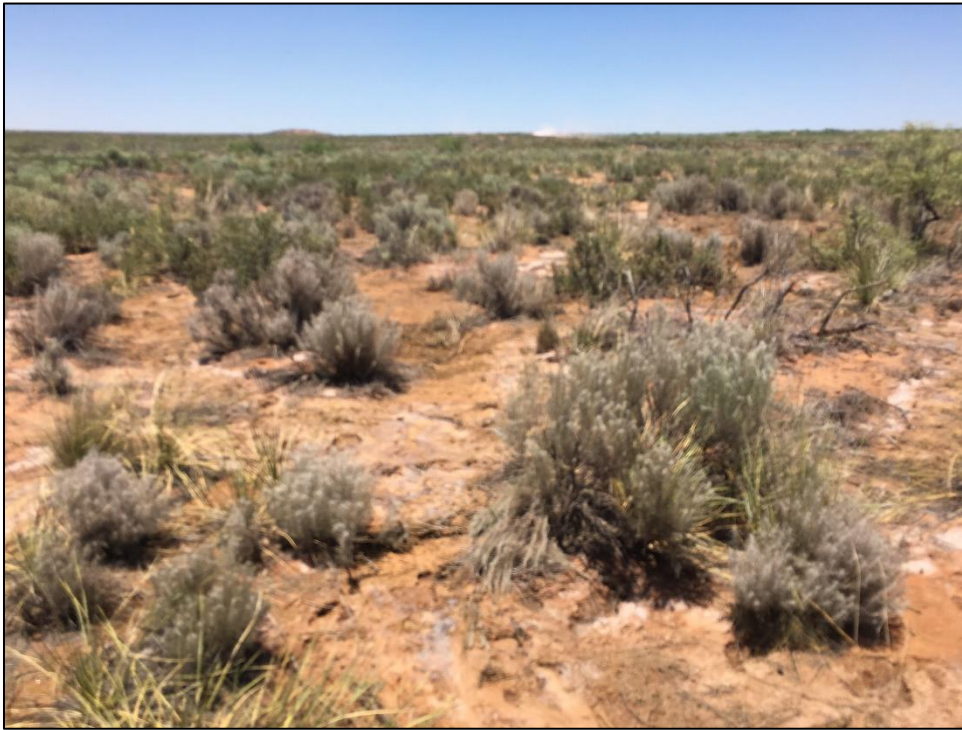
**PHOTO 7:** View of Release, Facing North. 6/07/2019

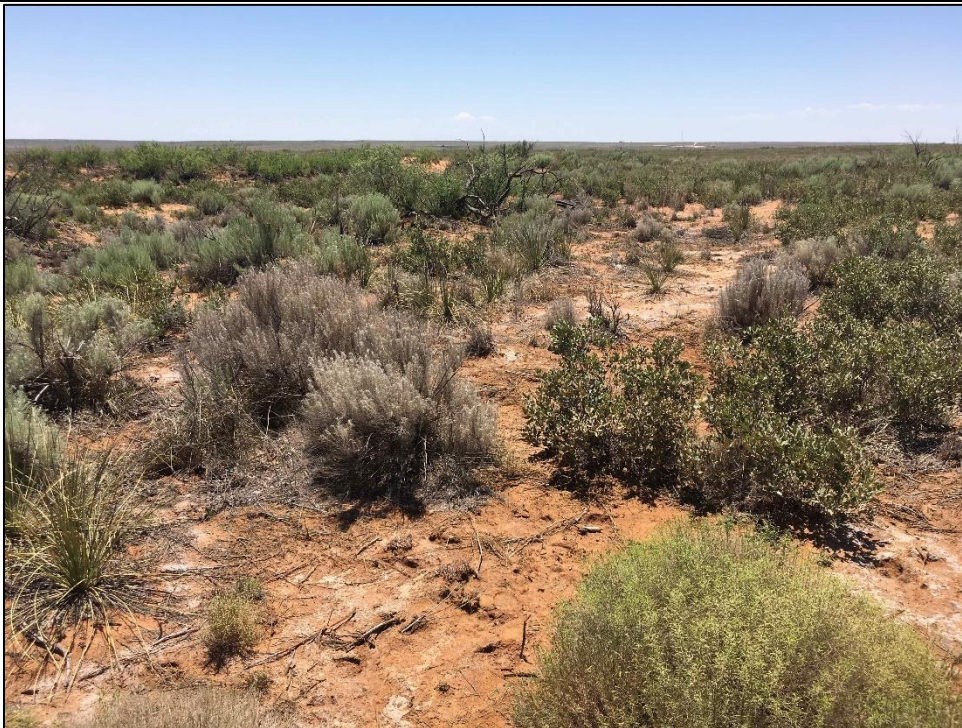
**PHOTO 8:** View of Release, Facing West. 6/07/2019

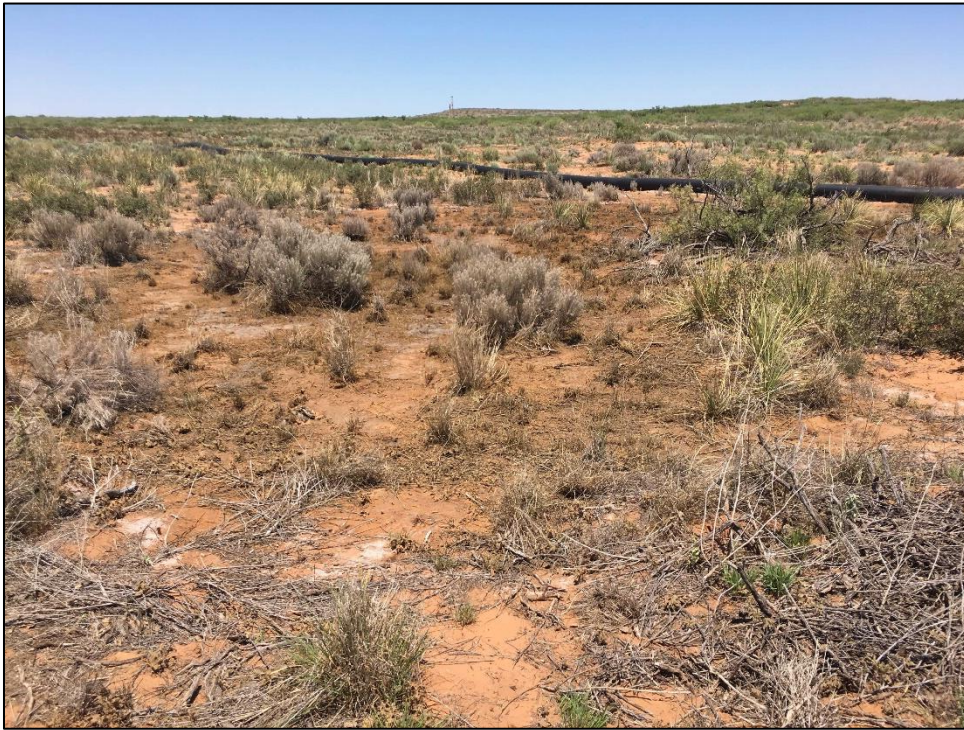
**PHOTO 9:** View of Release, Facing North East. 6/07/2019

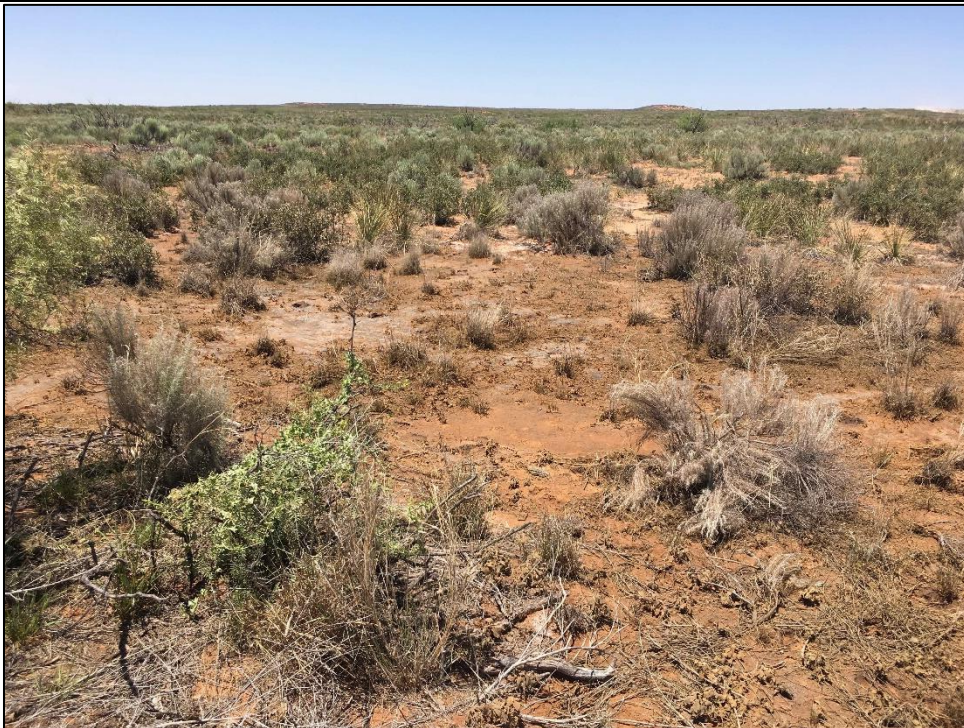
**PHOTO 10:** View of Release, Facing North. 6/07/2019

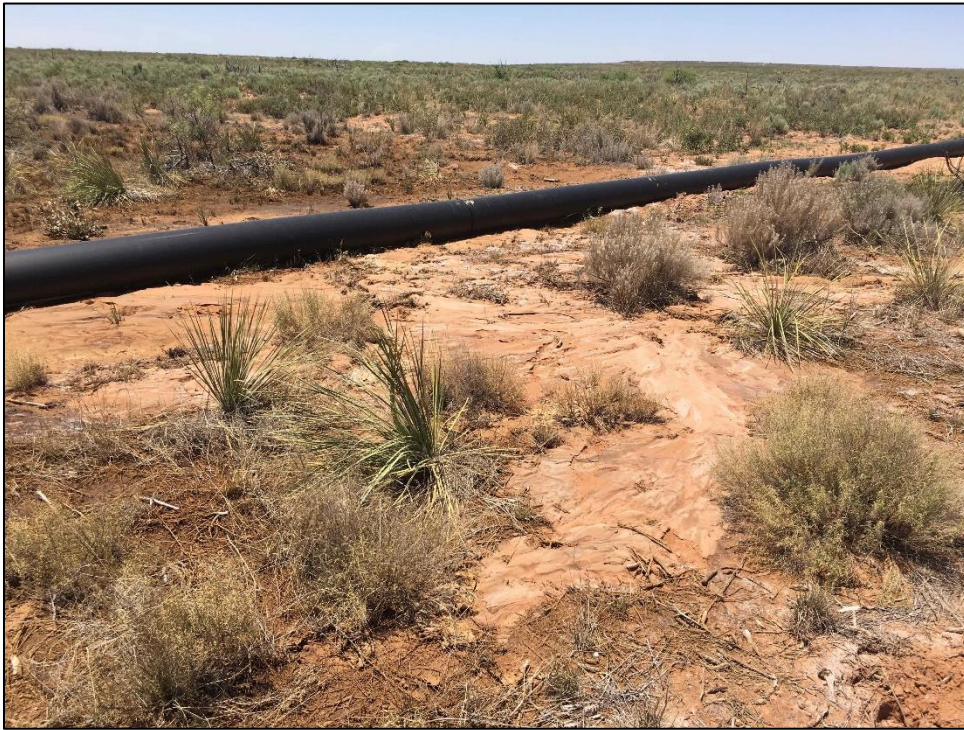
**PHOTO 11:** View of Southern End of Release, Facing West. 6/07/2019
