Release Notification

Site Name: Rojo 18/19 & 38/39 Tank Battery	Site Type: Tank Battery
Date Release Discovered: 1/31/2021	API# (if applicable) Nearest well: Rojo 7811 34-27 Federal #040H API #30-025-46097

Location Rojo 34-27 Fed Com 18/19 & 38/39 Tank Battery

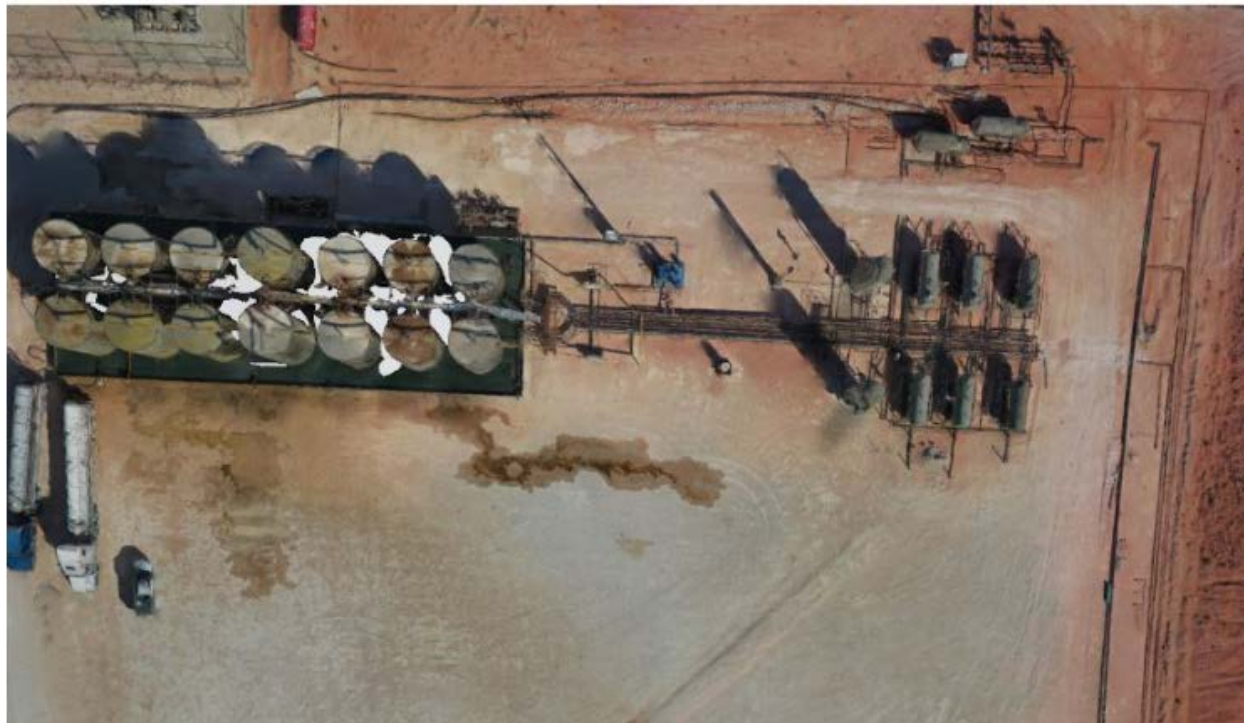
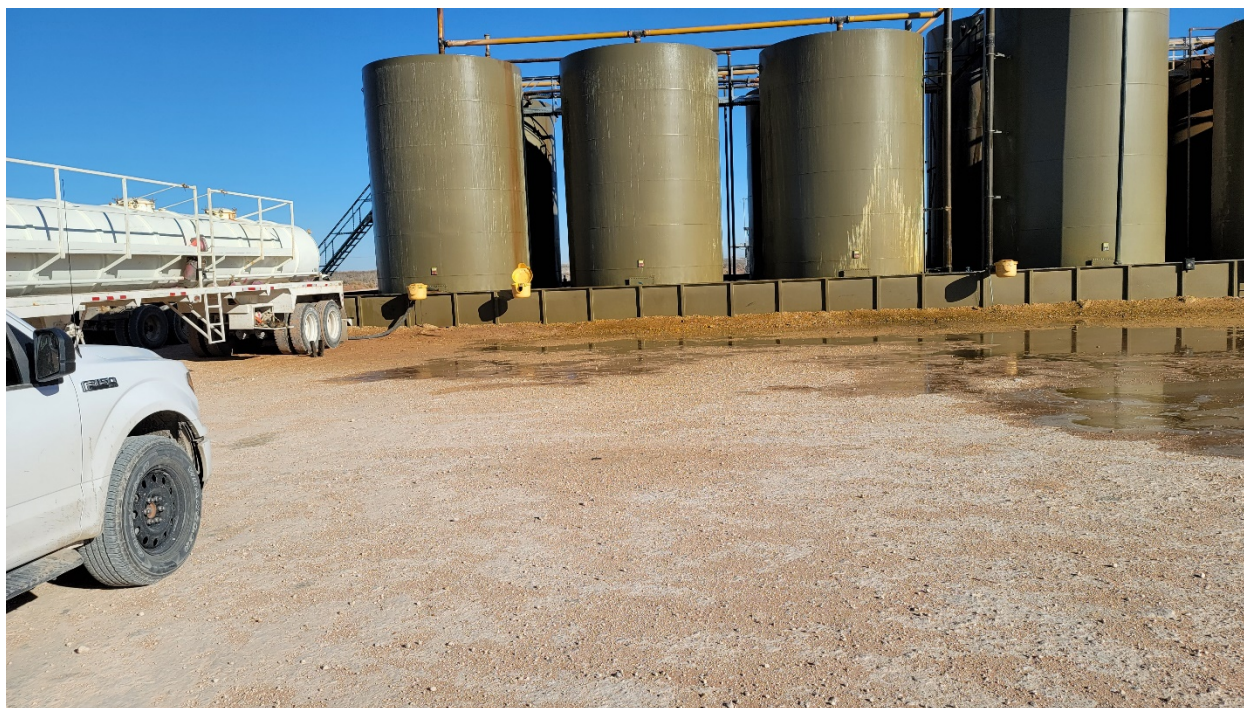
Rojo 34-27 Fed Com 18/19 & 38/39 Tank Battery
January 31, 2021

The PLC failed including failures of tank level measurement and a high-level alarm which caused a produced water tank to fill and overflow from the lined secondary containment volume at the tank battery. Produced water spilled onto the soil in the vicinity of the tank battery containment. Any soil that was wetted by the released fluid has been stockpiled on location.
(See attached spill calculation spreadsheet.)
