Re: Remediation Plan BTA Mesa B 8115 Federal Com #025H Incident ID: nAPP2112744758

RXSoil, Inc. is pleased to submit the remediation plan for the on-site remediation of impacted soil for the above release.

On behalf of BTA Oil Producers, LLC, RXSoil, Inc. ("RXSoil") has prepared this work plan that describes remediation of the above-mentioned produced water release.

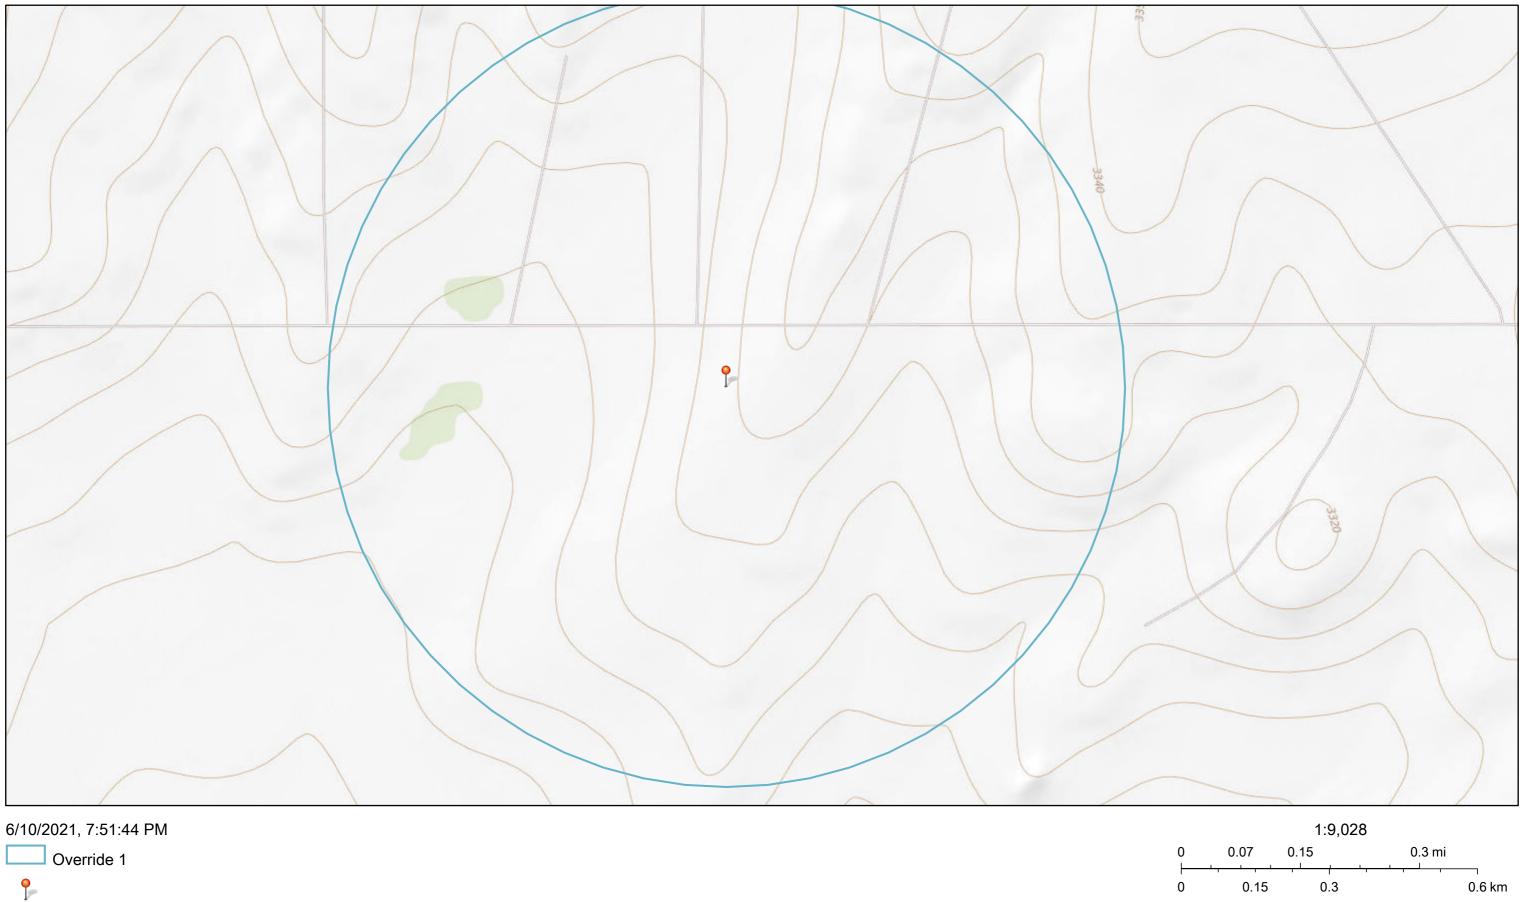
Figure 3 - Hydrology Map

- 3. **Wellhead protection area** There are no known water sources within a half mile of the release (see *Figure 3*).
- 4. **Distance to nearest significant watercourse** There is no known significant watercourse within a half mile, per USGS data.
