## Release Notification

Site Name Sandrock North Water Line (located approx. 1,090 ft northwest of the Payne 3E wellsite)	Site Type 4-inch Produced Water Line
Date Release Discovered 12/21/2021 @ 15:30 pm (MT)	API# 30-045-25953 (nearby Payne 3E wellsite)

**Subject: Remediation and Sampling Work Plan  
Sandrock North Water Line  
San Juan County, New Mexico  
NMOCD Incident Number: nAPP2200560379**

PROPOSED CONFIRMATION  
SAMPLING  
SANDROCK NORTH WATER LINE  
SAN JUAN COUNTY, NEW MEXICO  
HILCORP ENERGY COMPANY

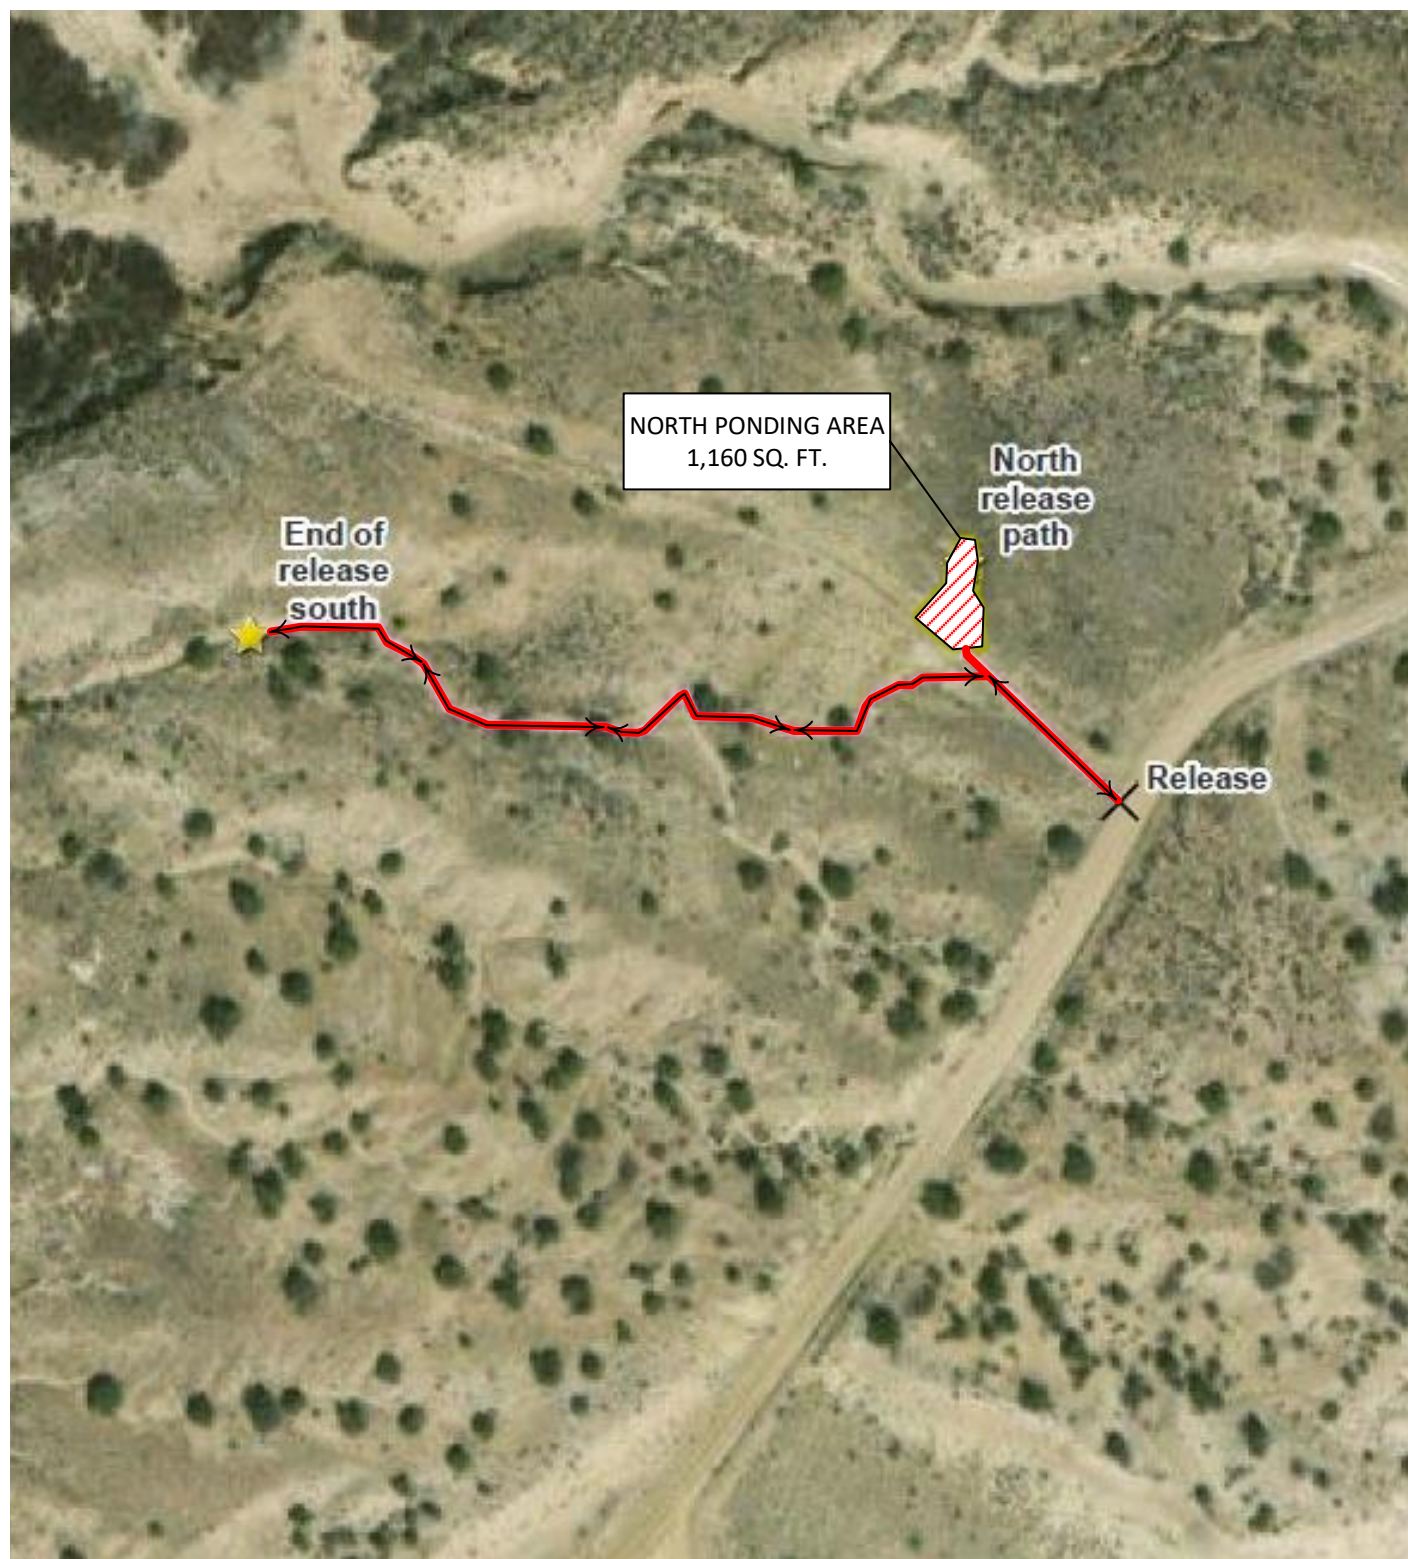
Figure: Proposed Confirmation Sampling

WSP conducted a site visit on January 27, 2022 to perform initial field screening of soils impacted by the produced water release. Based on the site visit, it appears that the majority of the released fluids migrated approximately 100 linear feet to the northwest from the pipeline down a two-track road. The fluids then ponded in a depression to the north of the two-track road and impacted an area measuring approximately 1,160 square feet. Based on field screening using Hach® chloride test strips, elevated chloride concentrations are predominantly present in the depression from the ground surface to approximately 6 to 12 inches below ground surface (bgs). Additionally, a thin stream of produced water also flowed west of the depression and into a small ephemeral wash. The produced water flowed overland in a thin stream approximately 1-foot wide and, based on field screening, impacted shallow soils along the pathway of the release (up to approximately 3 inches bgs). The total flow path of the release is approximately 450 linear feet. The attached figure shows the approximate release flow path and location of the depression.

Based on the above information, WSP and Hilcorp propose to mechanically remove impacted soil at the site and collect confirmation soil samples. In the ponding area, 5-point composite samples will be collected at a frequency of one sample per 200 square feet. Because of the narrow and shallow nature of the release in the flow areas of the two track road and wash, WSP and Hilcorp propose to collect one 5- point composite sample every 100 linear feet along the path of the release (this equates to a total of five composite samples). The attached figure depicts the approximate sampling areas proposed for this work.

- RELEASE PATH, APPROX. 450 LINEAR FEET
- ↔ CONFIRMATION SAMPLING AREAS, APPROX. 90 LINEAR FEET
