Site Characterization Work Plan
Saunders Salt Water Disposal #002 Release Site
Sabinal Energy Operating LLC
Incident ID: nSAP0230839785, nSAP0230537114, nSAP0232539443, nSAP0335031519, nSAP0335640026
N 03 15S 33E, Lea County, New Mexico

Project No. 12571917
Date January 2022

SITE LOCATION MAP

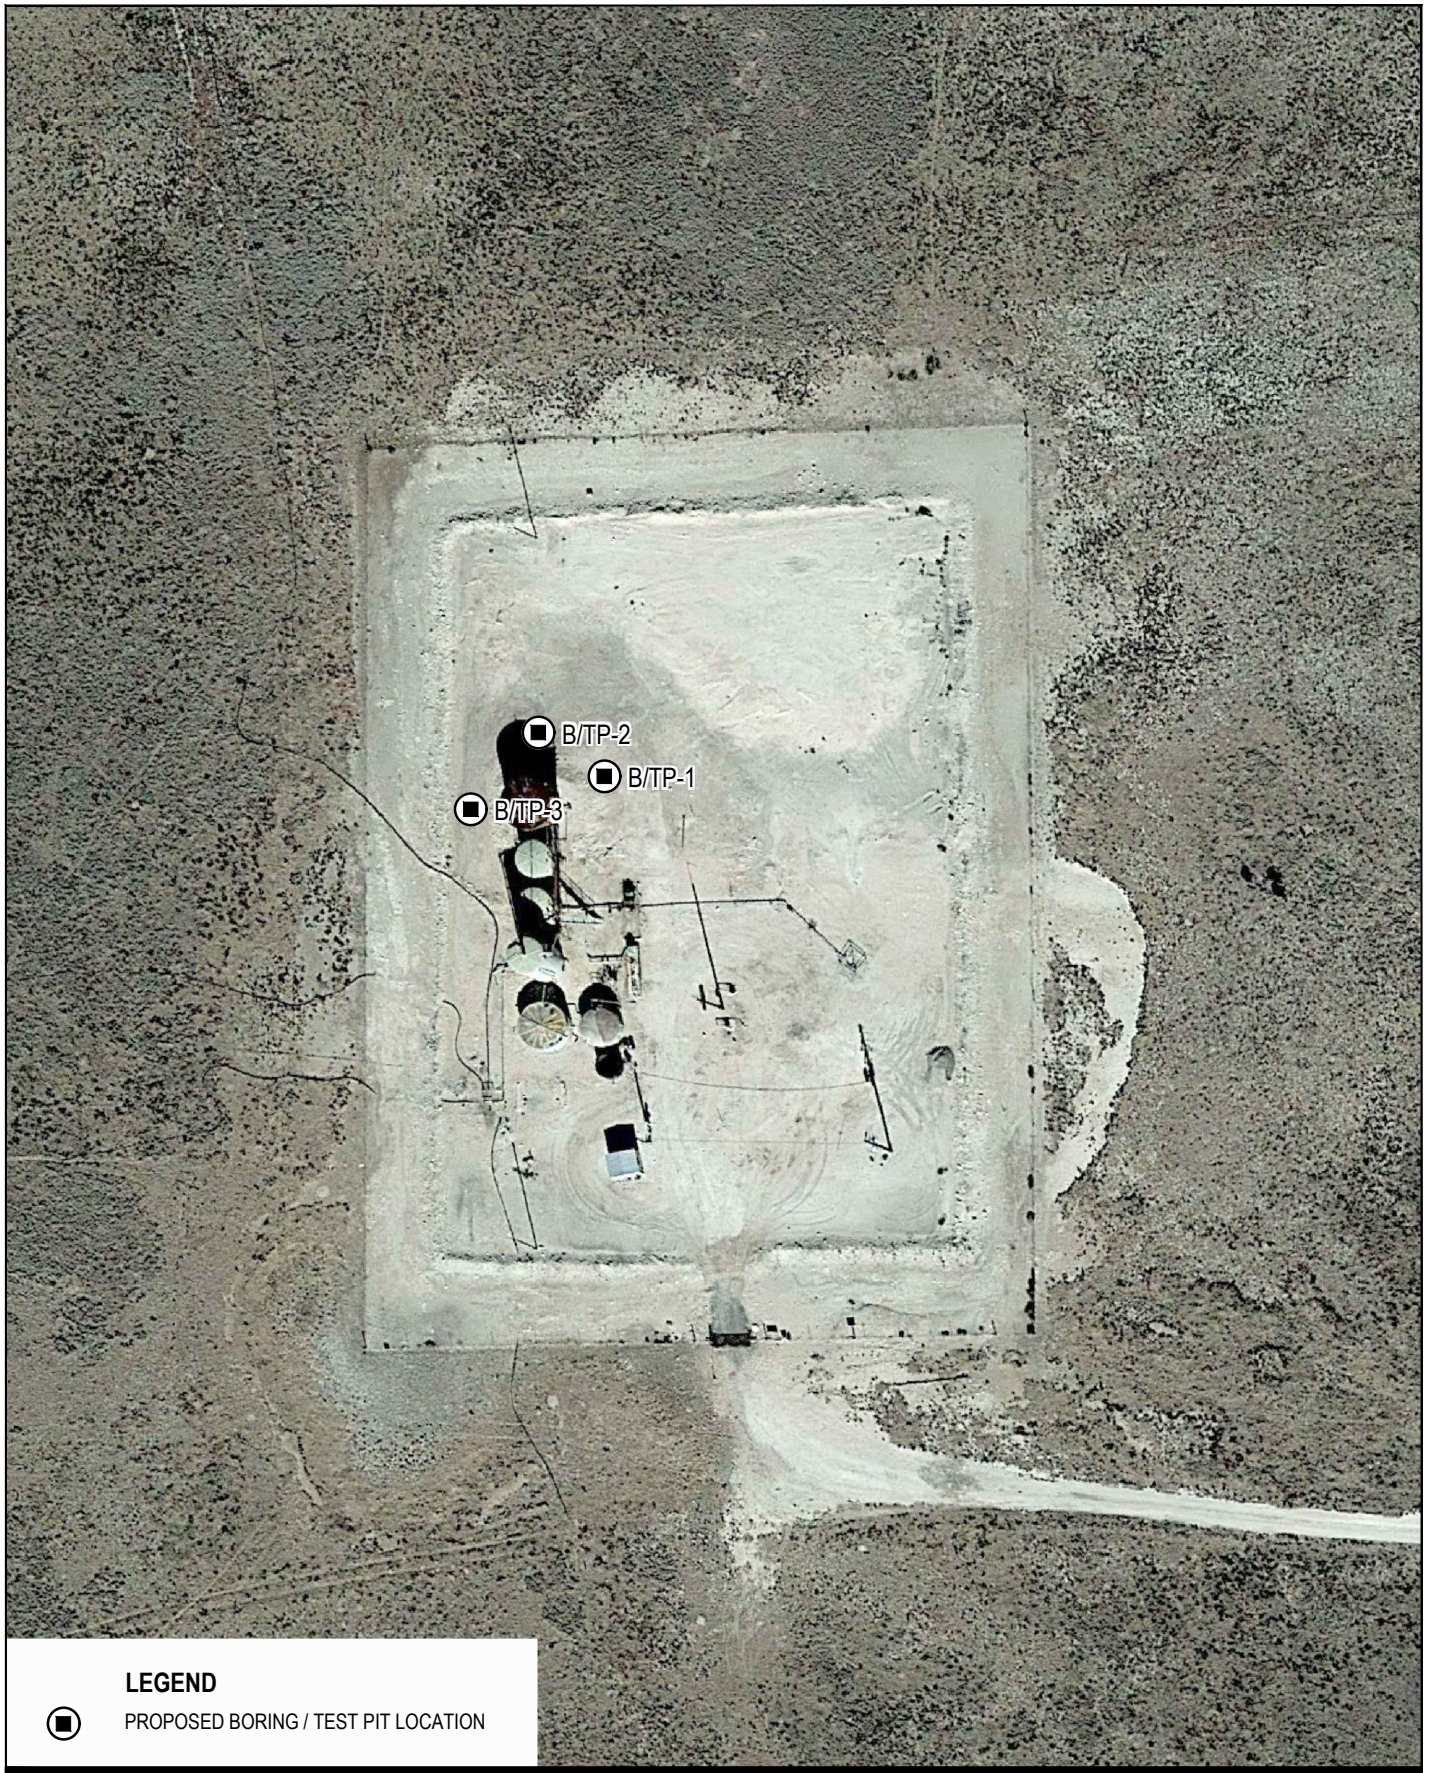
Three borings are proposed to assess historical releases associated with incidents nSAP0230839785, nSAP0230537114, nSAP0232539443, nSAP0335031519, and nSAP0335640026. Refer to Figure 2 for proposed boring locations. Borings will be advanced via hand auger to 4 ft bgs, if refusal is not met. Two soil samples will be collected per boring - one from approximately 1 ft bgs and one from the bottom of the boring. All soil samples will be analyzed for BTEX by Environmental Protection Agency (EPA) Method 8021B, TPH by Method 8015B Modified, and chloride by EPA Method 300.
