Release Notification

Site Name Questar CDP	Site Type Gas Well
Date Release Discovered 12/3/21	API# (if applicable)

Tank overflow

Questar CDP Spill Closure

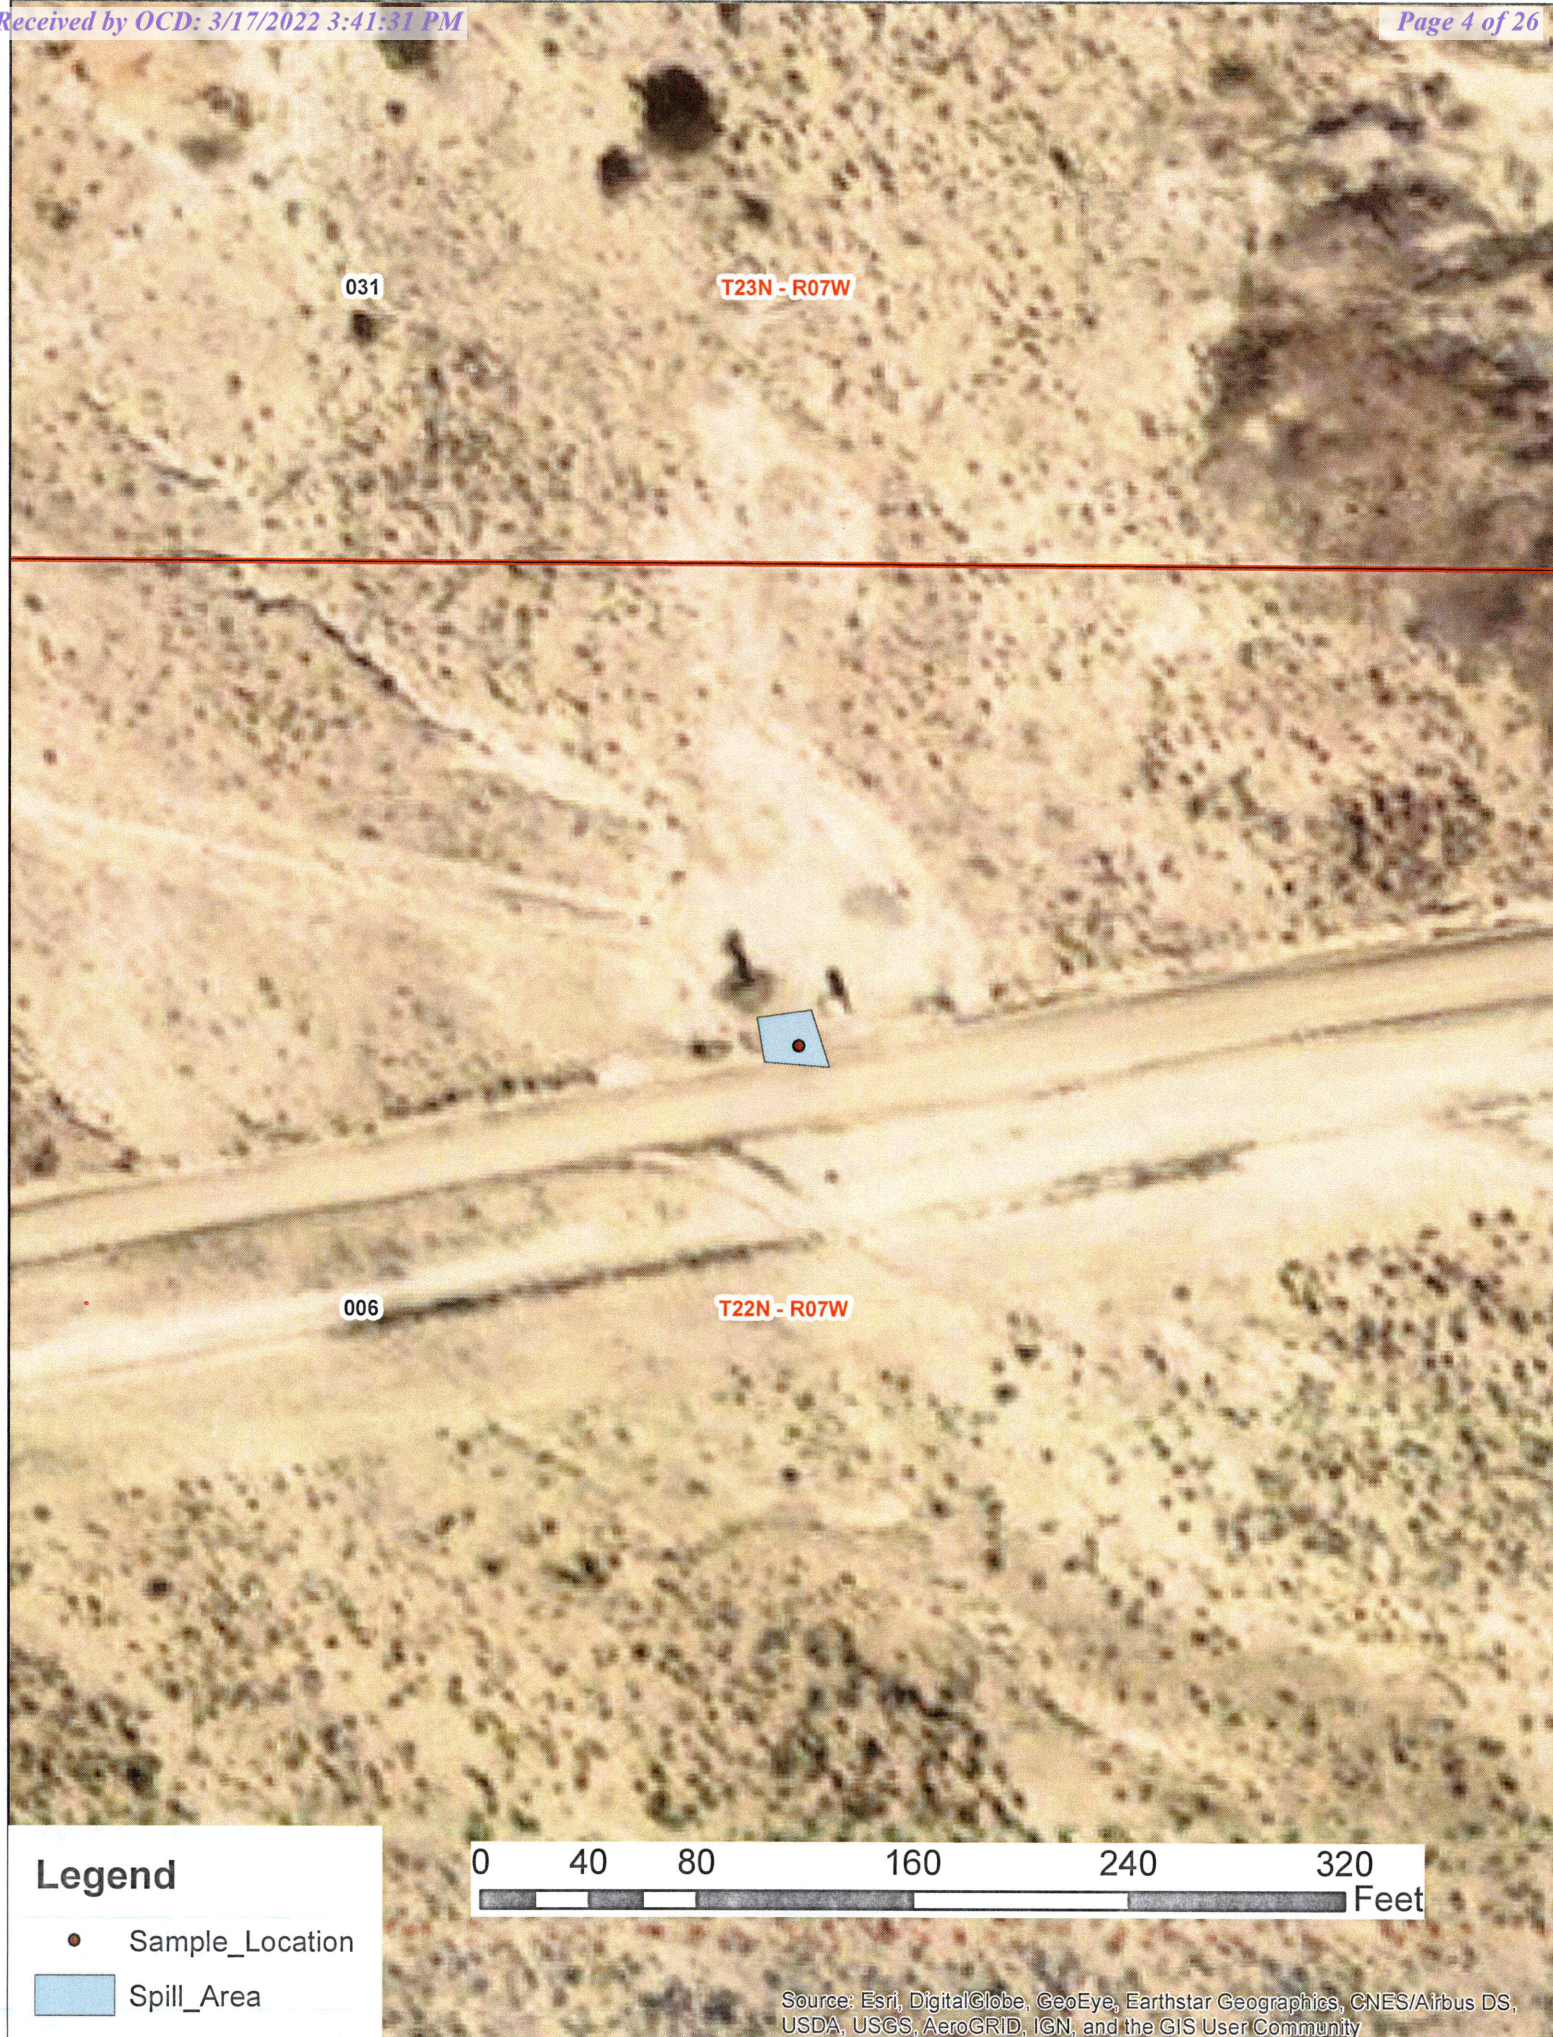
Sampling Diagram

• Sample_Location

Spill_Area

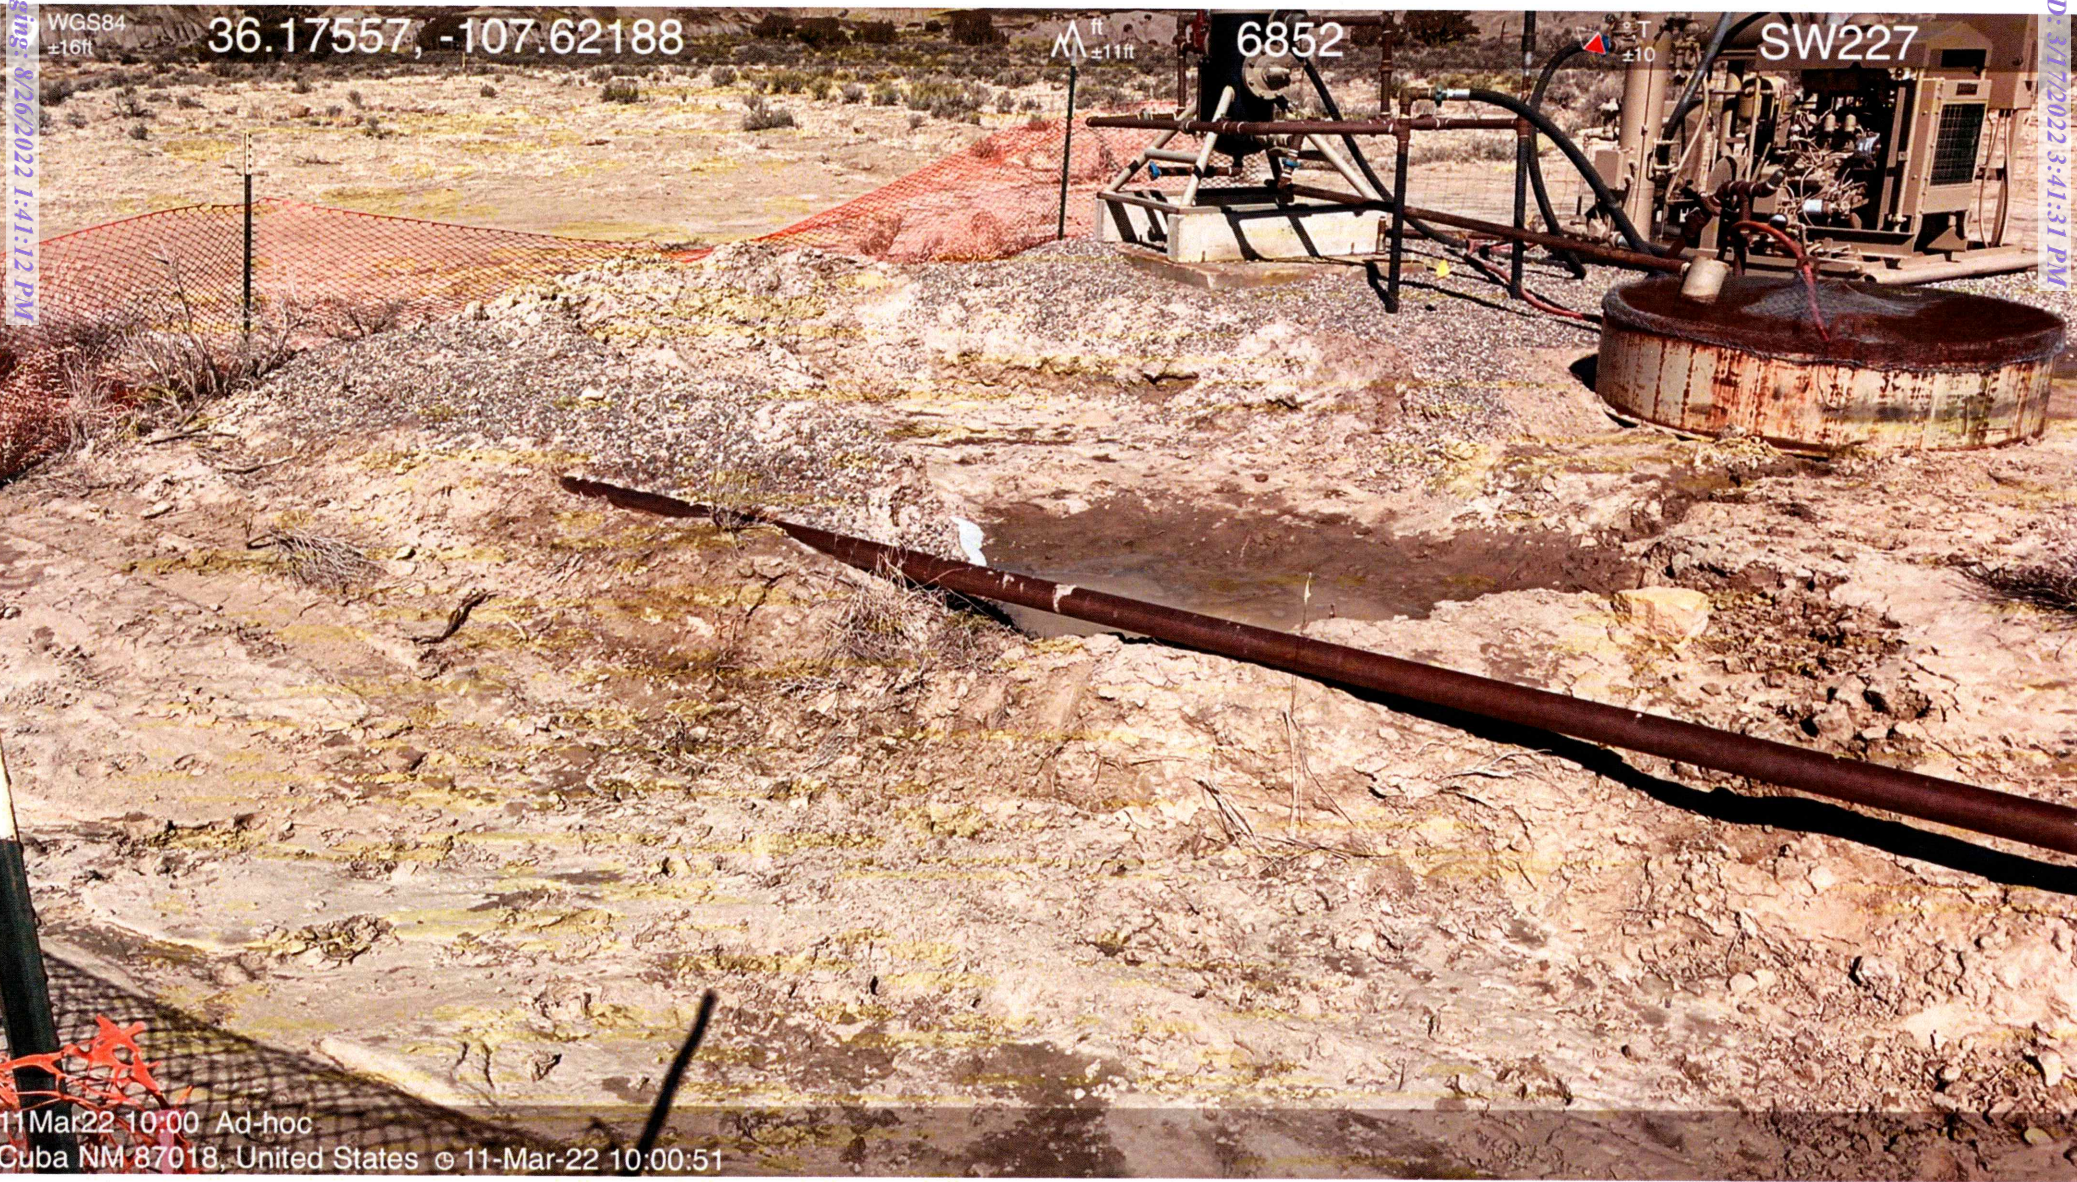
36.17557, -107.62188

11Mar22 10:00 Ad-hoc
Cuba NM 87018, United States © 11-Mar-22 10:00:51

The spill area was separated into the area surrounding a compressor scrubber container and a small area slightly below the storage container. The surface soils were removed and less than 1 dump box was hauled to Envirotech for remediation. The soils beneath were tested for Chlorides and it was found the soils were clean enough to proceed with back fill (less than 600 mg/kg chlorides).

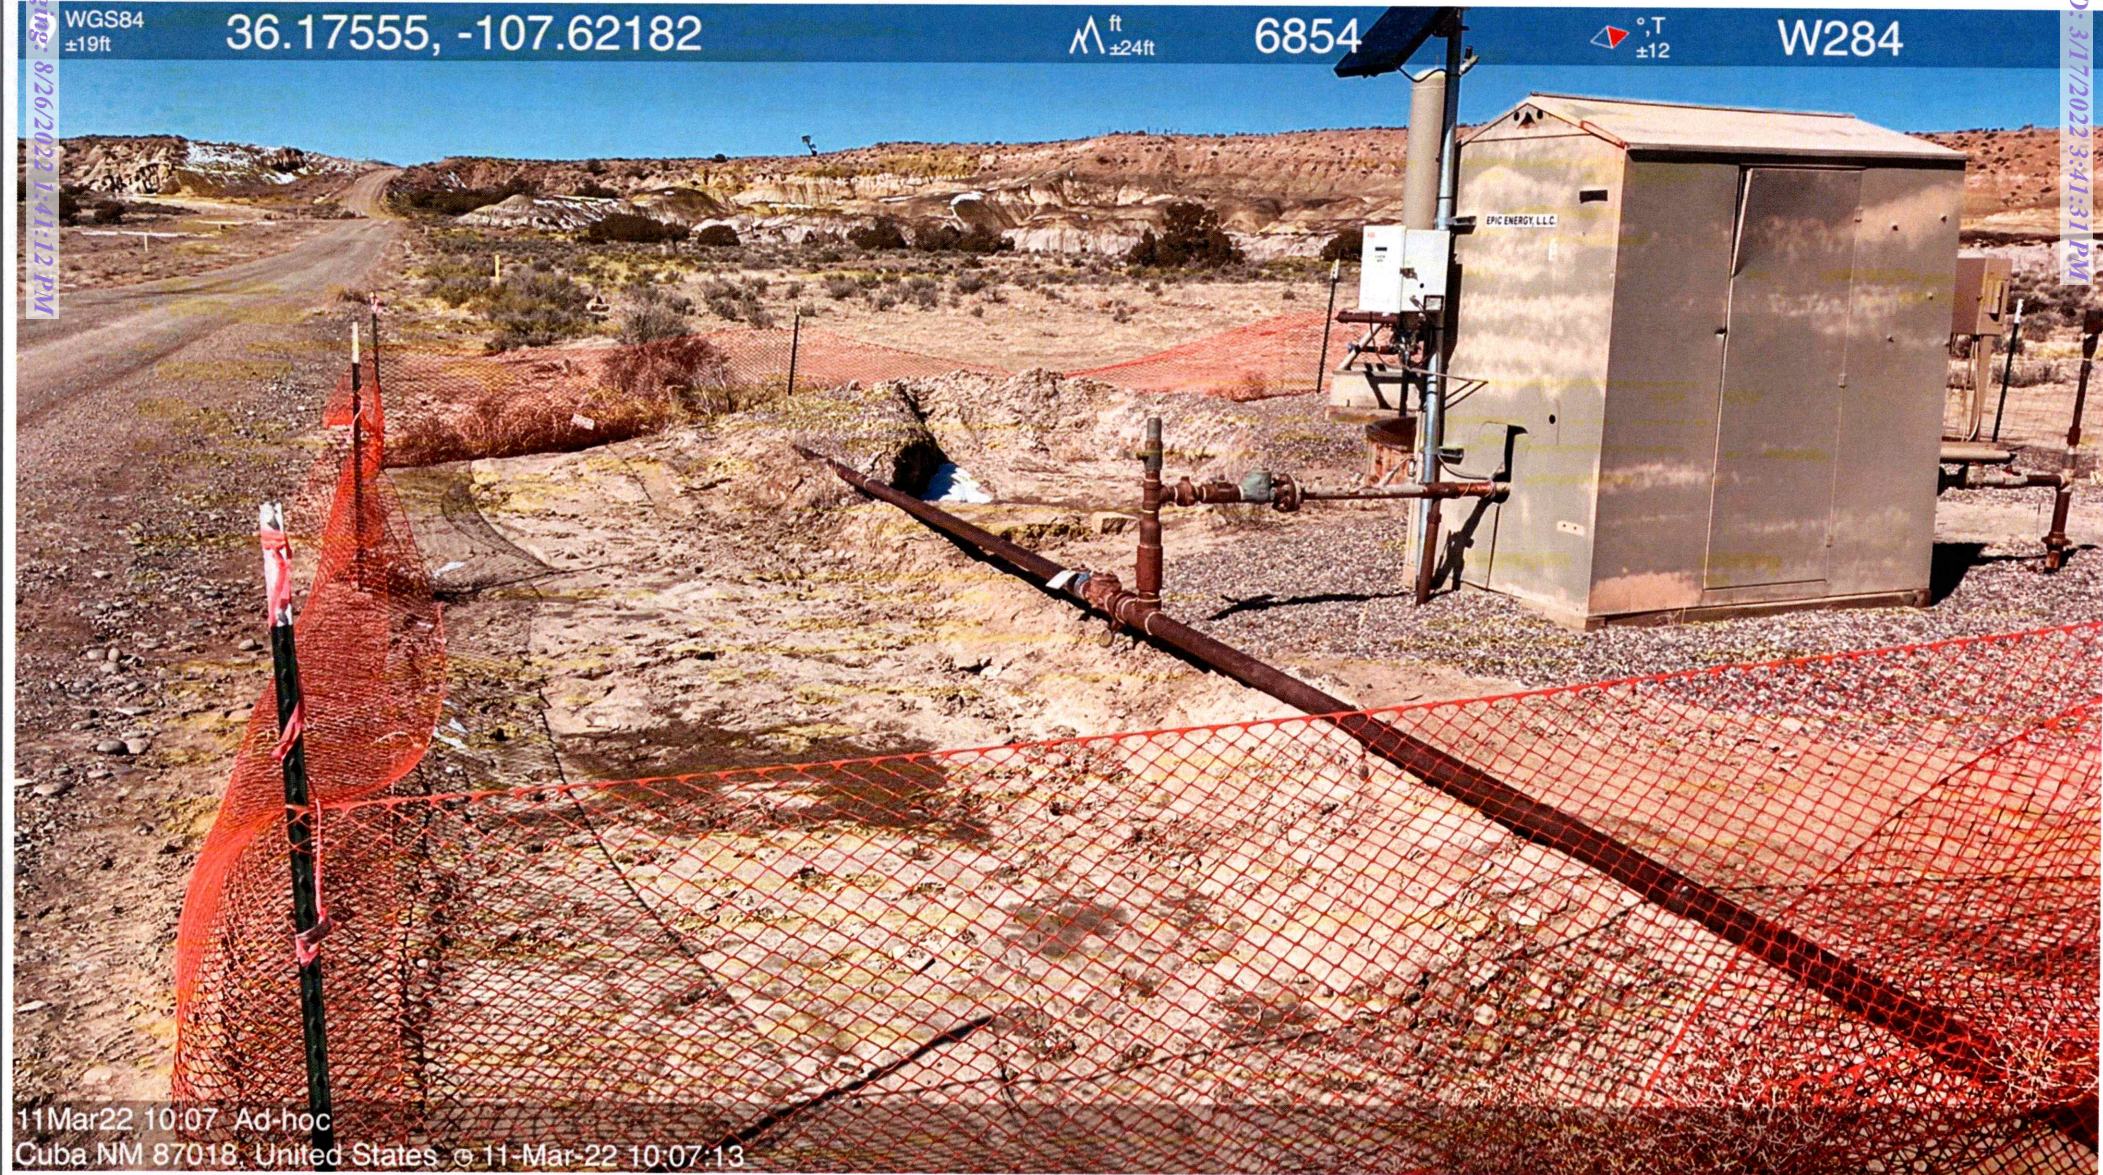
36.17555, -107.62182

11Mar22 10:07 Ad-hoc
Cuba NM 87018, United States © 11-Mar-22 10:07:13
