Incident ID	nAPP2226533583
District RP	
Facility ID	
Application ID

## Release Notification

Site Name: Culebra Bluff West 15 CTB	Site Type: oil
Date Release Discovered: 9-14-22	API# (if applicable)

Cause of Release: Valve washed out from the bottom due to sand.

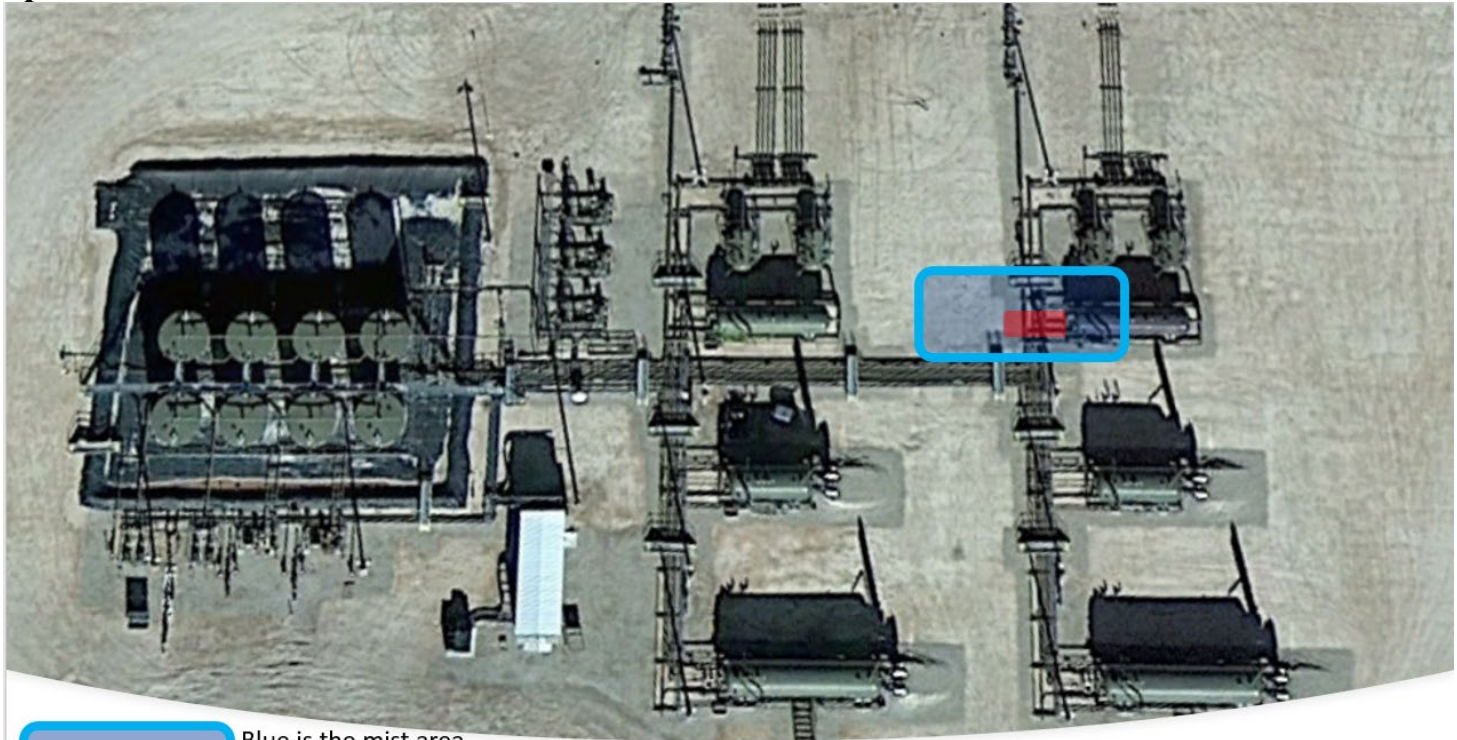
## Spill Calculations:

Blue is the mist area  
70ft x 50ft x 0.125in x 0.125in (Soil Penetration)  
Light Blue outline is the total area 90ft x 60ft

Red is the saturated area  
20ft x 10ft x 1in x 1.25in (Soil Penetration)
