Closure Report

Jack Sleeper Com 19 16 23S 28E #121H
Eddy, New Mexico
Incident # **nAPP2216854617**
N-04-23S-28E

Subject: **Closure Report**
Jack Sleeper Com 19 #121H
Eddy County, New Mexico
Incident # nAPP2206640765

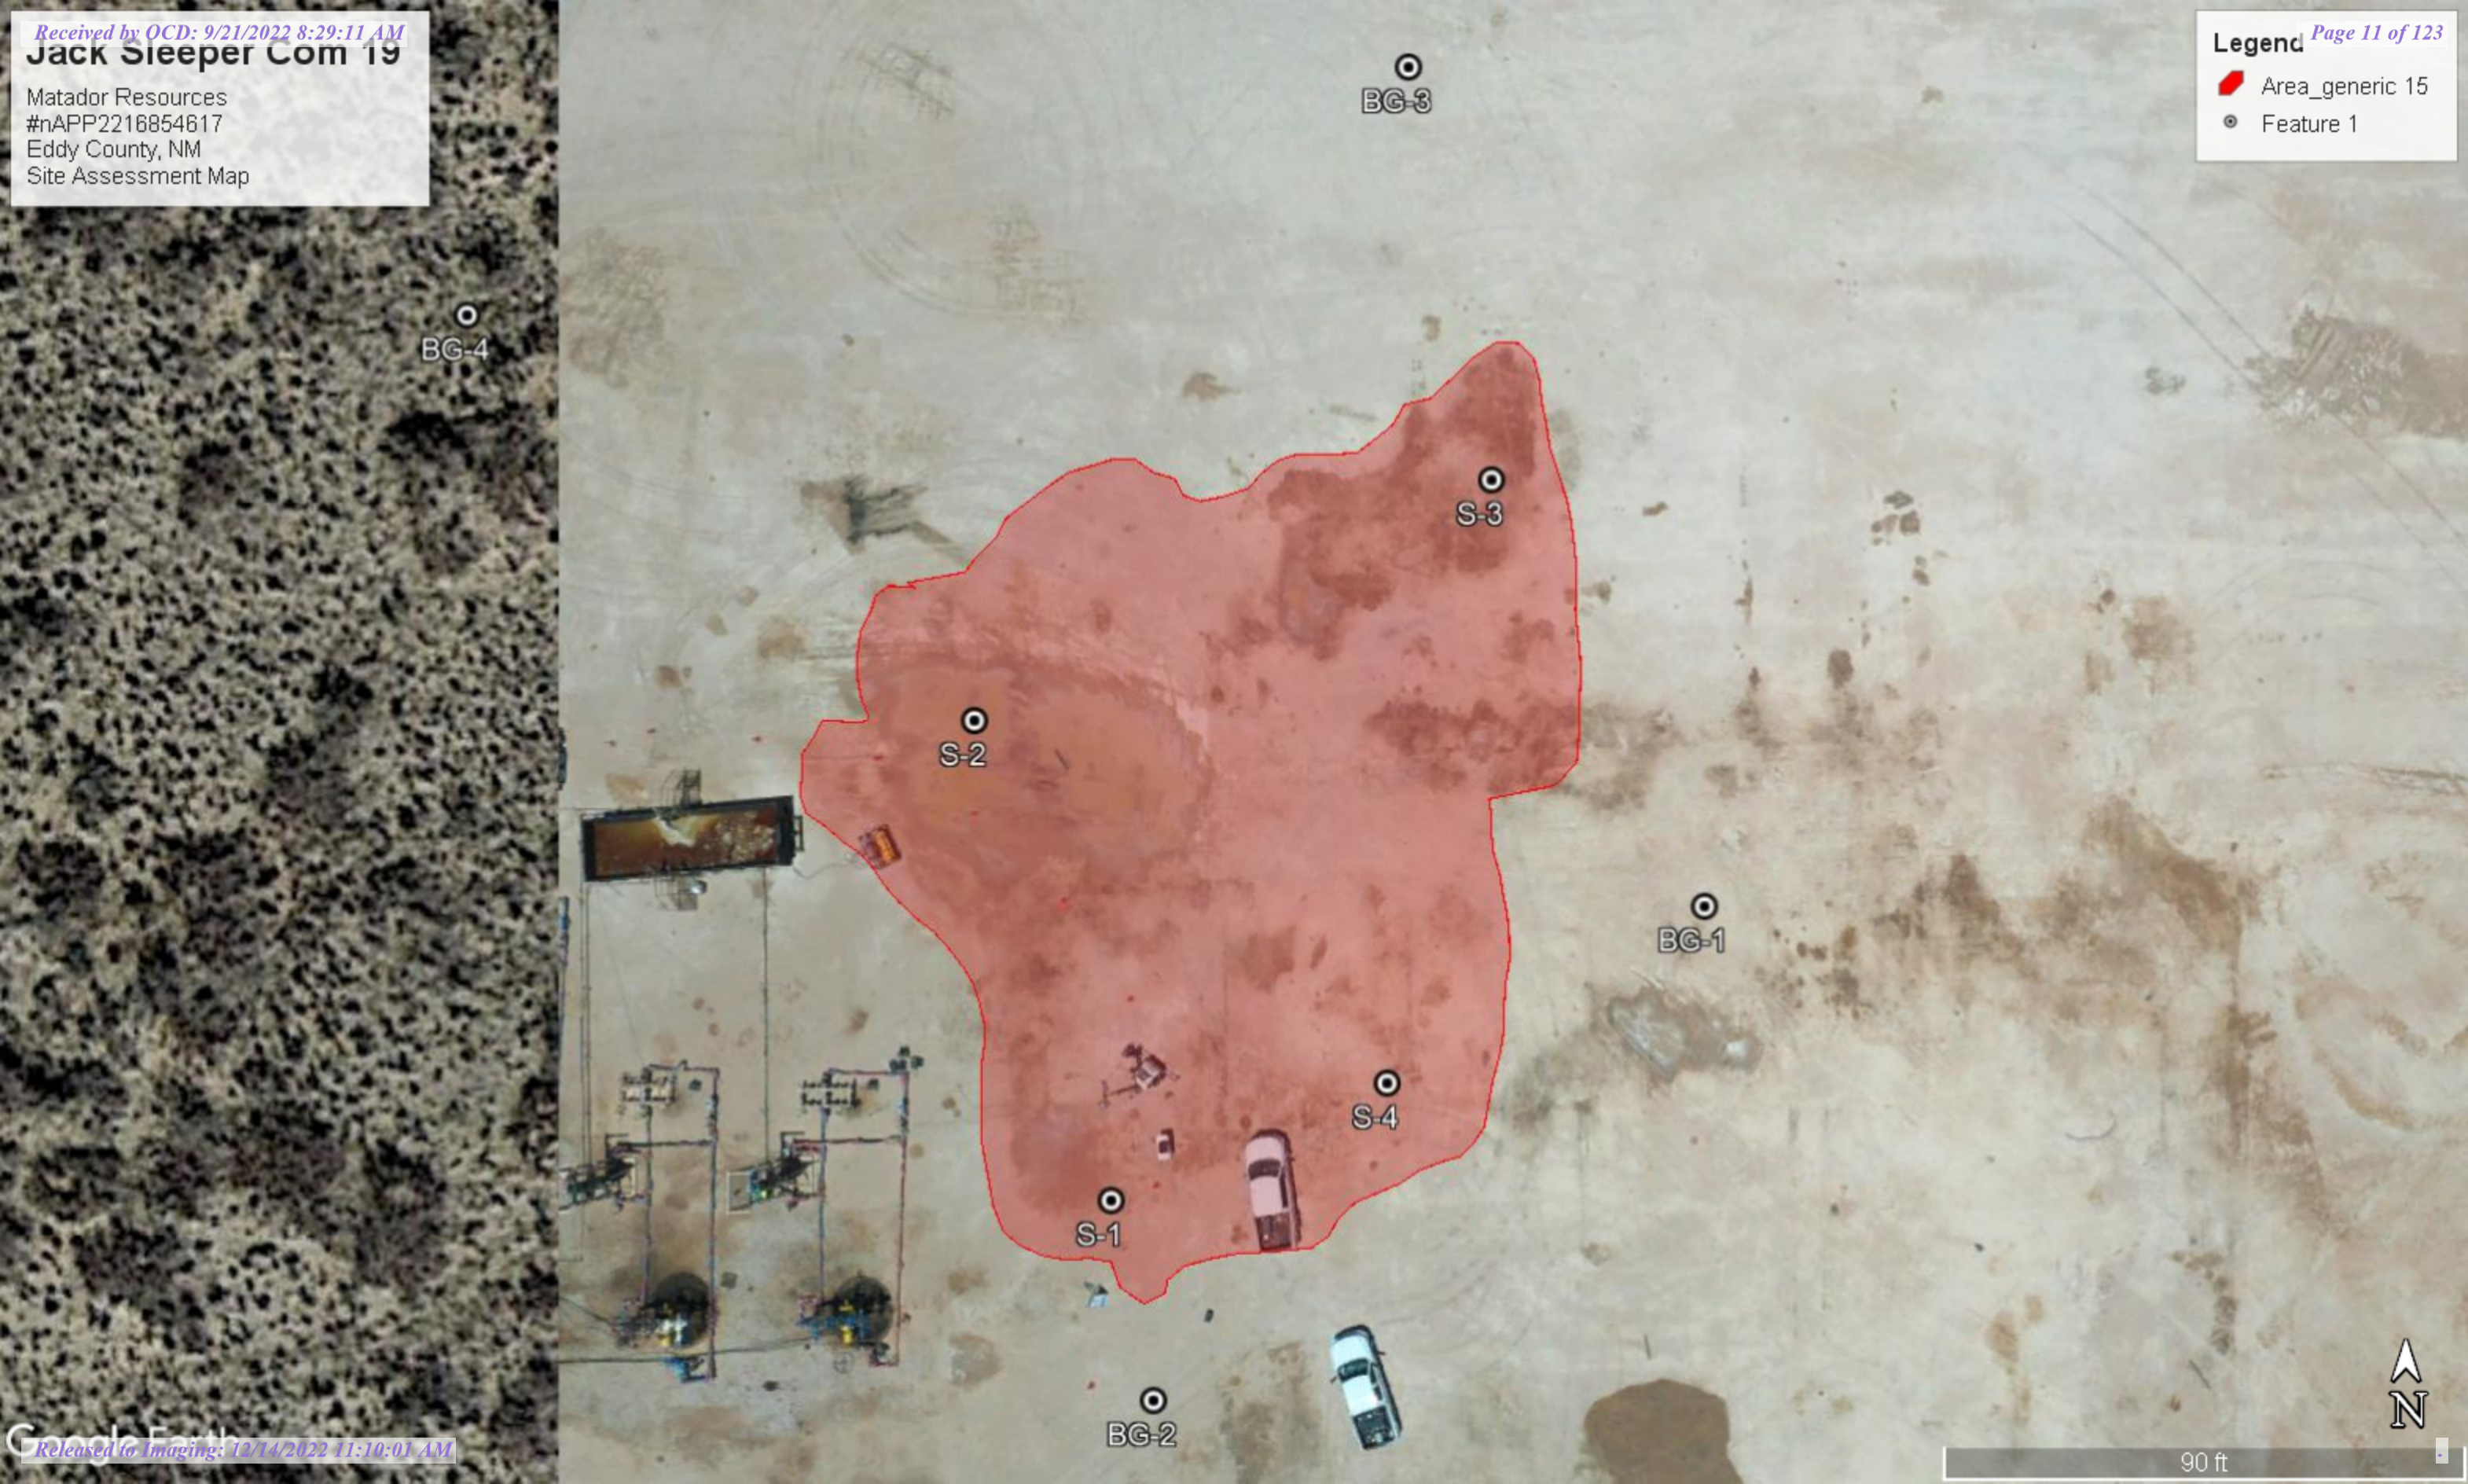
- 0.5' Excavation
- 1.5' Excavation
- 2.5' Excavation
- SW
- Jack Sleeper Com 19
- Sample Sites

- Background and sidewall samples were collected and analyzed in order to verify that horizontal remediation had been achieved in accordance with NMOCD clean-up criteria. All surface staining was removed and general housekeeping completed.

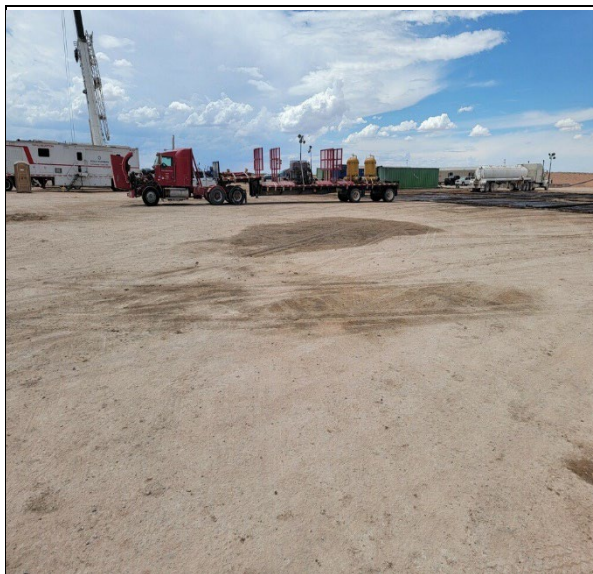
**Photograph No.1 Description:**

Spill Footprint Pad Area

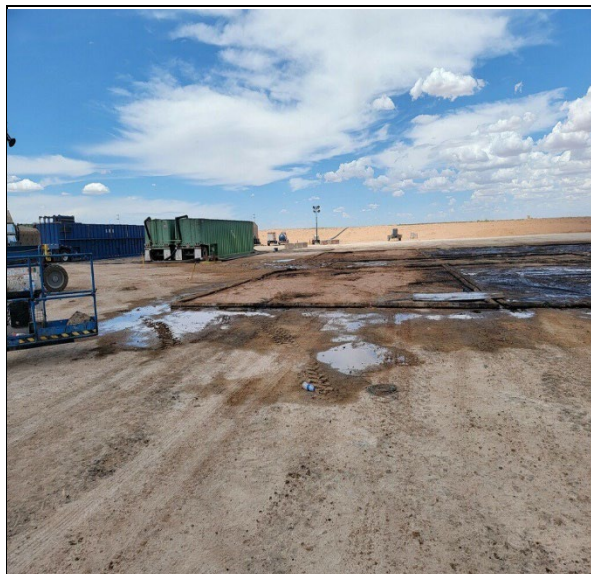
**Photograph No.2 Description:**

Impact from Frac Tanks

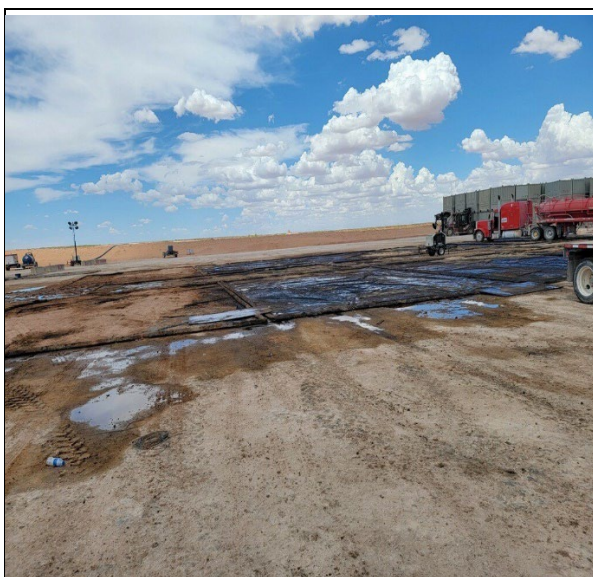
**Photograph No.3 Description:**

Standing Fluid

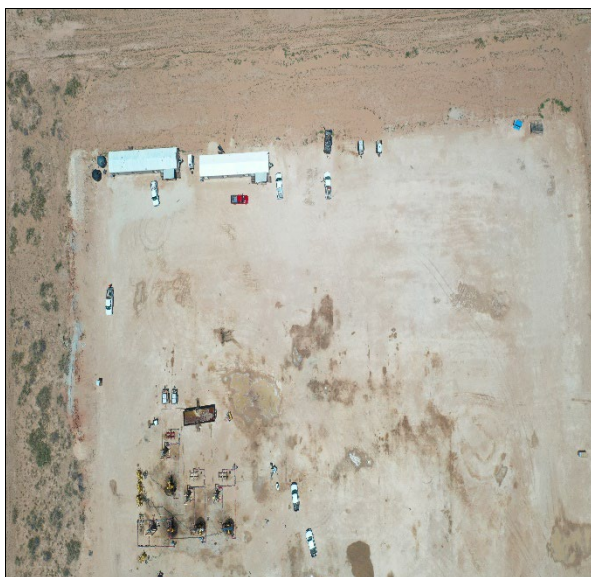
**Photograph No.4 Description:**

Aerial View of Impacted Pad.

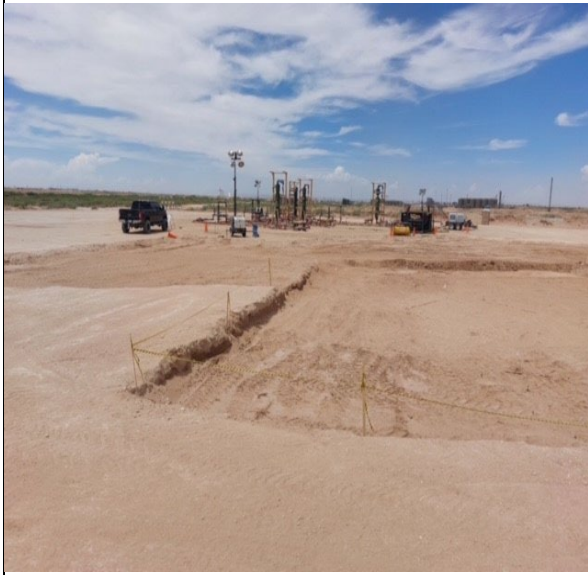
Photograph No.5 Description:

Backfill of excavation.

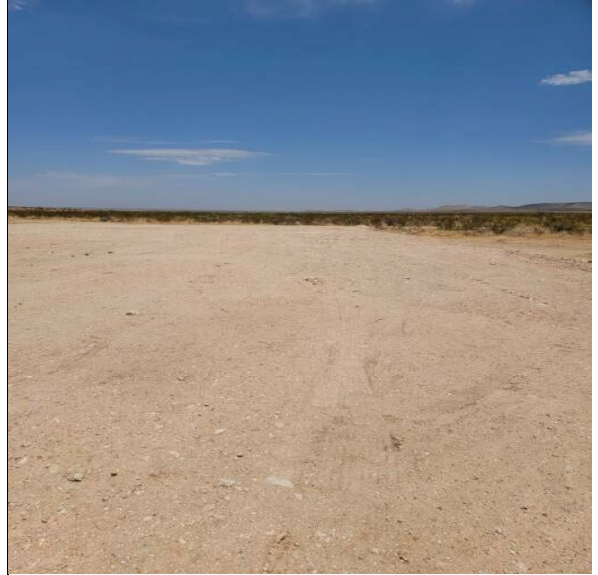
Photograph No.6 Description:

Site restored to grade.
