State of New Mexico Oil Conservation Division

Closure Report Attachment Checklist: Each of the following items must be included in the closure report.

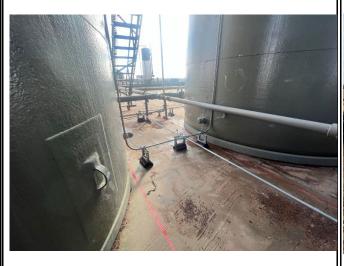
Description: View of the liner in containment deemed to be in good condition.
