Closure

Closure Criteria Worksheet			
Site Name: Coyote 12" Steel Line			
Spill Coordinates:		X: 32.788931	Y: -104.160235
Site Specific Conditions		Value	Unit
1	Depth to Groundwater	257	feet
2	Within 300 feet of any continuously flowing watercourse or any other significant watercourse	51,146	feet
3	Within 200 feet of any lakebed, sinkhole or playa lake (measured from the ordinary high-water mark)	17,923	feet
4	Within 300 feet from an occupied residence, school, hospital, institution or church	20,167	feet
5	i) Within 500 feet of a spring or a private, domestic fresh water well used by less than five households for domestic or stock watering purposes, or	6,236	feet
	ii) Within 1000 feet of any fresh water well or spring	6,236	feet
6	Within incorporated municipal boundaries or within a defined municipal fresh water field covered under a municipal ordinance adopted pursuant to Section 3-27-3 NMSA 1978 as amended, unless the municipality specifically approves	No	(Y/N)

An initial site inspection of the spill area was completed on August 18, 2022, which identified the area of the spill specified in the initial C-141 Reports, estimated the approximate square footage of the area and began

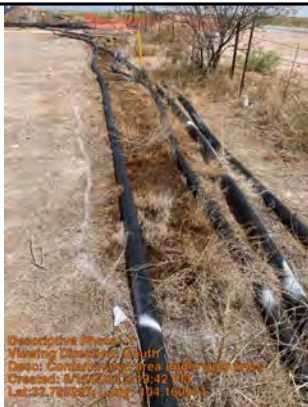
Viewing Direction: South

Contaminated area under poly lines

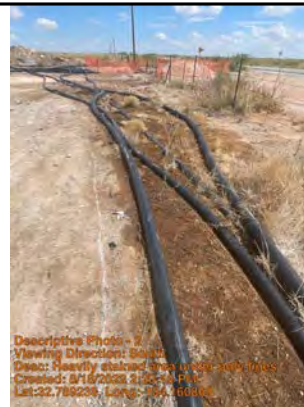
Viewing Direction: South

Heavily stained area under poly lines

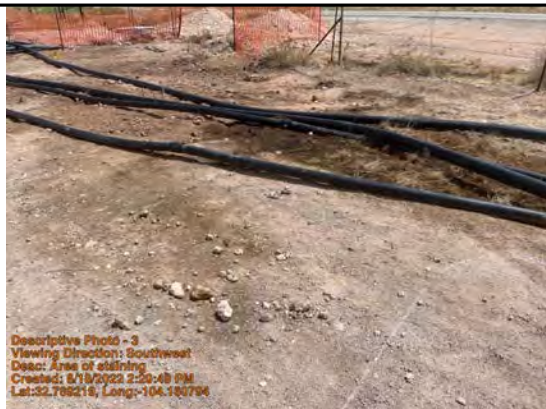
Viewing Direction: Southwest

Area of staining

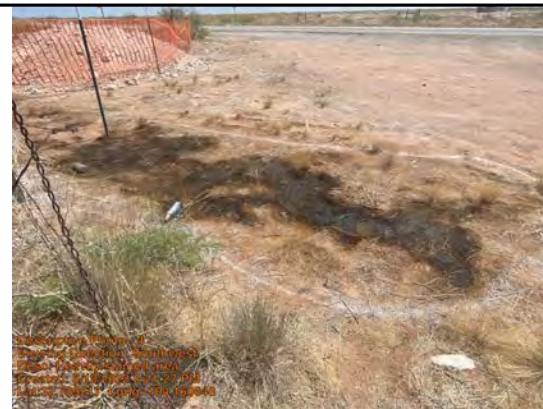
Viewing Direction: Southwest

Heavily stained area

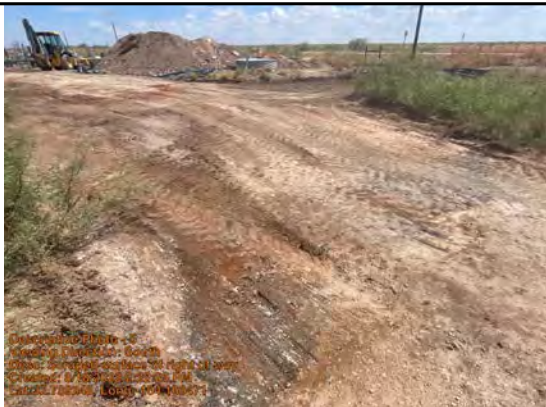
Viewing Direction: South

Scraped surface of right of way

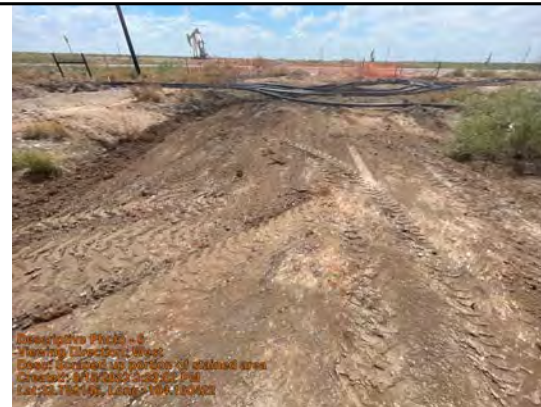
Viewing Direction: West

Scraped up portion of stained area near poly lines

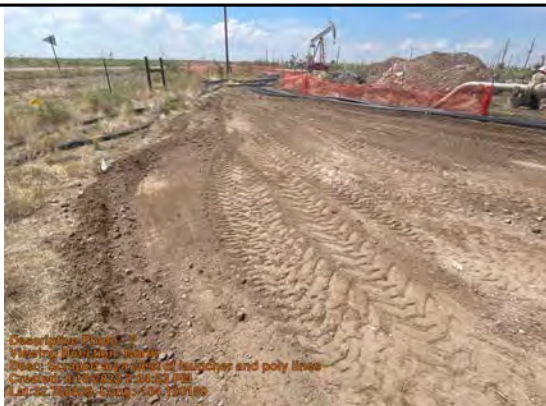
Viewing Direction: North

Scraped area west of launcher and poly lines

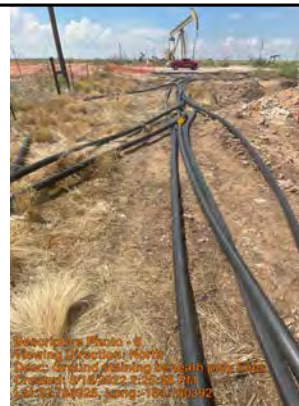
Viewing Direction: North

Ground staining beneath poly lines

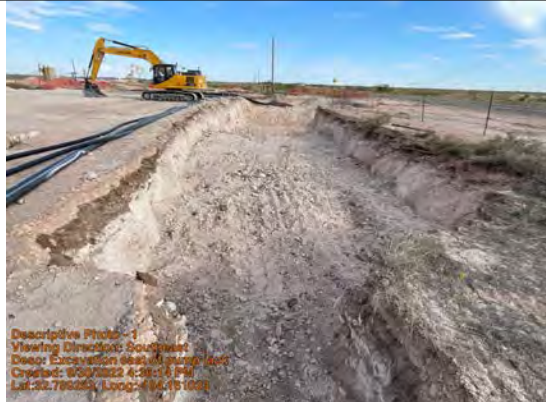
Viewing Direction: Southeast

Excavation east of pump jack

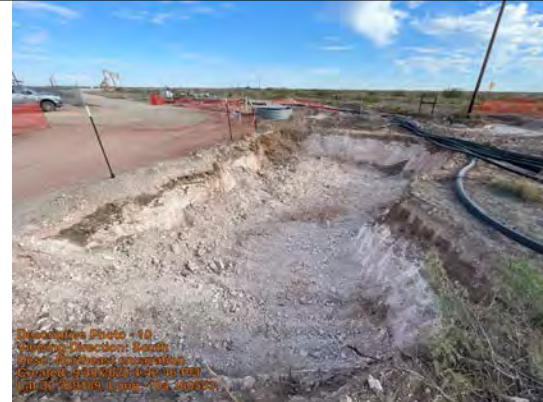
Viewing Direction: South

Northeast excavation

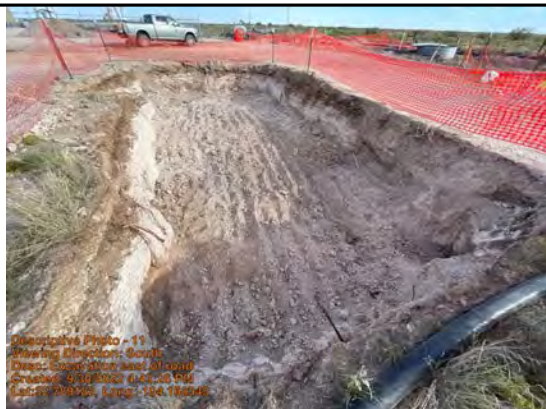
Viewing Direction: South

Excavation east of road

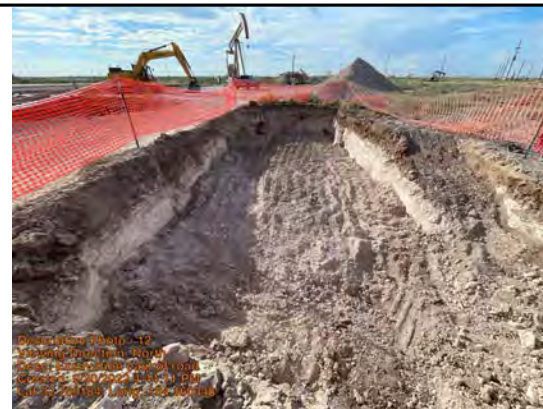
Viewing Direction: North

Excavation east of road

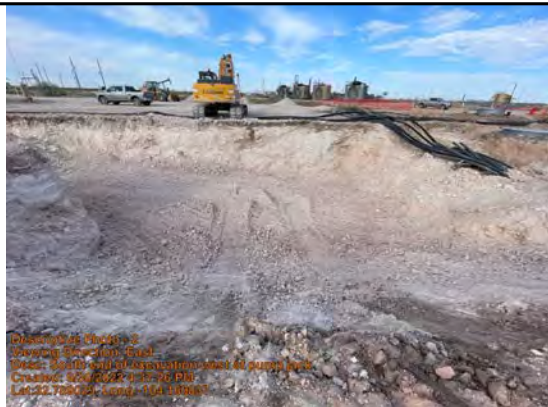
Viewing Direction: East

South end of excavation west of pump jack

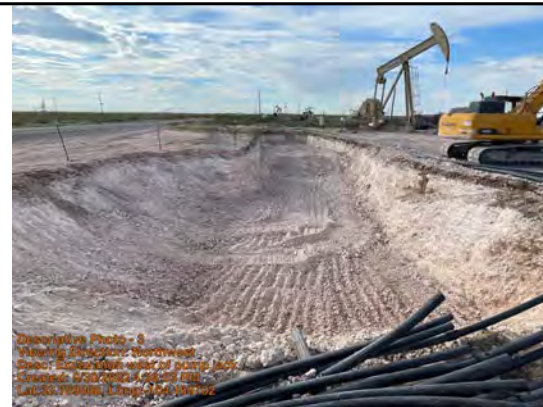
Viewing Direction: Northwest

Excavation west of pump jack

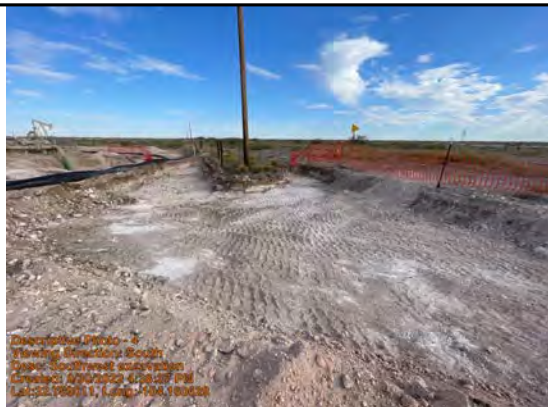
Viewing Direction: South

Southwest excavation

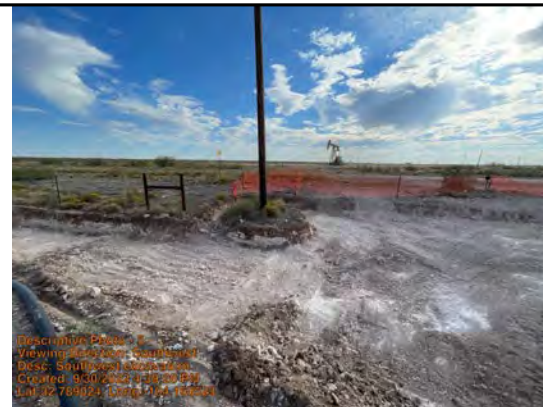
Viewing Direction: Southwest

Southwest excavation

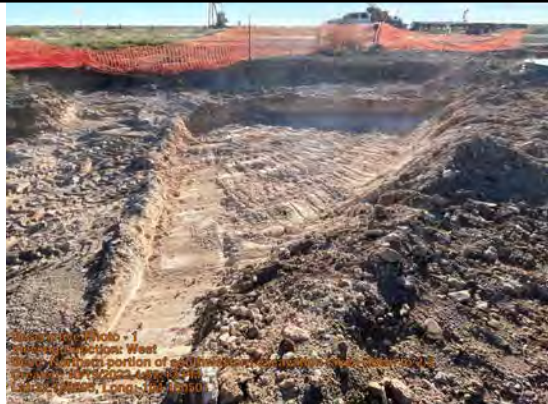
Viewing Direction: West

Northern portion of southwestern excavation taken down to 2.5'

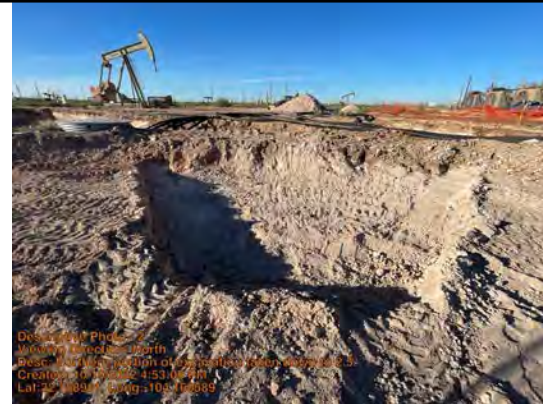
Viewing Direction: North

Northern portion of excavation taken down to 2.5'

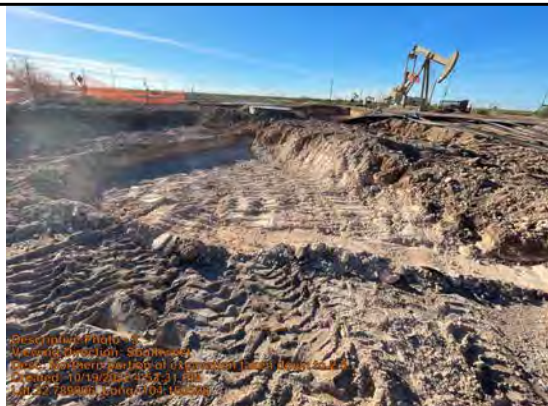
Viewing Direction: Northwest

Northern portion of excavation taken down to 2.5'

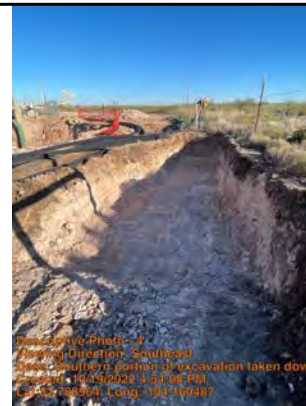
Viewing Direction: Southeast

Southern portion of excavation taken down to 2.5'

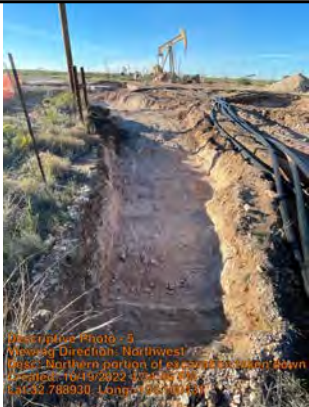
<p>Descriptive Photo - 8 Viewing Direction: Northwest Desc: Northern portion of excavation taken down Created: 10/19/2022 3:51:20 PM Lat:32.788930, Long:-104.160426</p> <p>Northern portion of excavation taken down to 2.5'</p>	<p>Viewing Direction: Northwest</p>

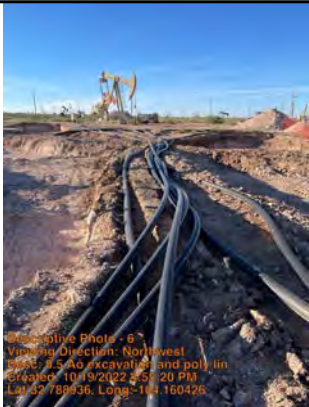
<p>Descriptive Photo - 8 Viewing Direction: Northwest Desc: 0.5 Ao excavation and poly lin Created: 10/19/2022 3:51:20 PM Lat:32.788936, Long:-104.160426</p> <p>0.5' excavation and poly lines</p>
<p>Viewing Direction: West</p>

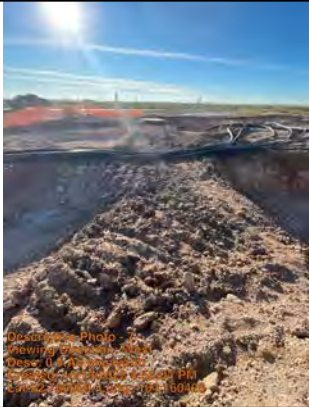
<p>Descriptive Photo - 8 Viewing Direction: West Desc: 0.5 Ao excavation Created: 10/19/2022 4:36:37 PM Lat:32.789020, Long:-104.160637</p> <p>0.5' excavation</p>	<p>Viewing Direction: East</p>

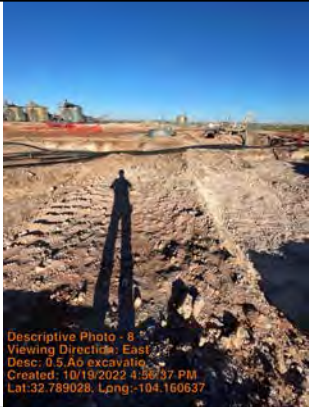
<p>Descriptive Photo - 8 Viewing Direction: East Desc: 0.5 Ao excavation Created: 10/19/2022 4:36:37 PM Lat:32.789020, Long:-104.160637</p> <p>0.5' excavation</p>
