## **Closure Report**

Site Description						
Site Name:	Skelly 605 Battery					
Company:	COG Operating LLC					
Legal Description:	U/L J, Section 14, T17S, R31E					
County:	Eddy County, NM					
GPS Coordinates:	N 32.83277 W-103.83914

Release Data						
Date of Release:	11/28/2016					
Type of Release:	Produced water					
Source of Release:	Flow line					
Volume of Release:	35 bbls					
Volume Recovered:	30 bbls

Remediation Specifications							
Remediation Parameters:	Excavate the entire leak area to a depth of 4 feet. Place an impermeable liner in the excavated area. Backfill the site with clean soil.						
Remediation Activities:	04/18/2018 to 0	5/04/2018					
Plan Sent to OCD:	02/07/2017	Email from Cliff Brunson to Mike Bratcher					
OCD Approval of Plan:	Verbal	Verbal approval in meeting					
Plan Sent to BLM:	02/07/2017 Email from Cliff Brunson to Henryetta Price						
BLM Approval of Plan:	11/21/2017	Email from Henryetta Price to Cliff Brunson

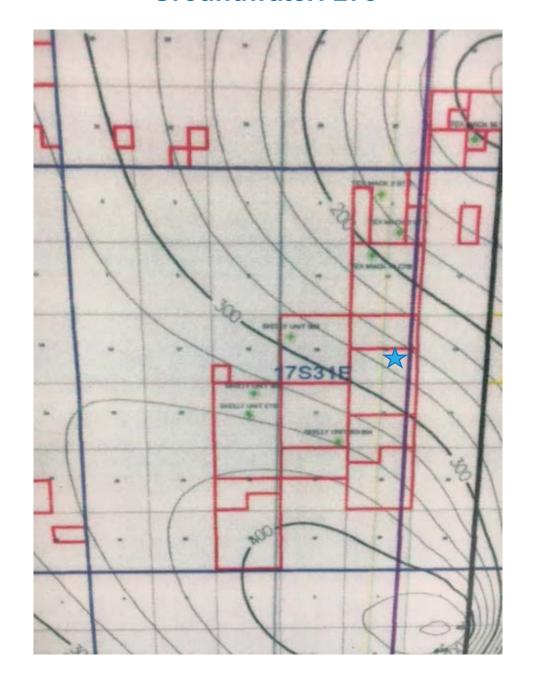
COG, Skelly 605 Battery

Sample points, hand auger SP1, N 32.83289 W-103.83919 SP2, N 32.83297 W-103.83914 SP3, N 32.83310 W-103.83908

NORTH, N 32.83315 W-103.83904 SOUTH, N 32.83282 W-103.83923 EAST, N 32.83295 W-103.83910 WEST, N 32.83299 W-103.83918
