May 3, 2023

**Re: Release Characterization and Remediation Work Plan
ConocoPhillips
James A Waterflood Facility Release
Unit Letter P, Section 2, Township 22 South, Range 30 East
Eddy County, New Mexico
Incident ID NAB1912759510
2RP-5399**

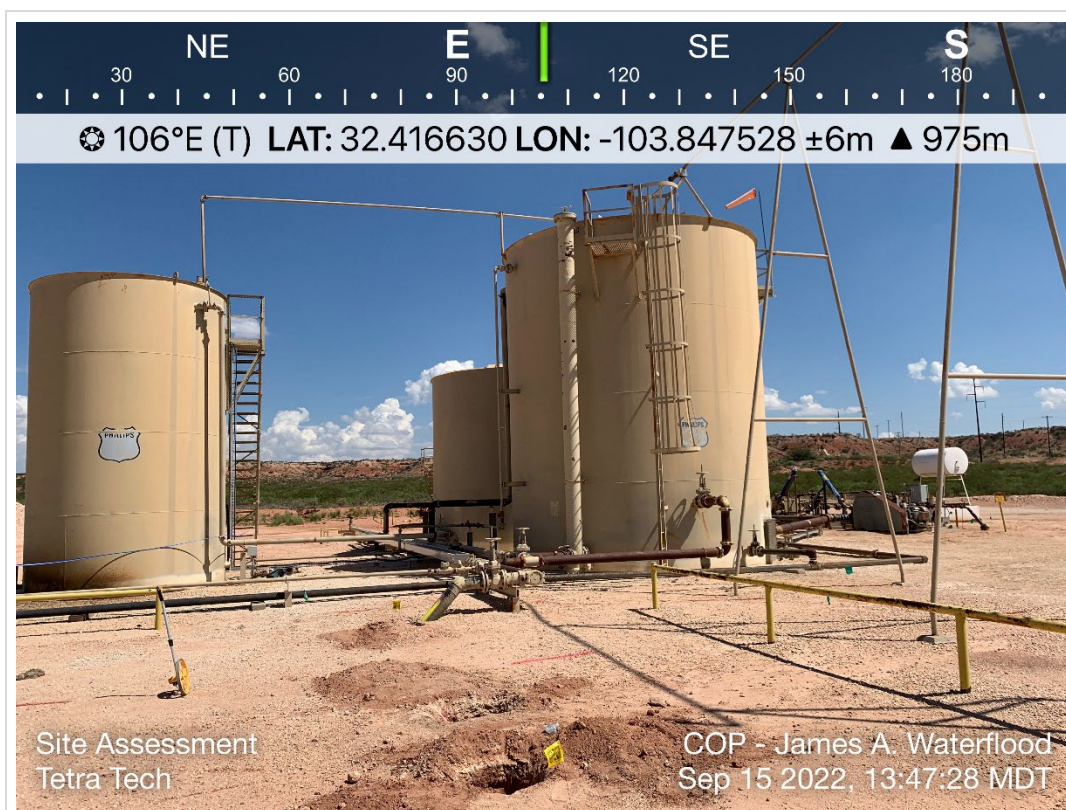
TETRA TECH, INC. PROJECT NO. 212C-MD-02792	DESCRIPTION	View east. View of tank batteries and injection pumps. Pothole for utility verification.	3
	SITE NAME	ConocoPhillips James Waterflood Releases	9/15/2022

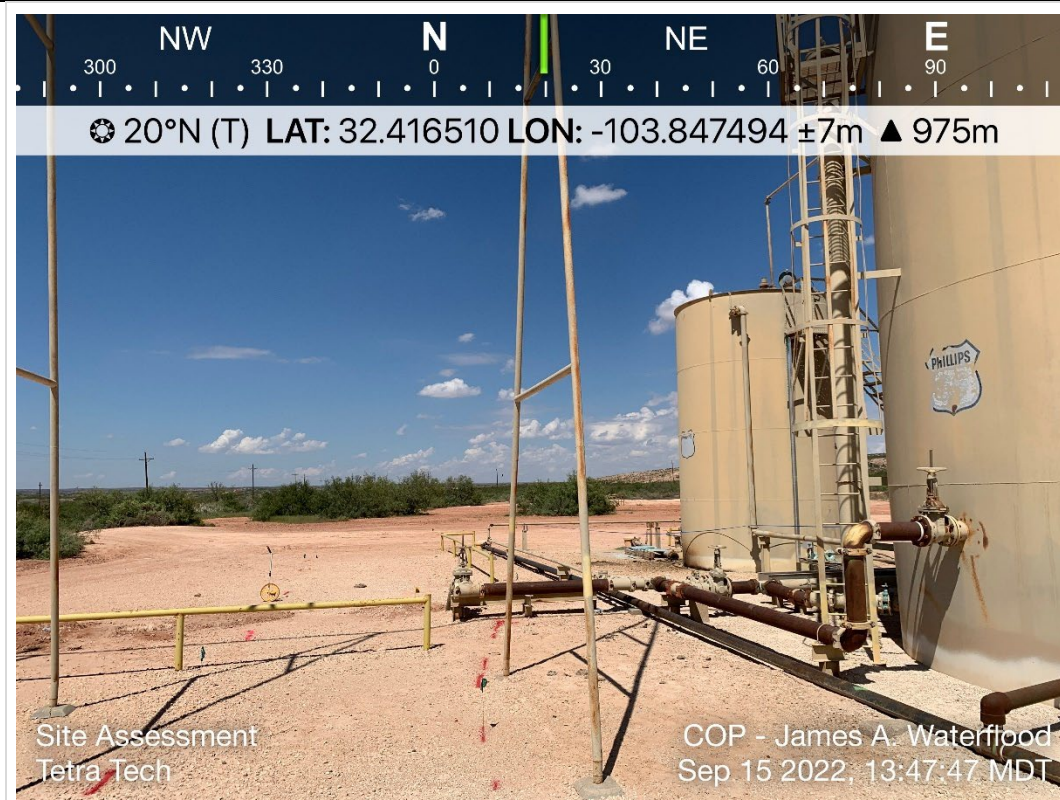
TETRA TECH, INC. PROJECT NO. 212C-MD-02792	DESCRIPTION	View north northeast. View of tank batteries. Subsurface electrical lines.	4
	SITE NAME	ConocoPhillips James Waterflood Releases	9/15/2022

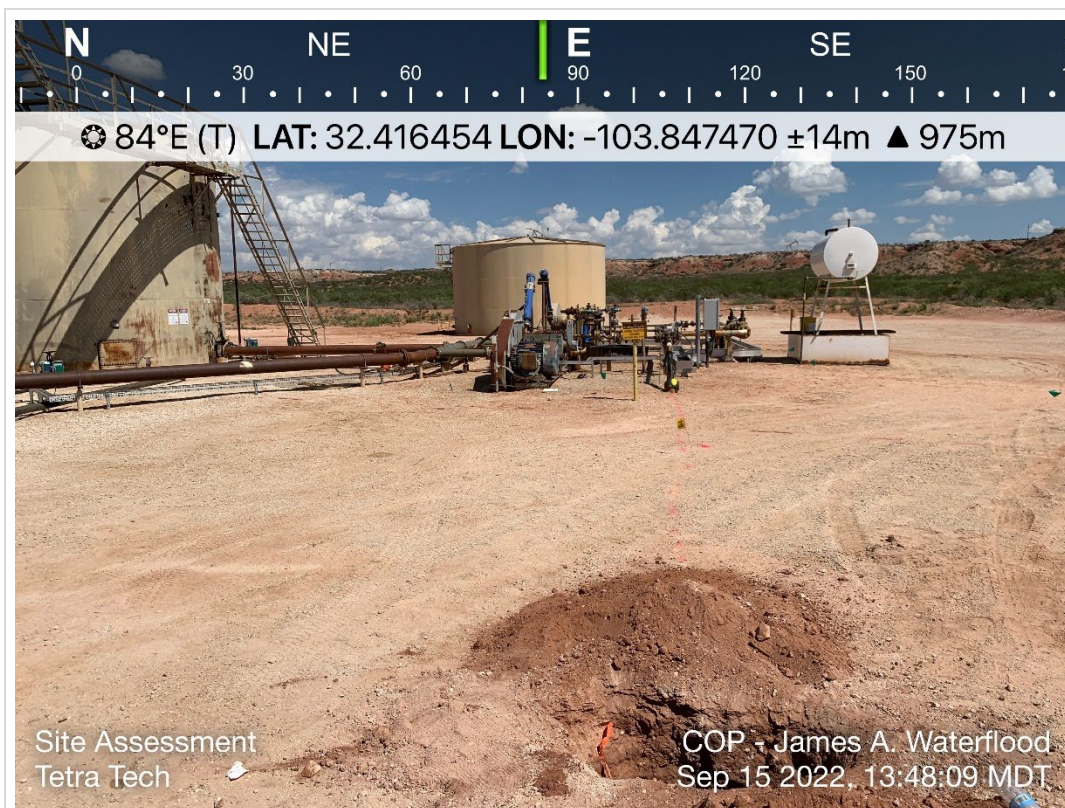
TETRA TECH, INC. PROJECT NO. 212C-MD-02792	DESCRIPTION	View east. Pothole for utility verification. View of injection pump. Approximate release point of 2P-5398. Subsurface utilities.	5
	SITE NAME	ConocoPhillips James Waterflood Releases	9/15/2022

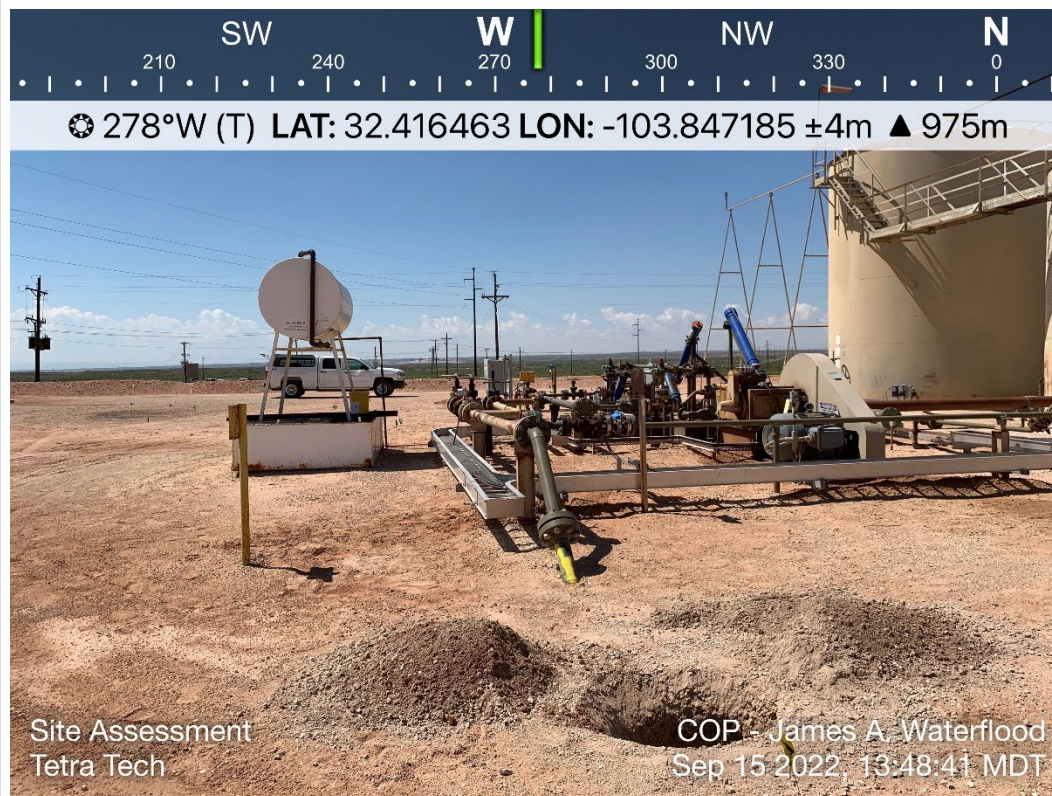
TETRA TECH, INC. PROJECT NO. 212C-MD-02792	DESCRIPTION	View west. Pothole for utility verification View of injection pump. Approximate release point for 2RP-5017.	6
	SITE NAME	ConocoPhillips James Waterflood Releases	9/15/2022

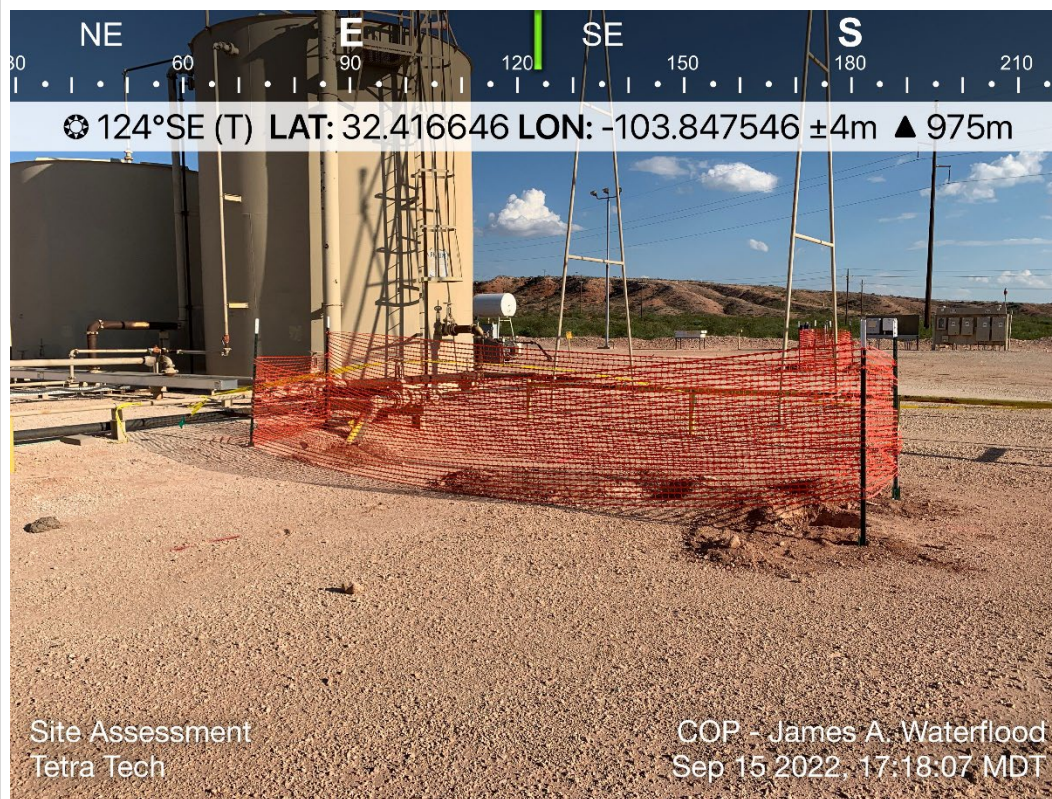
TETRA TECH, INC. PROJECT NO. 212C-MD-02792	DESCRIPTION	View east southeast. View of tank battery. Subsurface utilities. Barricaded pothole for utility verification.	8
	SITE NAME	ConocoPhillips James Waterflood Releases	9/15/2022

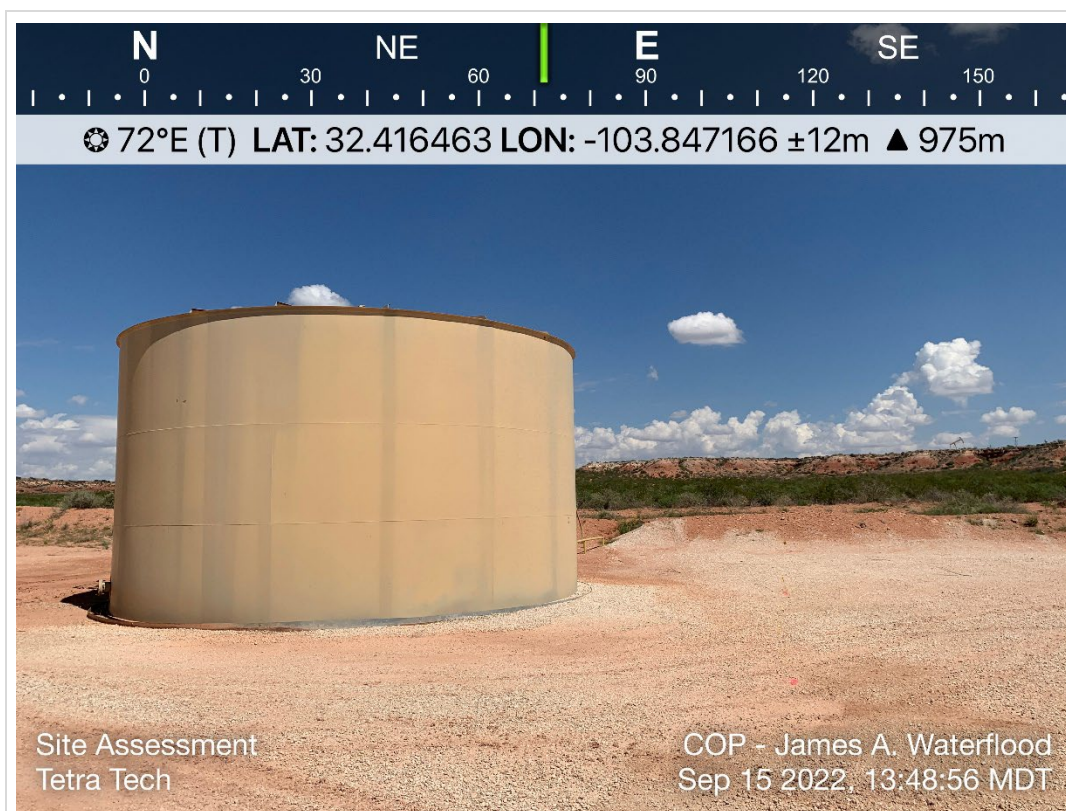
TETRA TECH, INC. PROJECT NO. 212C-MD-02792	DESCRIPTION	View northwest east. Approximate release point for 2RP-5399.	9
	SITE NAME	ConocoPhillips James Waterflood Releases	9/15/2022

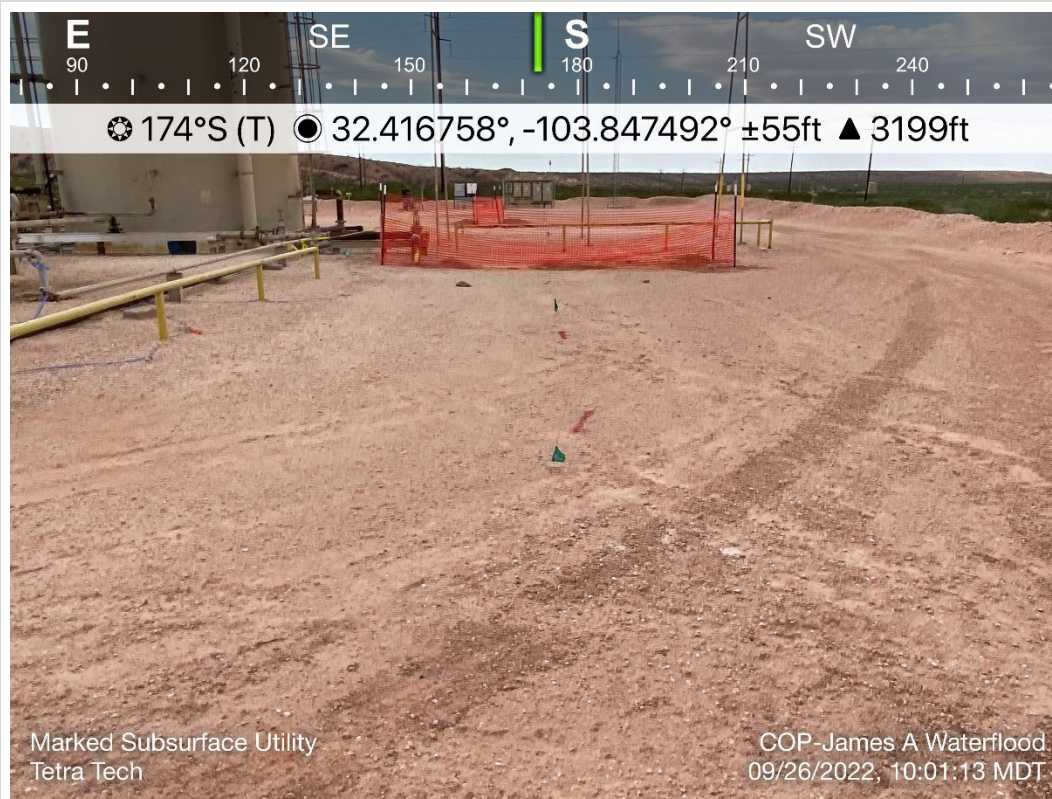
TETRA TECH, INC. PROJECT NO. 212C-MD-02792	DESCRIPTION	View south. Subsurface utility lines. Barricaded pothole for utility verification.	10
	SITE NAME	ConocoPhillips James Waterflood Releases	9/26/2022

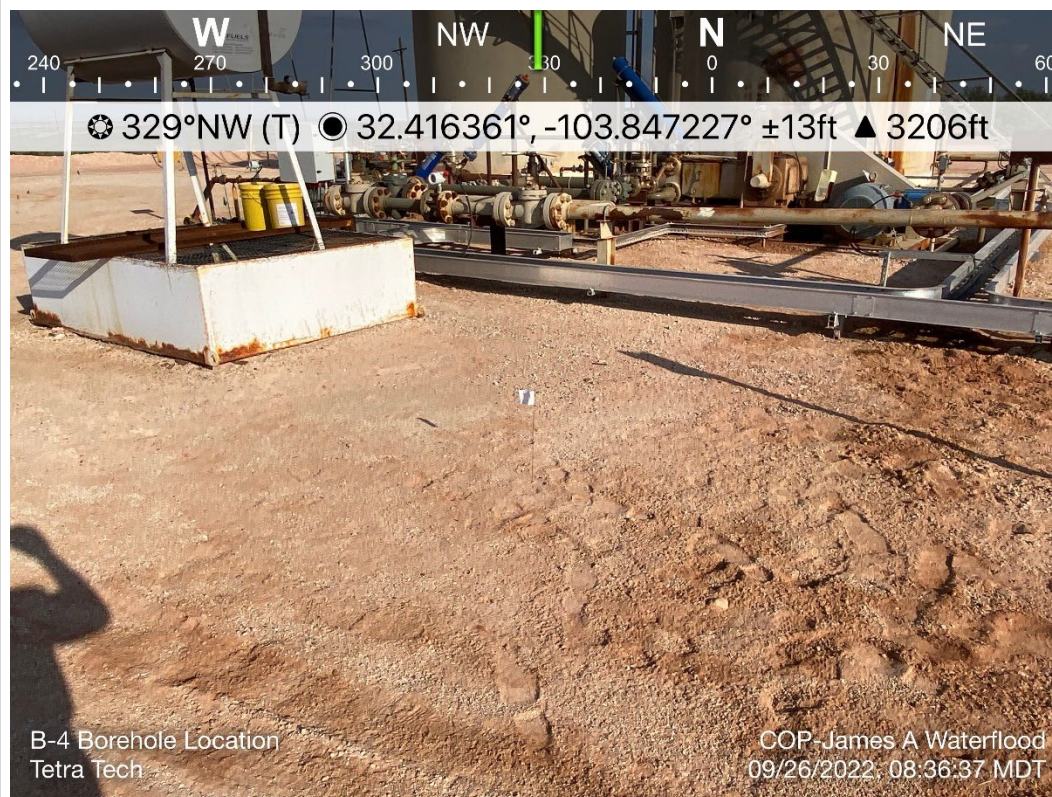
TETRA TECH, INC. PROJECT NO. 212C-MD-02792	DESCRIPTION	View northwest. View of injection pump. Approximate release point for 2RP-5017 and 2RP-5398.	12
	SITE NAME	ConocoPhillips James Waterflood Releases	9/26/2022

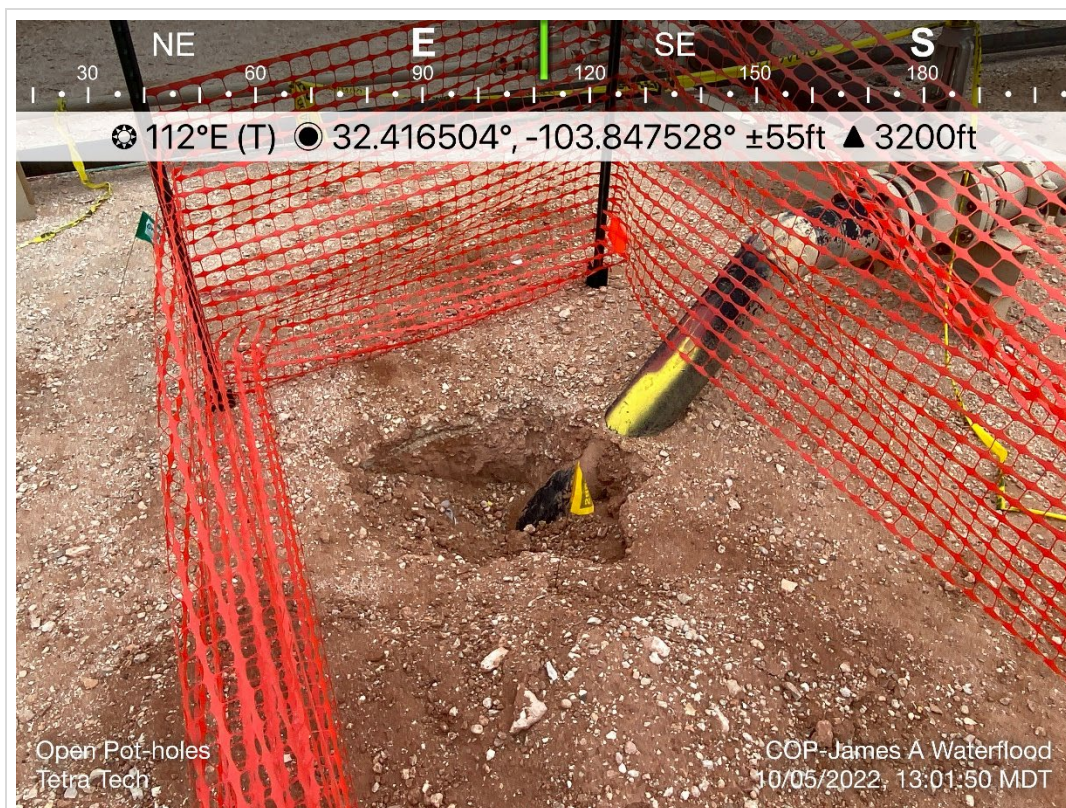
TETRA TECH, INC. PROJECT NO. 212C-MD-02792	DESCRIPTION	View east southeast. Pothole with view of subsurface line.	13
	SITE NAME	ConocoPhillips James Waterflood Releases	9/26/2022

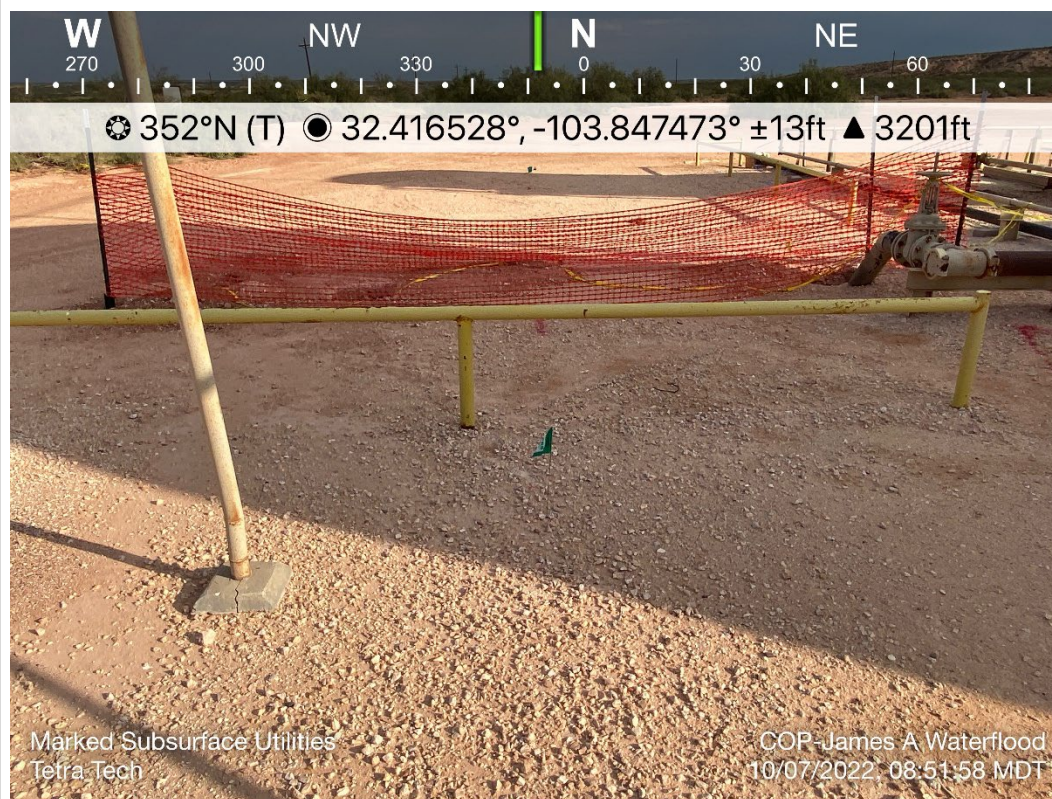
TETRA TECH, INC. PROJECT NO. 212C-MD-02792	DESCRIPTION	View north. Subsurface utilities.	14
	SITE NAME	ConocoPhillips James Waterflood Releases	10/7/2022

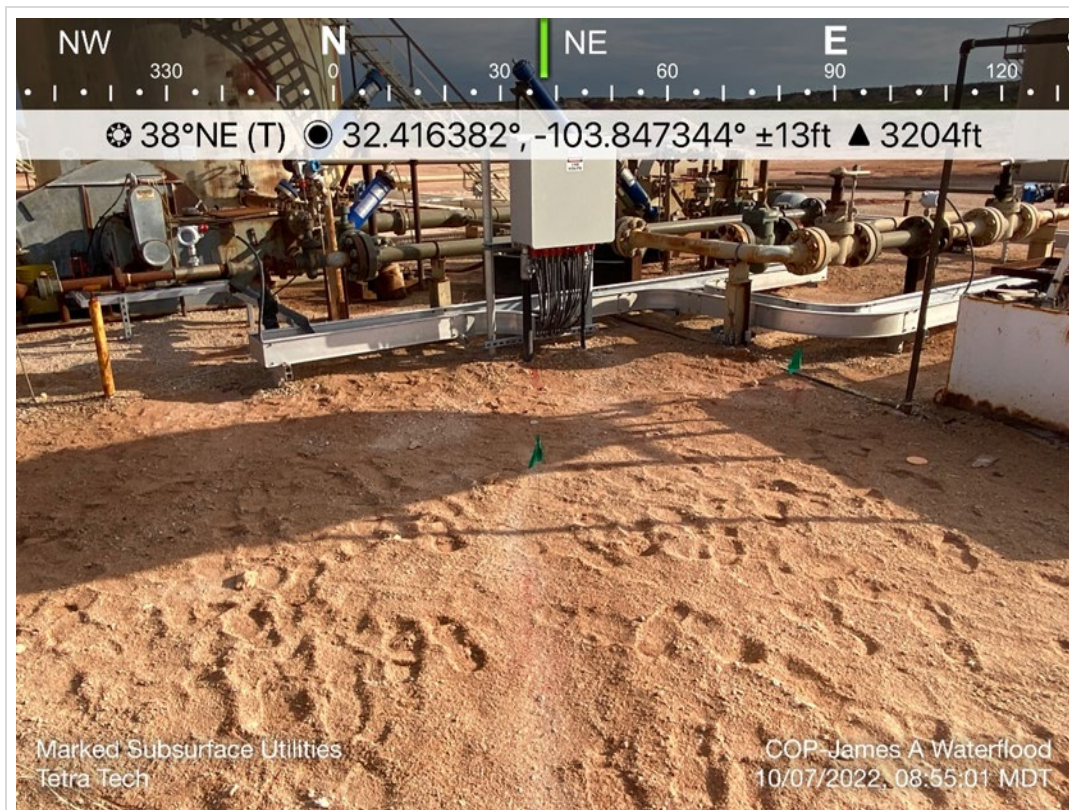
TETRA TECH, INC. PROJECT NO. 212C-MD-02792	DESCRIPTION	View northeast. View of Injection pump. Approximate release areas.	15
	SITE NAME	ConocoPhillips James Waterflood Releases	10/7/2022
