**Re: Site Assessment and Closure Report**  
**Jayhawk 7 CTB 3**  
**API No. N/A**  
**GPS: Latitude 32.054686 Longitude -103.506041**  
**UL -- J, 7, T26S, R34**  
**Lea County, NM**  
**NMOCD Ref. No. NAPP2123638914**

Pima Environmental Services, LLC. (Pima) has been contracted by Devon Energy Production Company, LP (Devon) to perform a spill assessment, and submit this closure report for a produced water release that occurred at the Jayhawk 7 CTB 3 (Jayhawk). The initial C-141 was submitted on August 24, 2021 (Appendix C). This incident was assigned Incident ID NAPP2123638914 by the New Mexico Oil Conservation Division (NMOCD).

**NAPP2123638914:** On August 7, 2021, a pipe developed on a water line, causing fluid to be released on the pad. The released fluids were calculated to be approximately 12.5 barrels (bbls) of produced water. No fluid was able to be recovered.

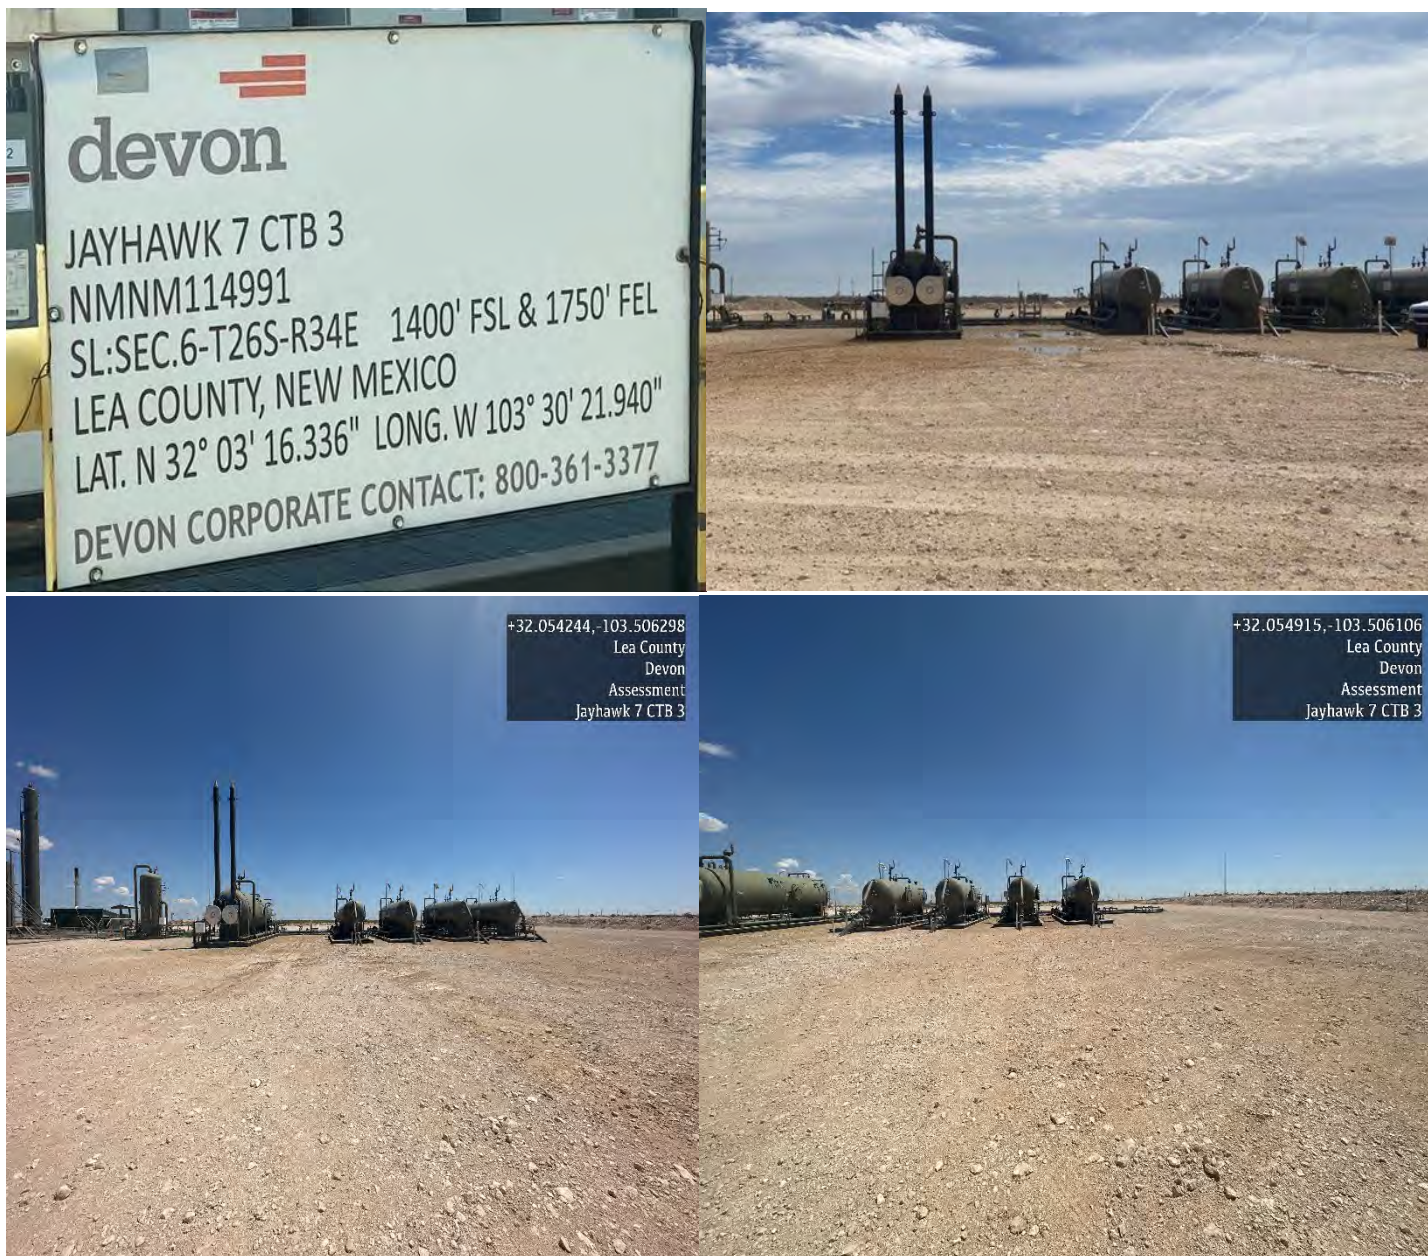
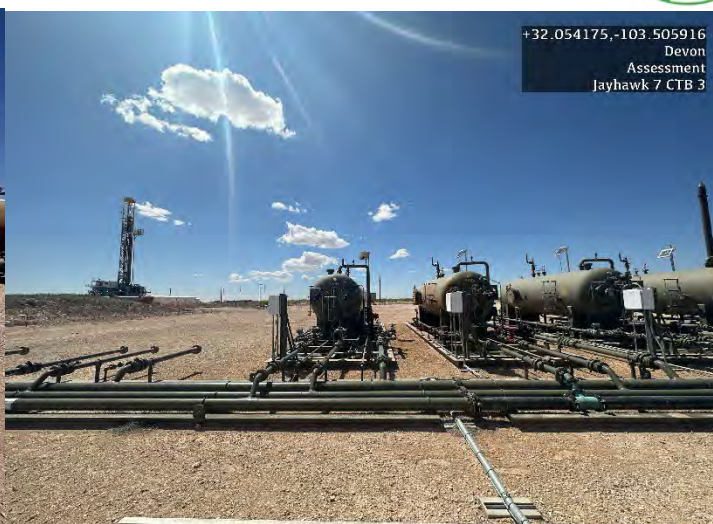
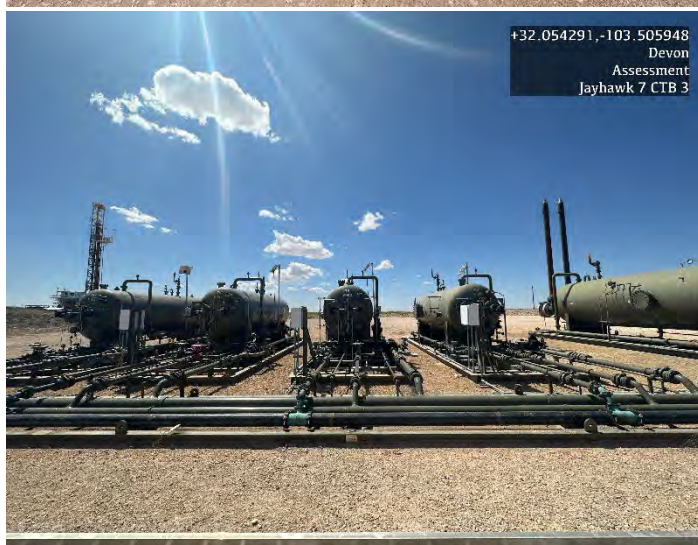
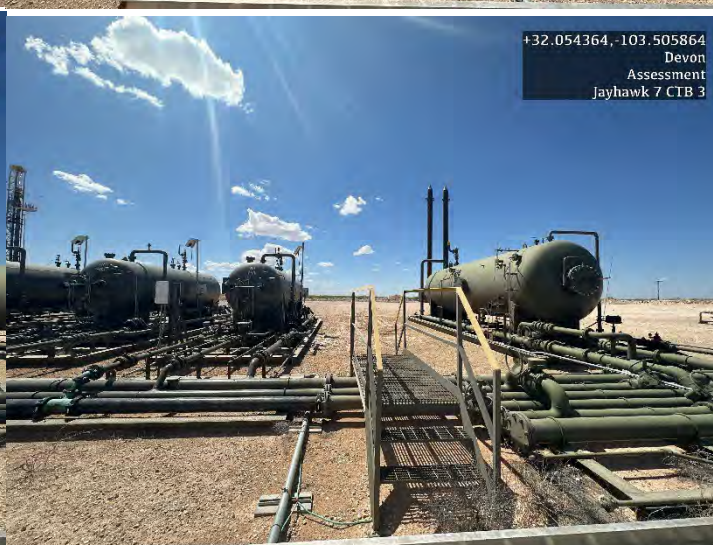
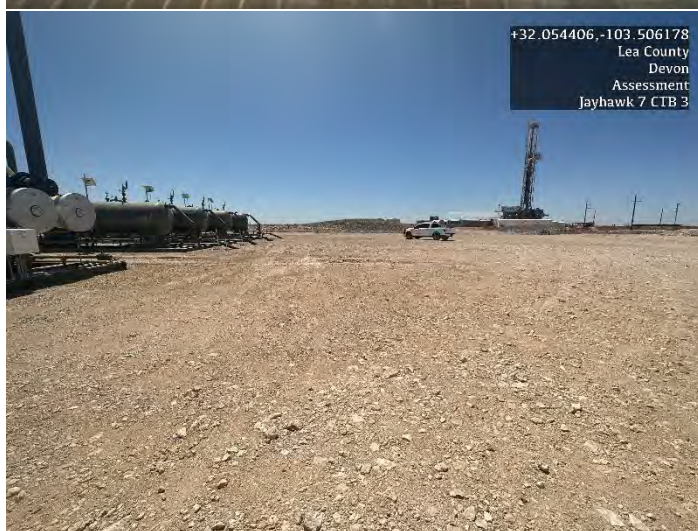
**SITE PHOTOGRAPHS  
DEVON ENERGY  
JAYHAWK 7 CTB 3**

**Site Assessment**

The sample results were below NMOCD Closure Criteria 19.15.29 NMAC. Based on these findings, Devon Construction Department will schedule personnel and equipment to conduct a scrape and remove any surface staining. No further remediation activities are required at this time.
