Incident ID	nAPP2326927720
District RP	
Facility ID	fKJ1518128159
Application ID

Release Notification

Site Name	North Hobbs Unit NIB	Site Type	Central Tank Battery
Date Release Discovered	8/28/2023	API#	(if applicable)

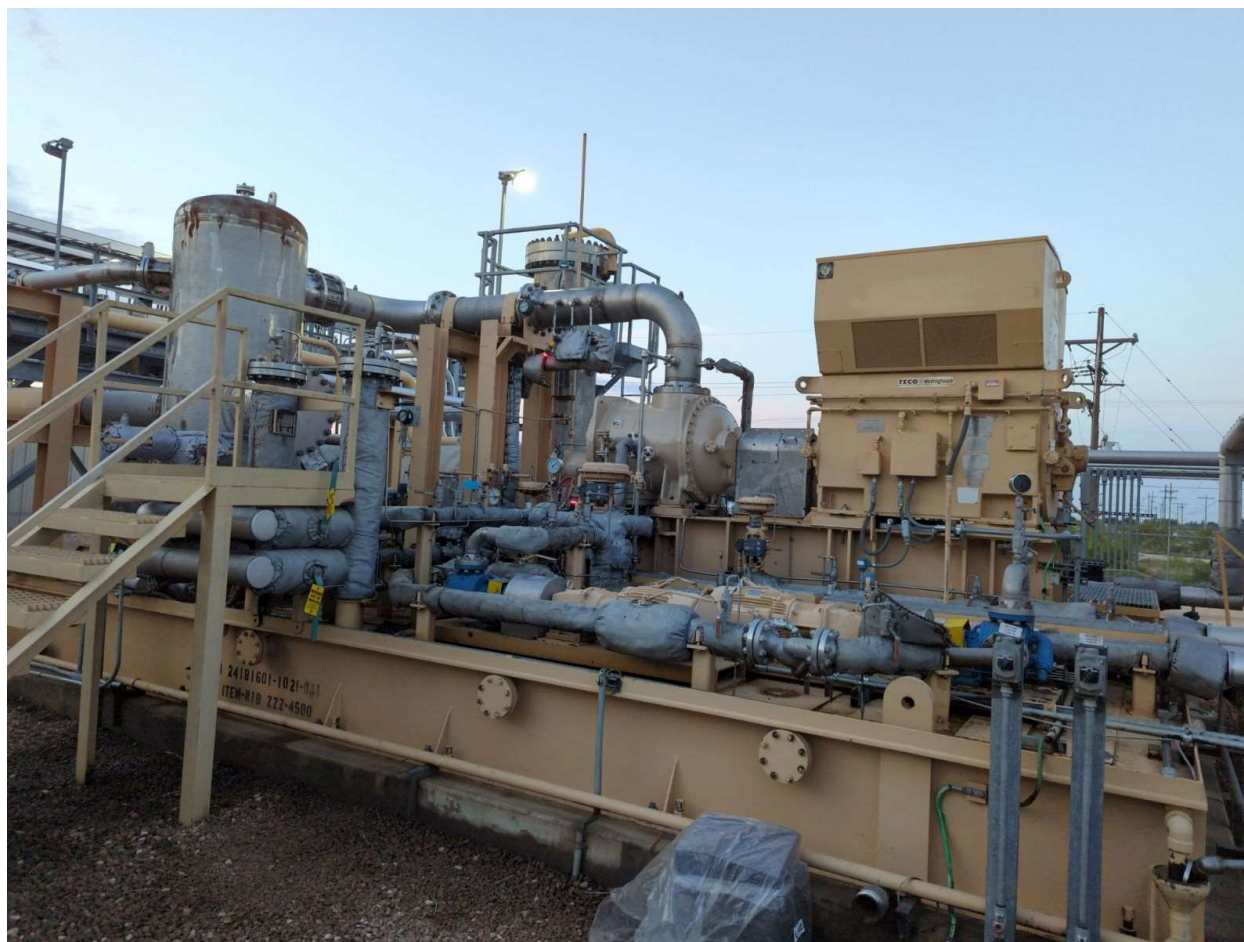
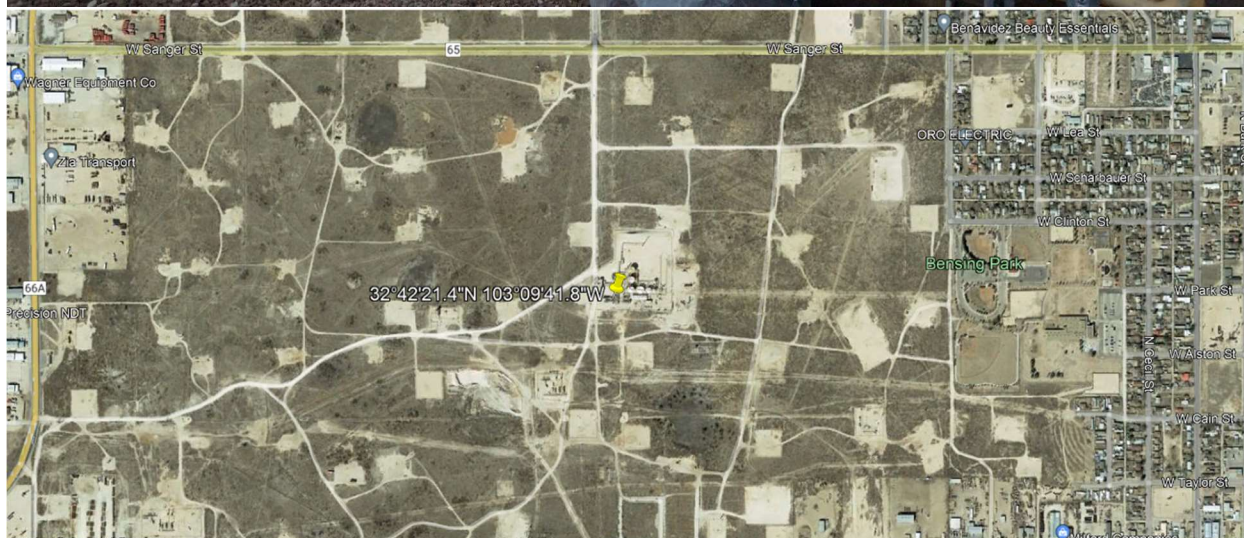
Discharge pressure was low and the compressor would not fully load and move the gas it needed too. This resulted in us bumping the flare. Had Operator and Enerflex technician dispatched. Found the set point on the discharge pressure transmitter was set wrong. They moved it to the right set point and compressor start moving more gas
