November 30, 2023

**Re: Remediation Work Plan
ConocoPhillips Company (Heritage COG Operating, LLC)
King Tut Federal #003H
Unit Letter D, Section 30, Township 24 South, Range 32 East
Lea County, New Mexico
Incident ID# nOY1713048453**

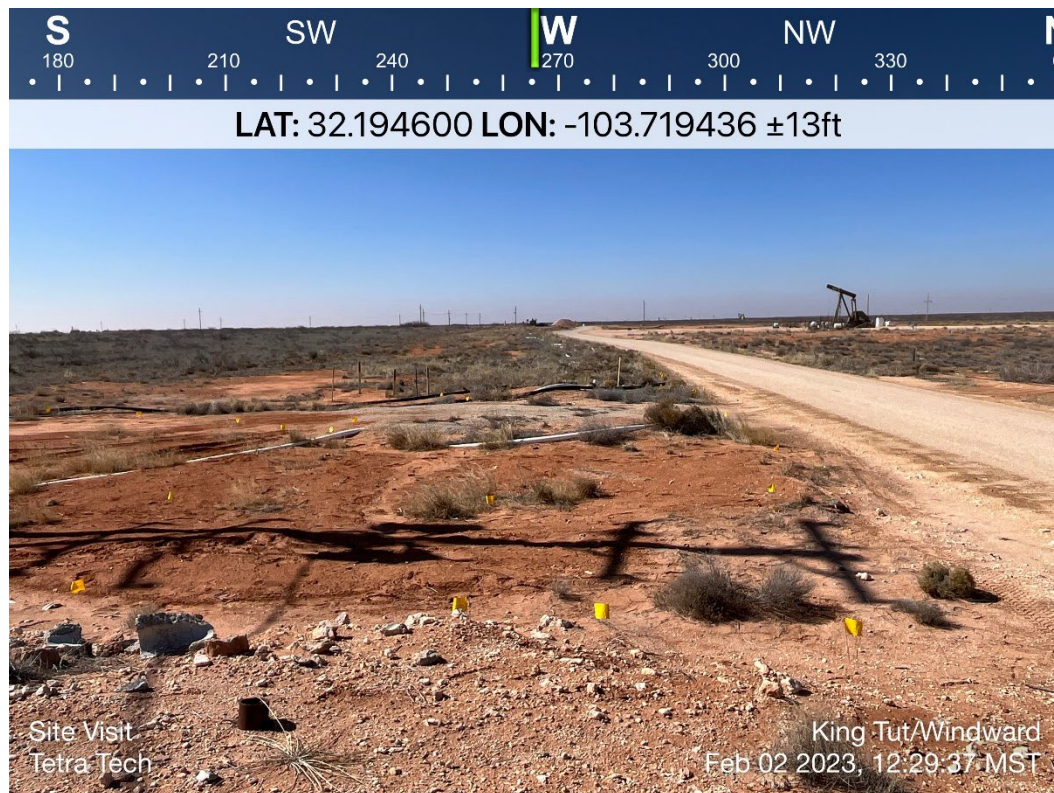
TETRA TECH, INC. PROJECT NO. 212C-MD-02999	DESCRIPTION	View W towards lease road.	4
	SITE NAME	KING TUT FEDERAL #001H, KING TUT FEDERAL #003H, & WINDWARD FEDERAL #001H Releases	2/2/2023

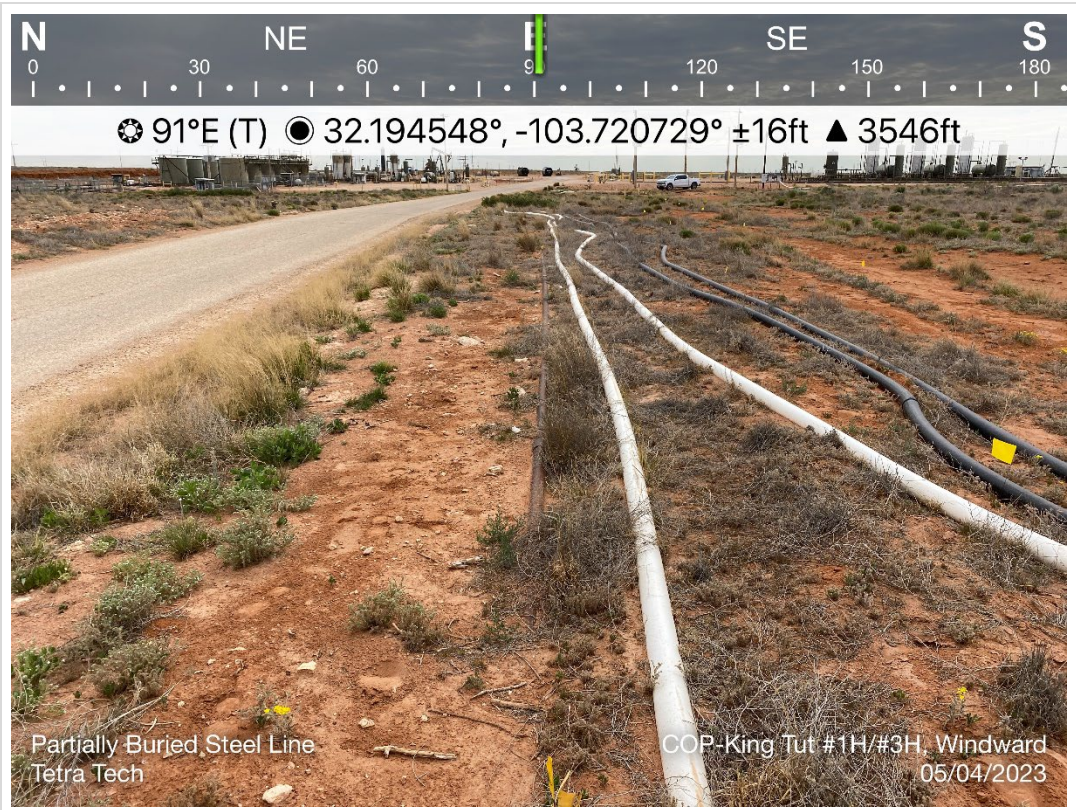
TETRA TECH, INC. PROJECT NO. 212C-MD-02999	DESCRIPTION	View west. View of historical release area. Surface poly lines and buried steel line.	5
	SITE NAME	KING TUT FEDERAL #001H, KING TUT FEDERAL #003H, & WINDWARD FEDERAL #001H Releases	5/4/2023

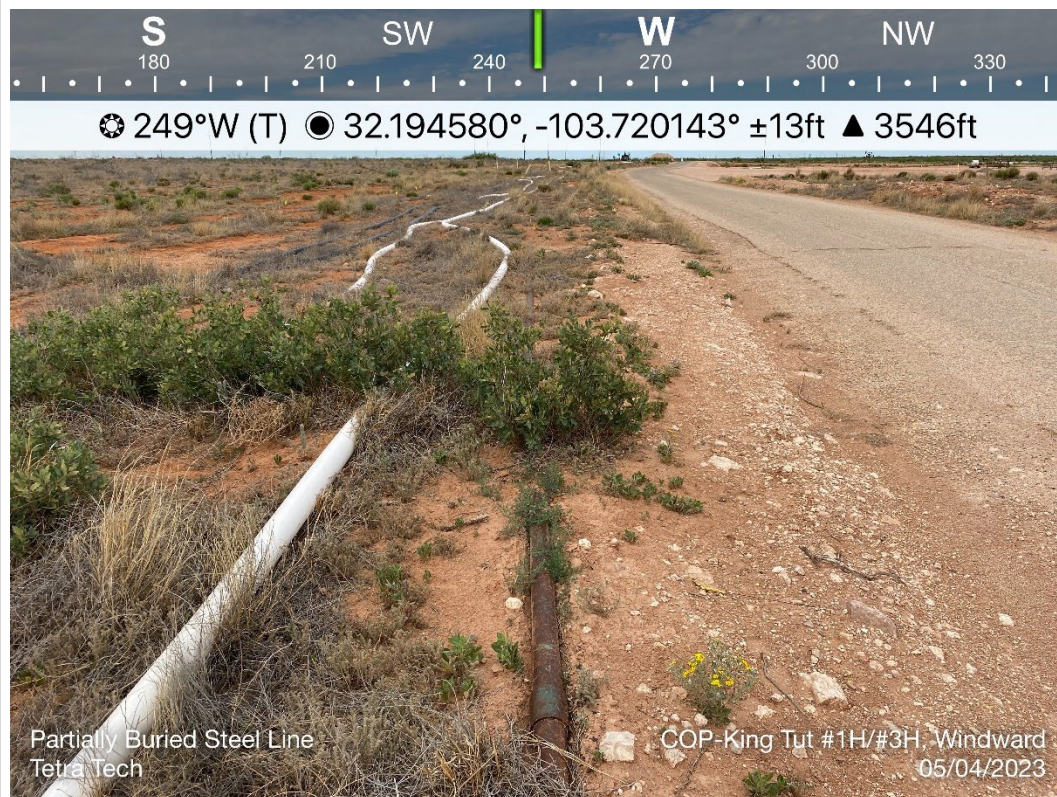
TETRA TECH, INC. PROJECT NO. 212C-MD-02999	DESCRIPTION	View southwest west. View surface poly lines and buried steel line.	10
	SITE NAME	KING TUT FEDERAL #001H, KING TUT FEDERAL #003H, & WINDWARD FEDERAL #001H Releases	5/4/2023
