RE: Closure Report
Malachite 22 Federal #002H
API No. 30-025-40389
GPS: Latitude 32.6520462 Longitude -103.6548004
UL "C", Section 22, Township 19S, Range 33E,
Lea County, NM
NMOCD Reference No. NJXK1523052658

Malachite 22 Fed 2H

Raybaw Operating
API #30-025-40389
Lea County, NM
Horizontal Delineation Map

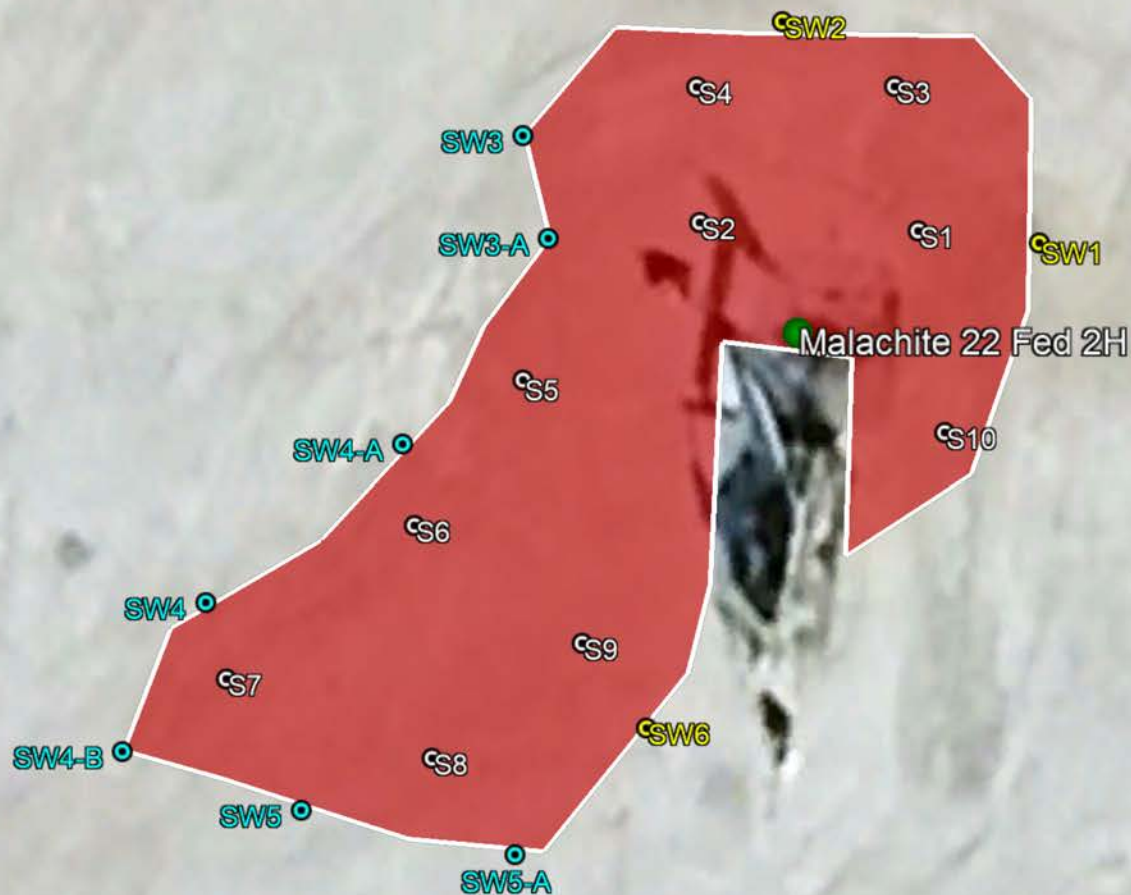
The conditionally approved remediation plan can be found in OCD Online: Permitting – Action Status, under the Application ID: 283263. The conditions can be found in the Incident Event log. A Horizontal Delineation Map can be found in Figure 1.

On November 29, 2023, Pima personnel mobilized to the site to collect and field test the approved 7 additional 5-point composite samples from each sample location. Two of the sample points we recollected from a further distance, the sample points and GPS coordinates are as follows:

SW3 – Latitude 32.652166, Longitude -103.654893
SW3-A – Latitude 32.652129, Longitude -103.654882
SW4-A – Latitude 32.652055, Longitude -103.654945

SW4 – Latitude 32.651998, Longitude -103.655030
SW4B – Latitude 32.651944, Longitude -103.655066
SW5 – Latitude 32.651923, Longitude -103.654989
SW5A – Latitude 32.651907, Longitude -103.654897

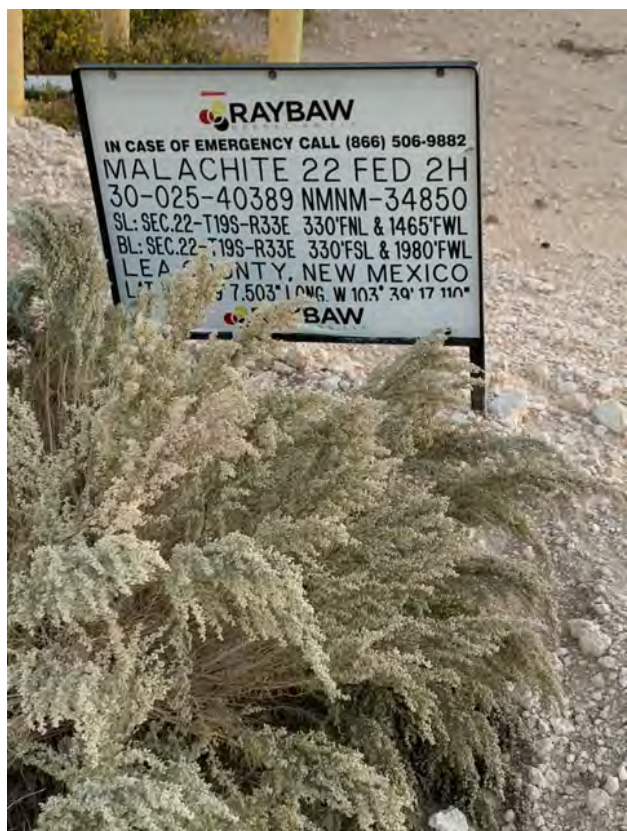
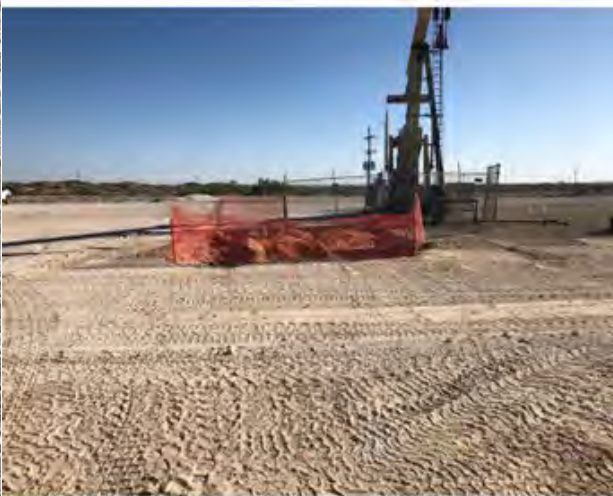
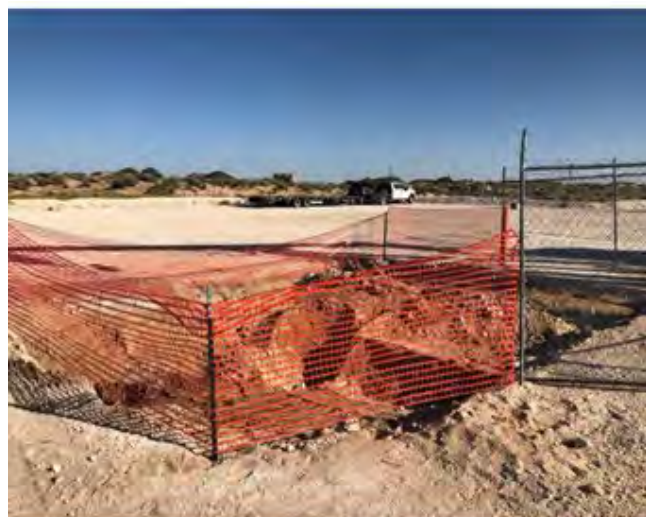
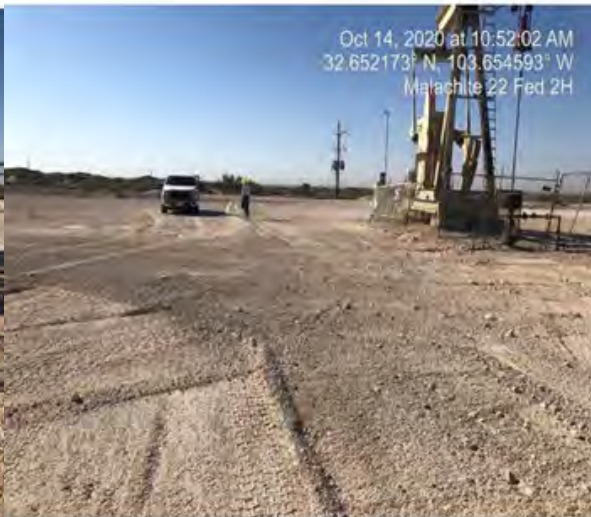
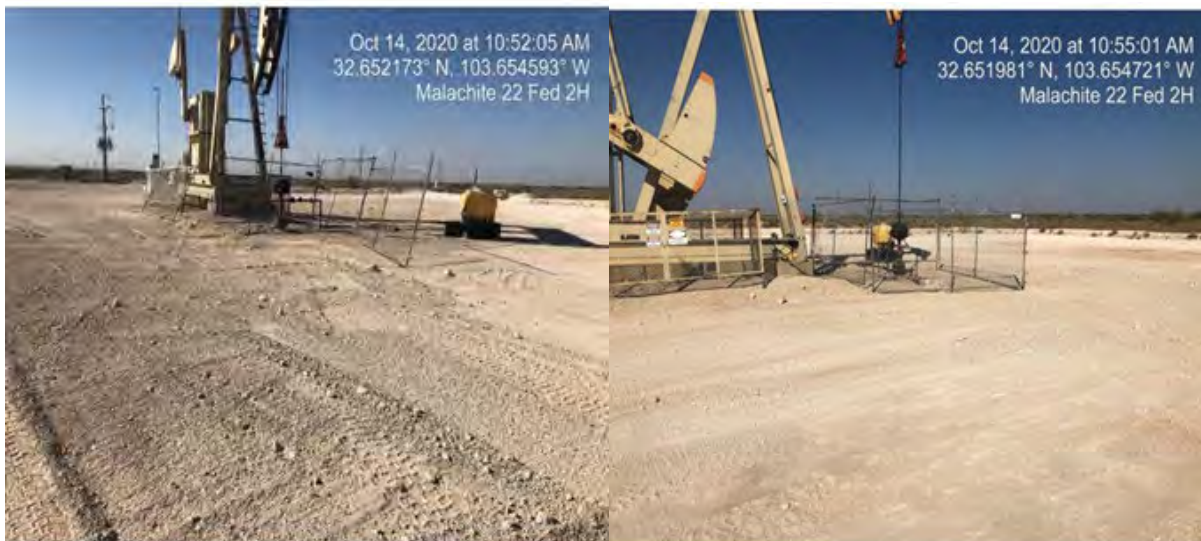
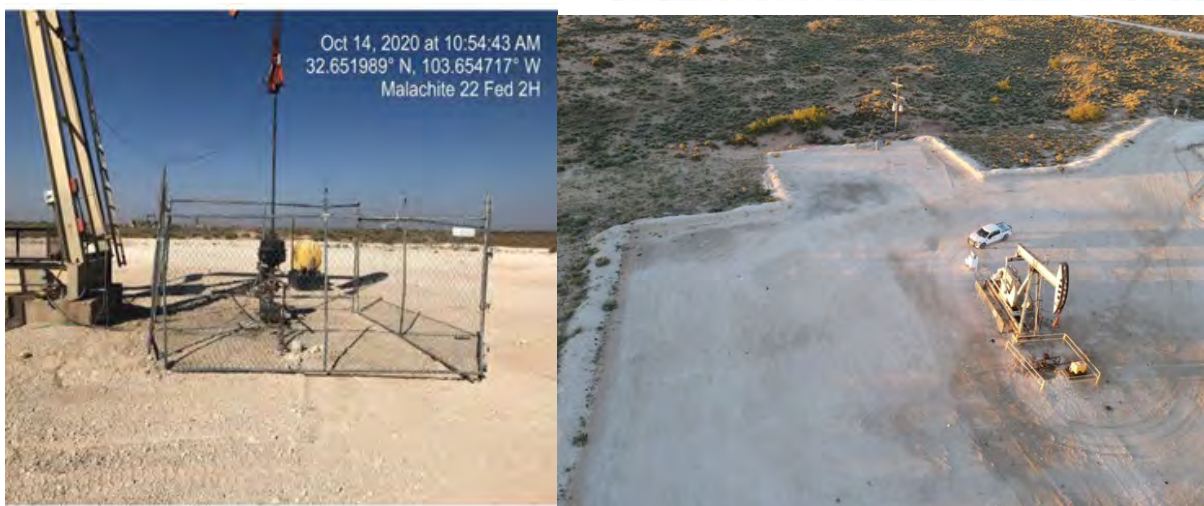
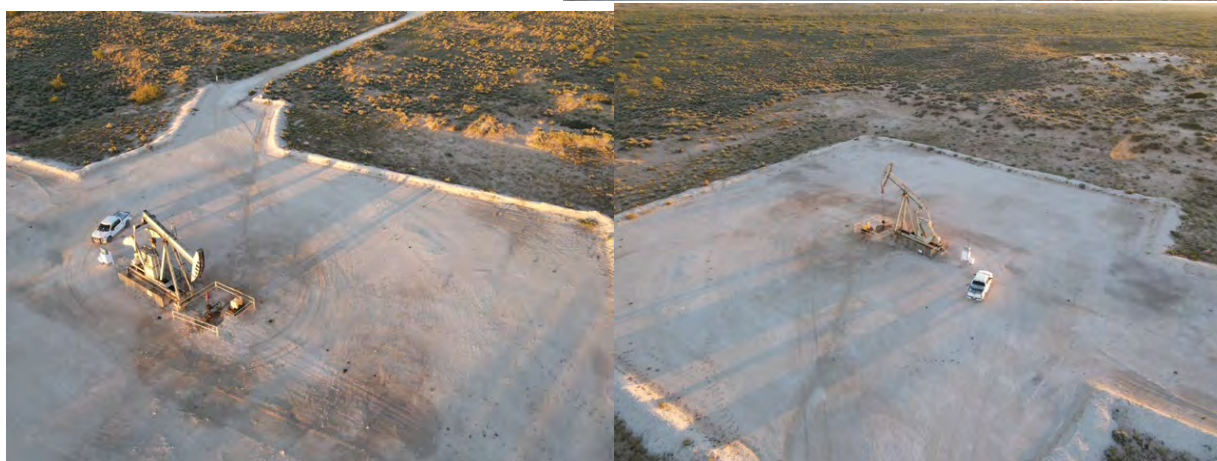
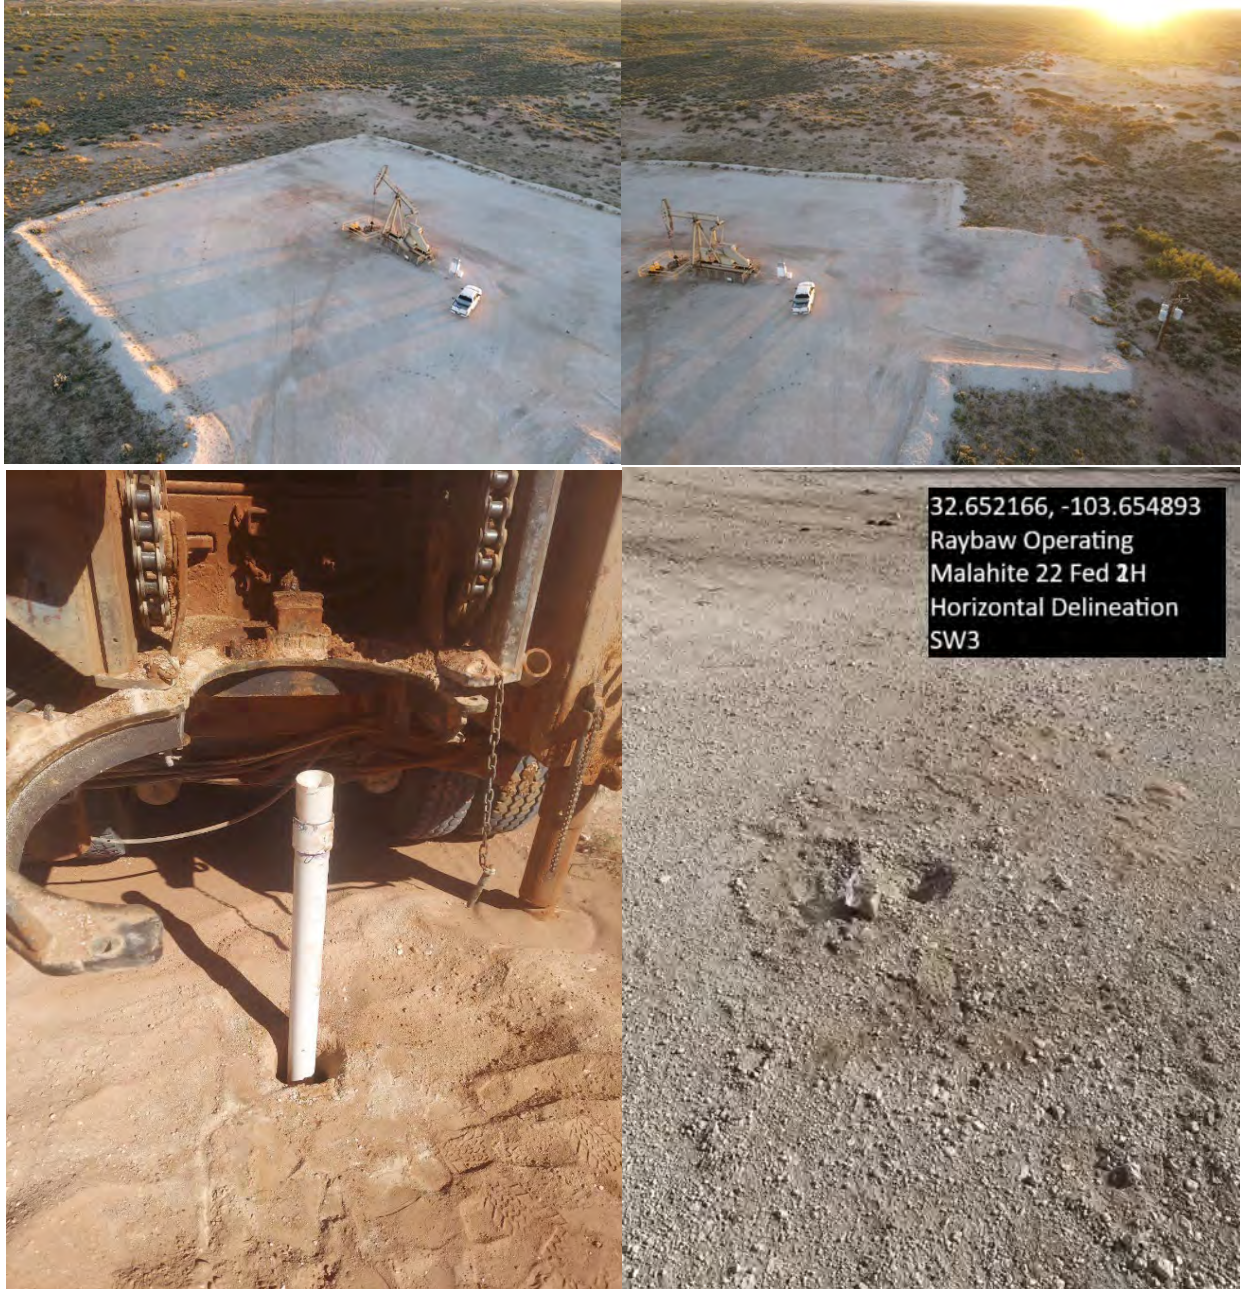
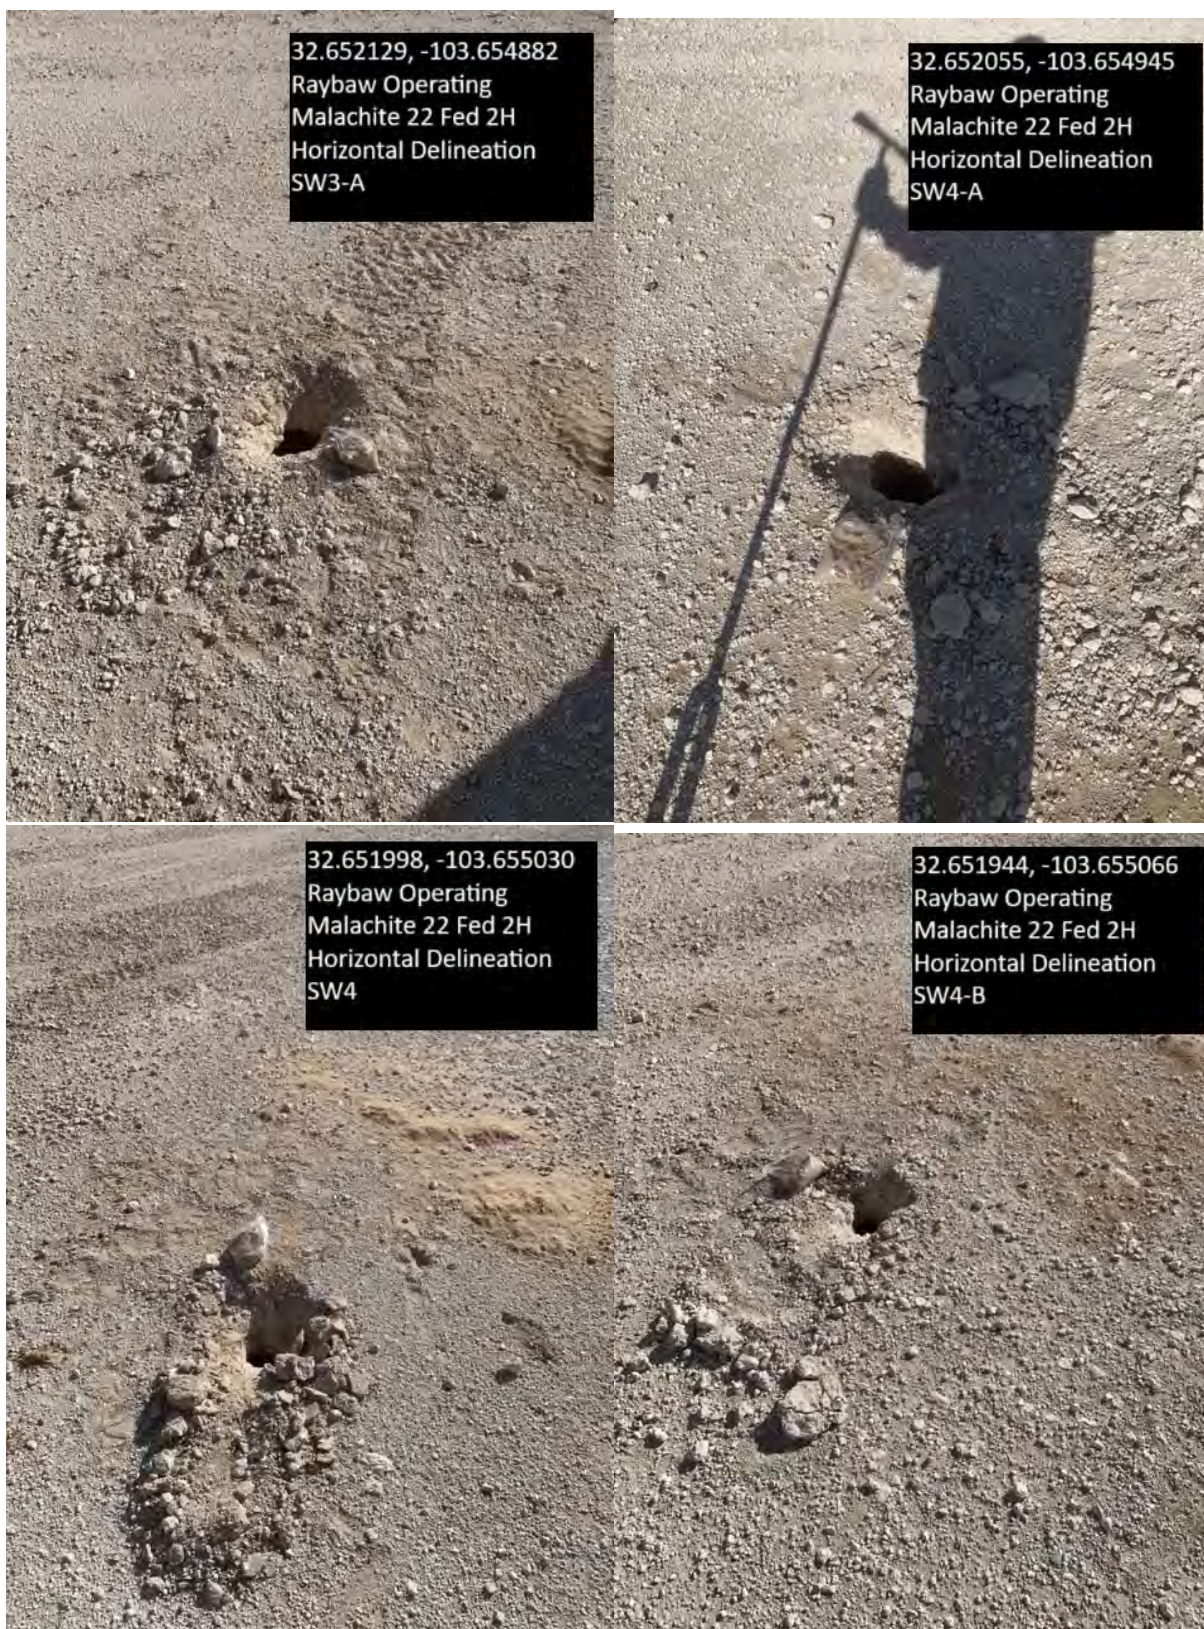
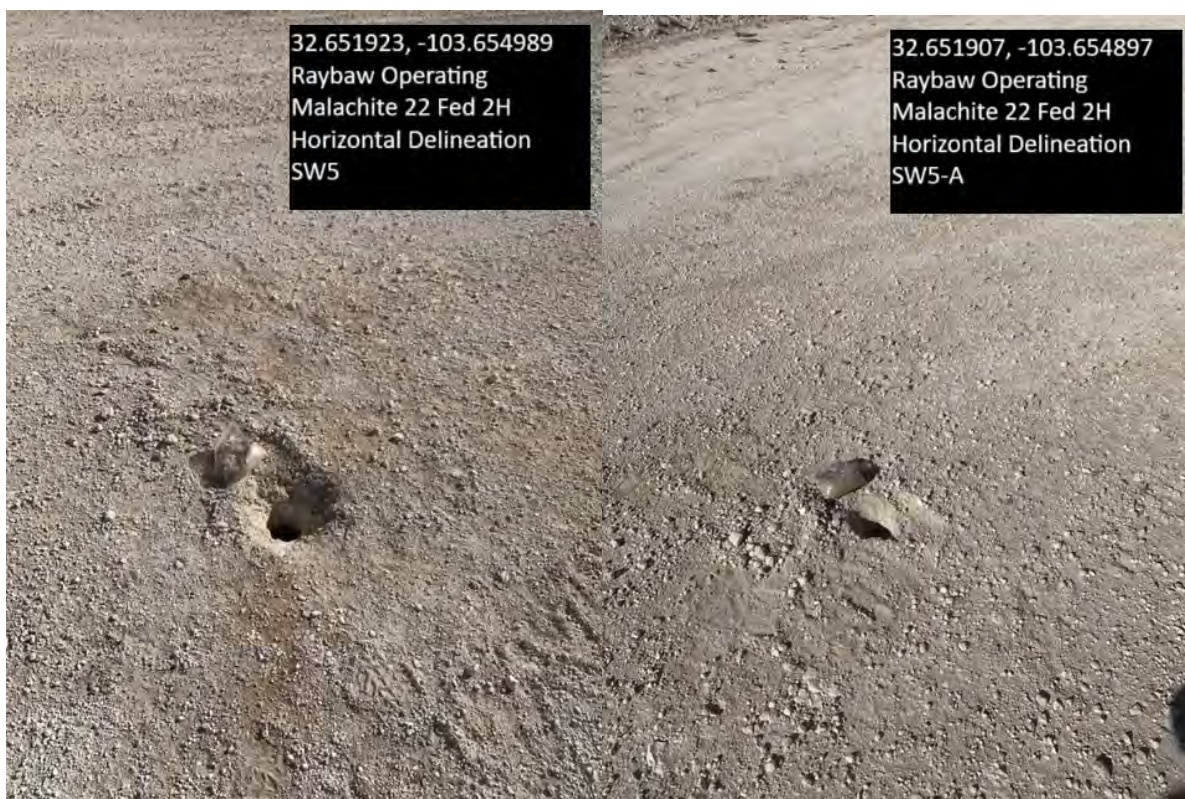
The results of this sampling event can be found in the Data Table included in Figure 2. Each sample was promptly jarred and put on ice, then prepared for delivery to an NMOC approved laboratory. Photographic Documentation of this event can be found in Figure 3. Complete Laboratory Reports can be found in Appendix B.
