Closure Report
Corral Draw AQH Federal #2
Eddy County, New Mexico
Unit F Sec 13 T24S R29E
32.219388°, -103.940270°

Incident ID: NKMW0735539280
Crude Oil Release
Point of Release: Equipment Failure
Release Date: 06/08/06
Volume Released: 12 Barrels of Crude Oil
Volume Recovered: 5 Barrels of Crude Oil

Incident ID: NAB1509049752
Crude Oil and Produced Water Release
Point of Release: Pressure Gauge Failure on Pumping Unit
Release Date: 03/14/15
Volume Released: 5 Barrels of Crude Oil & 10 Barrels of Produced Water
Volume Recovered: 4 Barrels of Crude Oil & 9 Barrels of Produced Water

**Re: Closure Report
Corral Draw AQH Federal #2
EOG Resources Inc.
Incident #: NAB1509049752 & NKMW0735539280
Site Location: Unit F Sec 13 T24S R29E
(Lat 32.219388°, Long -103.940270°)
Eddy County, New Mexico**

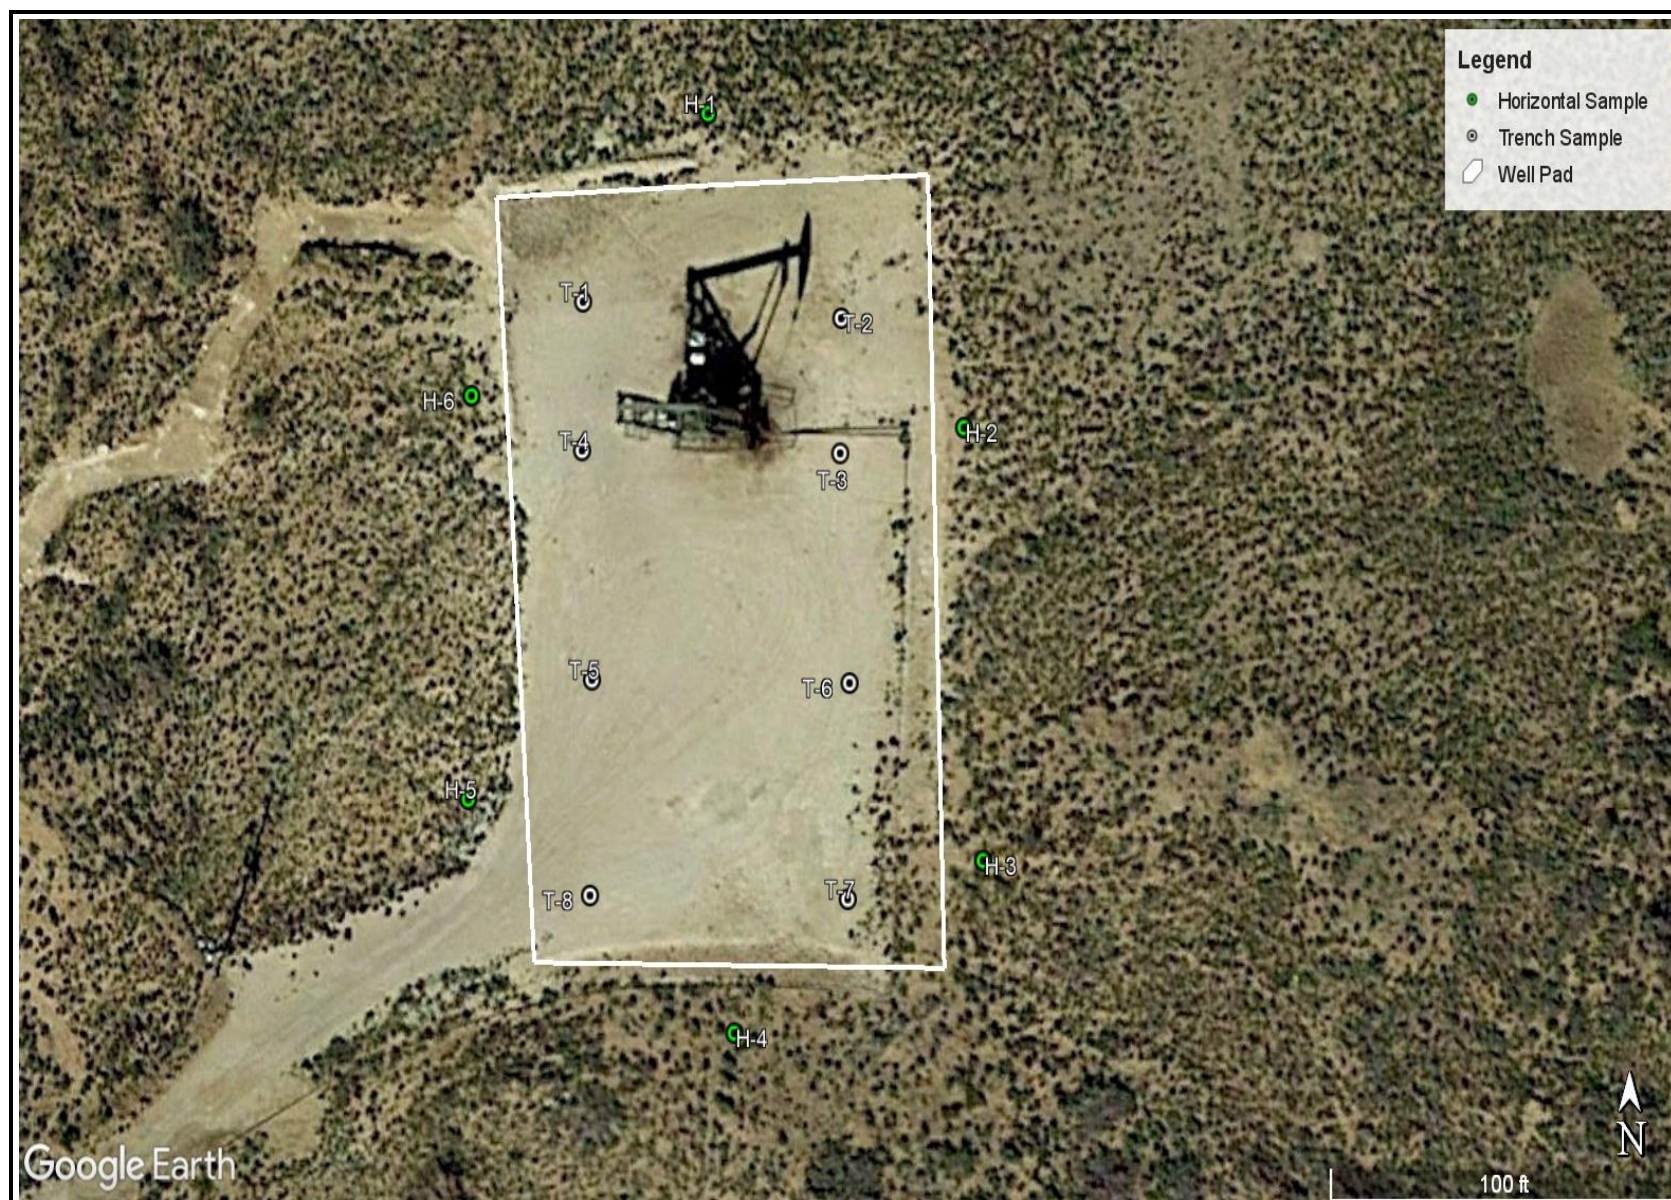
FIGURE 2

TOPOGRAPHIC MAP
EOG RESOURCES
CORRAL DRAW AQH FEDERAL #2
EDDY COUNTY, NEW MEXICO
32.219388°, -103.940270°

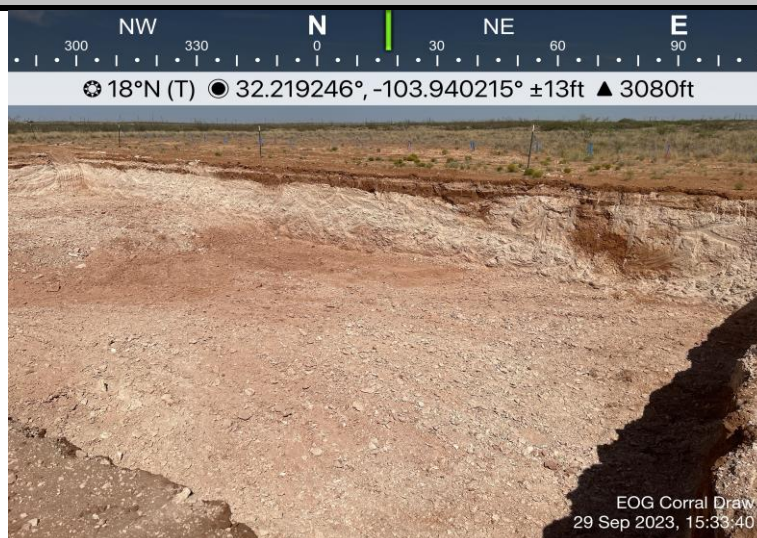
Photograph No. 2

View North, area of CS-10 through CS-22.

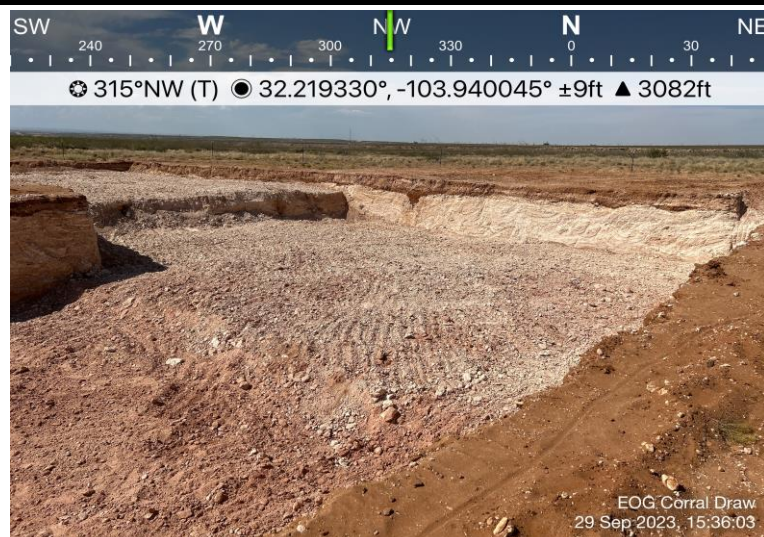
Photograph No. 3

View Northwest, area of CS-23 through CS-38.

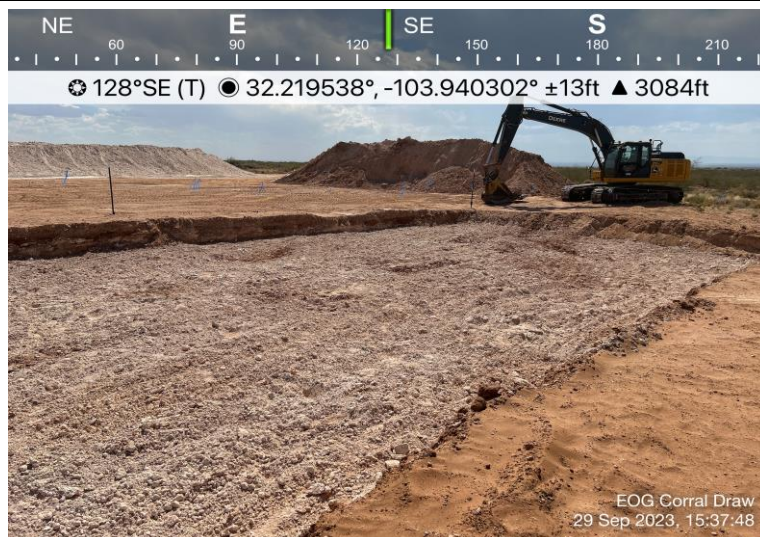
View Southeast, area of CS-39 through CS-52.

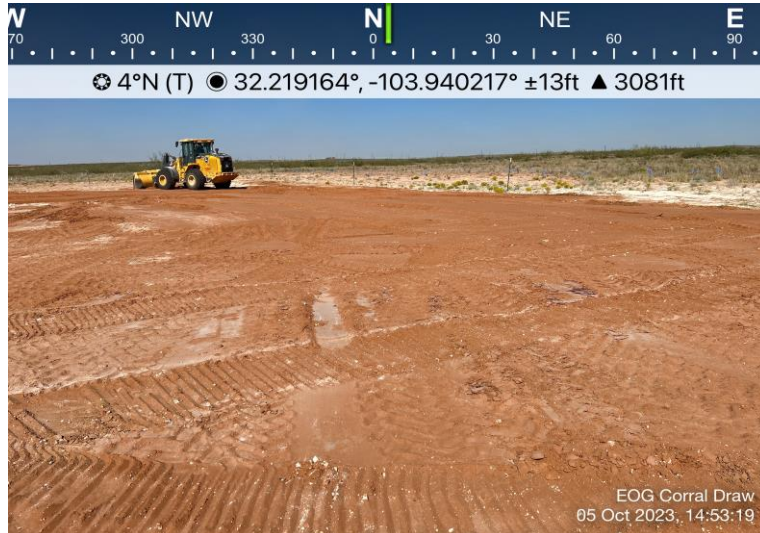
Photograph No. 5

View North, backfilled excavation.

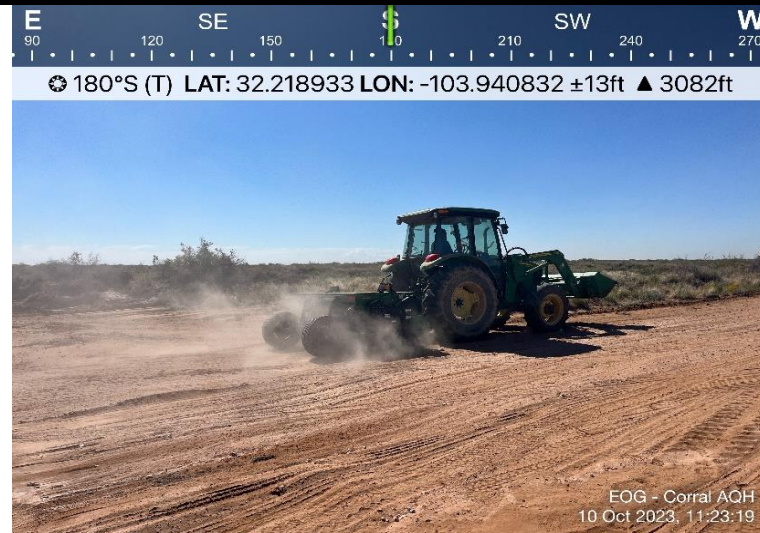
Photograph No. 6

View South of excavation in the process of being reseeded.

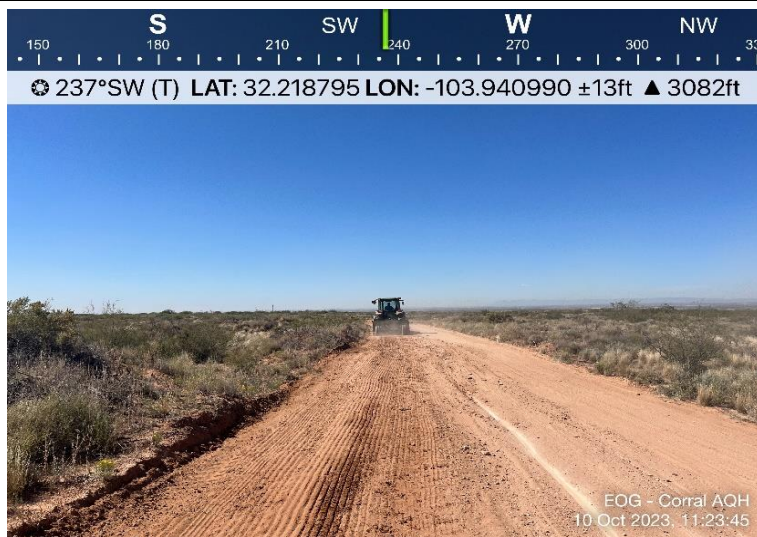
View Southwest of lease road in the process of being reseeded.

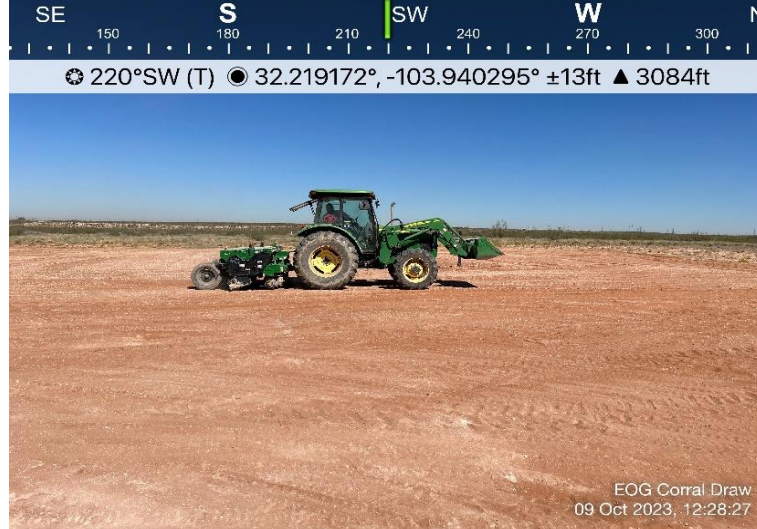
Photograph No. 8

View Southwest of excavation and pad in the process of being reseeded.

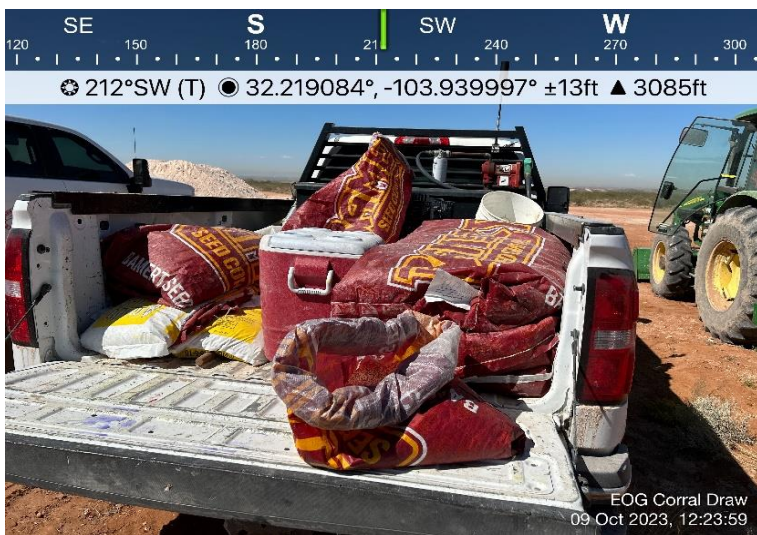
Photograph No. 9

View Southwest of seed mixture being staged for reseeded.

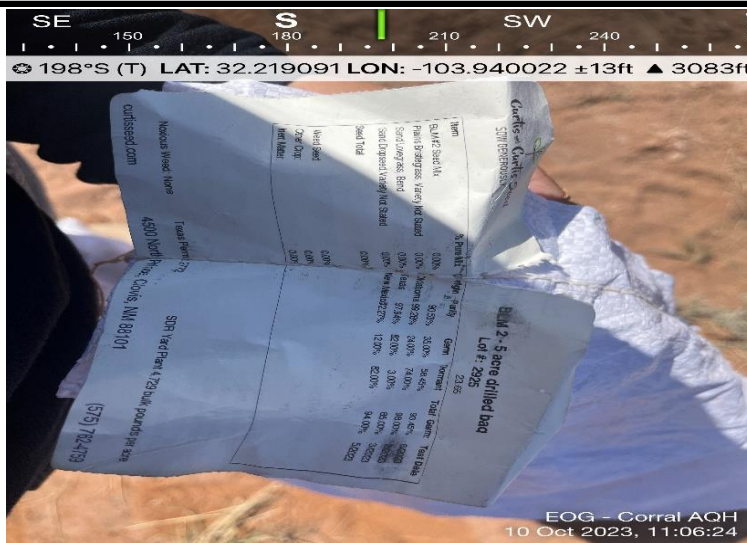
View South of receipt of specifications for seed mixture.
