March 25, 2024

**Re: 2023 Annual Groundwater Monitoring Report**

McCoy Gas Com D 1E  
San Juan County, New Mexico  
Hilcorp Energy Company  
NMOCD Incident Number: NCS2105634419

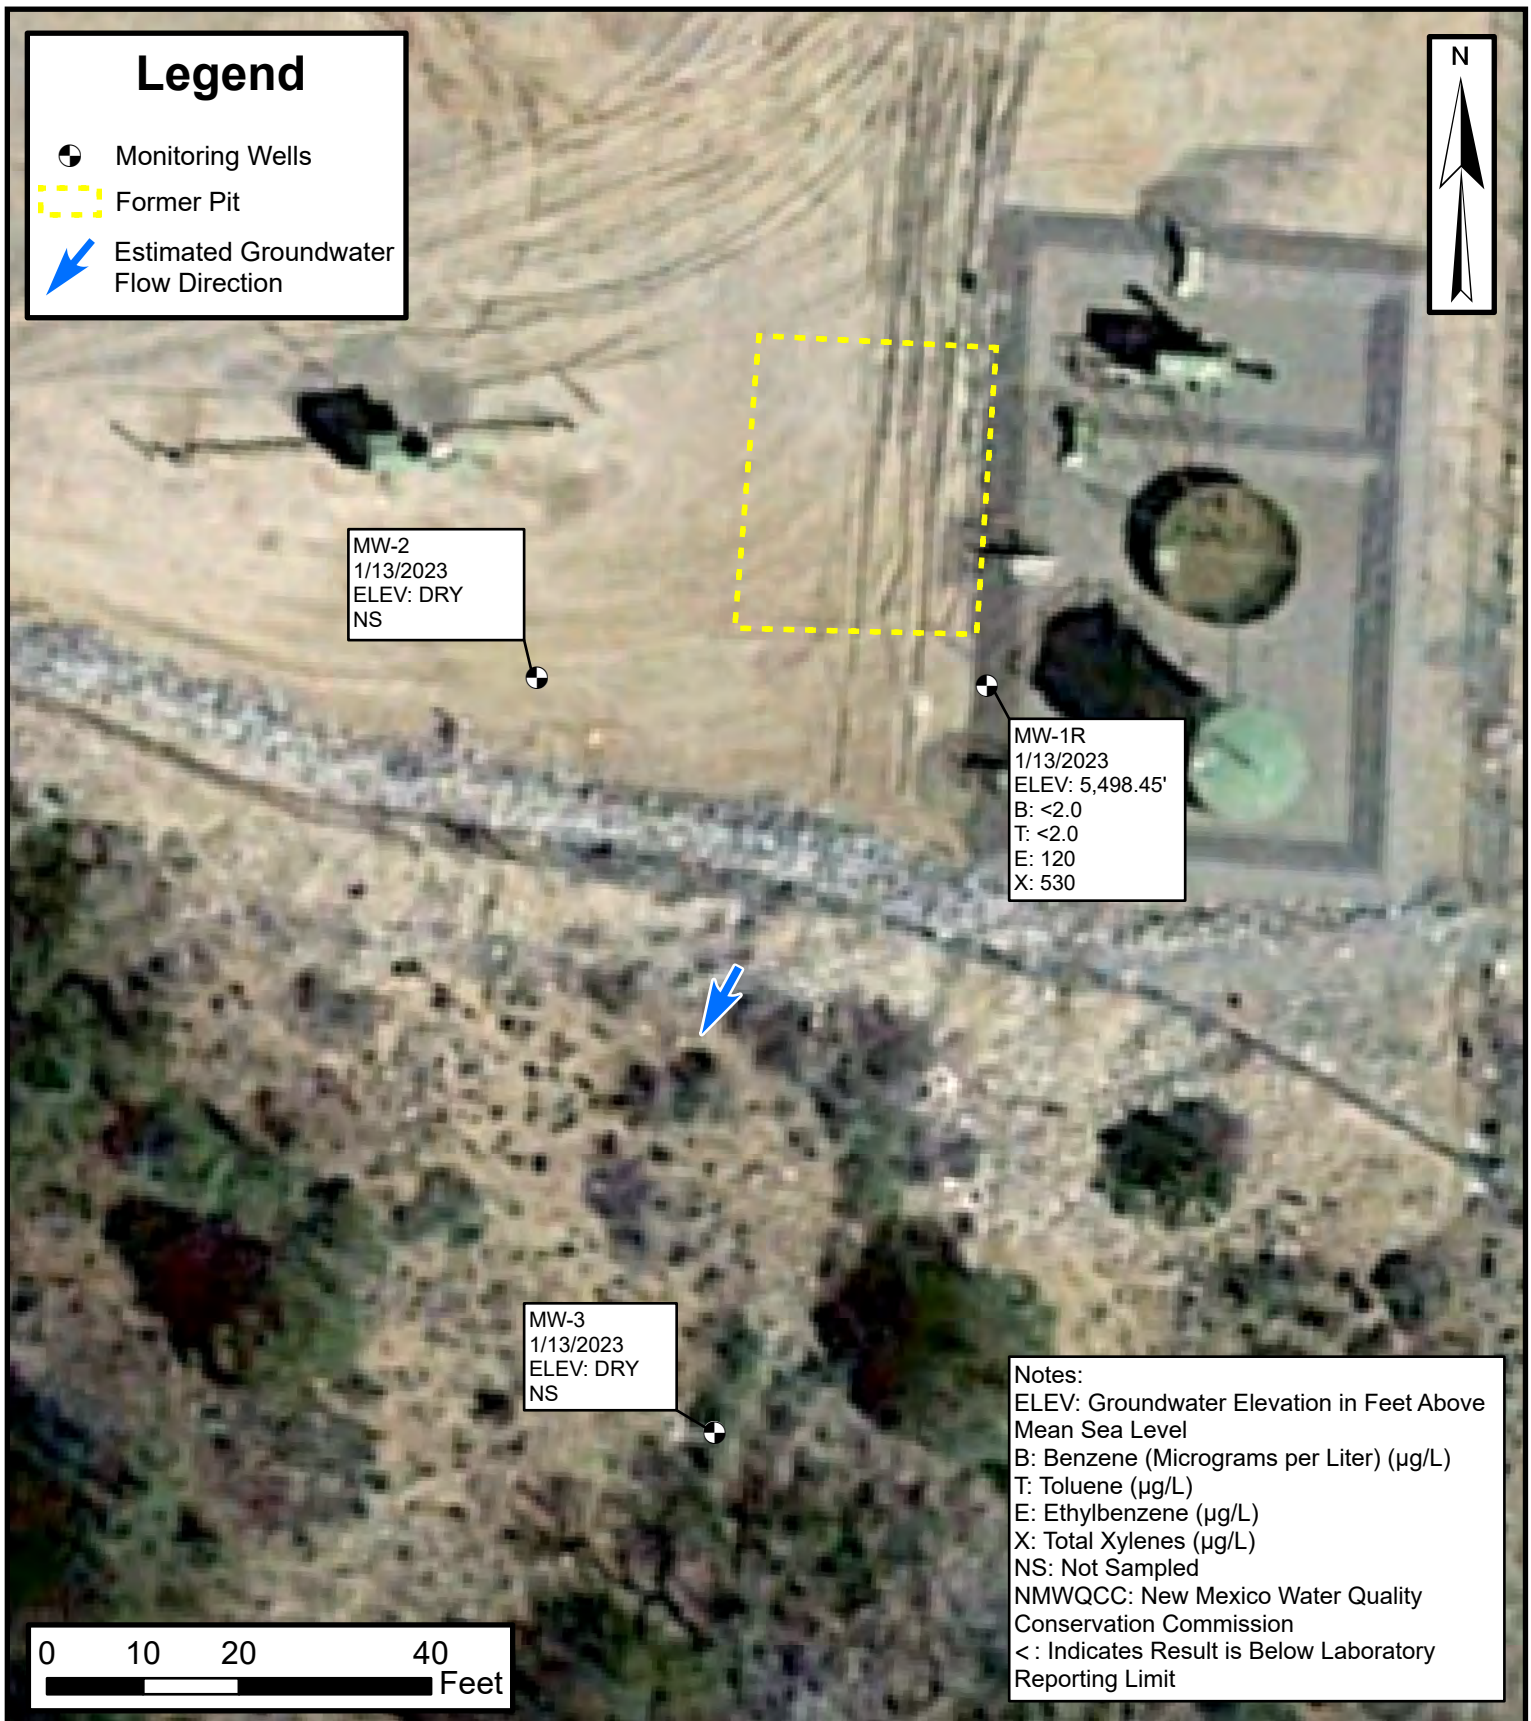
FIGURE

## Groundwater Elevation and Analytical Results (January 2023)

Groundwater level measurements were collected in January, May, July, and October 2023 at all wells, and samples were collected from well MW-1R during these monitoring events. Static groundwater level monitoring included recording depth-to-groundwater using an oil/water interface probe. The interface probe was decontaminated with Alconox™ soap and rinsed with distilled water prior to each measurement to prevent cross-contamination. Measured depths-to-groundwater and calculated groundwater elevations are presented in Table 1. The inferred groundwater flow direction was to the north-northeast during the 2023 sampling events, as indicated on Figures 2, 3, 4, and 5.

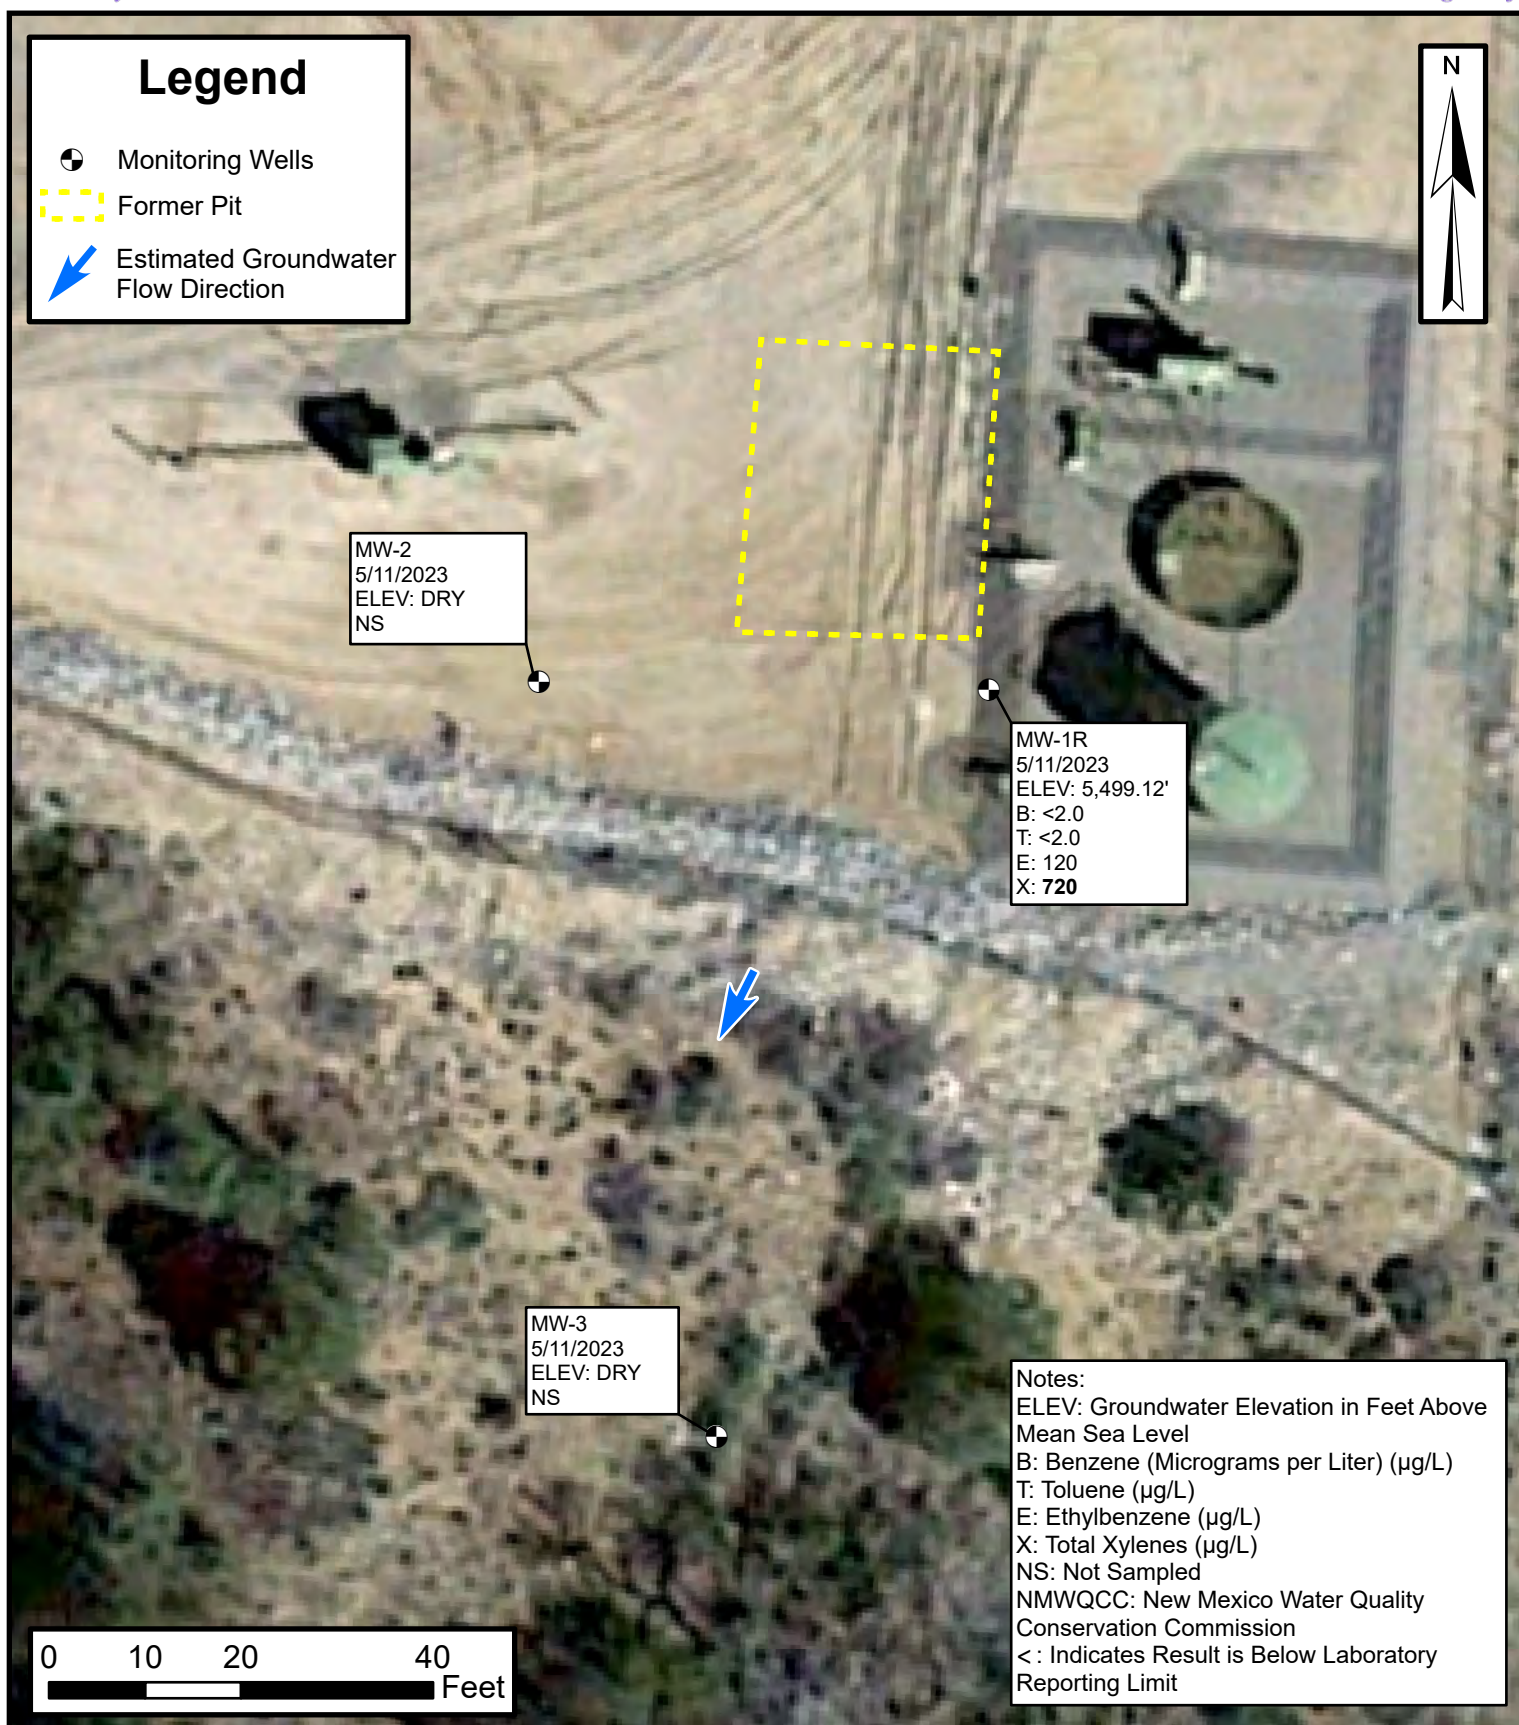
FIGURE

## Groundwater Elevation and Analytical Results (May 2023)

Total Xylenes were detected at MW-1R above the NMWQCC standards during the May 2023 Sampling event. Besides this single exceedance, no BTEX constituents were detected in groundwater from well MW-1R at concentrations exceeding the NMWQCC standards during the rest of the quarterly sampling events in 2023. Analytical results are summarized in Table 2 and depicted on Figures 2 through 5, with complete laboratory analytical reports attached as Appendix A.

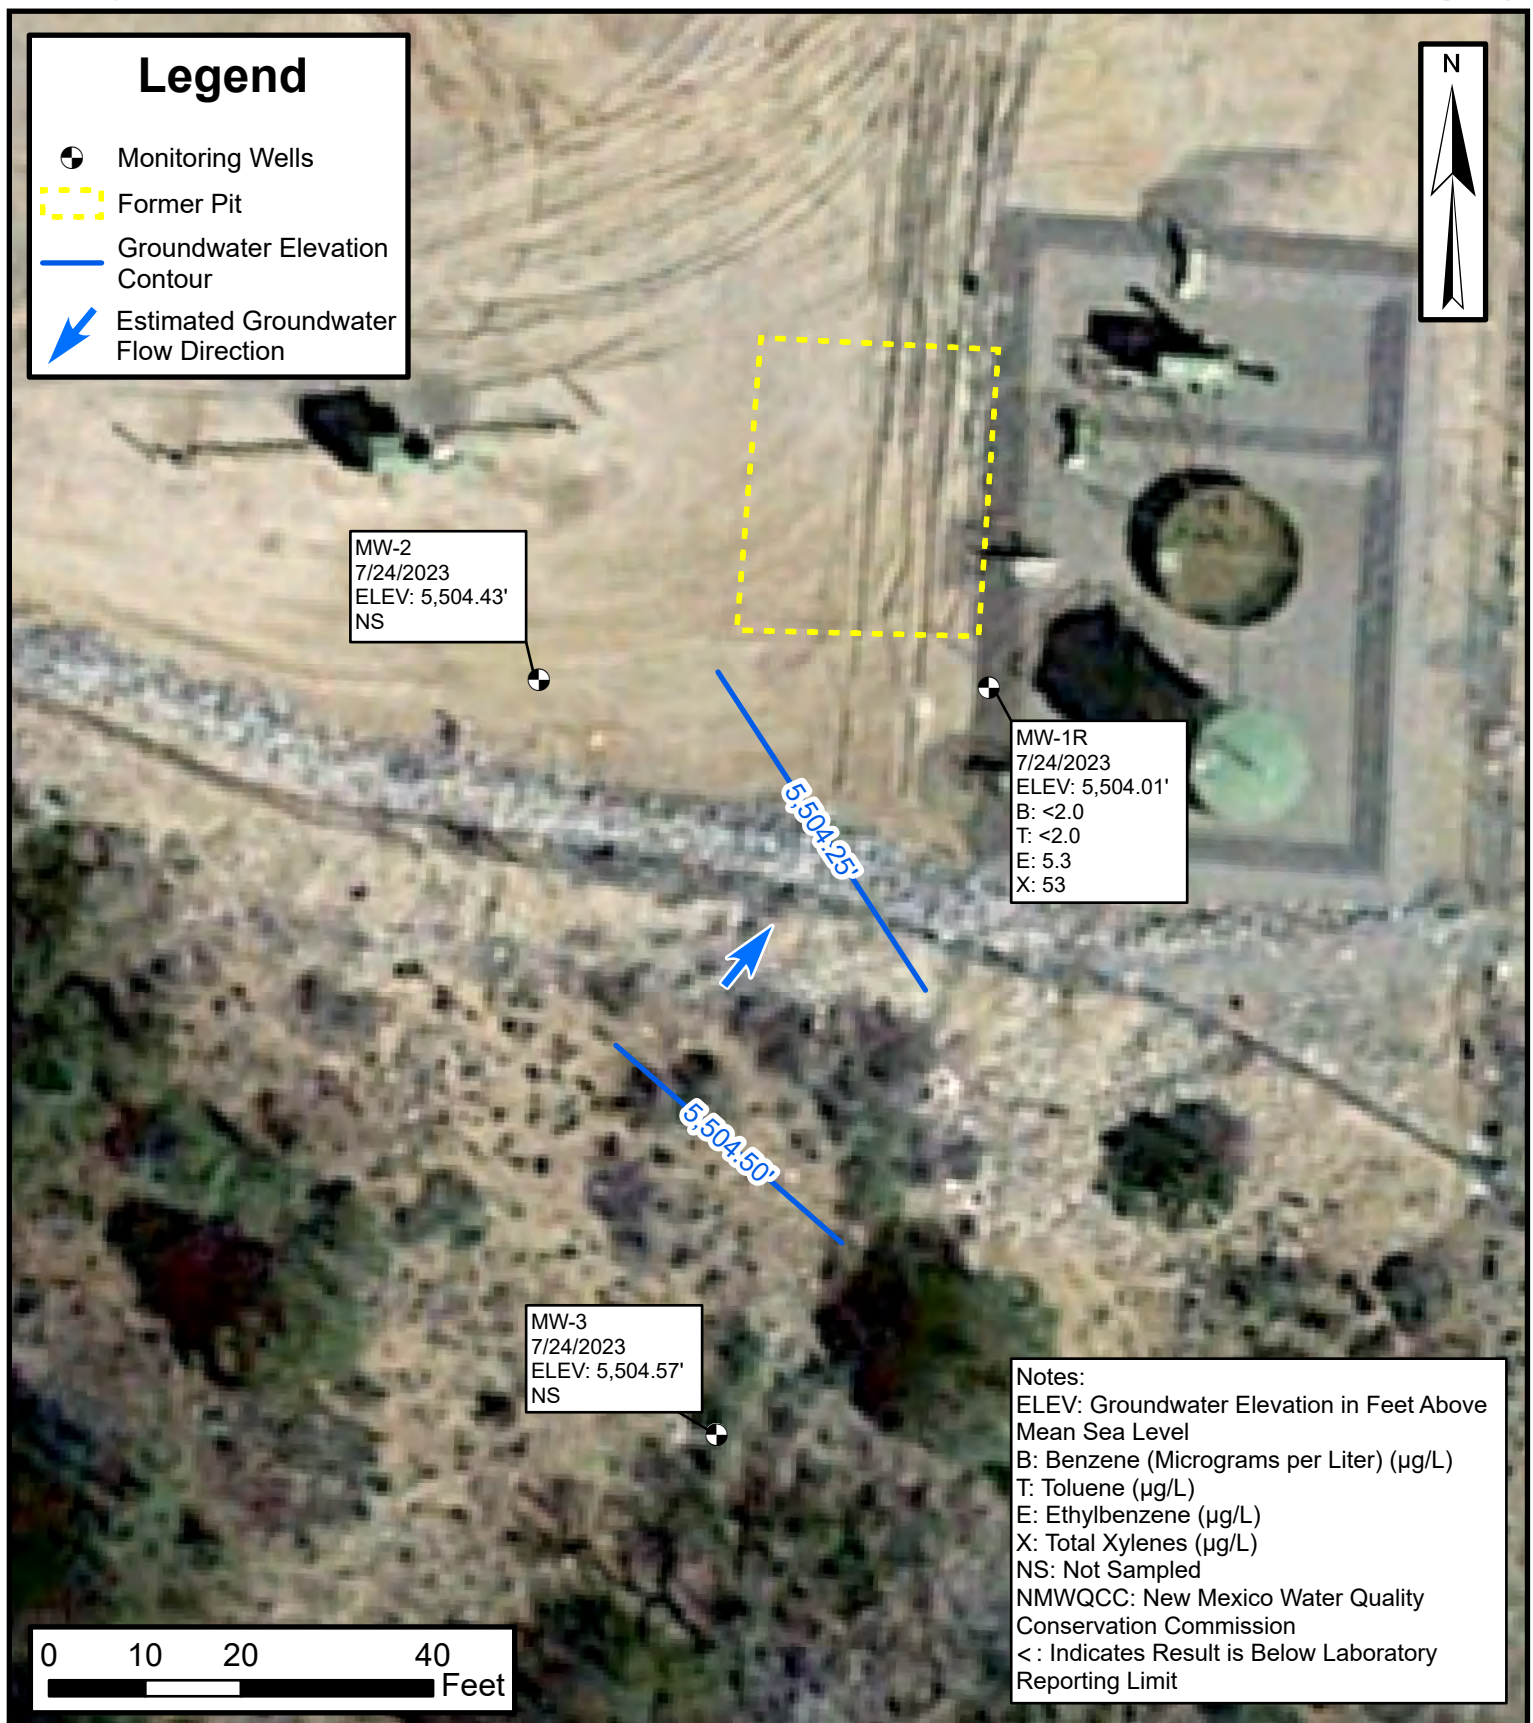
FIGURE

## Groundwater Elevation and Analytical Results (July 2023)
