**Re: Closure Request  
Rustler Breaks East Loop Water Line  
Incident Number nAPP2418024950  
Eddy County, New Mexico**

Ensolum, LLC (Ensolum), on behalf of San Mateo RB Pipeline, LLC (San Mateo), has prepared this *Closure Request* to document assessment, excavation, and soil sampling activities at the Rustler Breaks East Loop Water Line (Site). The purpose of the Site assessment and soil sampling activities was to assess for the presence or absence of impacts to soil following a release of produced water onto the pipeline right-of-way and adjacent pasture. Based on field observations, field screening activities, and soil sample laboratory analytical results, San Mateo is submitting this *Closure Request*, describing Site assessment, excavation, and delineation activities that have occurred and requesting no further action for Incident Number nAPP2418024950.

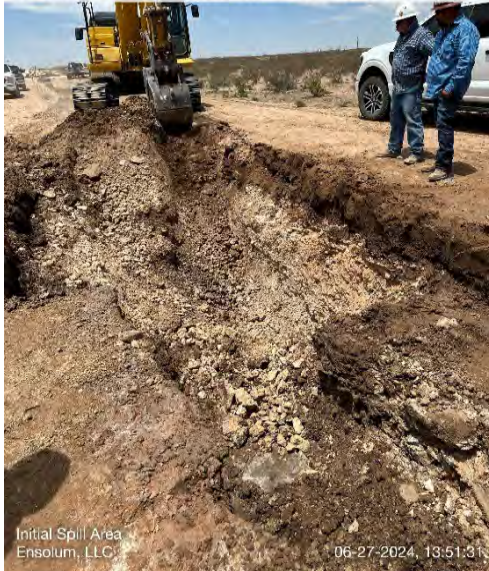
#### South Elevation

Initial Spill Area  
Ensolum, LLC

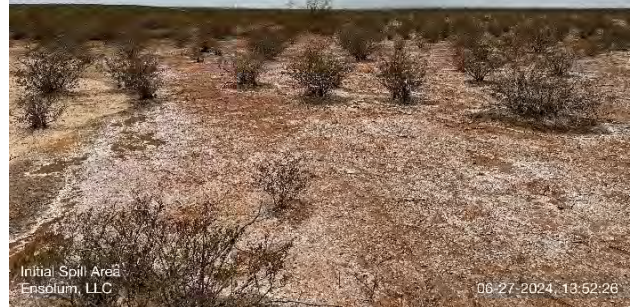
#### North East Elevation

Initial Spill Area  
Ensolum, LLC

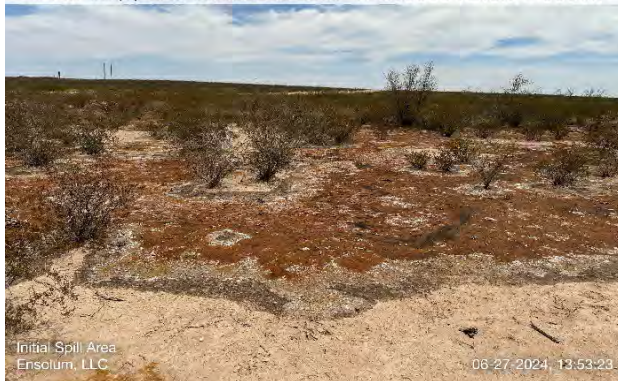
#### North West Elevation

Initial Spill Area  
Ensolum, LLC

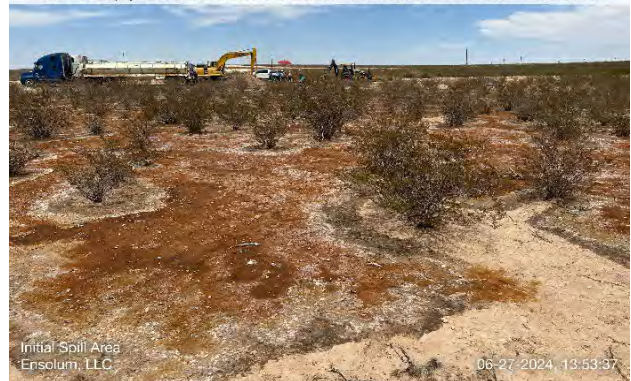
#### West Elevation

Initial Spill Area  
Ensolum, LLC

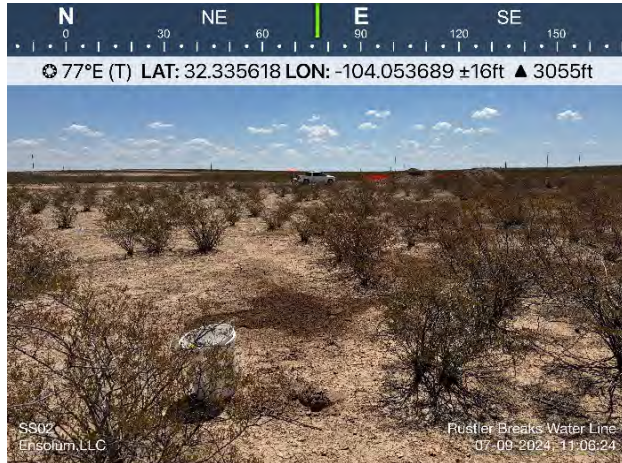
Photograph 5 Date: 07/09/2024  
Description: Lateral Delineation Sampling  
View: East

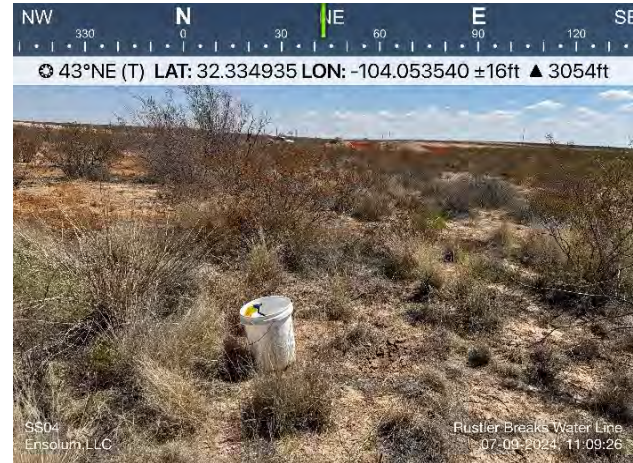
Photograph 6 Date: 07/09/2024  
Description: Lateral Delineation Sampling  
View: Northeast

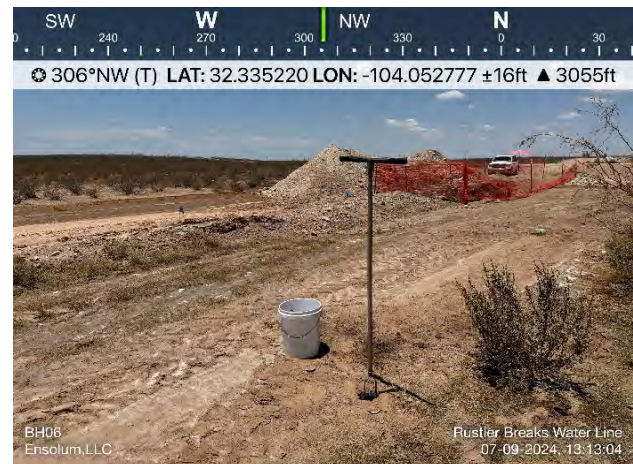
Photograph 8 Date: 07/09/2024  
Description: Vertical Delineation Sampling  
View: Northwest

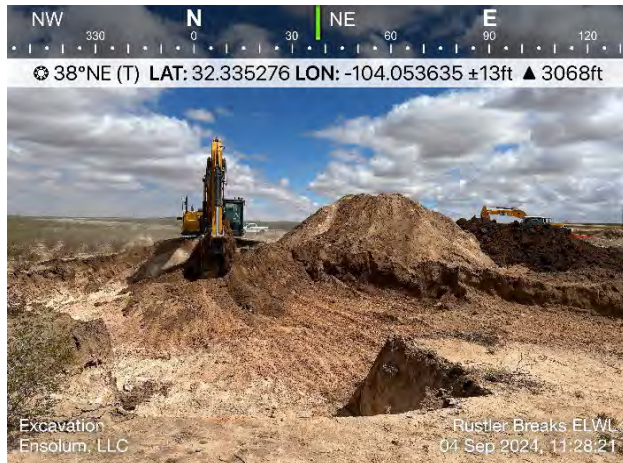
Photograph 13

Description: Excavation Activities

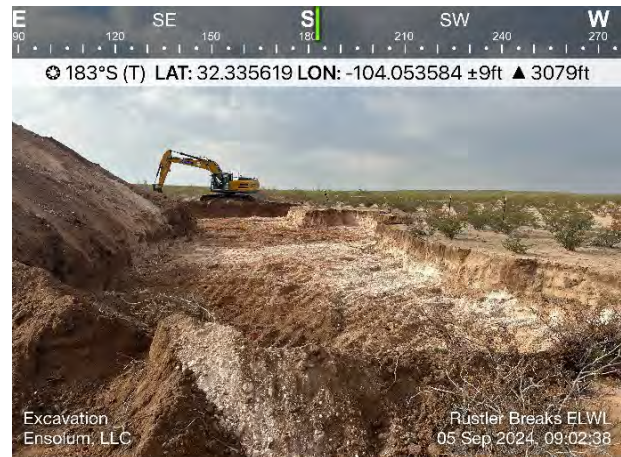
Photograph 14

Description: Excavation Activities

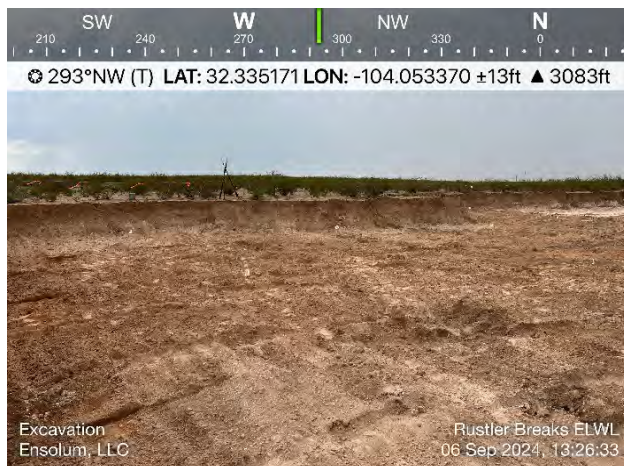
Photograph 15

Description: Confirmation Sampling Areas

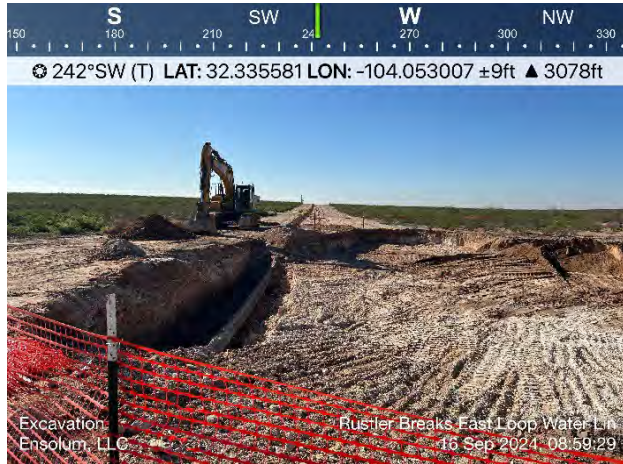
Photograph 17 Date: 09/16/2024  
Description: Excavation Activities  
View: Southwest

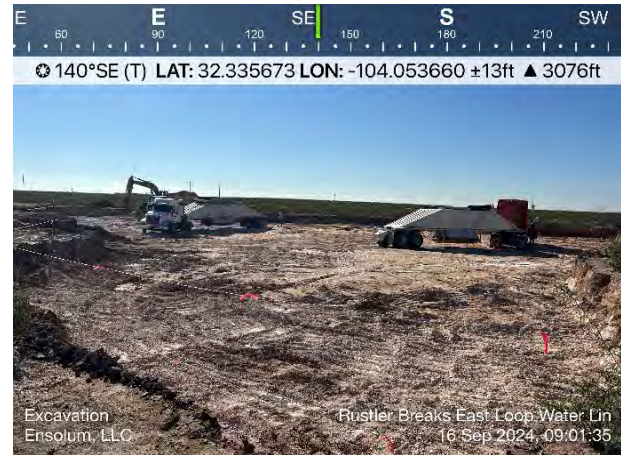
Photograph 18 Date: 09/16/2024  
Description: Excavation Activities  
View: Southeast

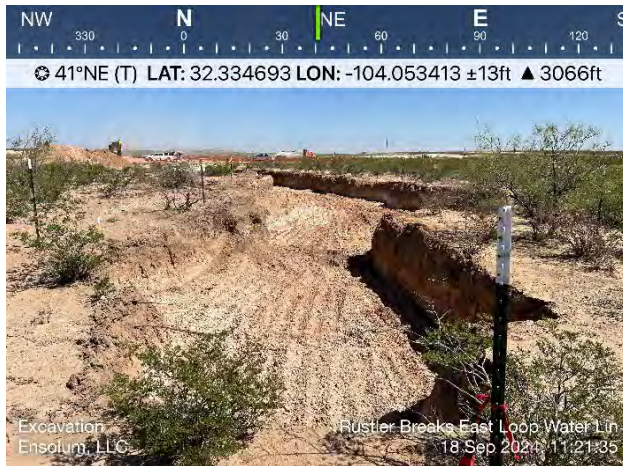
Photograph 21

Description: Excavation Activities

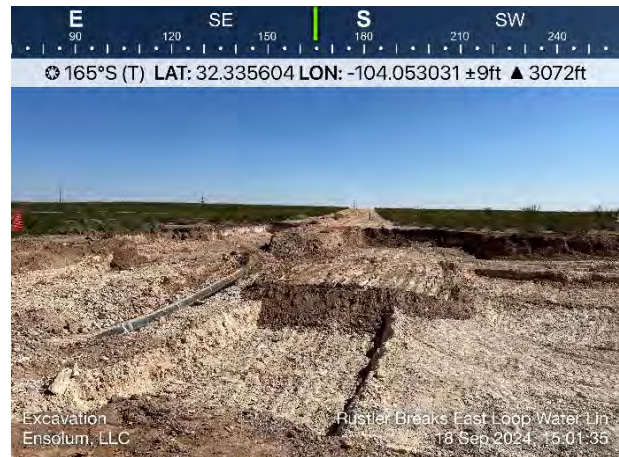
Photograph 22

Description: Excavation Activities

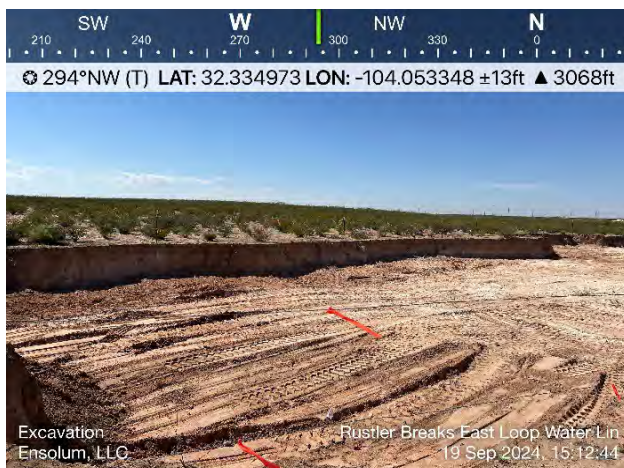
Photograph 23

Description: Excavation Activities

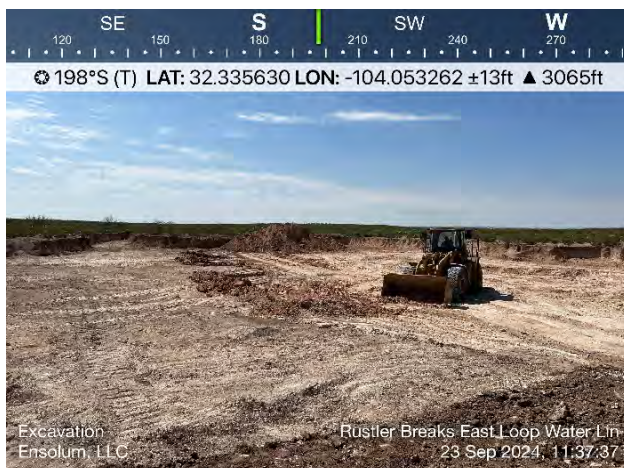
Photograph 27

Description: Excavation Activities
