CLOSURE REPORT

Mewborne Stage Fright

**Unit P, S18, T21S, R26E
32.473185° N, 104.324258° W
Eddy County, New Mexico
NMOCD Incident ID: nAPP2420029251**

October 30, 2024
Ensolum Project No. 03B1226338

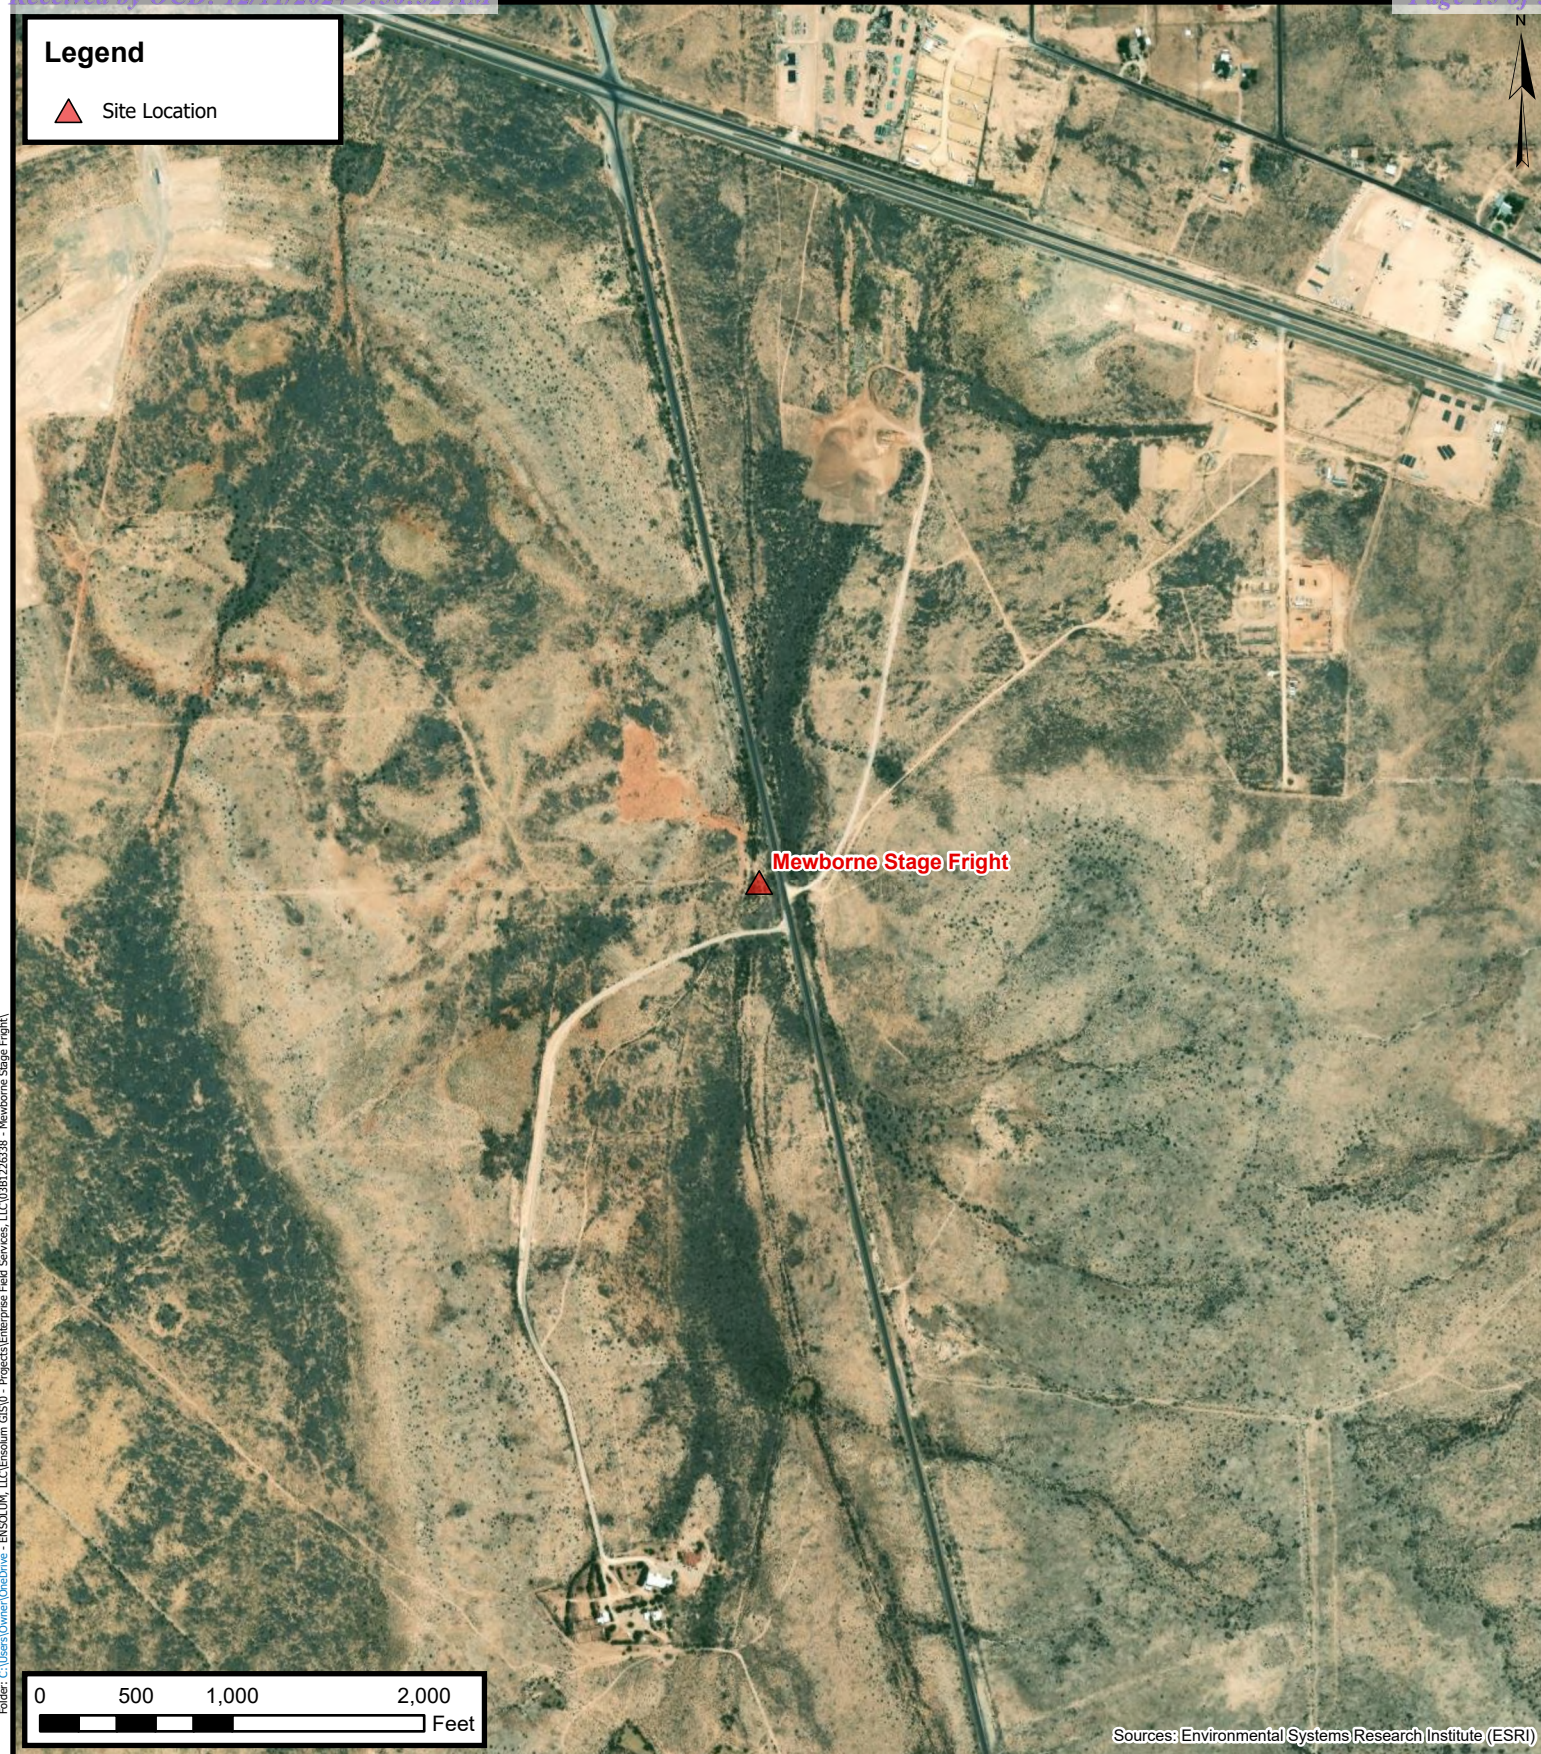
FIGURE

Site Vicinity Map

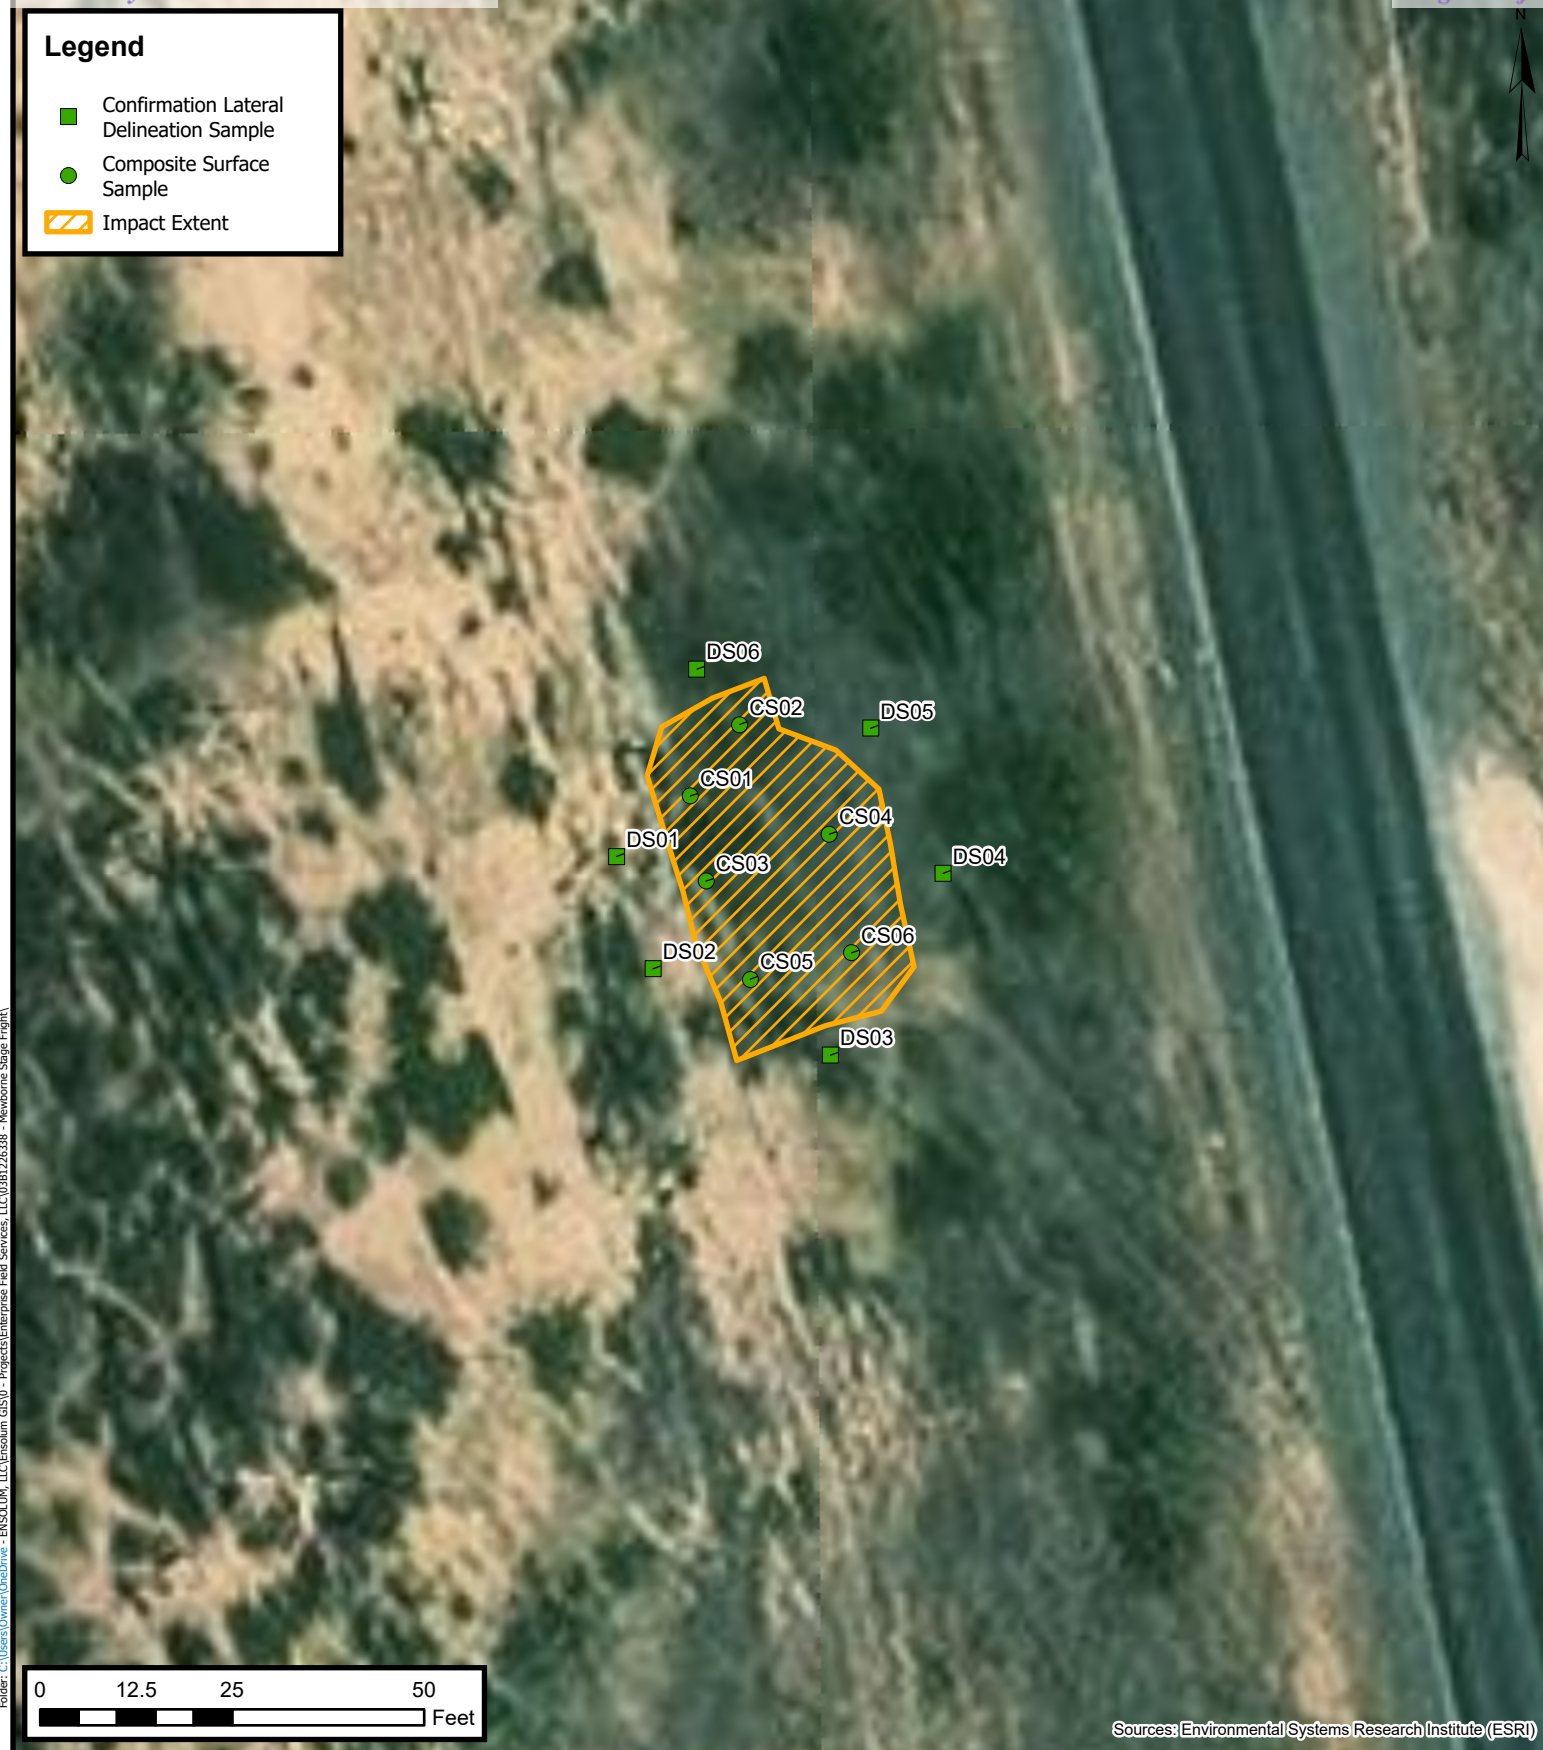
FIGURE
3

Figure 3 is a map that identifies approximate soil sample locations and depicts the approximate dimensions of the impacted areas with respect to Site boundaries (**Appendix A**). Photographic documentation of the field activities is included in **Appendix C**.

Site Map
Enterprise Field Services, LLC
Mewborne Stage Fright
Project Number: 03B1226338
32.473185, -104.324258
Eddy County, New Mexico

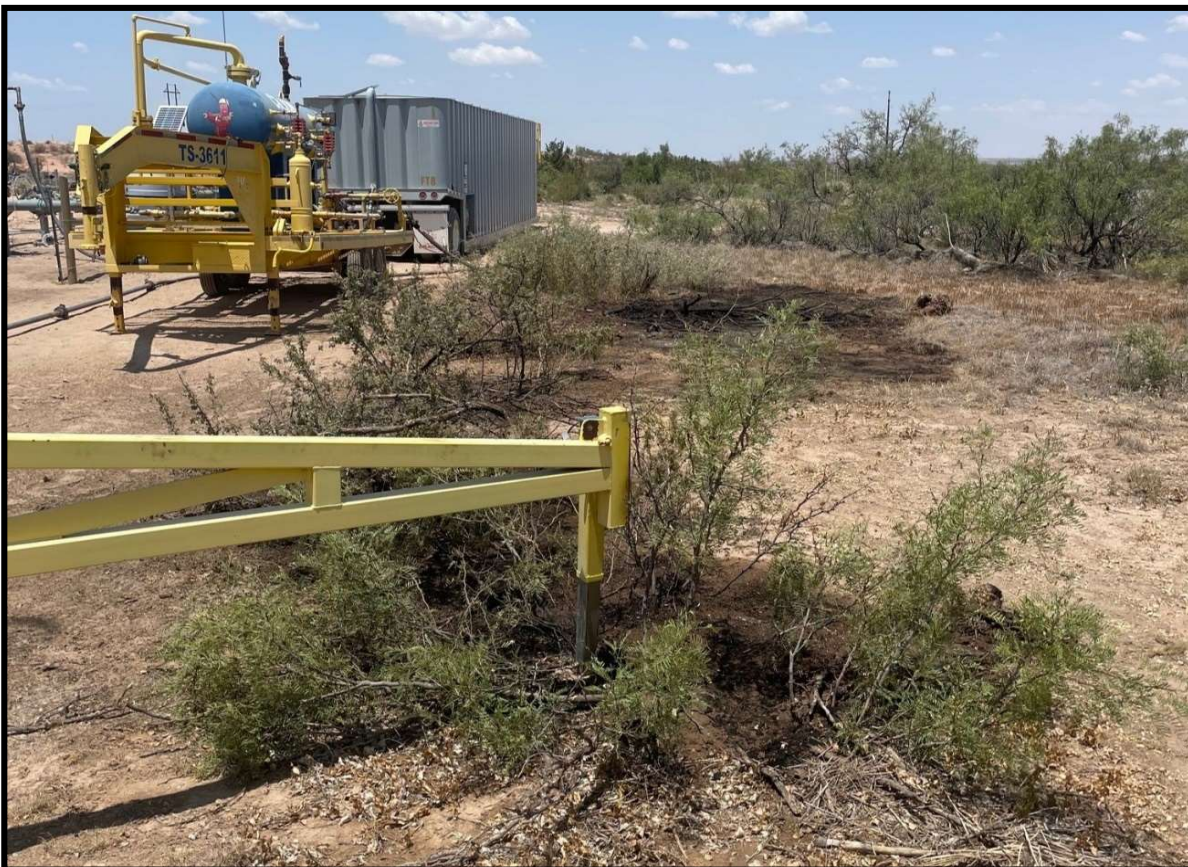
View of the extent of the impact prior to remediation activities, facing north (July 17, 2024).

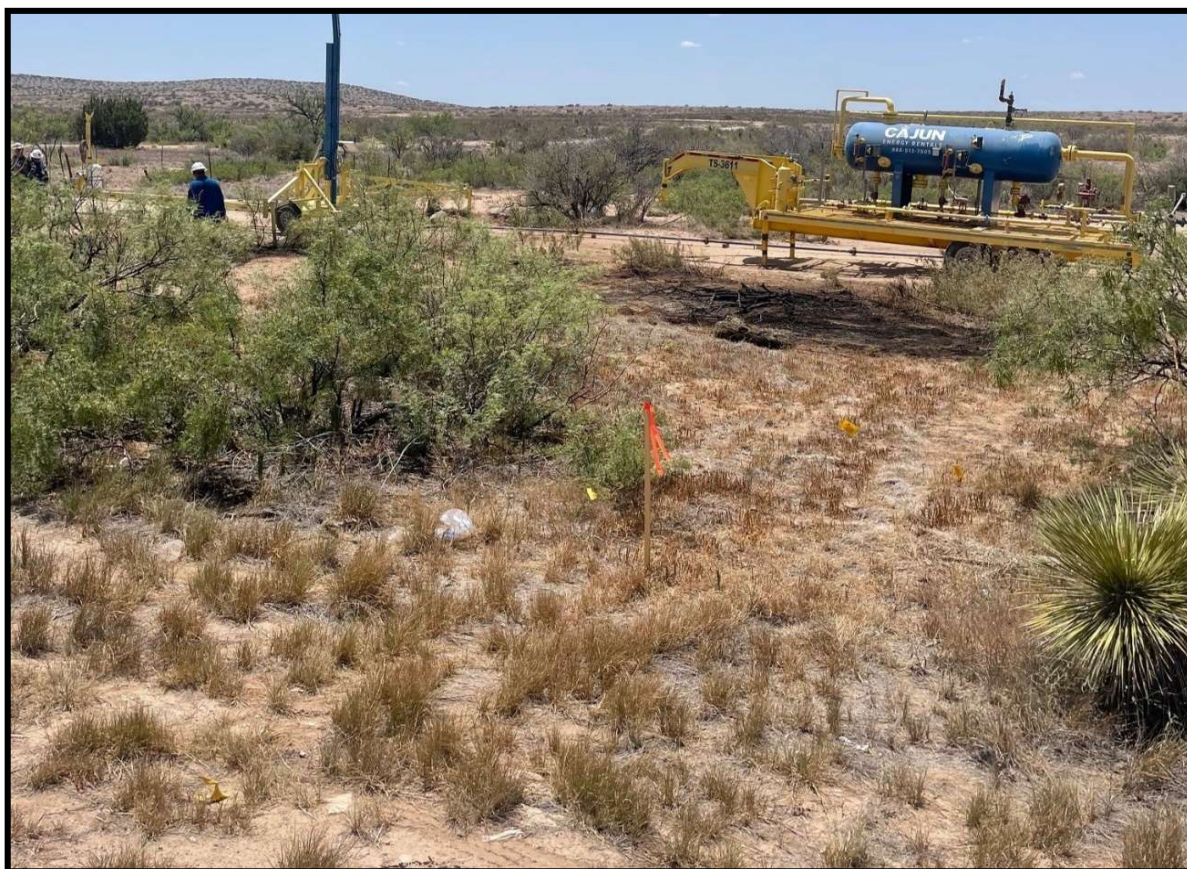
View of the extent of the impact prior to remediation activities, facing west (July 17, 2024).

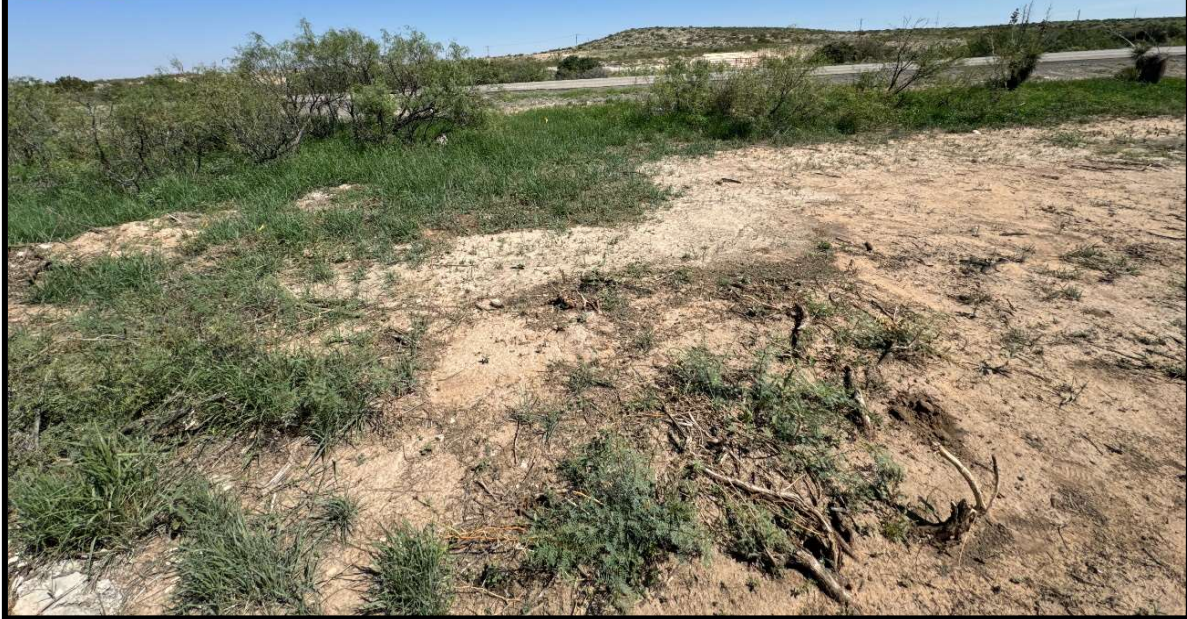
View of the impacted area during sampling activities, facing southeast (September 23, 2024).

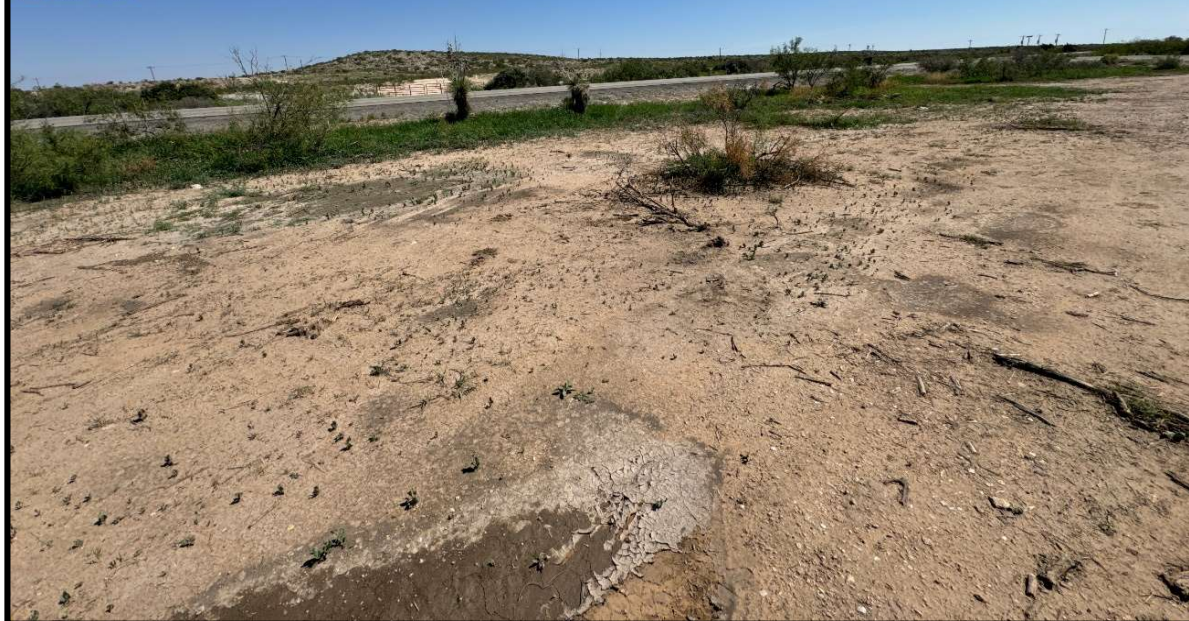
View of the impacted area during sampling activities, facing southeast (September 23, 2024).

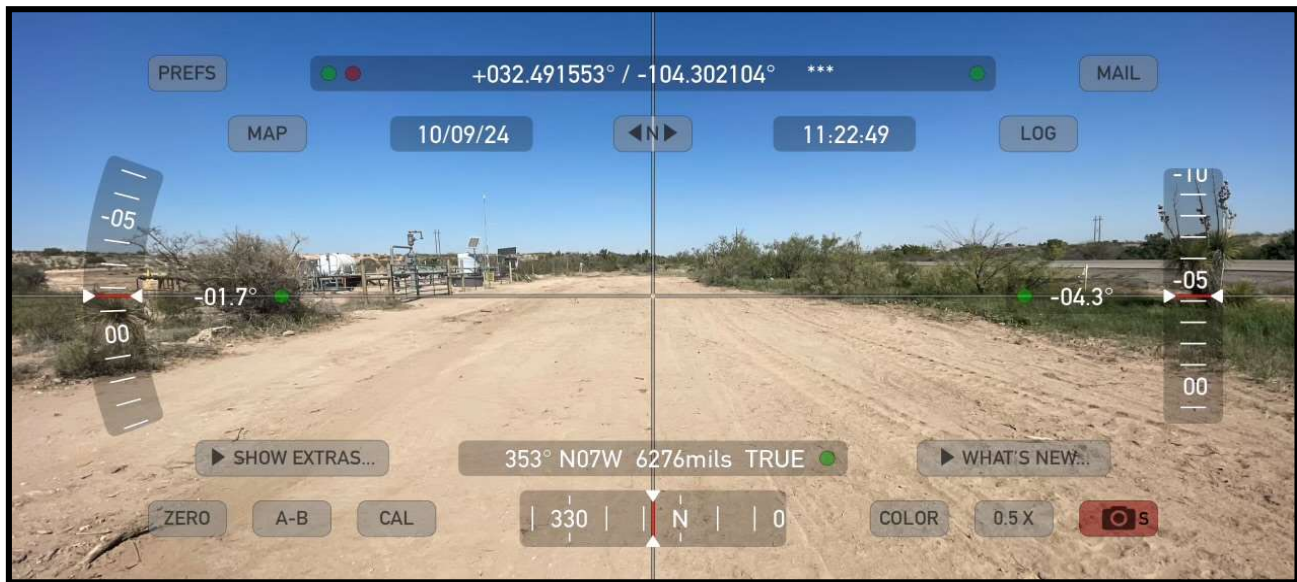
View of scraped impacted area, facing north (October 9, 2024).

A total of approximately 10 cubic yards of fire-stained soils were removed from the Site and transported to the Lea Land, LLC facility in Carlsbad, New Mexico. The scraped impacted area will be recontoured to the original surrounding grade, and a NMSLO-approved seed mixture will be sown into the surface area of the backfill for re-vegetation.
