**C-141 - CO2 GAS RELEASE ONLY (NO LIQUIDS)**  
**EVENT SUMMARY, VARIANCE REQUEST & CLOSURE REQUEST REPORT**

<b>Facility ID:</b>	fKJ1517634129	<b>Incident #:</b>	nAPP2507951339
<b>Facility Name:</b>	North Hobbs RCF	<b>Flare Date:</b>	03/16/2025
<b>Event Duration:</b>	24 Minutes	<b>MCF Flared:</b>	204
<b>Start Time:</b>	07:39 PM	<b>End Time:</b>	08:03 PM
<b>Cause:</b>	Emergency Flare > G & H Train Shut Down > Compressor Malfunction		
<b>Method of Flared Gas Measurement:</b>	Gas Flare Meter

**C-141 EVENT SUMMARY & VARIANCE REQUEST:**

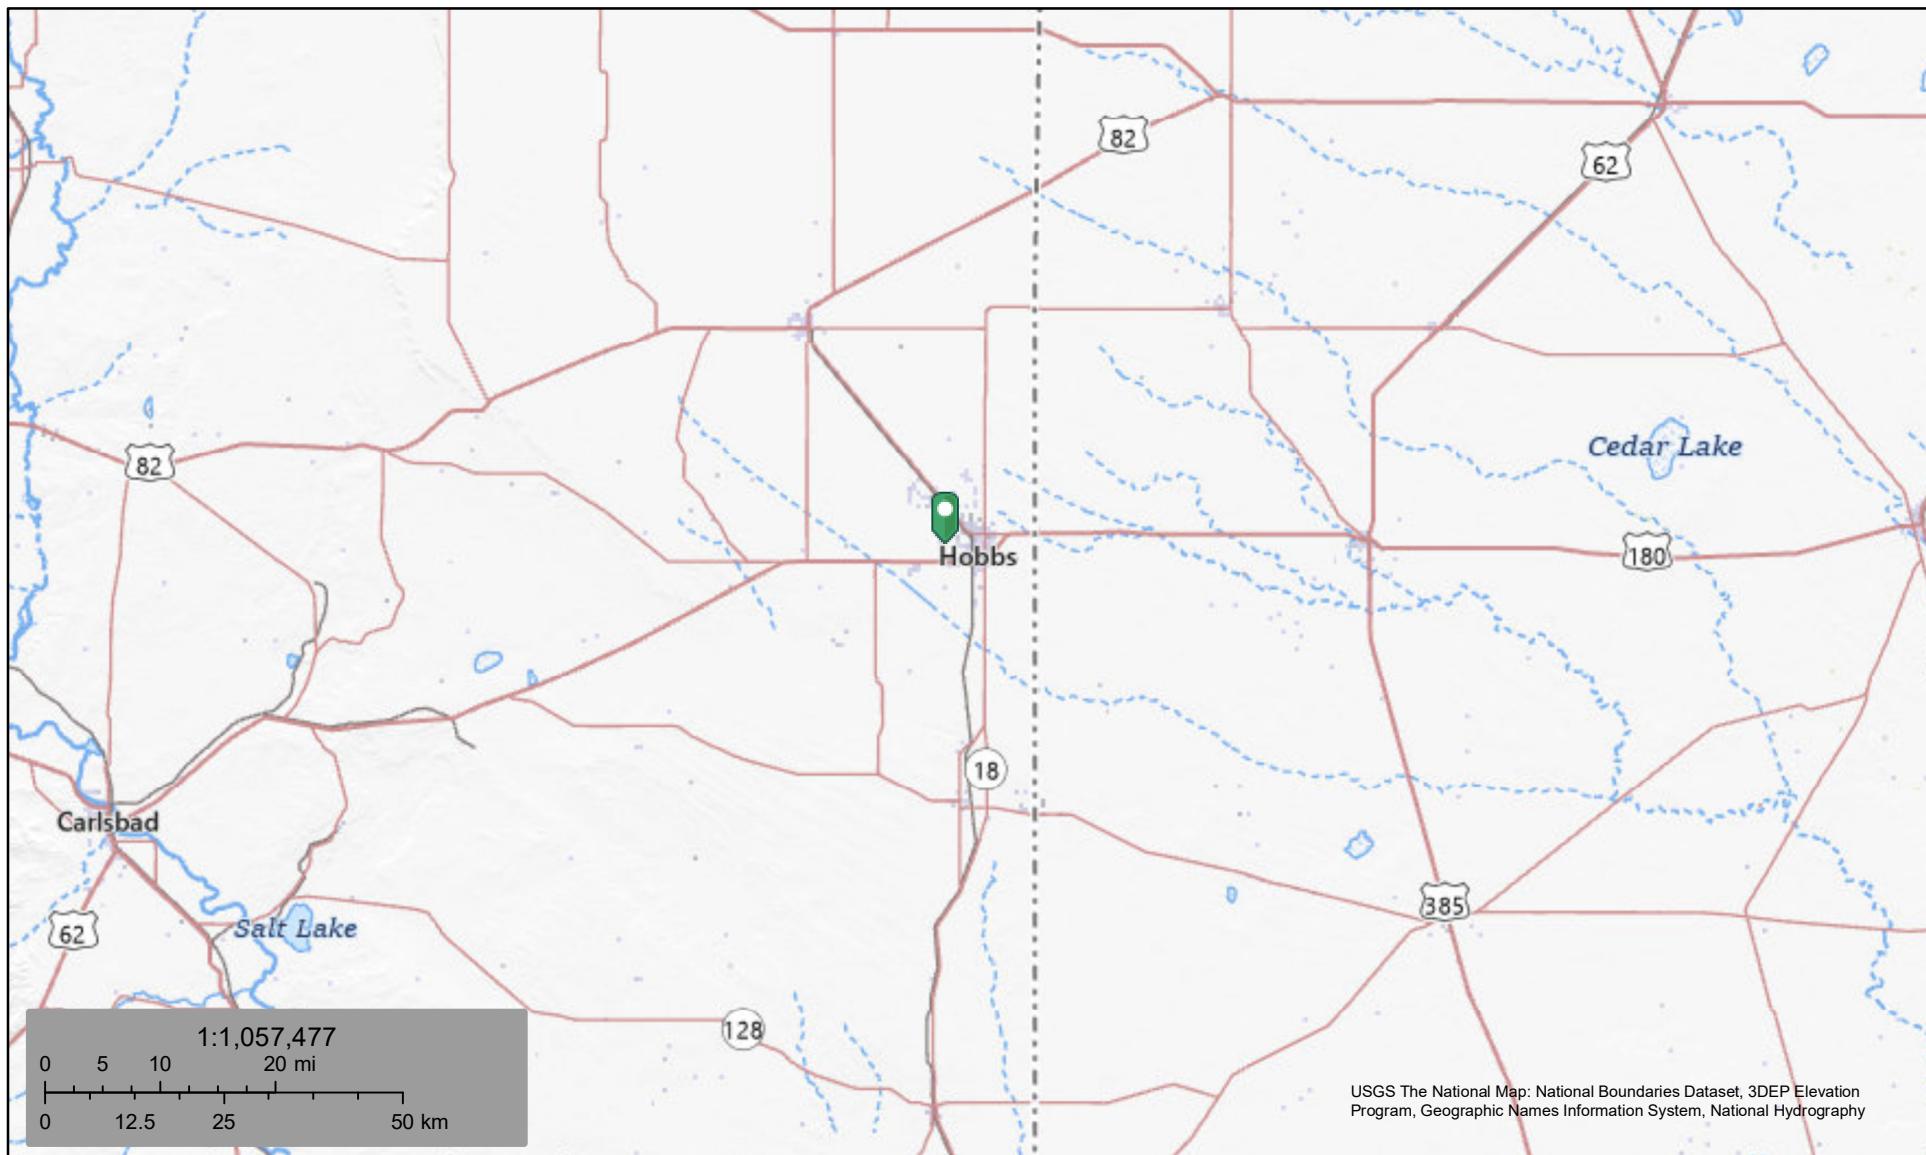
## NH RCF - Surface Waters Map

Intermittent Stream  
Perennial Stream

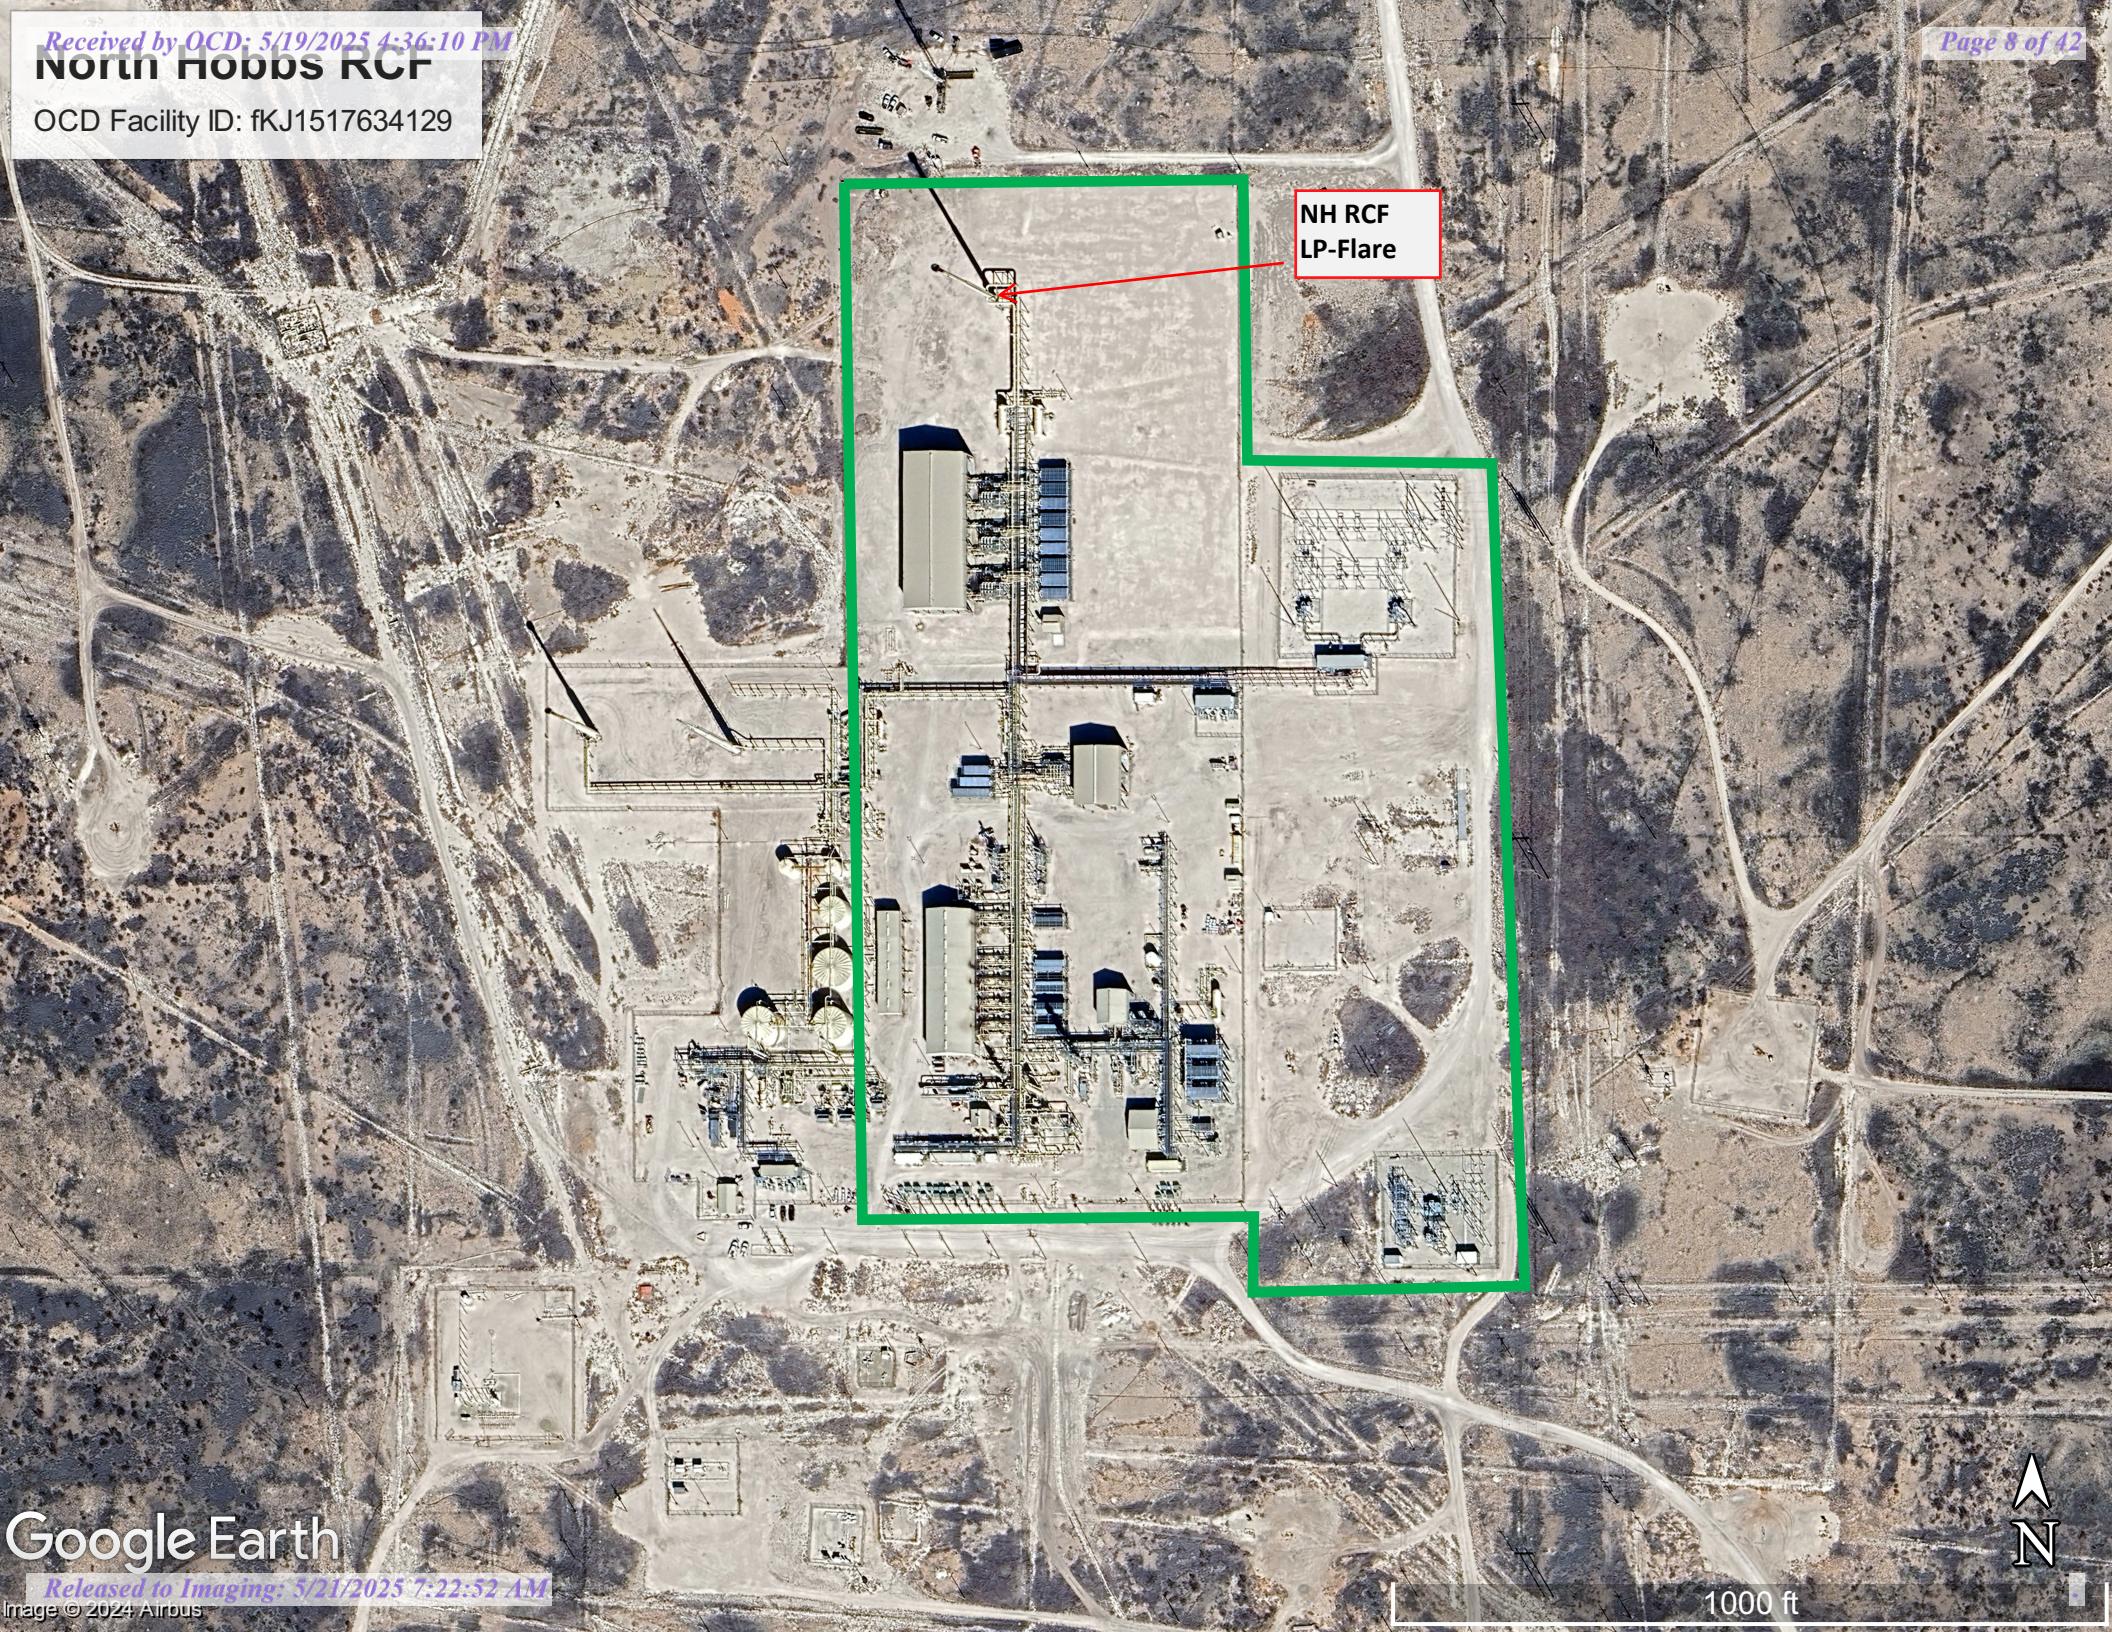
## Scaled Site Map

# NORTH HOBBS RCF

OCD Facility ID: fKJ1517634129

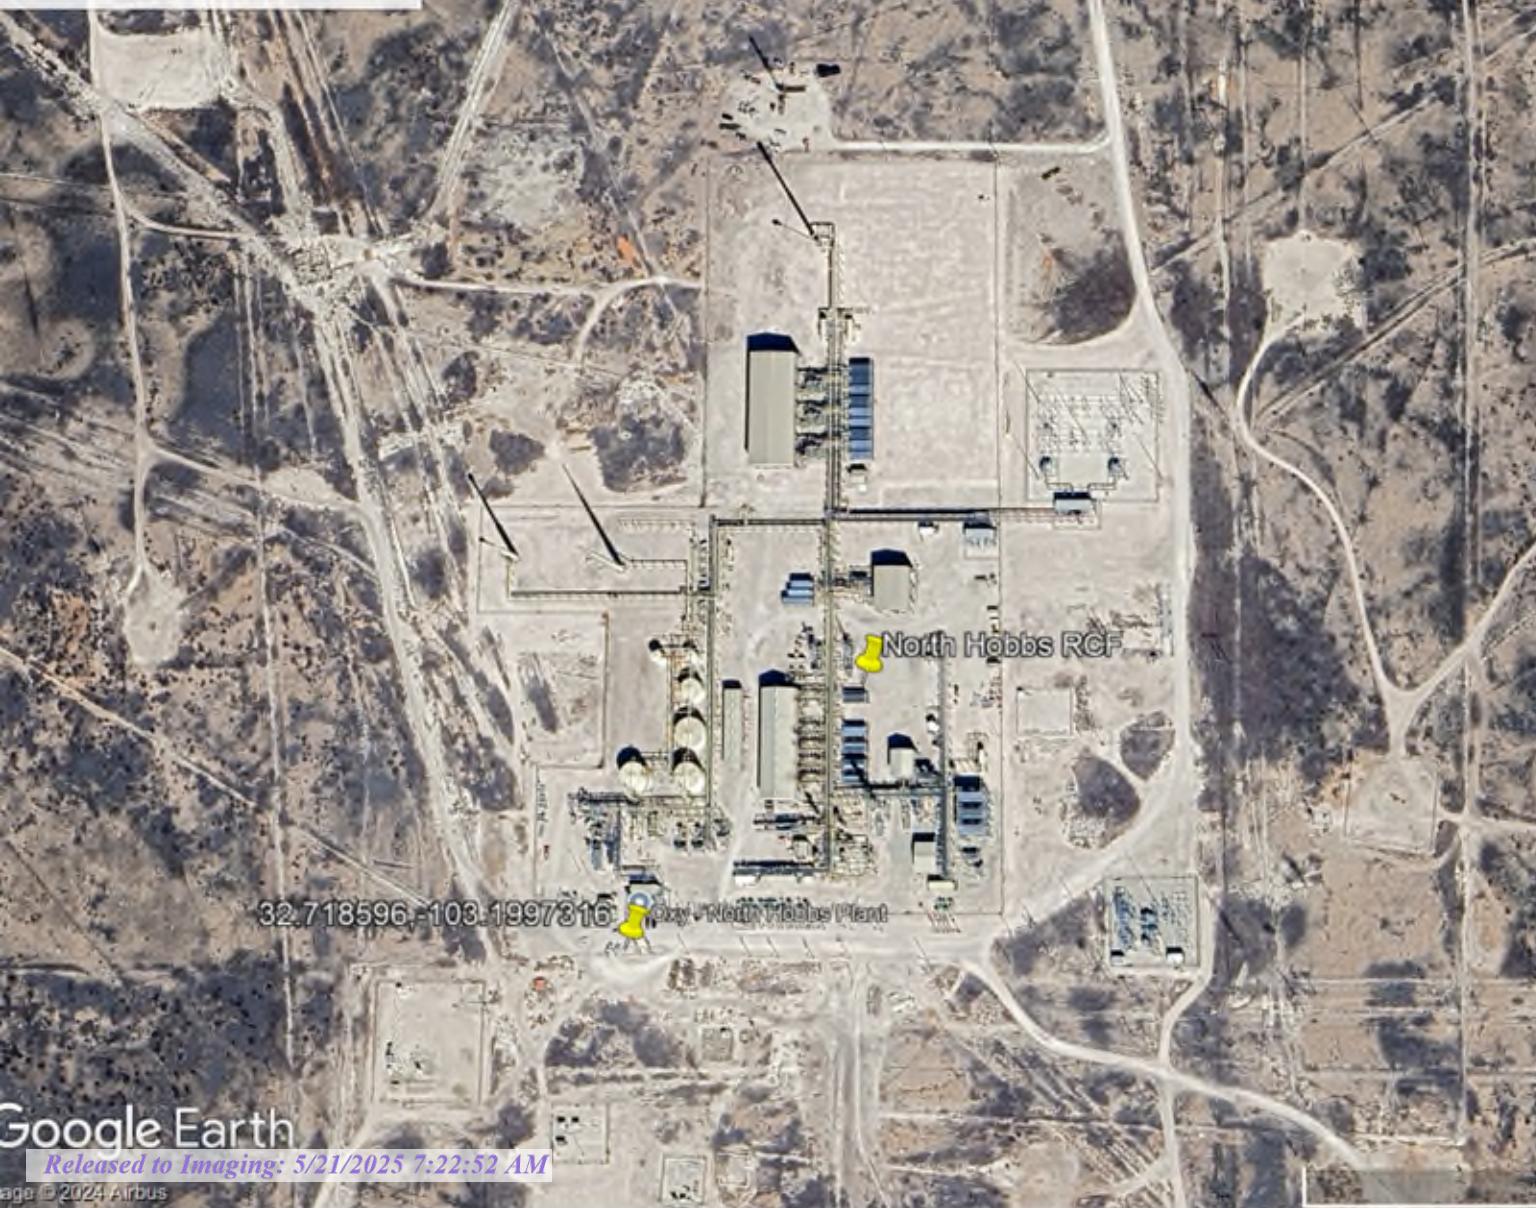
## Depth to Groundwater

OXY  
fKJ1517634129

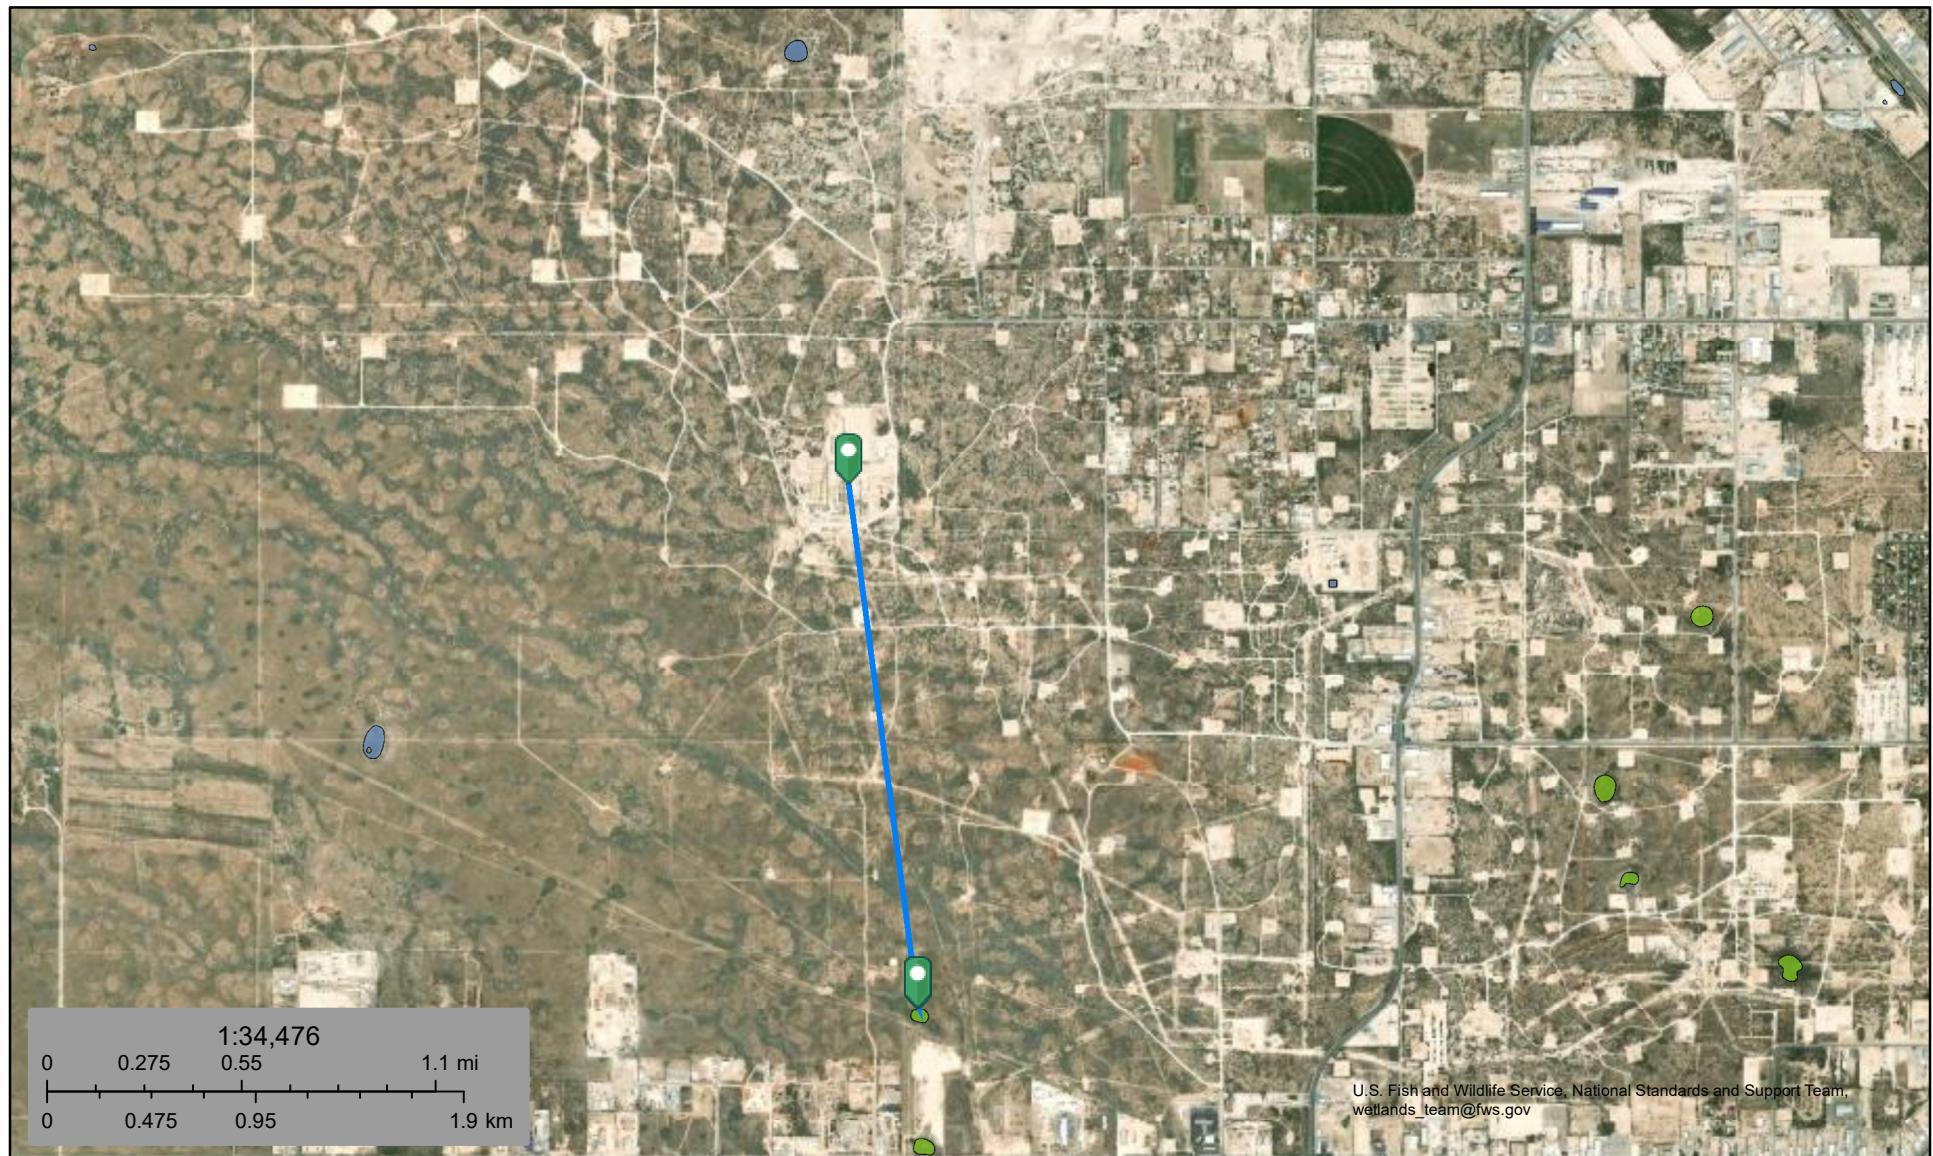
## NH RCF - Wetlands Map

- Estuarine and Marine Wetland
- Lake
- Other
- Riverine

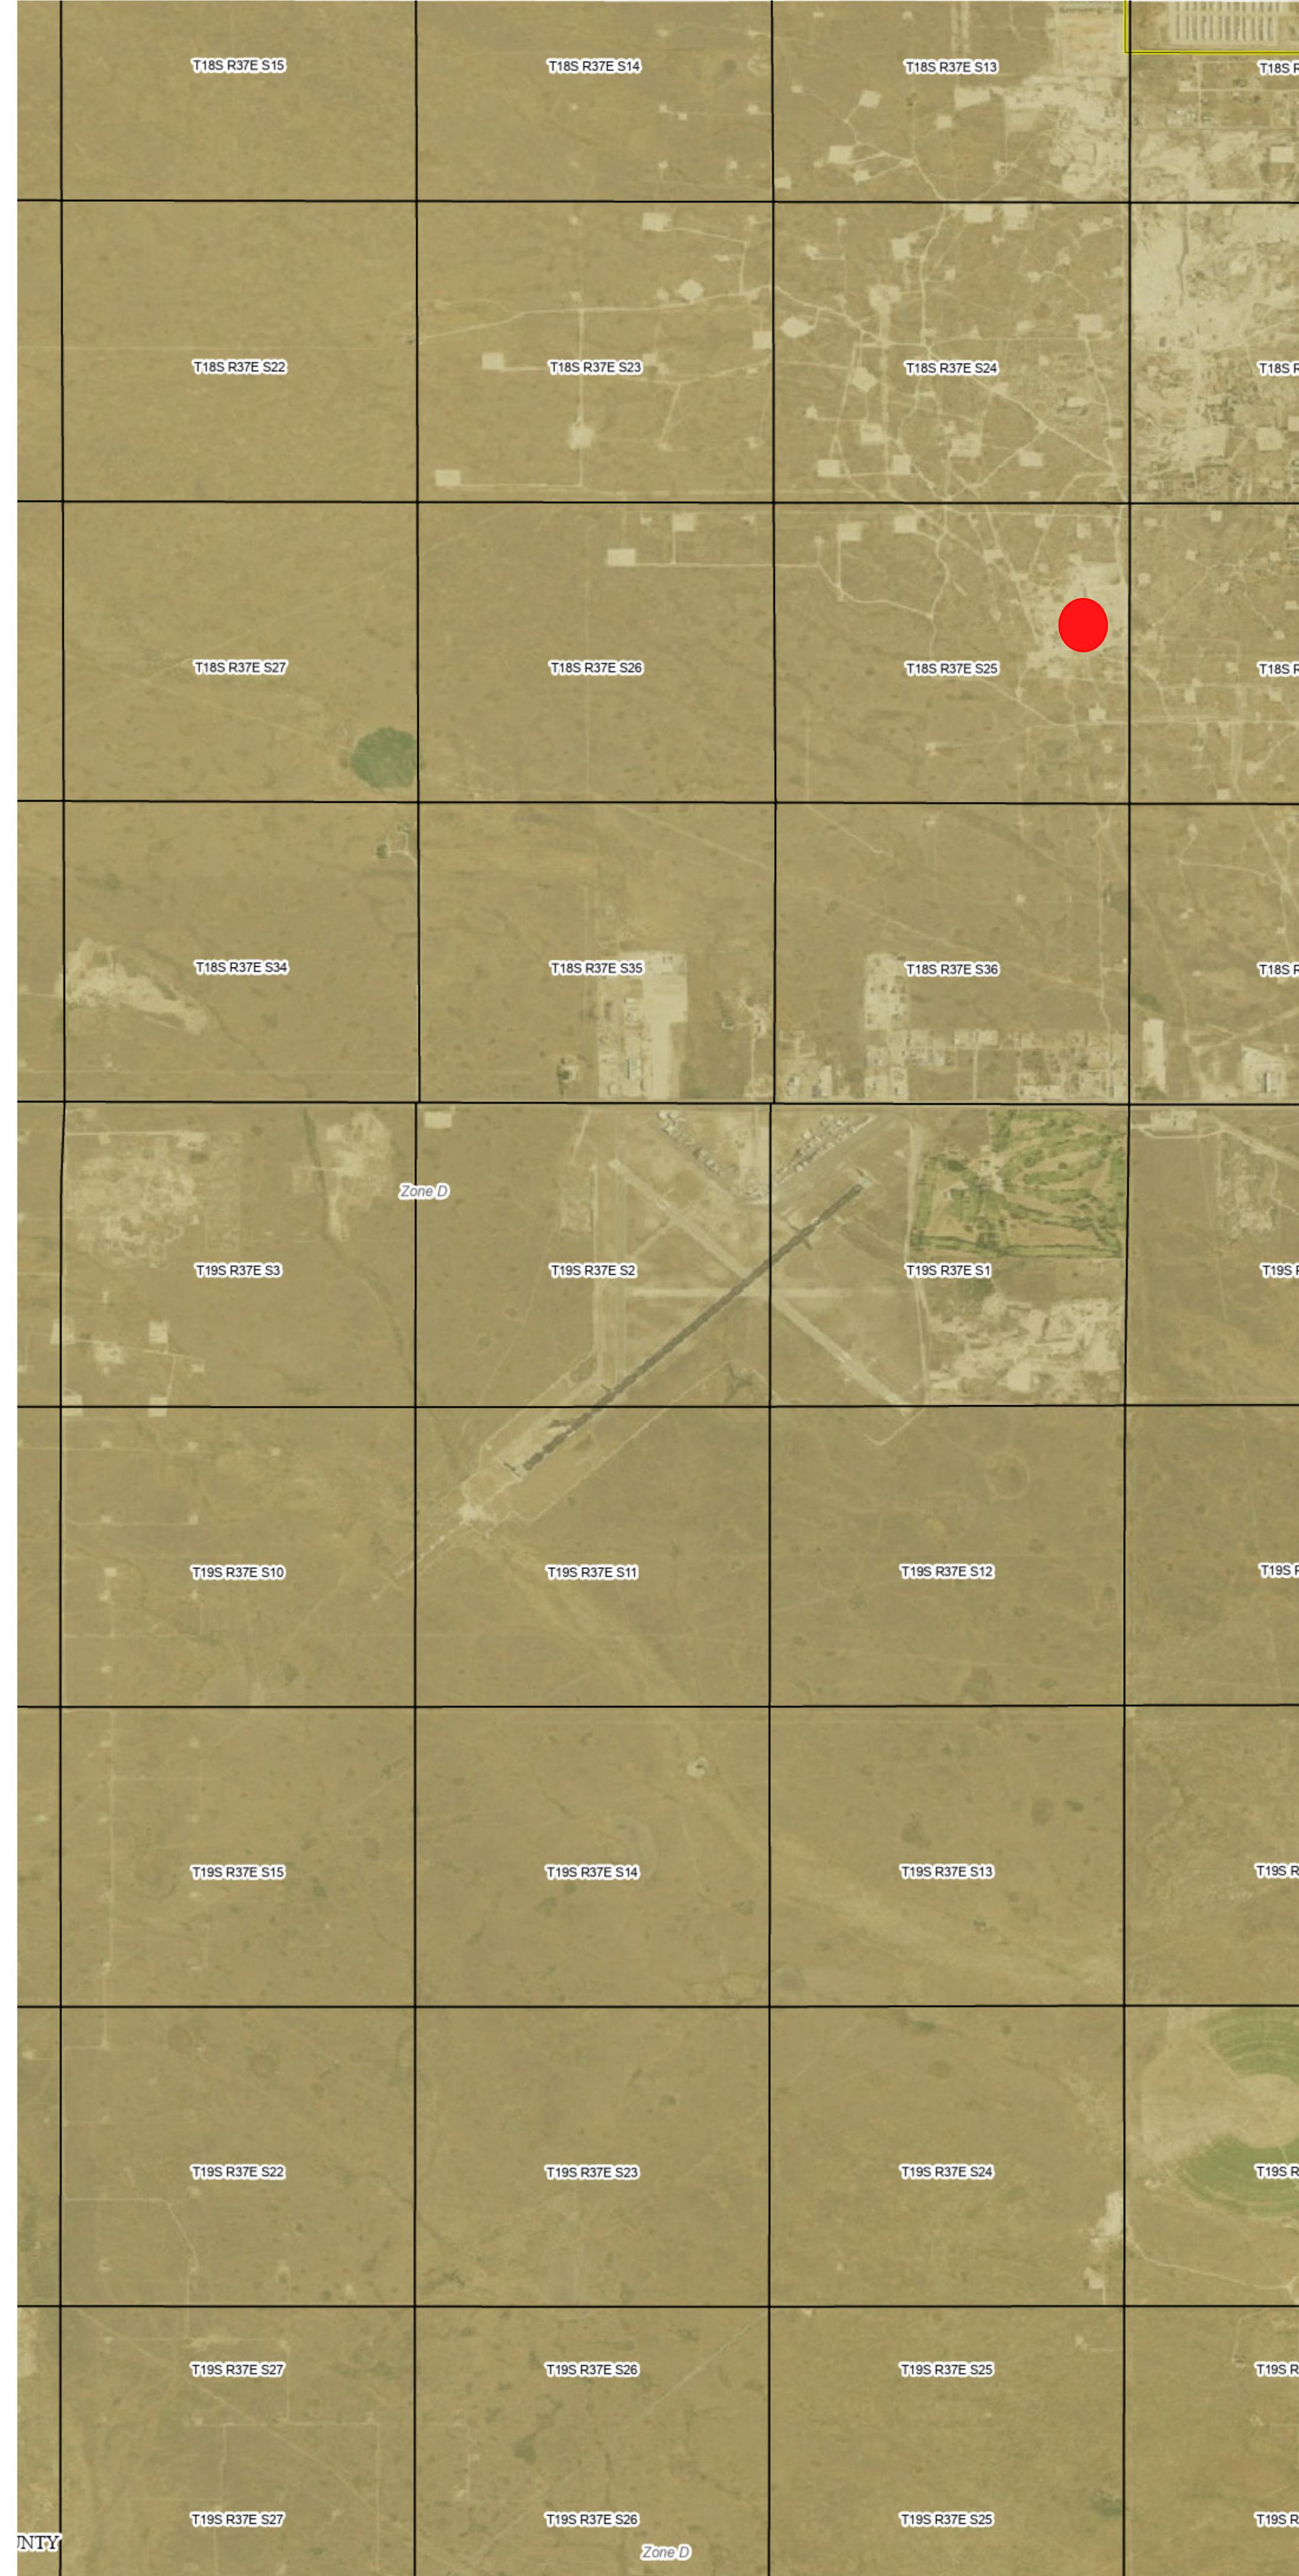
PANEL 1350 of 2102

**FLOOD HAZARD INFORMATION**SEE FIS REPORT FOR DETAILED LEGEND AND INDEX MAP  
FOR DRAFT FIRM PANEL LAYOUT

**Facility Location****SCALE**
