Remediation Summary & Soil Closure Request

3R Operating, LLC Shell State 4 Flowline

Lea County, New Mexico

NMOCD Reference No. nAPP2301367245, nPAC0715030512 & nPAC0600429640

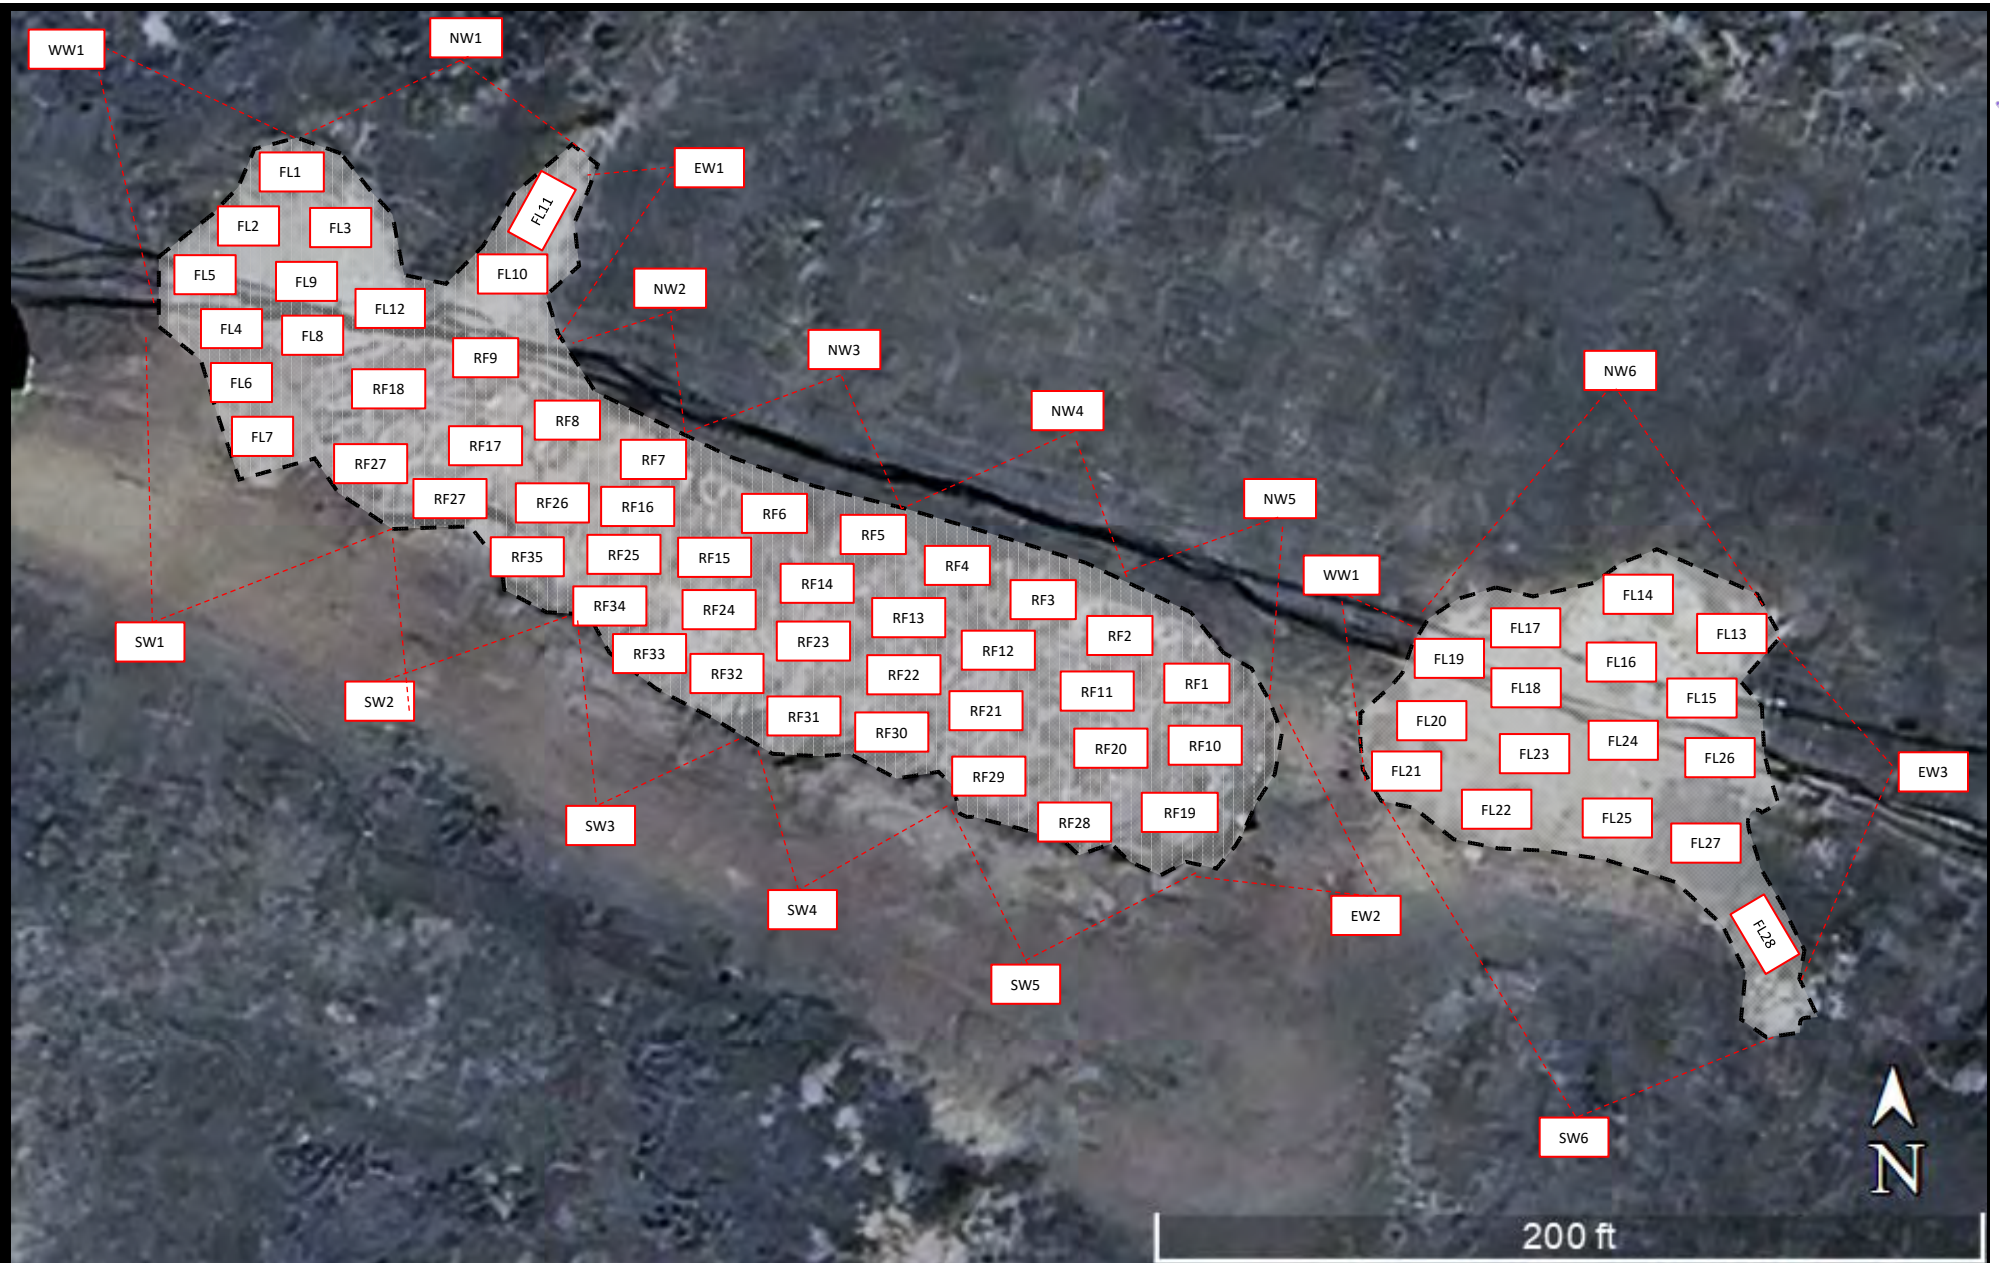
Figure 3

Sample Location Map

In addition, Etech collected 35 replacement floor composite samples from the area previously remediated by an alternative environmental contractor. The collected soil samples were submitted to the laboratory for analysis of BTEX, TPH, and chloride concentrations. Laboratory analytical results indicated BTEX, TPH, and chloride concentrations were below the applicable NMOCD Closure Criteria and NMOCD Reclamation Standards in each of the submitted soil samples.

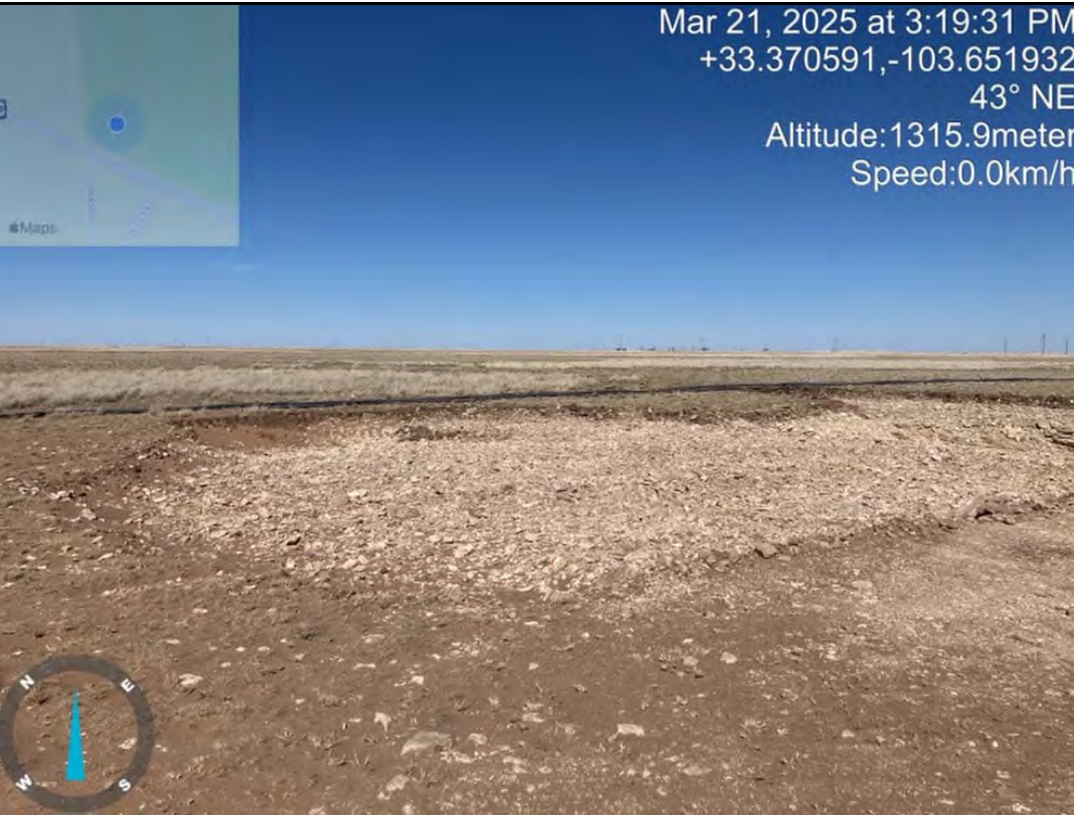
Photo Number: 3

<p>Mar 21, 2025 at 3:19:31 PM +33.370591,-103.651932 43° NE Altitude:1315.9meter Speed:0.0km/h</p>
Photo Direction: South	
Photo Description: View of portion of the excavated area.

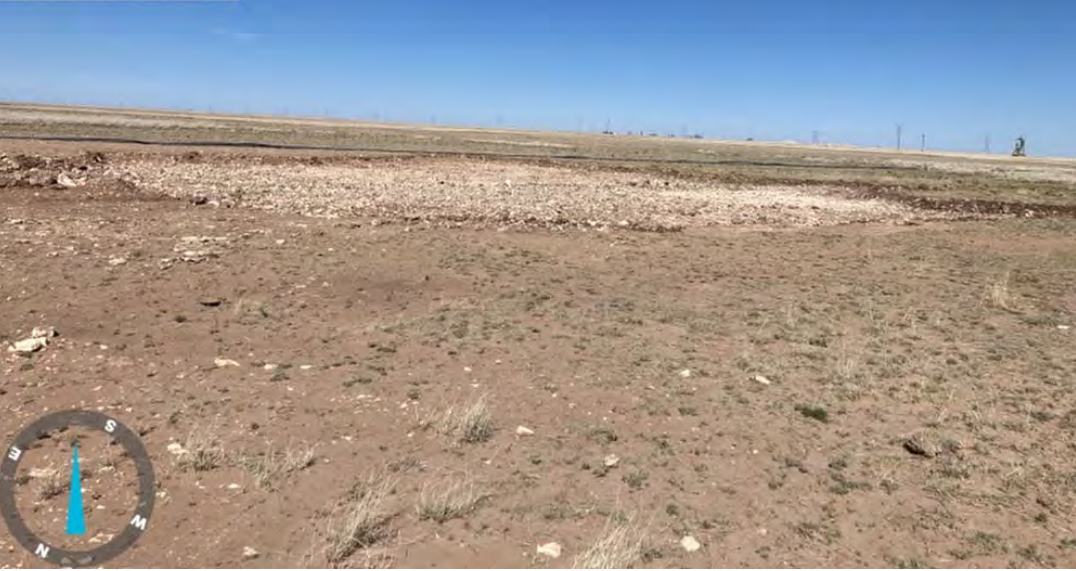
Mar 21, 2025 at 3:17:35 PM +33.370306,-103.651177 151° SE Altitude:1318.6meter Speed:1.9km/h
Photo Direction: Southeast	
Photo Description: View of portion of the excavated area.

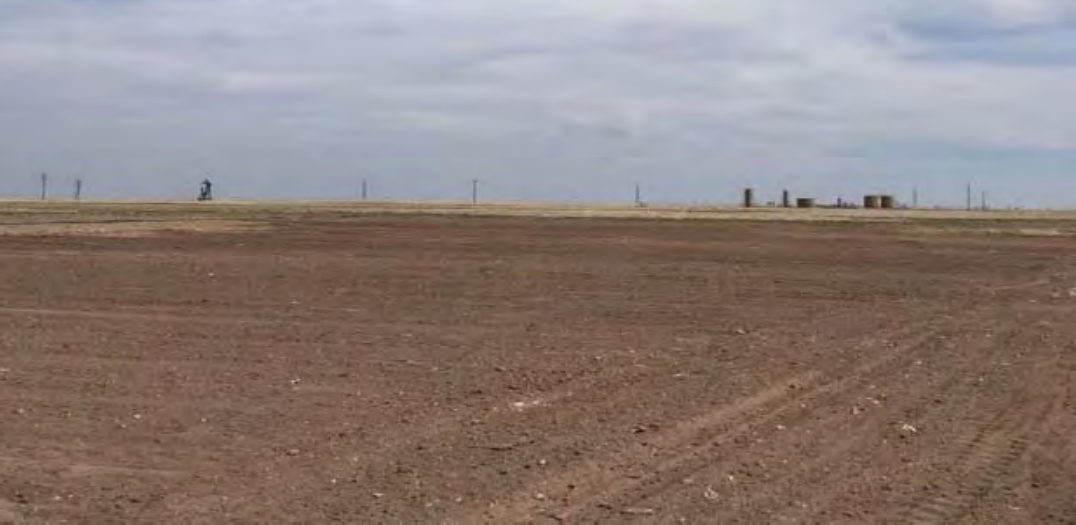
Photo Number: 6

3/27/25, 2:04 PM +33.370485,-103.651812 NM,Tatum
Photo Direction: East	
Photo Description: View of affected area after remediation activities.

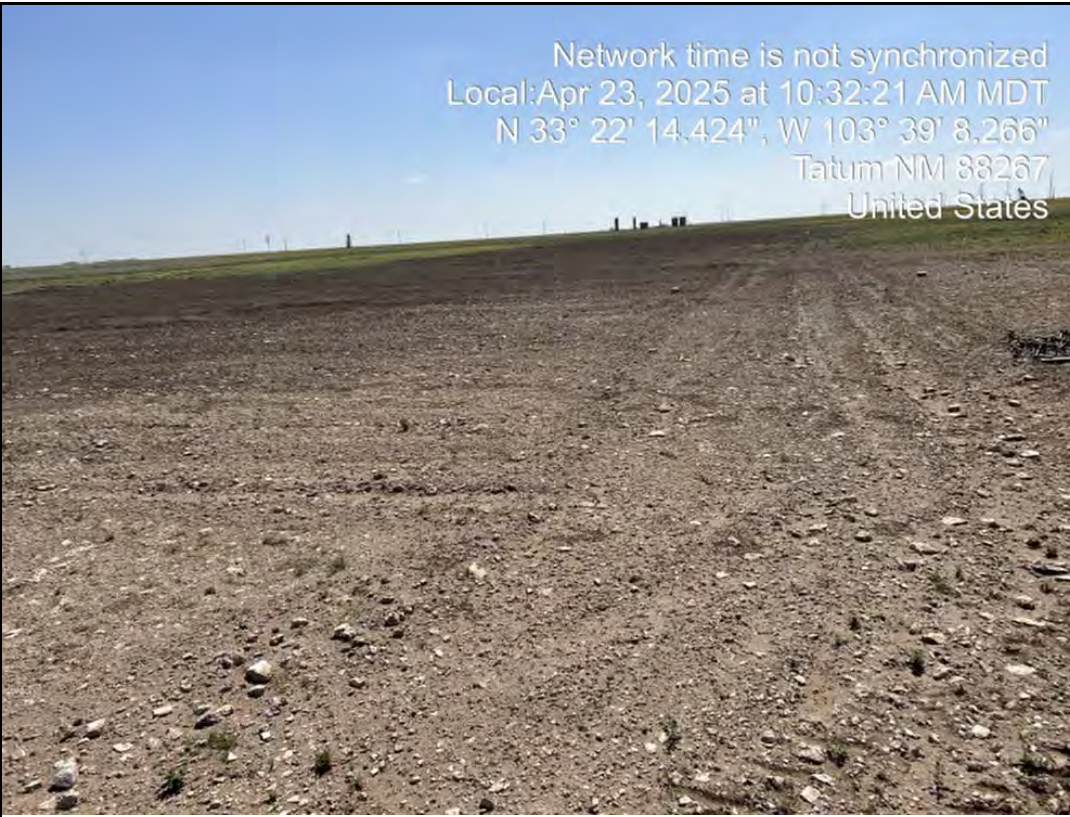
Photo Number: 7	<div>Network time is not synchronized Local: Apr 23, 2025 at 10:32:21 AM MDT N 33° 22' 14.424", W 103° 39' 8.266" Tatum NM 88267 United States</div>

Photo Direction: Southeast	
Photo Description: View of portion of the excavated area.

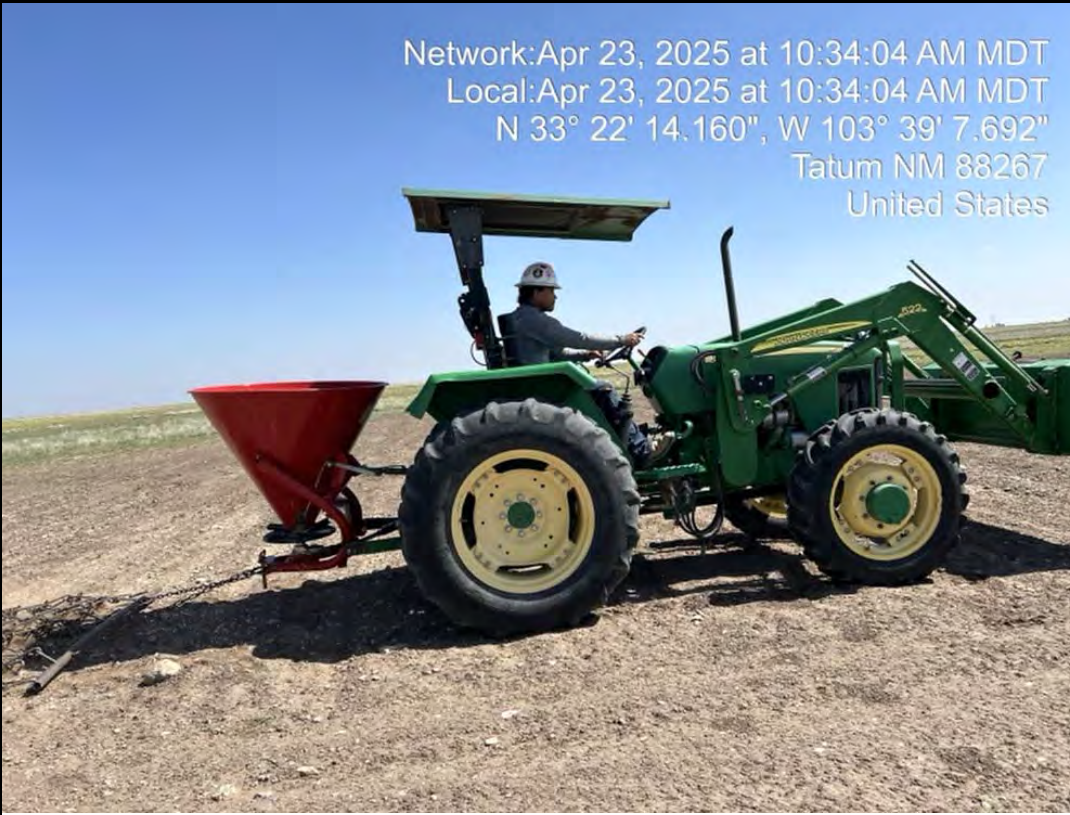
Photo Number: 8	<div>Network: Apr 23, 2025 at 10:34:04 AM MDT Local: Apr 23, 2025 at 10:34:04 AM MDT N 33° 22' 14.160", W 103° 39' 7.692" Tatum NM 88267 United States</div>

Photo Direction: East	
Photo Description: View of affected area after remediation activities.
