**C-141 - CO2 GAS RELEASE ONLY (No Liquids)**  
**EVENT SUMMARY, VARIANCE REQUEST & CLOSURE REQUEST REPORT**

| <b>Facility Name:</b> | North Hobbs CTB | <b>Flare Date:</b> | 07/21/2025 |
| <b>Cause:</b> | Controlled gas release only, no liquids involved - Combusted in a flare to reduce emissions | | |

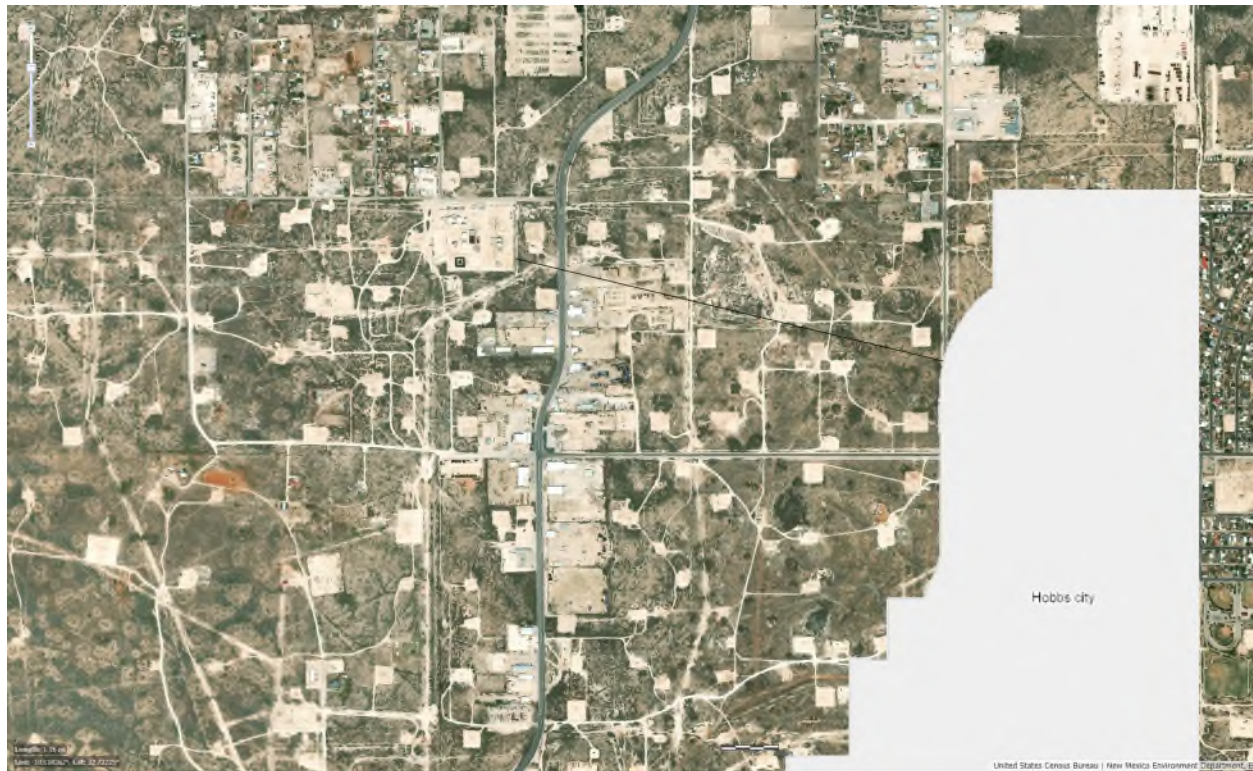
Municipal Boundaries: ~1.16 miles (~6124 feet)
