**Re: Reclamation Report
Sundance SDS 11-1 SWD
Incident Number nAPP2224356841
Eddy County, New Mexico**

Ensolum, LLC (Ensolum), on behalf of Oxy USA Inc. (Oxy), has prepared the following *Reclamation Report* for the Sundance SDS 11-1 SWD (Site). This *Reclamation Report* documents the Site history, reclamation activities completed to date, and proposes a vegetation monitoring plan.

Oxy USA Inc.
 Reclamation Report
 Sundance SDS 11-1 SWD

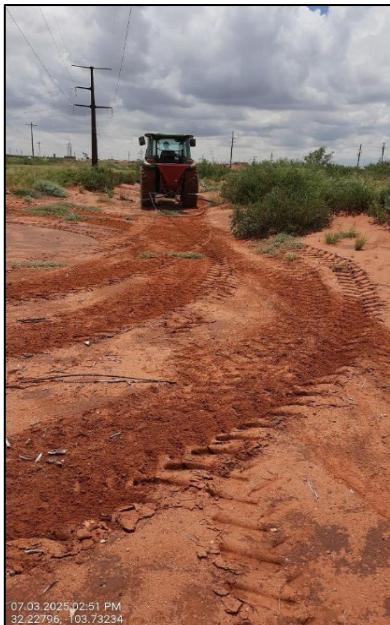
Photograph: 1

Description: Reseeding Activities

View: Northwest

Following broadcast seeding, in the area was chained to cover the seed. Photographs of the backfilled excavation and seeding of the reclaimed area are provided in Appendix A.

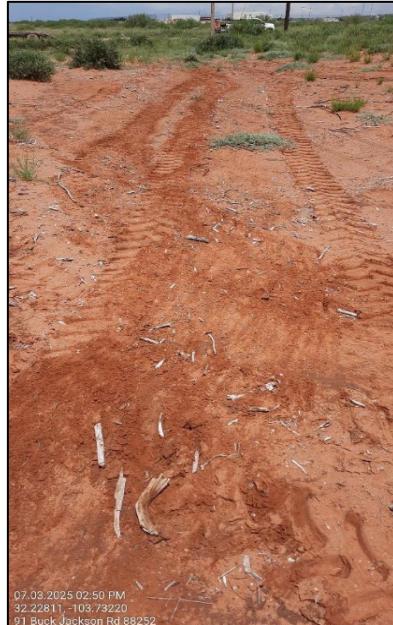
Photograph: 2

Description: Reseeding Activities

View: West

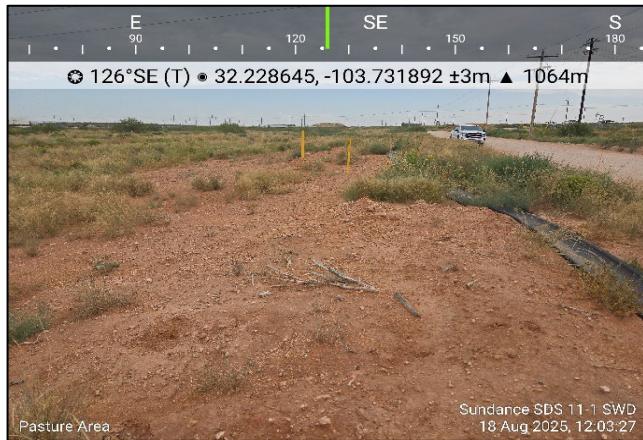
Photograph: 3

Description: Backfill Sampling

View: Southeast

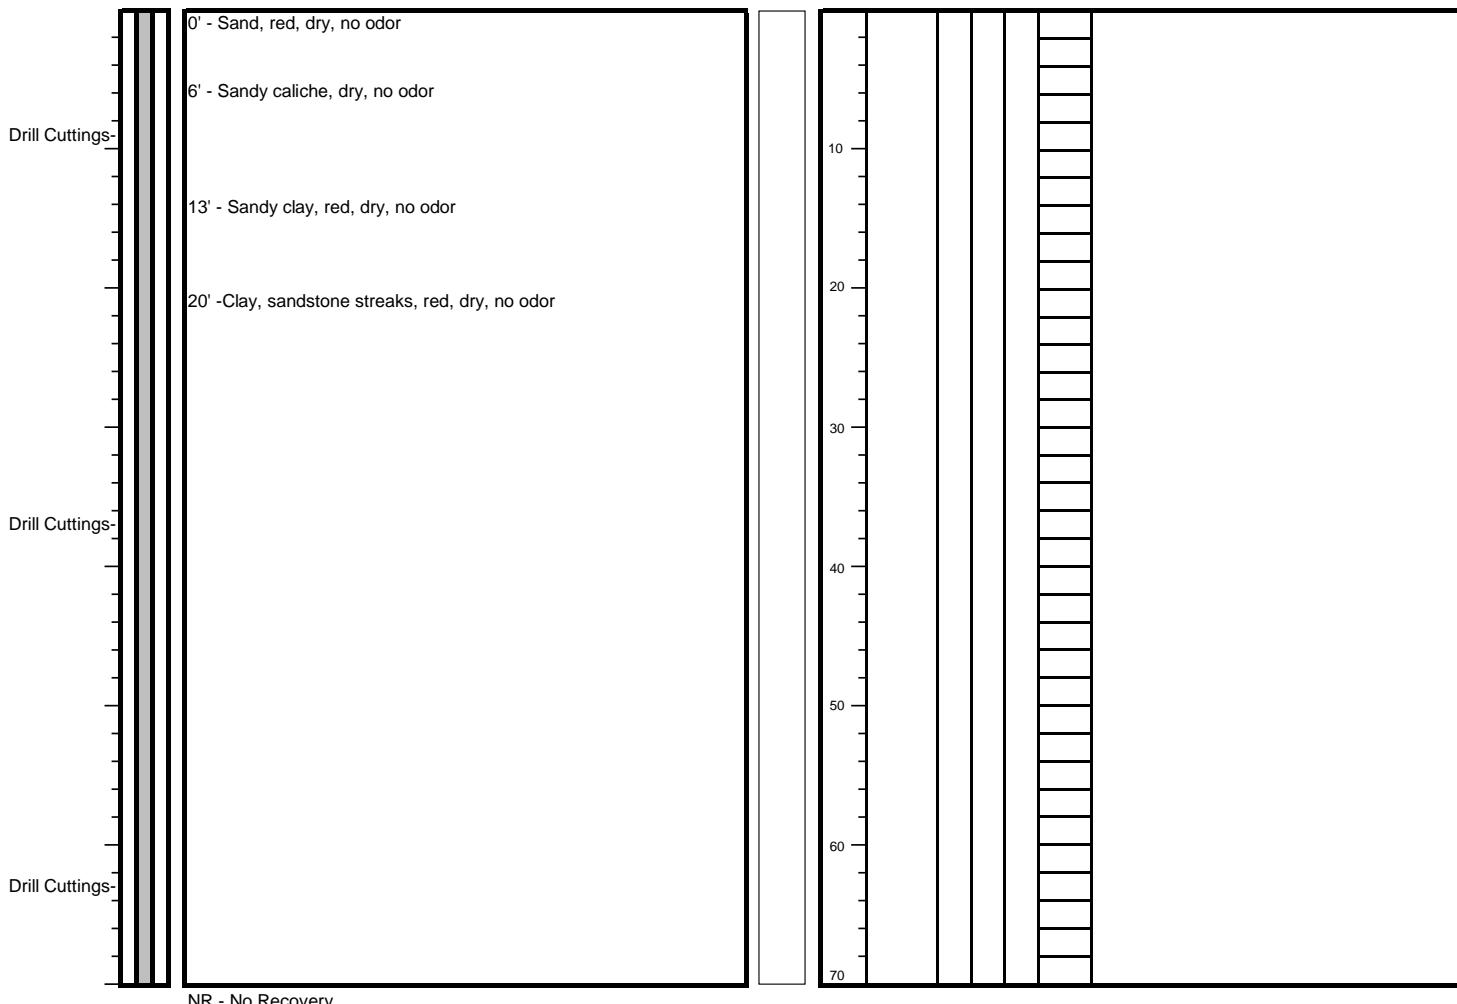
SOIL BORING / WELL LOG

Due to the unknown depth to groundwater in the 0.5-mile vicinity, a depth to water soil boring (SB-1 (C-04687-POD1)) was installed on November 29, 2022 by Ensolum personnel. The soil boring was installed adjacent to the release area. The soil boring was installed to 112.53 feet bgs, and groundwater was not encountered 72-hours after the soil boring was installed. The applicable Closure Criteria were utilized based on the lack of groundwater observed within the first 112.53 feet bgs at the Site.

Soil Boring Detail	SOIL CLASSIFICATION	Stratum

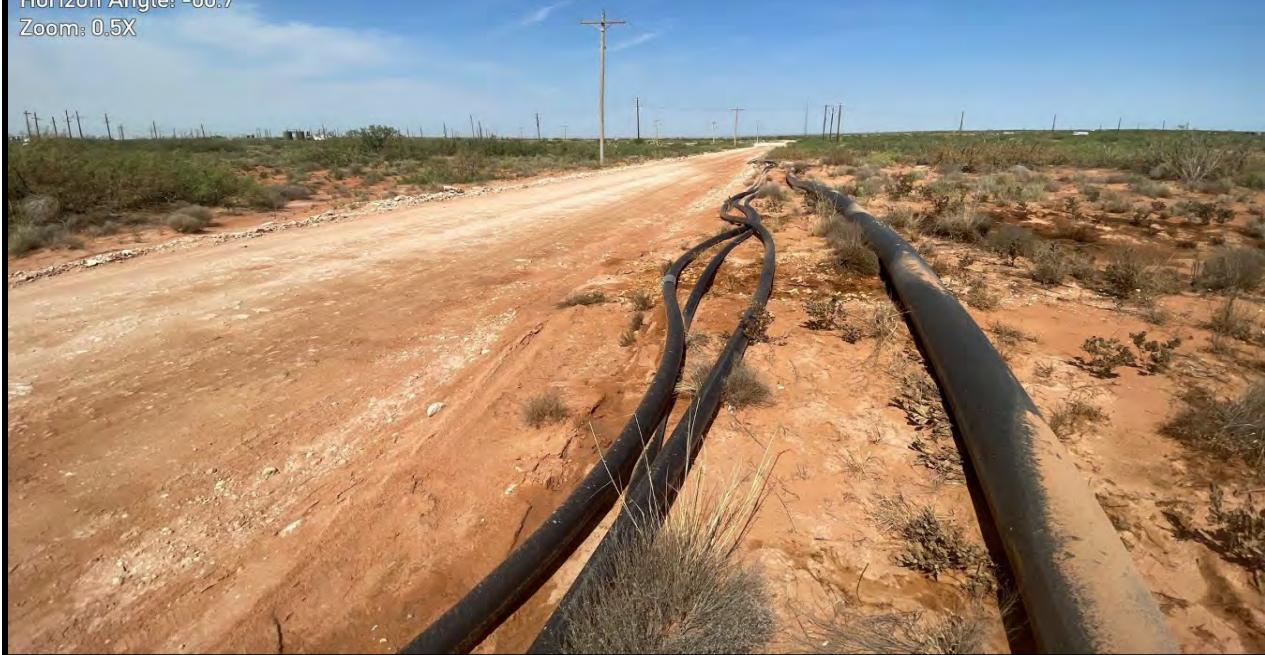
View of release point during initial soil sampling activities, facing northwest.

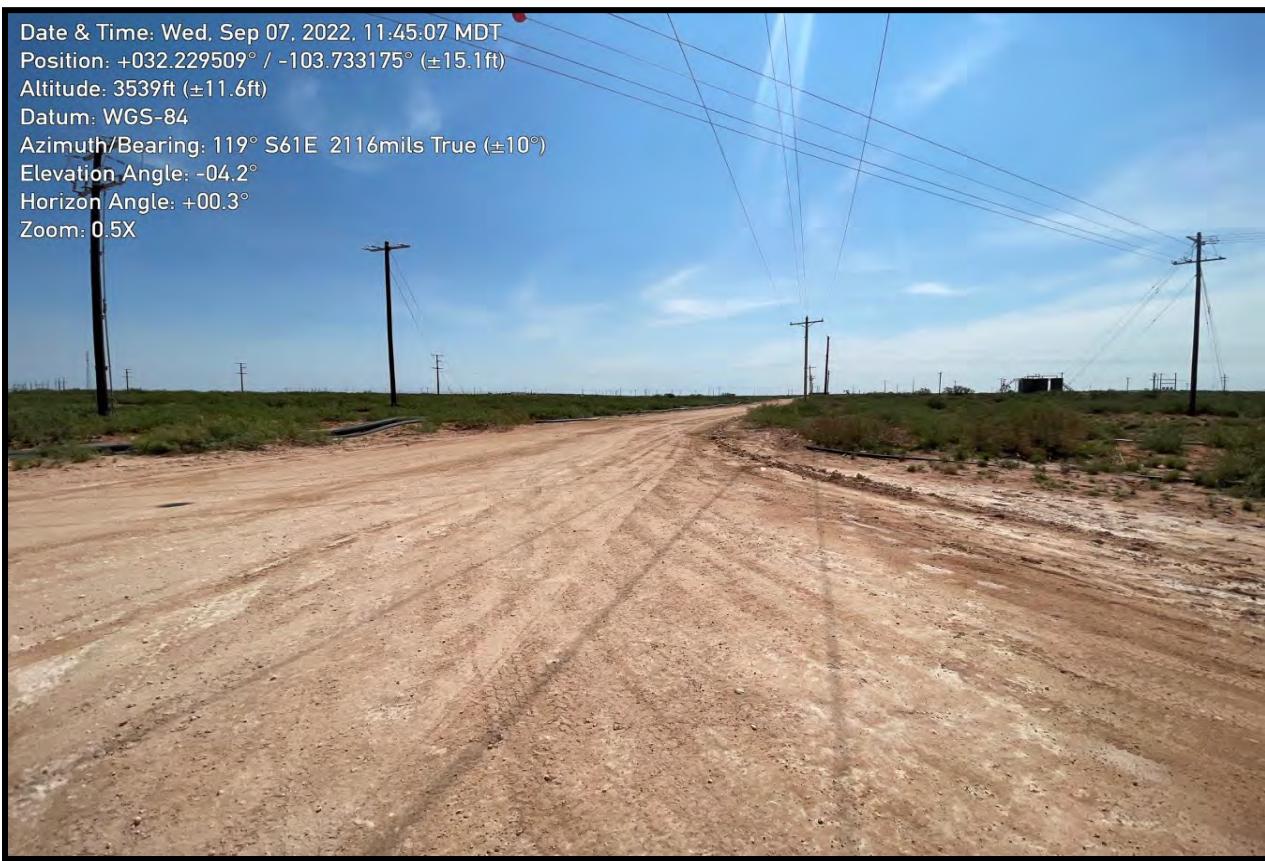
View of release area during initial soil sampling activities, facing southeast.
