**C-141 - CO2 GAS RELEASE ONLY (No Liquids)**  
**EVENT SUMMARY, VARIANCE REQUEST & CLOSURE REQUEST REPORT**

**Facility ID:** fKJ1517634129

**Facility Name:** North Hobbs RCF**Flare Date:** 12/01/2025**Duration of Event:** 19minutes**MCF Flared:** 394 MCF**Start Time:** 8:43PM**End Time:** 9:02PM**Cause:** controlled release of gas only, no liquids involved - combusted in a flare to reduce emissions;

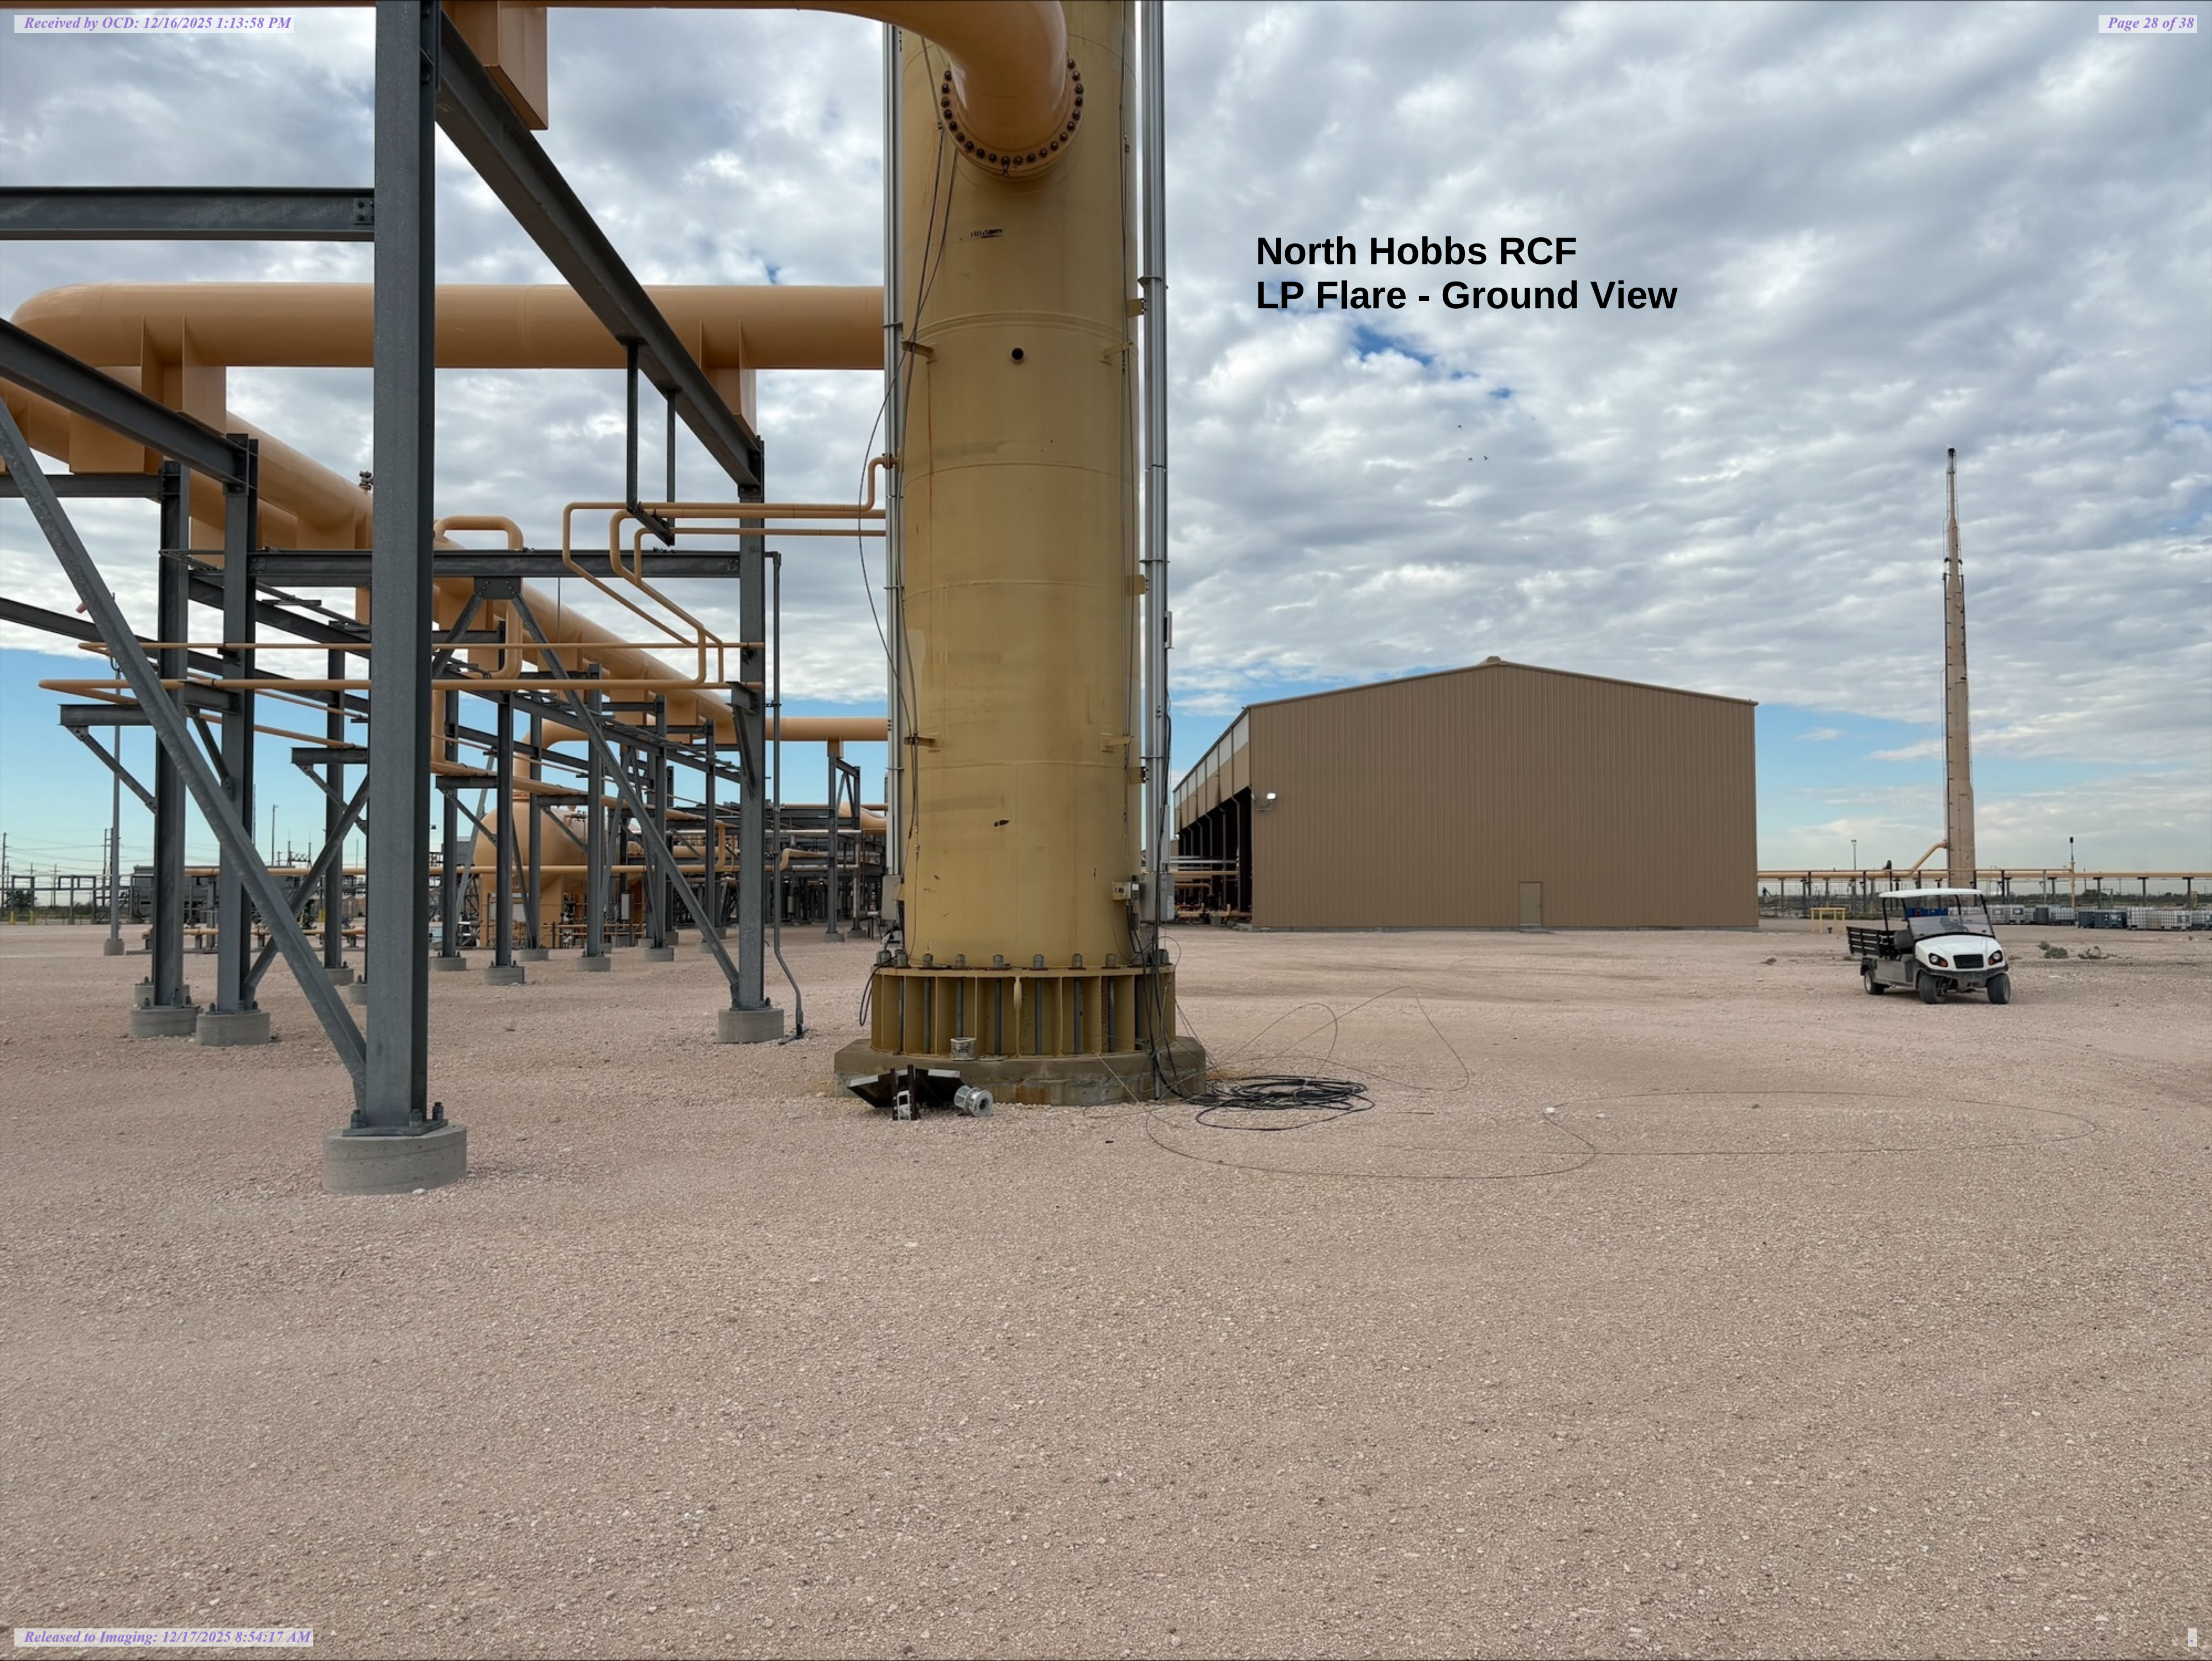
**North Hobbs RCF  
LP Flare - Ground View**

- III. The flaring event has ceased.
- IV. This flare event consists primarily of CO2 gas and includes a small number of hydrocarbons. This flaring event did not result in a fire or result of a fire and no injuries were sustained or reported.

- V. This flare event did not result in the release of any liquids or fluids that reached, or have the potential to reach, the ground, a surface, a watercourse, or any other area. It poses no reasonable probability or chance of endangering public health, the environment, or fresh water.

- VI. There was no liquid or fluid impact to the area since there were no liquid or fluid spills and/or physical remedial actions required for the soil, groundwater, surface water, or environment, in or around the flare area as nothing impacted or occurred on the ground.
