**C-141 - CO2 GAS RELEASE ONLY (No Liquids)**  
**EVENT SUMMARY, VARIANCE REQUEST & CLOSURE REQUEST REPORT**

**Facility Name:** South Hobbs CTB**Flare Date:** 12/26/2025**Duration of Event:** 39minutes**MCF Flared:** 98 MCF**Start Time:** 8:21PM**End Time:** 9:00PM**Cause:** controlled release of gas only, no liquids involved - combusted in a flare to reduce emissions;

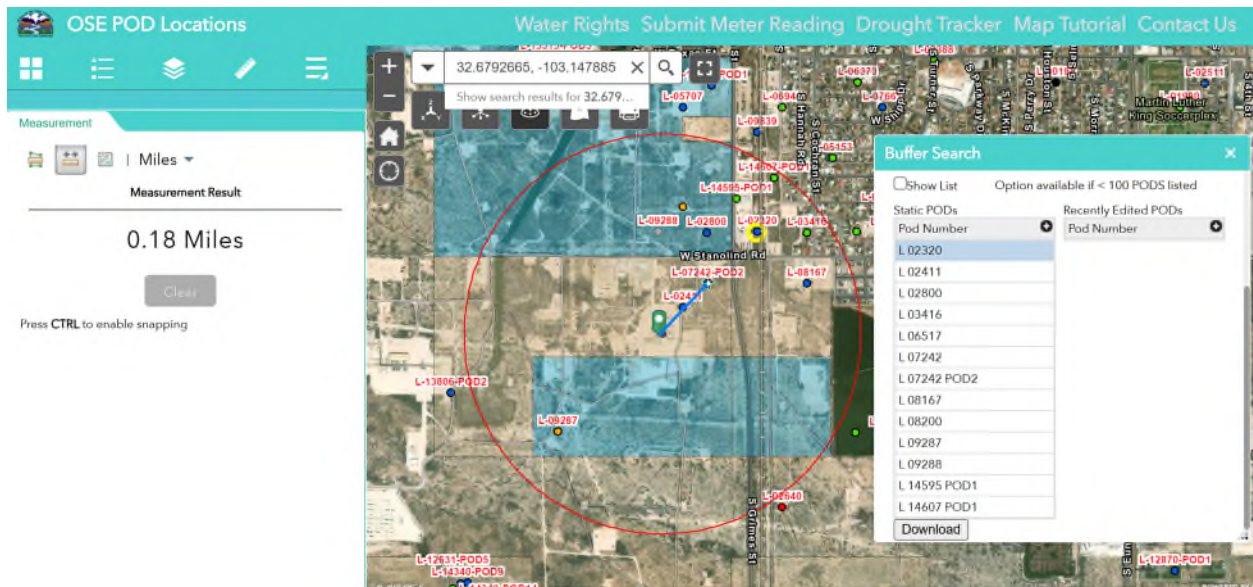
Any other fresh water well or spring: 0.18 miles (~950 feet)

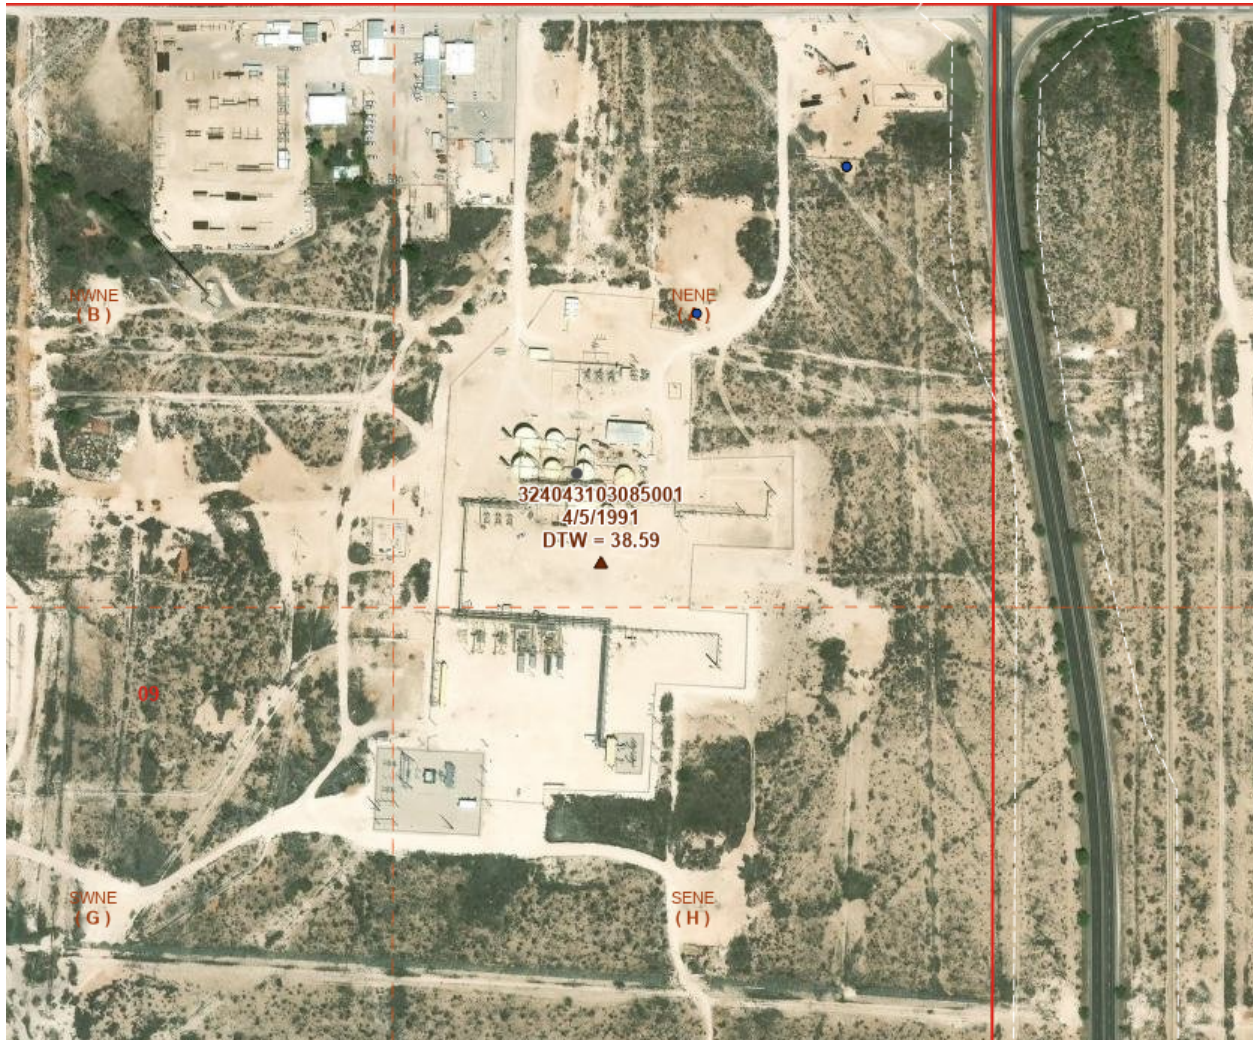
Depth to Water: 26 to 50 feet, determined by USGS
