**Re: Reclamation and Revegetation Report and Restoration Complete Request
Federal 12-1H Battery
Incident Number nAPP2328651429
Eddy County, New Mexico**

Ensolum, LLC (Ensolum), on behalf of Oxy USA Inc. (Oxy), has prepared the following *Reclamation and Revegetation Report and Restoration Complete Request (Report)* for the Federal 12-1H Battery (Site). The *Report* documents the Site history, reclamation activities, and vegetation assessment activities completed at the Site. Based on the findings included in this *Report*, Oxy is respectfully requesting Restoration Complete Status for this Site.

Oxy USA, Inc
Reclamation and Revegetation Report and Restoration Complete Request
Federal 12-1H Battery

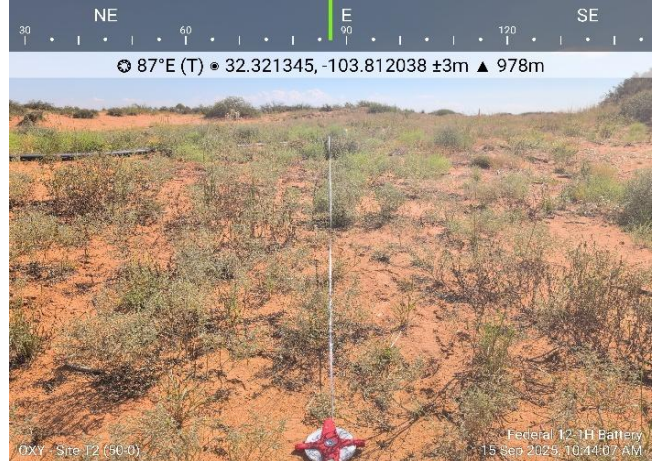
Photograph: 5 Date: 9/15/2025
Description: Revegetated overview along utilities
View: West

Photograph: 6 Date: 9/15/2025
Description: Vegetation overview
View: East

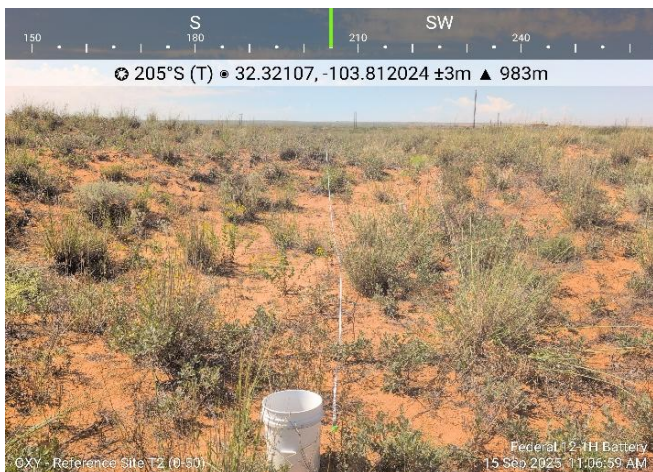
Photograph: 7 Date: 9/15/2025
Description: Vegetation overview
View: Northeast

Photograph: 8 Date: 9/15/2025
Description: Pasture transect
View: Southwest

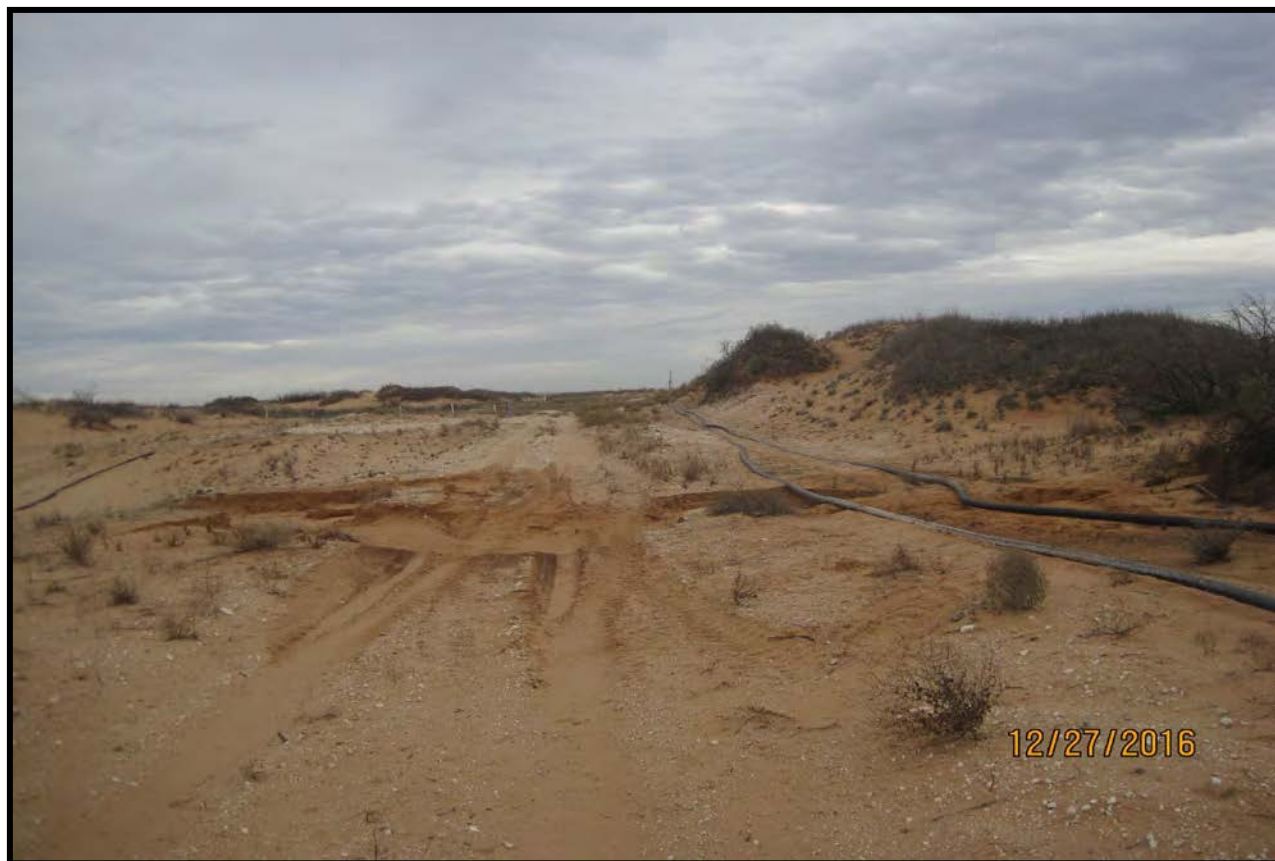
View of initial spill, facing southeast.

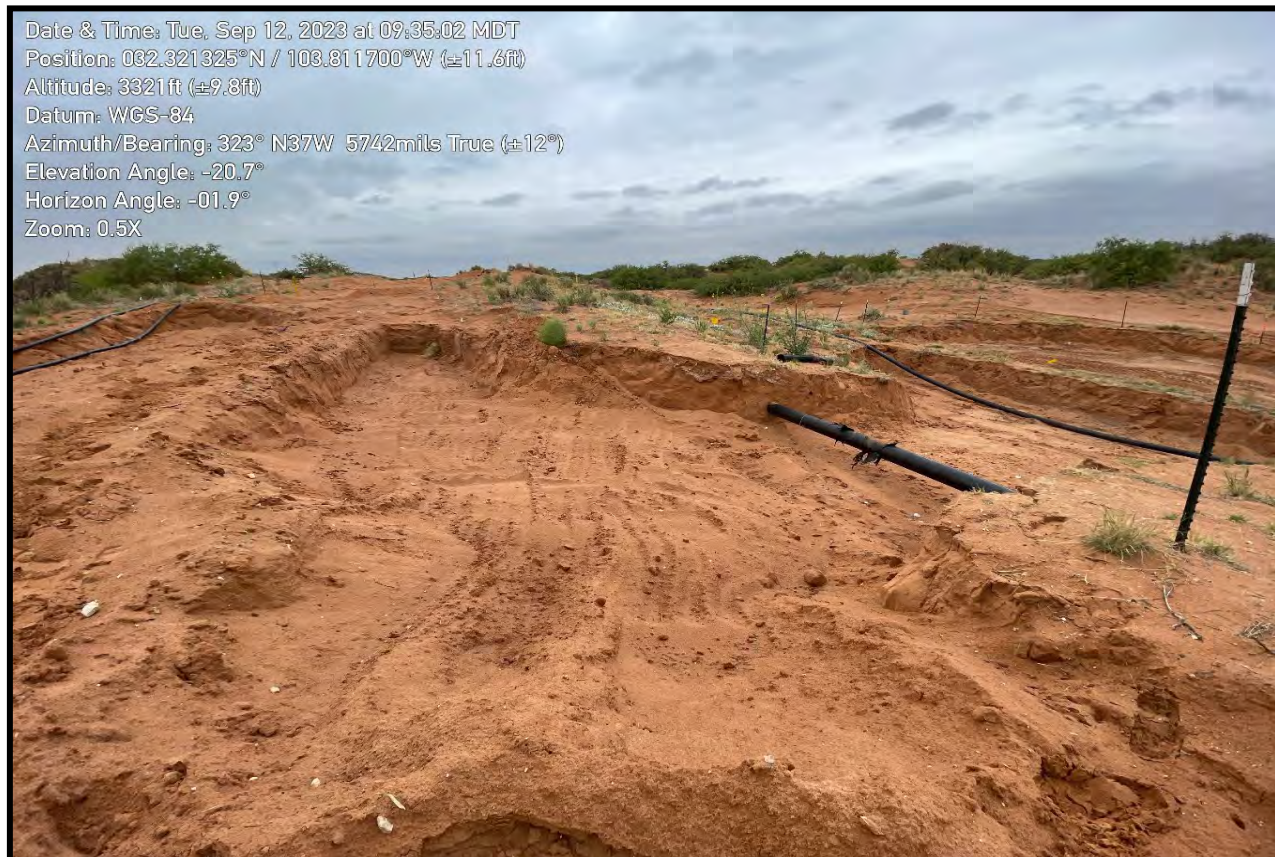
View of initial excavation activities, facing northwest.

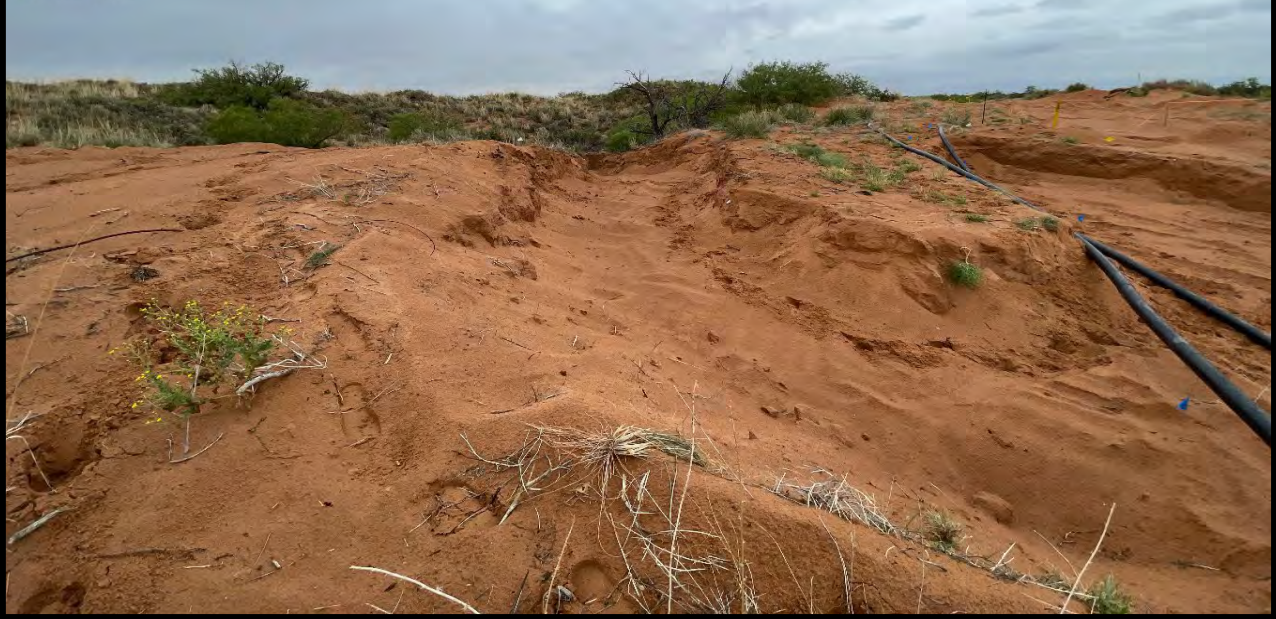
View of initial excavation activities, facing northwest.

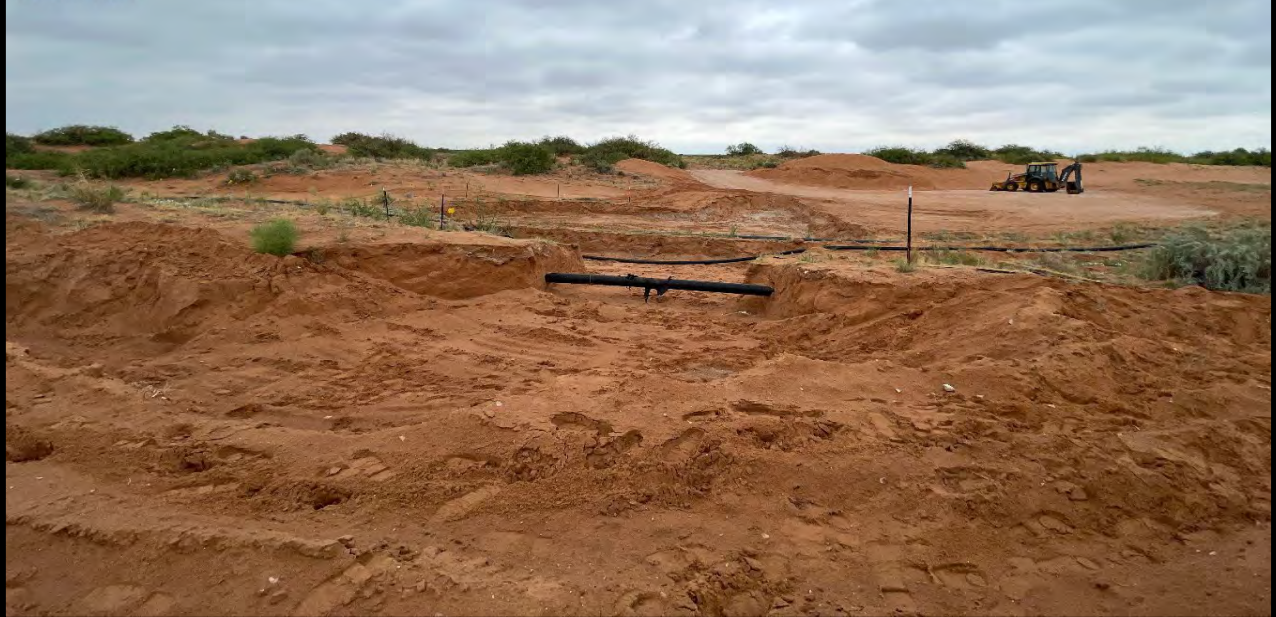
View of initial excavation activities, facing northeast.
