Closure Report

INCIDENT ID#: nAPP2430232859

Site Name:	CEDAR CANYON 28 4CTB
Company:	Oxy USA, Inc.
Legal Description:	U/L M, Section 24, T204N, R28E
County:	EDDY County, NM
GPS Coordinates:	N 32.19817,-104.04769

Date of Release:	10/16/2024
Type of Release:	Produced water
Source of Release:	The line didn't pass pressure test and leaked
Volume of Release:	6 BBLS
Volume Recovered:	6 BBLS

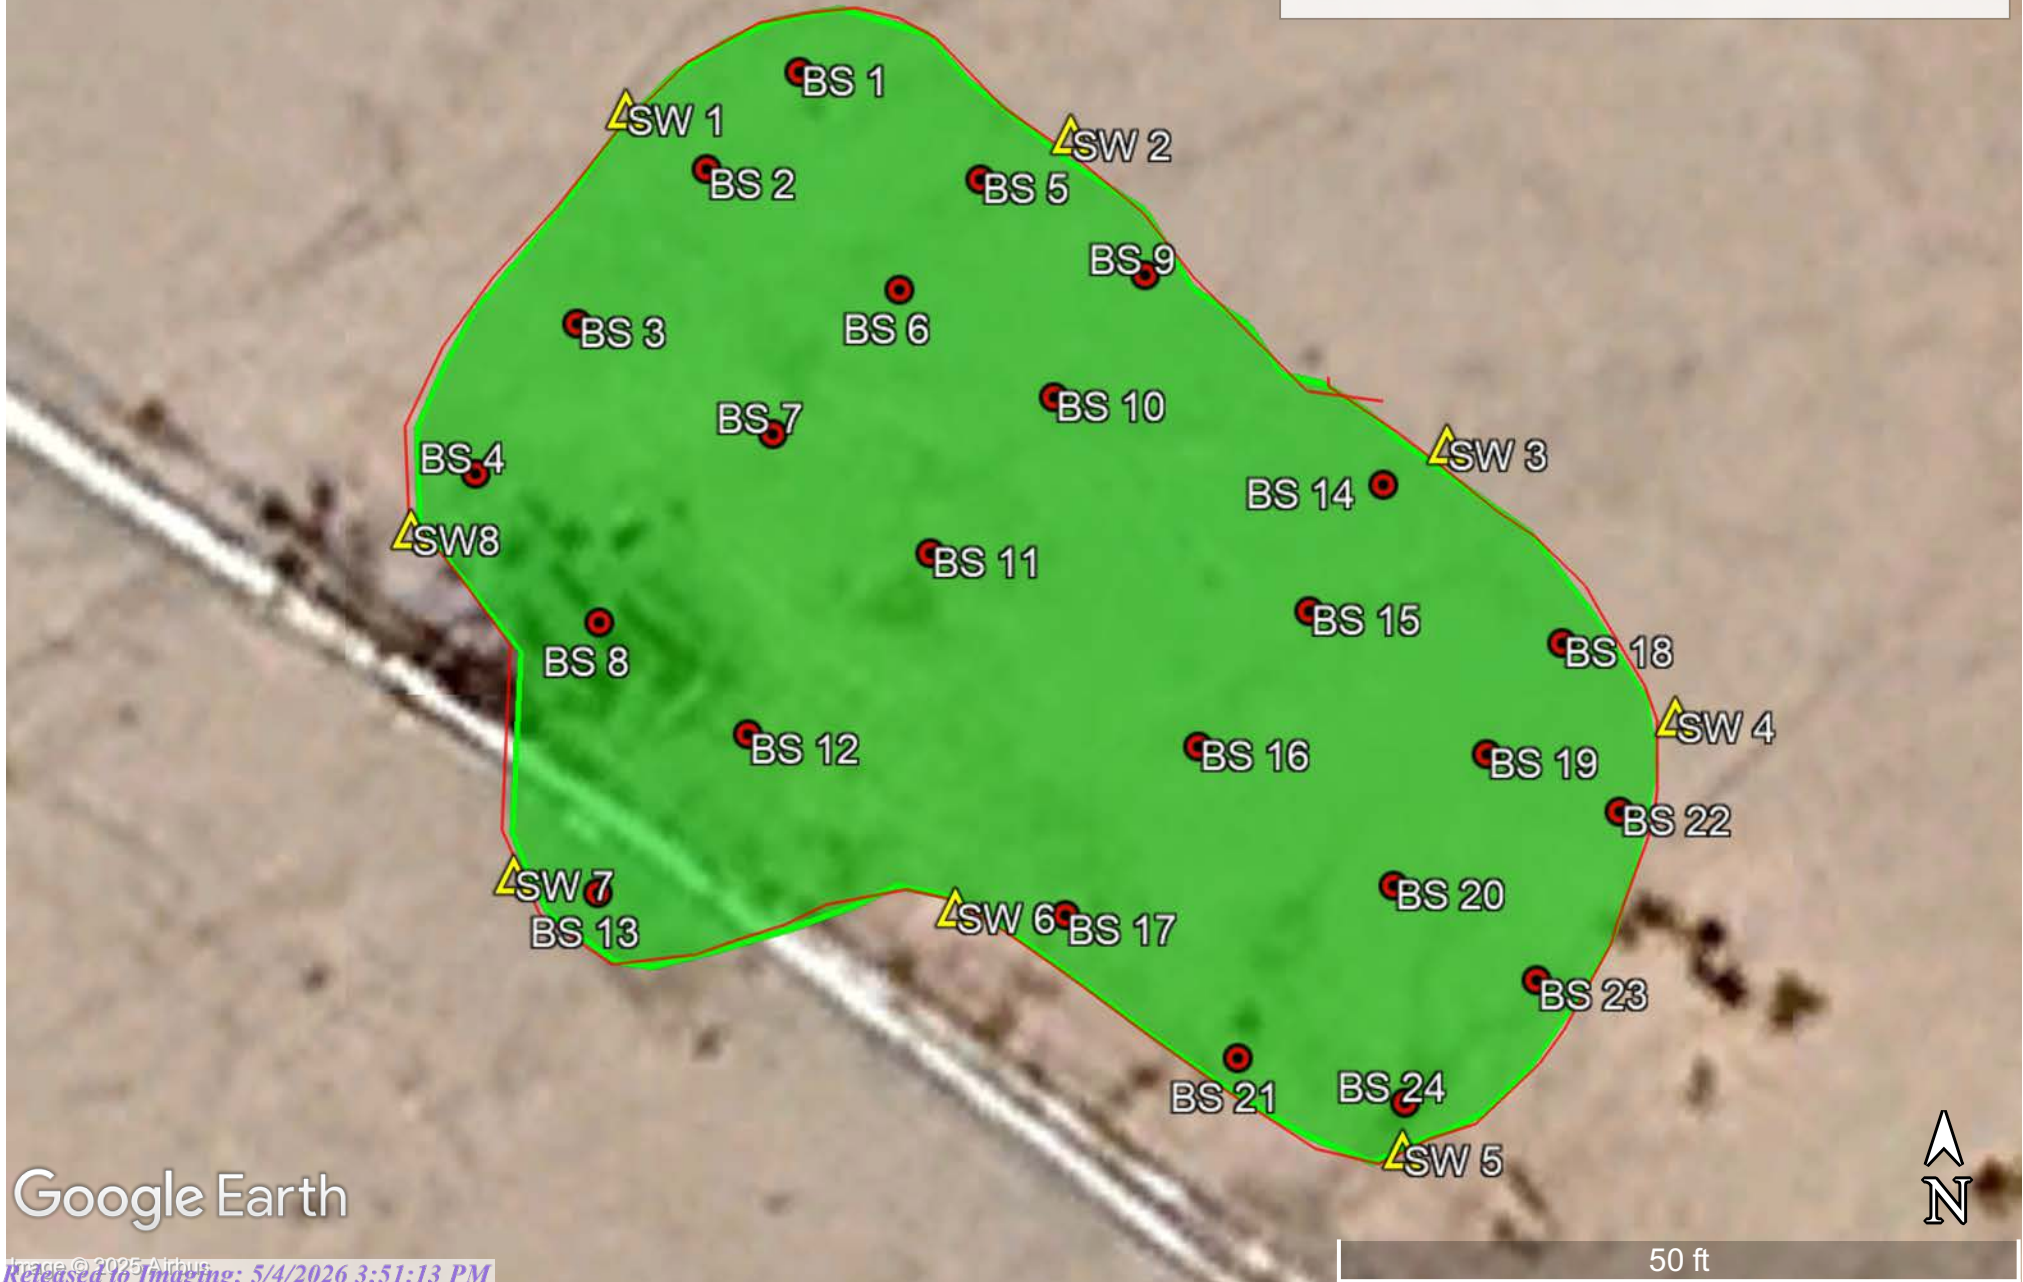
LEAK DATE :10/16/24
EDDY COUNTY,NM
ID#nAPP2430232859

- 4' EXCAVATION
- BOTTOM CONFIRMATION SAMPLE POLINTS
- ⊗ LEAK AREA
- ▲ SIDEWALL CONFIRMATION SAMPLE POINTS

The excavation measured approximately 4,688 square feet in areal extent. A total of approximately 864 cubic yards of impacted soil was removed during the excavation activities. The impacted soil was transported and properly disposed of at the Lea Land, LLC landfill located in Lea County, New Mexico.

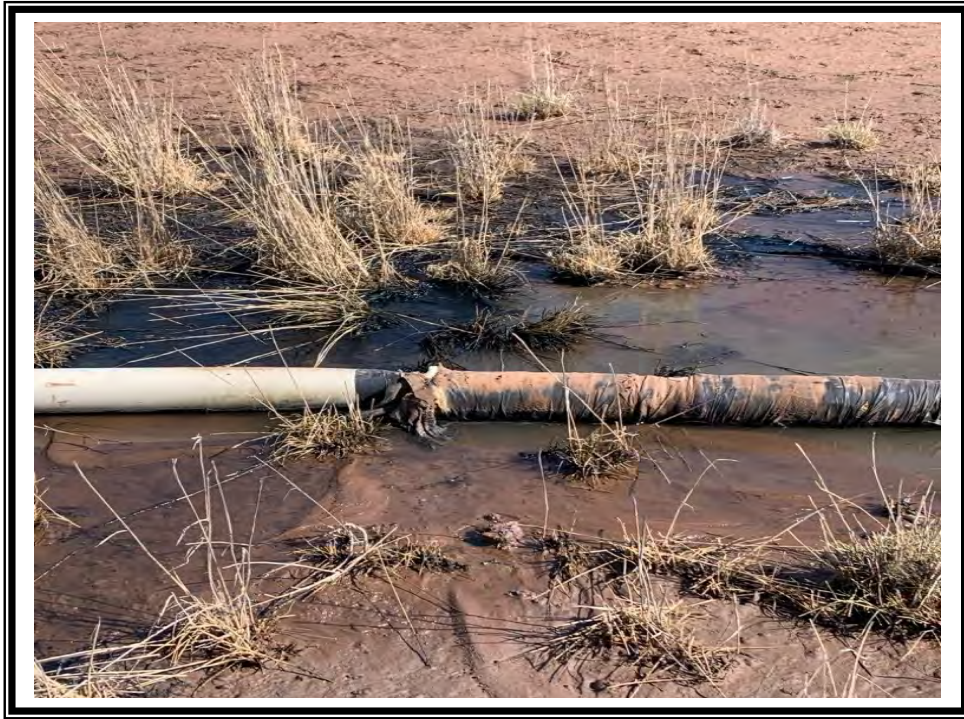
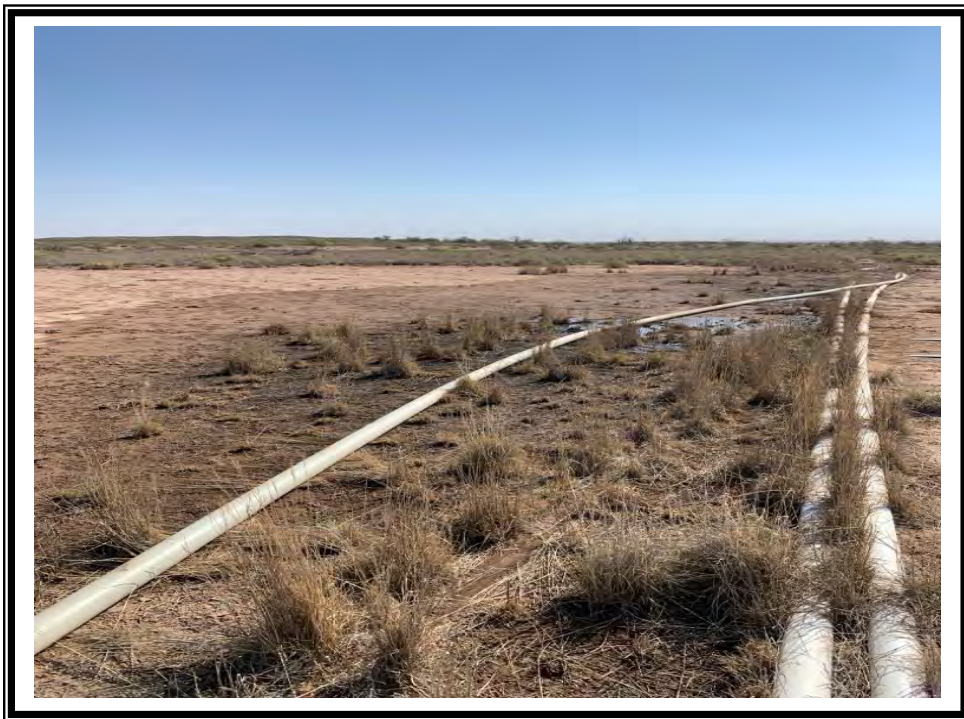
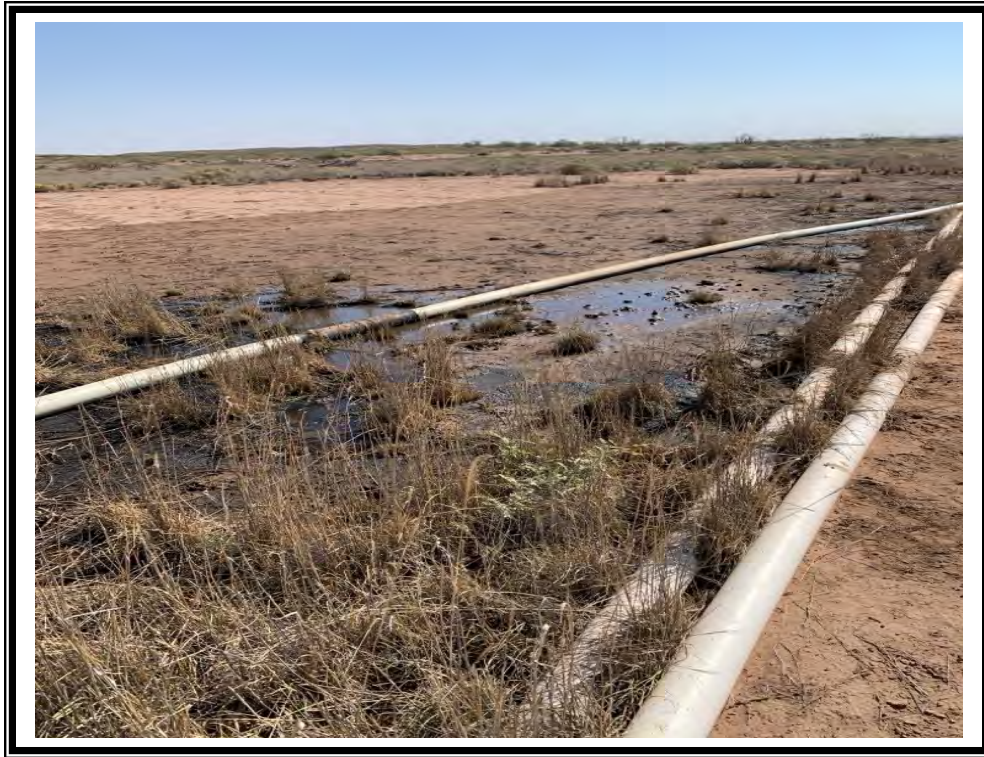
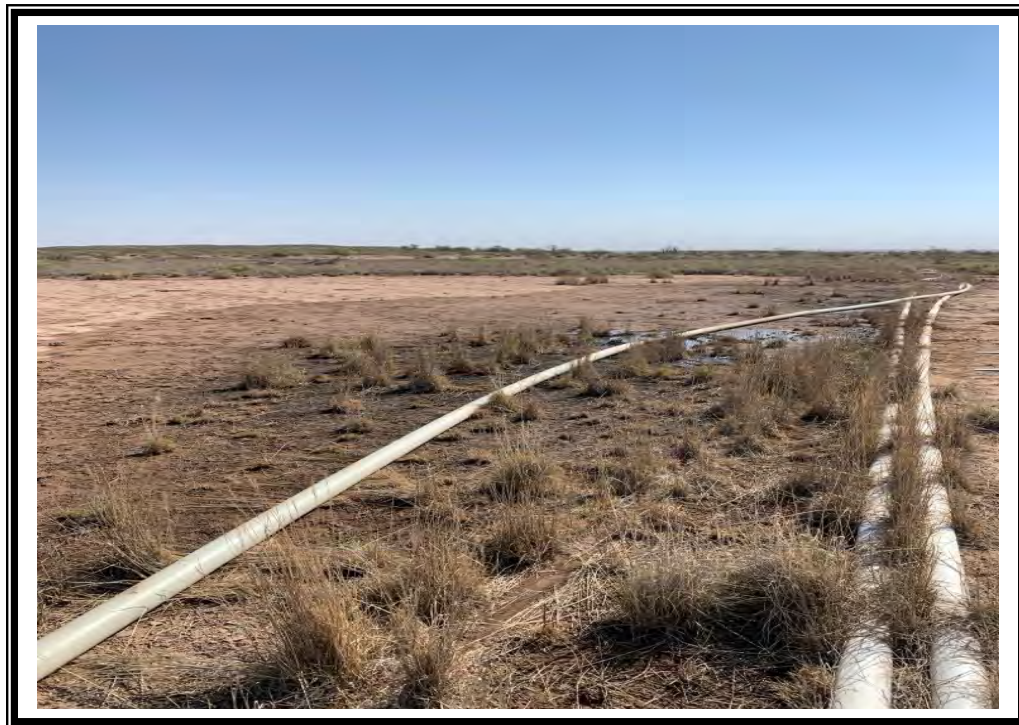
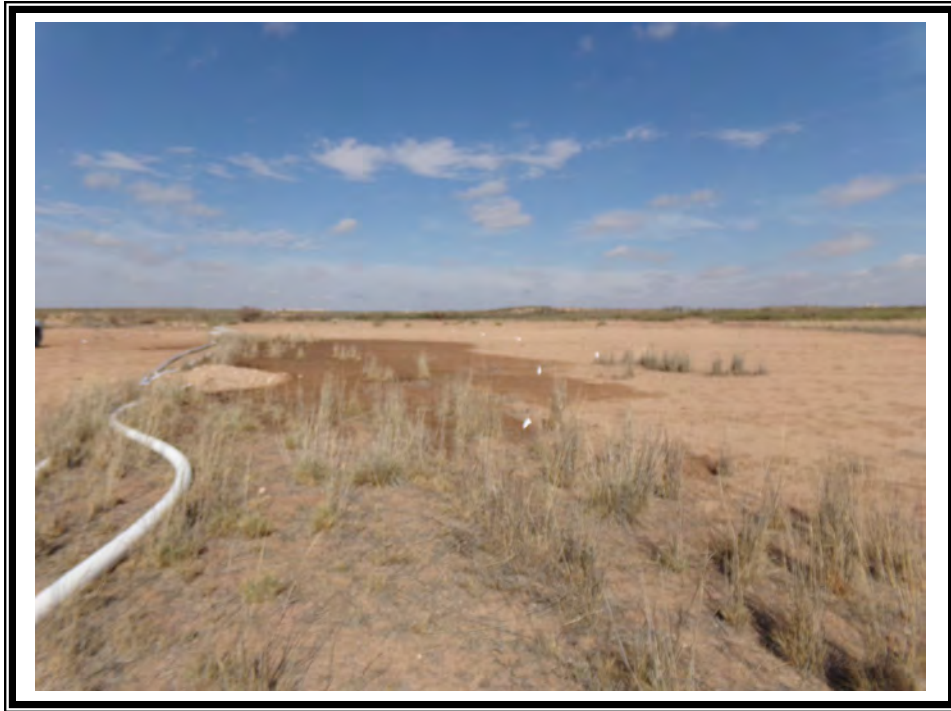
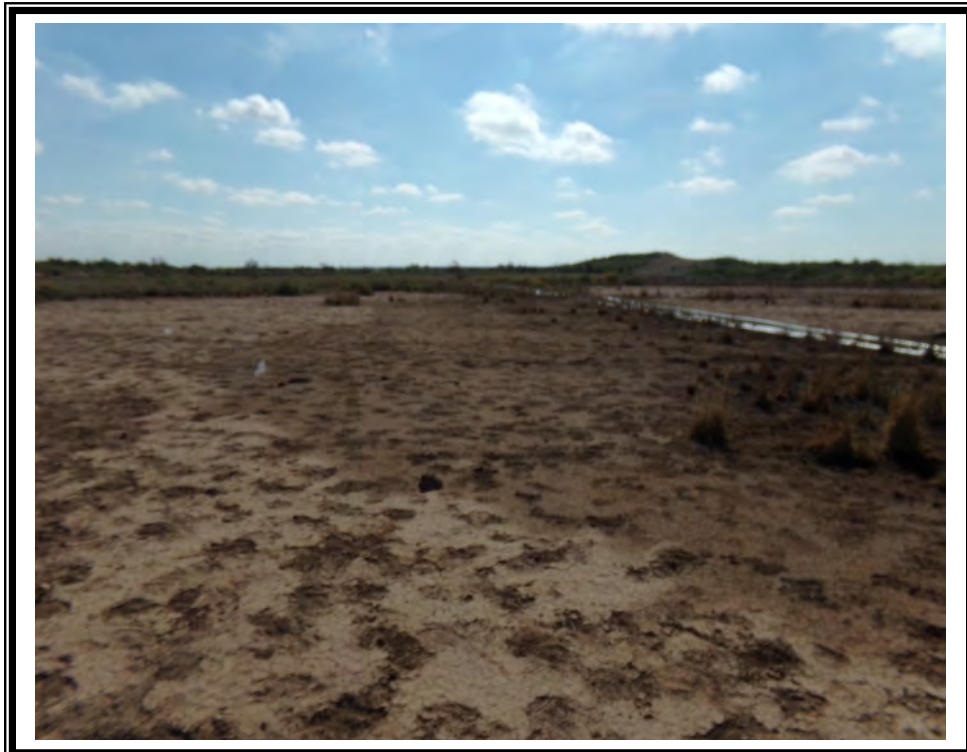
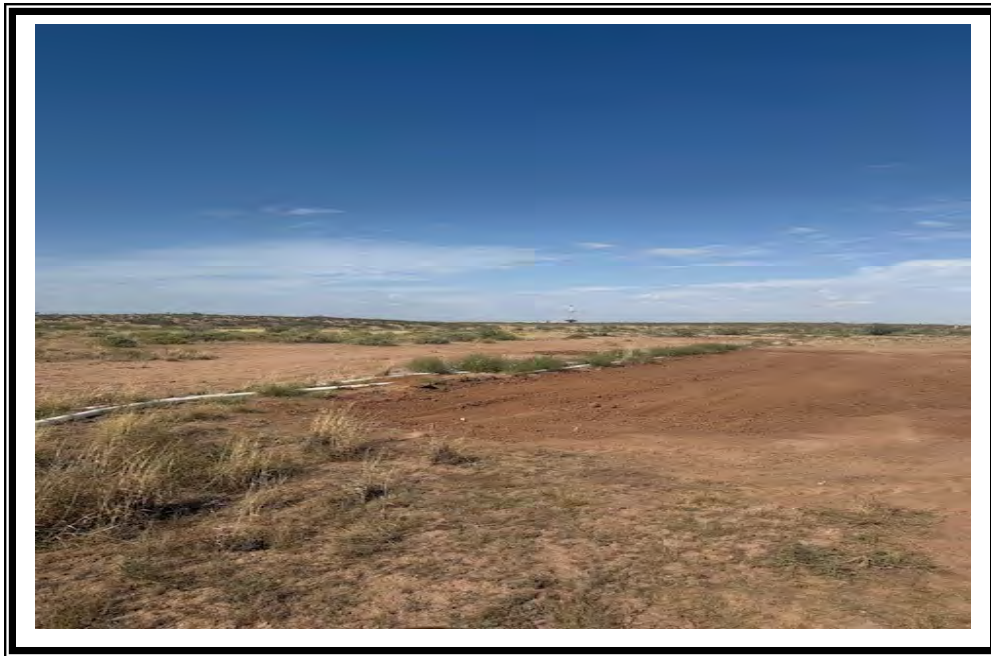
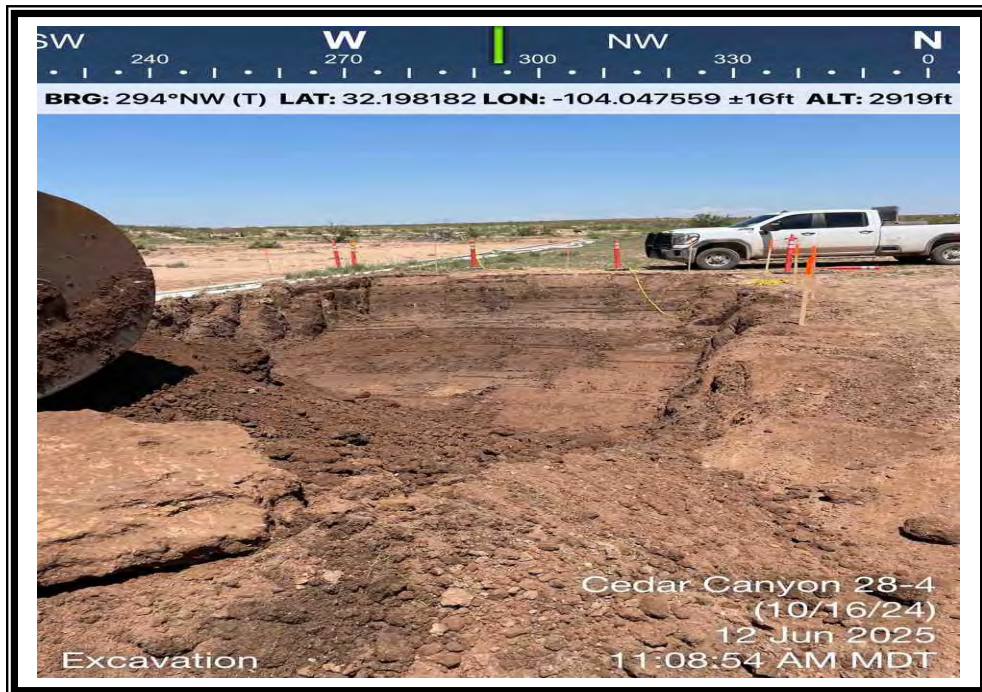
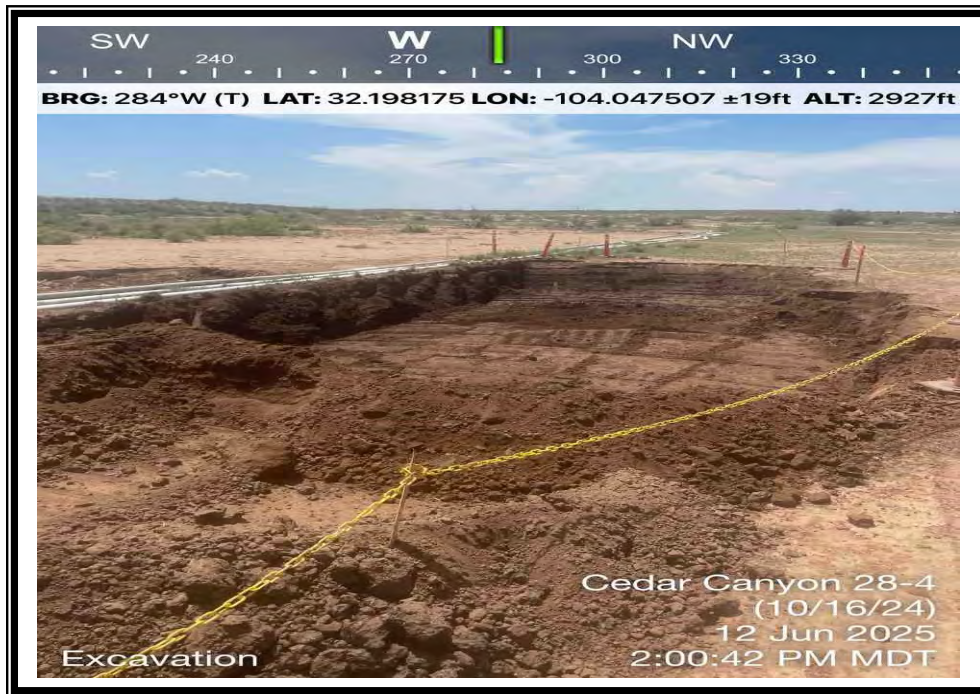
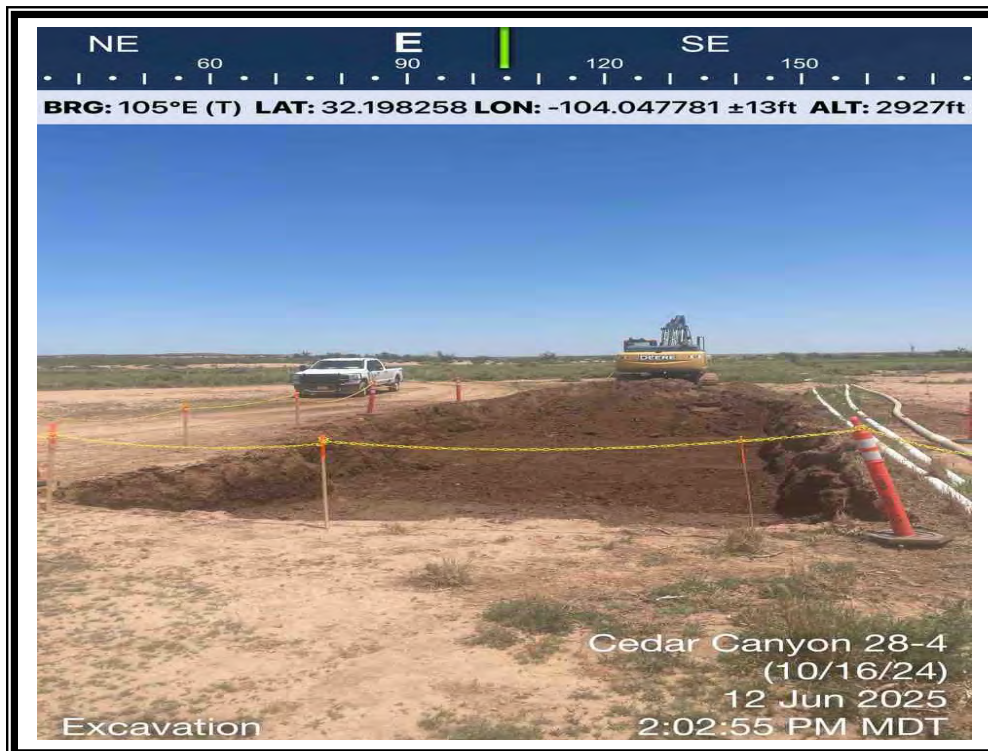
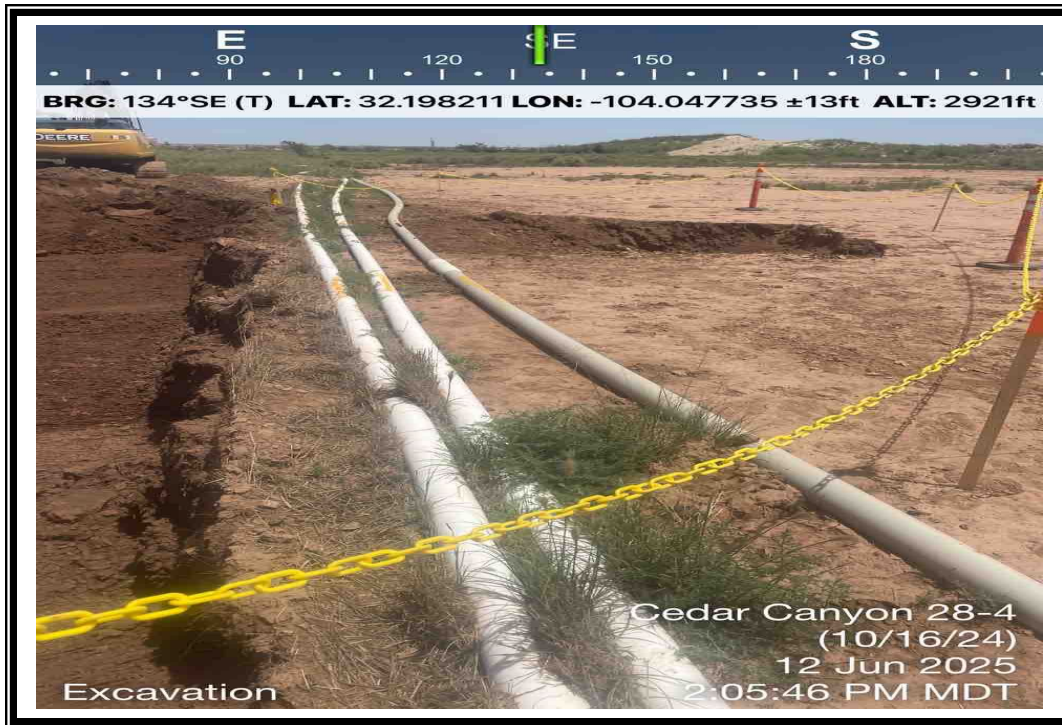
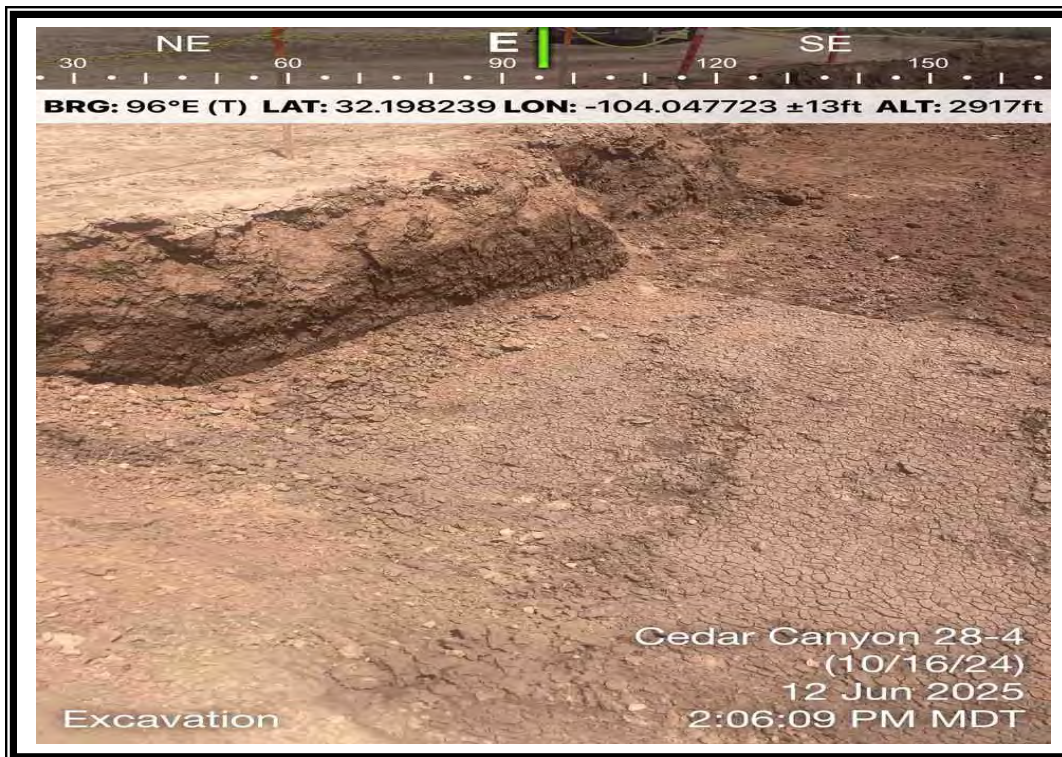
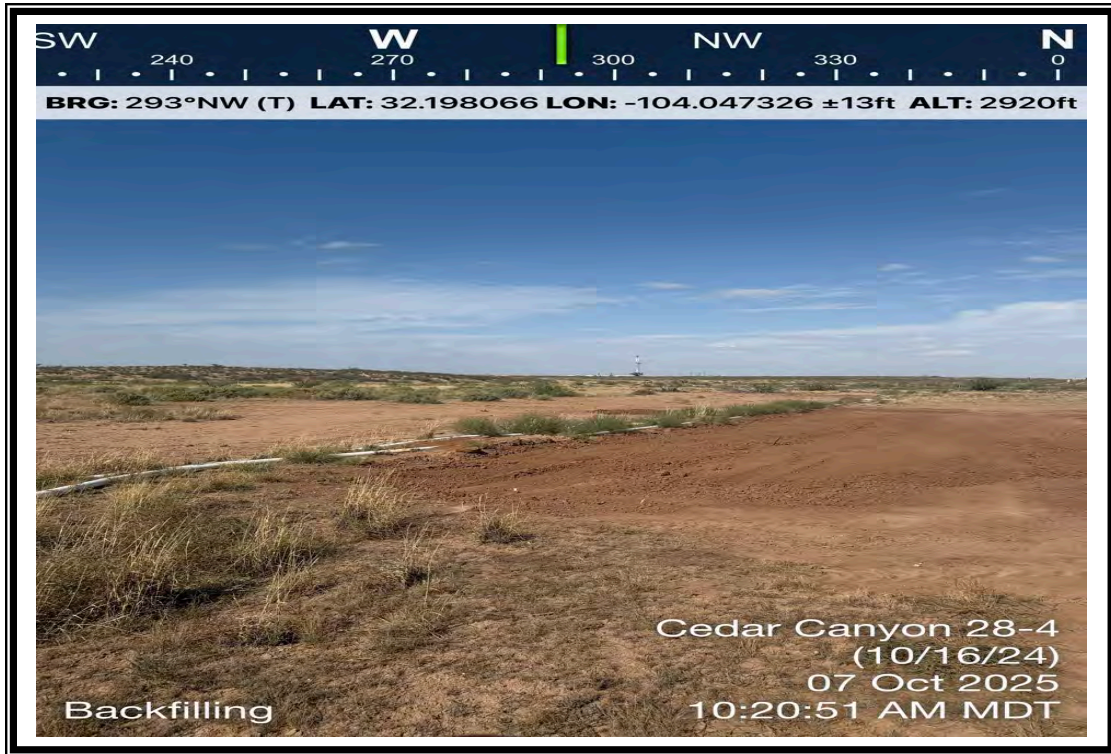
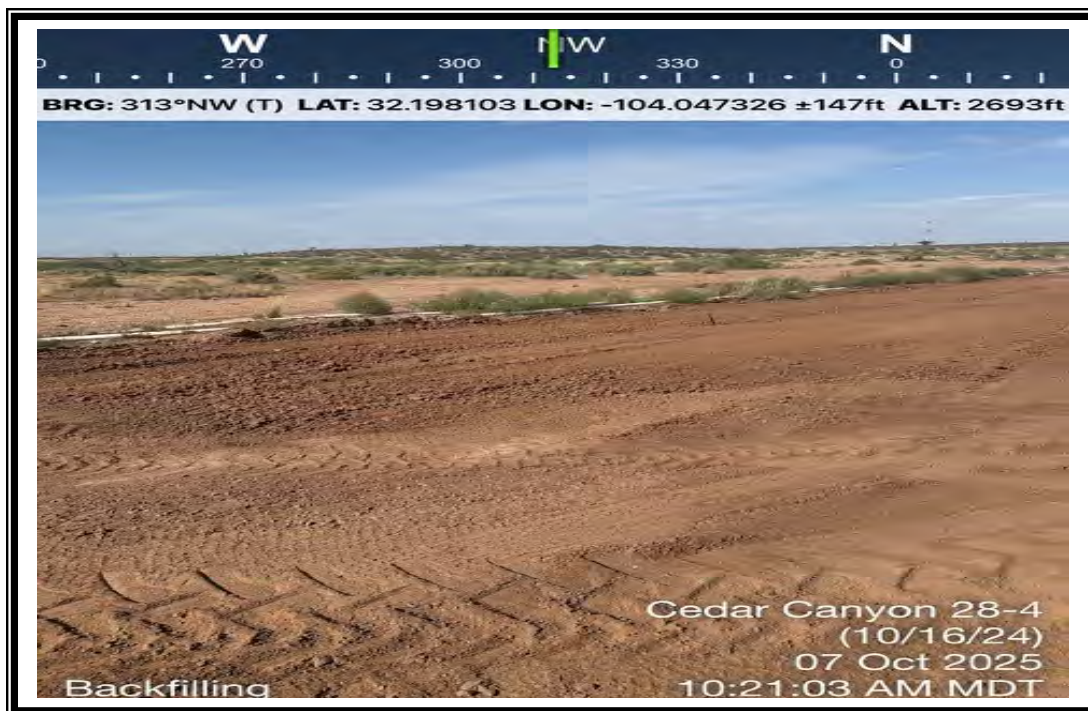
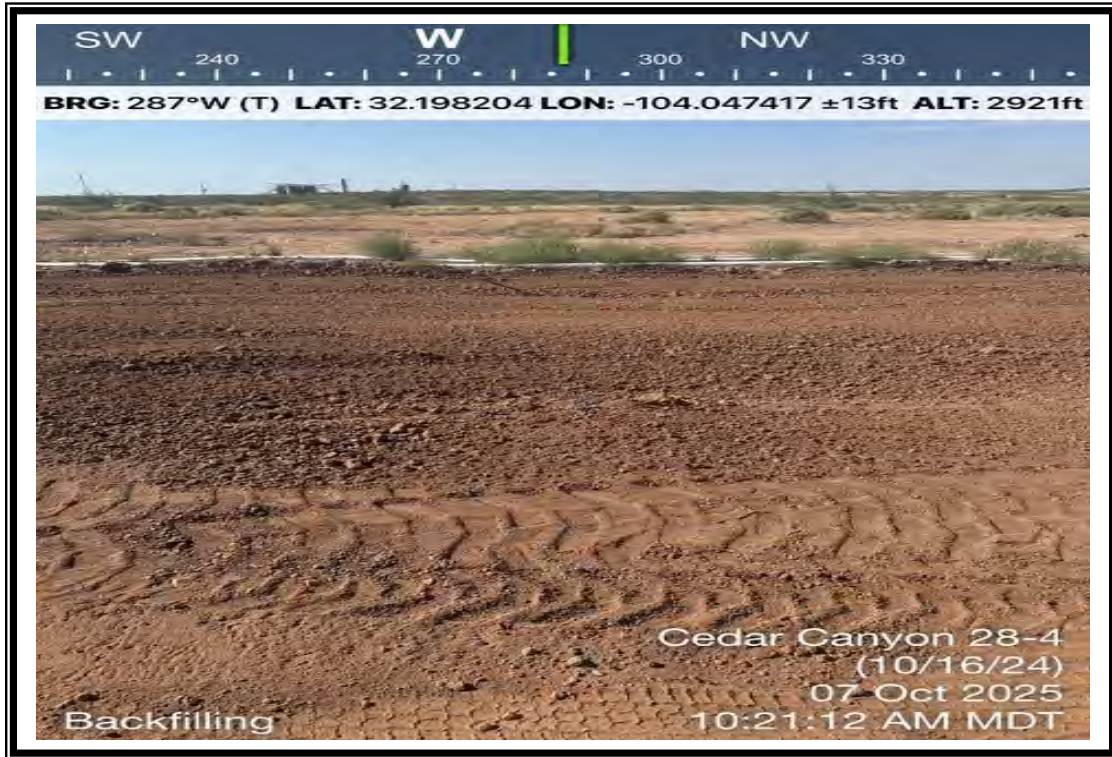
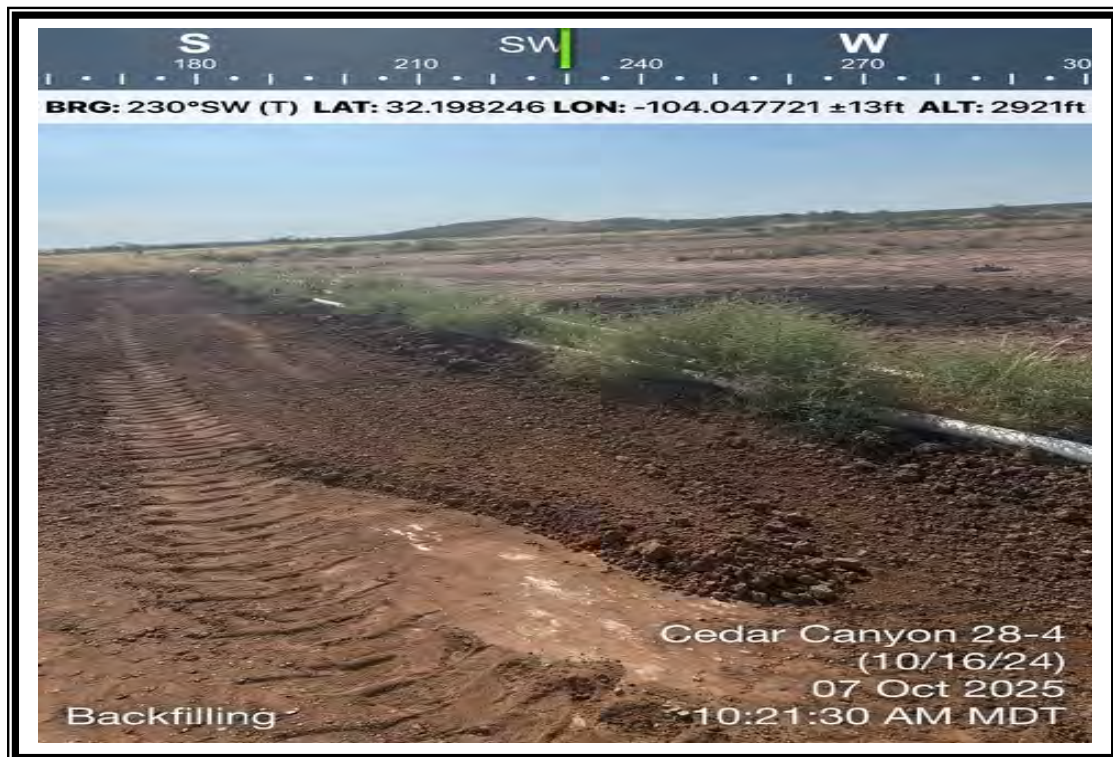
OXY, CEDAR CANYON 28 4 CTB (10/16/24)

Between June 10, 2025 and October 7, 2025, Oxy conducted assessment, delineation, and excavation activities at the Site with an (At Risk Remediation plan). During July 2025, BBC completed excavation of all impacted soil. Excavation activities were performed utilizing a trackhoe and transport vehicles. The excavation was completed to a depth of 4 feet. Following the removal of impacted soil, on September 8-9, 2025, BBC personnel collected 5-point composite soil samples every 200 square feet for both bottom and sidewalls of the excavation area. The excavation area and soil sample locations were mapped utilizing a handheld GPS and are presented in the report. Photographic documentation was completed during the remediation activities and a photographic log is included in report.
