RE: Summary of Events
Enterprise Field Services, LLC
Chaco Plant – B Plant Fire
UL M Section 16 T26N R26W; 36.482090, -108.121991
NMOCD Incident #nAPP2602936959

Enterprise Field Services, LLC (Enterprise) is submitting this Summary of Events to the New Mexico Oil Conversation Division (NMOCD) documenting the fire that occurred at Chaco Plant on January 28, 2026. This submittal is a closure request for NMOCD Incident Number nAPP26029369598, which was reported on January 28, 2026.

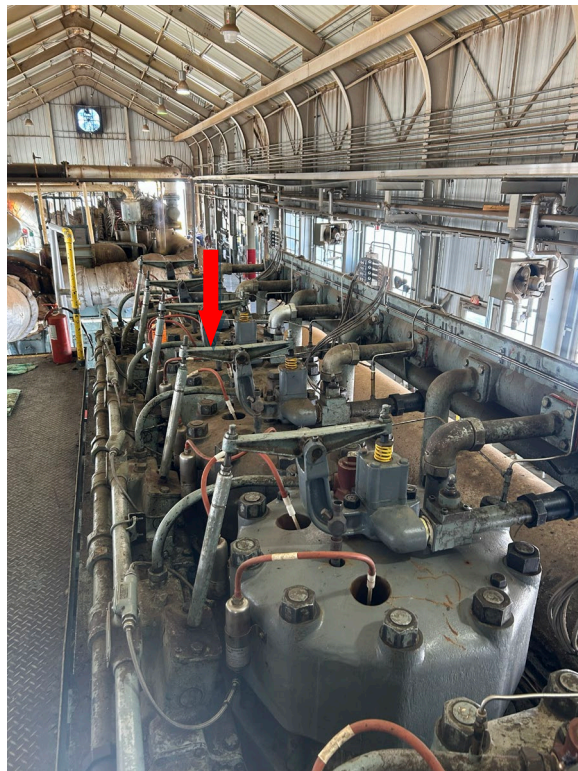
On January 28, 2026, at approximately 15:15 MT, a fire occurred at the Chaco Plant – B Plant. There were no injuries nor fatalities. No emergency services responded. No liquids were released. The fire self-extinguished. The fire was a result of a cracked bonnet on a cylinder head in which the fire eye caught the flame and caused emergency shutdown.

Photo 2: View of where the flash fire occurred.

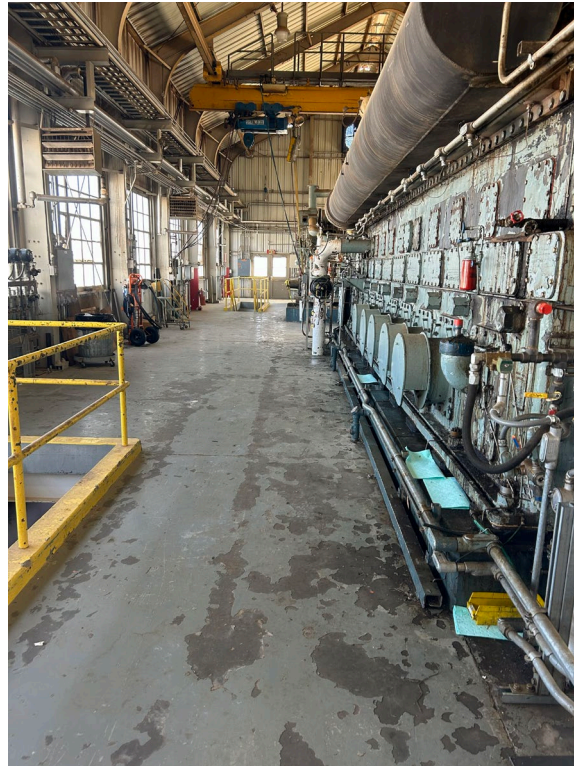
Per 19.15.29.7 New Mexico Administrative Code (NMAC), this event is defined as a “Major Release,” and soil sampling would ordinarily be required. Enterprise is requesting a variance to the soil sampling requirement per 19.15.29.12.D (1) NMAC, since the fire occurred inside the B Plant building, which has a concrete floor and no liquids were released.

Photo 3: View of concrete floor below the compressor.

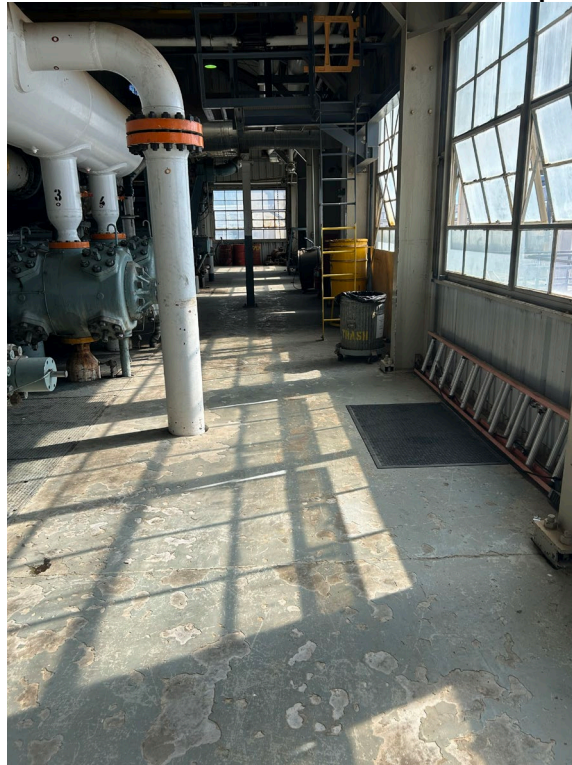
Photo 4: View of concrete floor below the compressor.
