Liquid Release Volume Calculator - E&P Exempt Material

Liner Inspection and Closure Report

Solaris Water Midstream LLC

East State Line Air Gap
Incident ID: nAPP2611849053
Lea County, NM

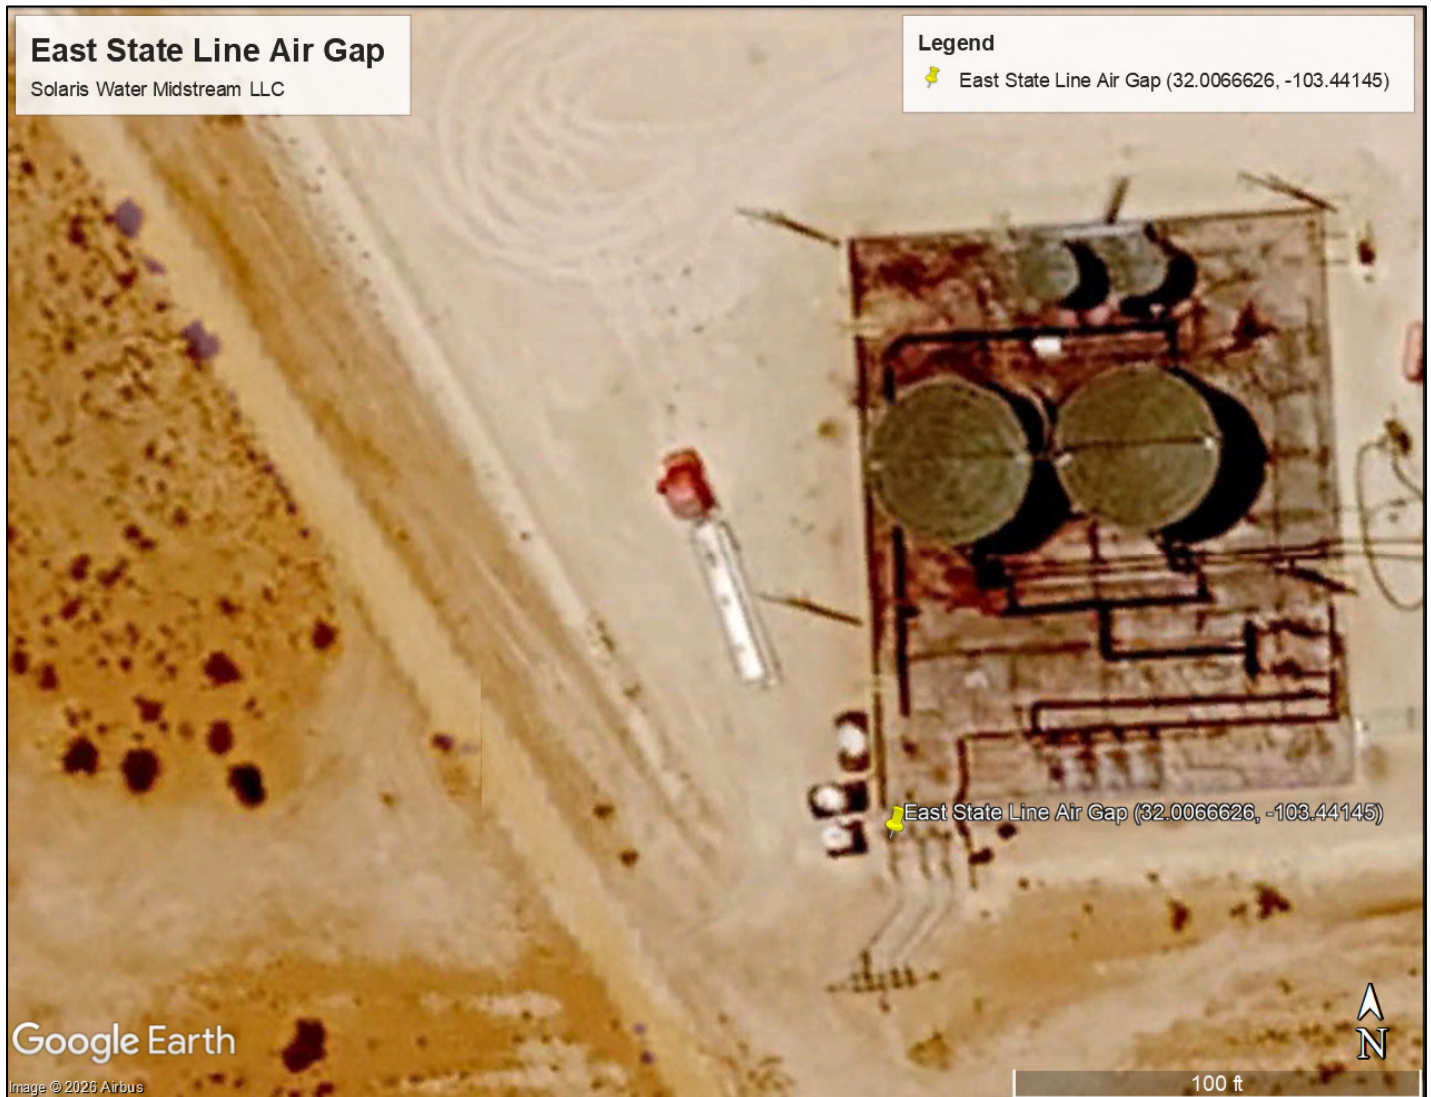
Site Diagram:

Inspection Question	Yes	No	Comments
Are there tears or holes in the liner?		X	
Is the liner retaining any fluids?		X	
Does the liner have integrity to contain a leak?	X

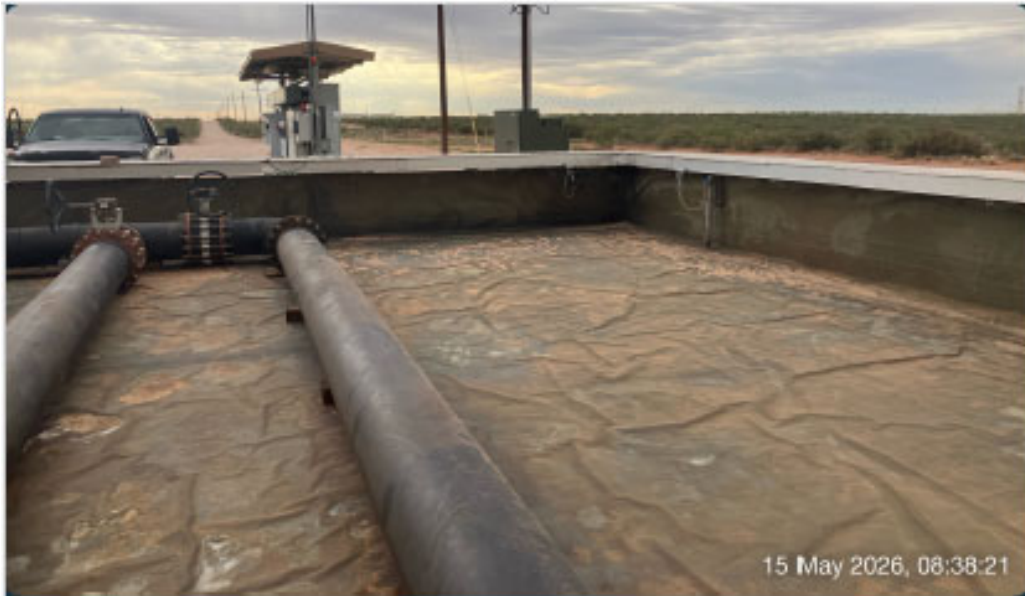
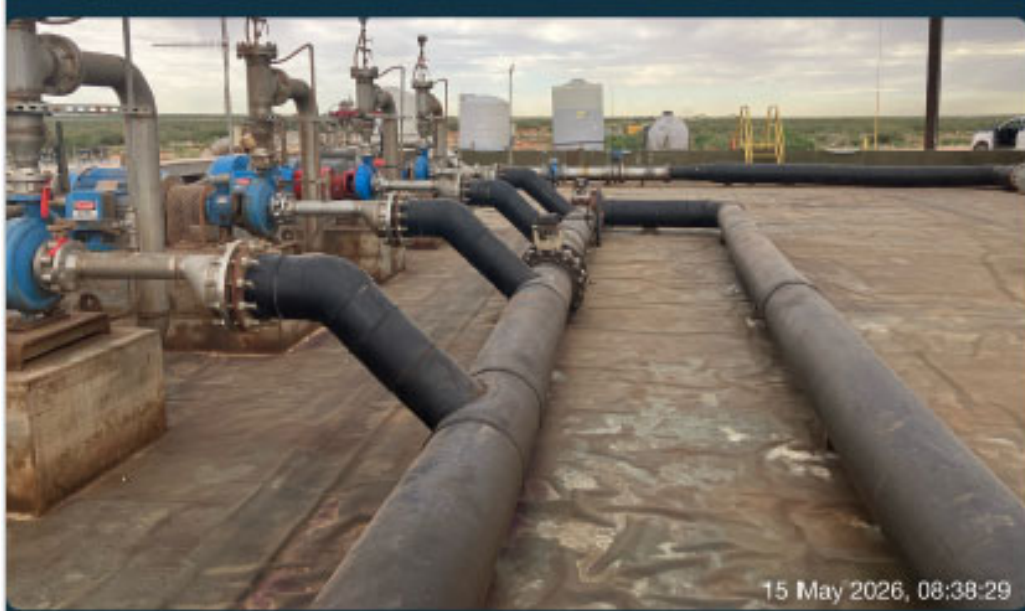
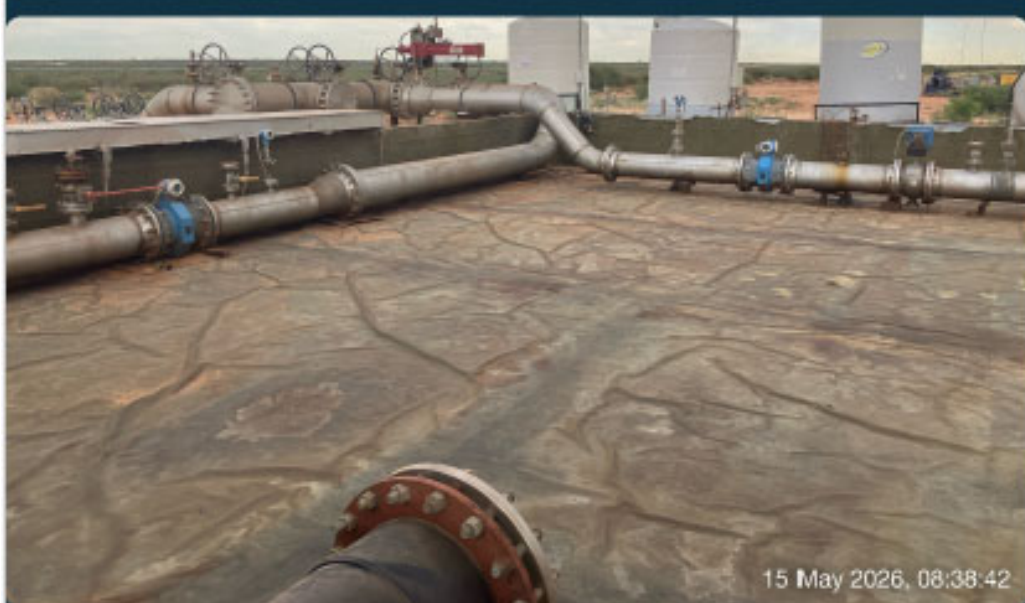
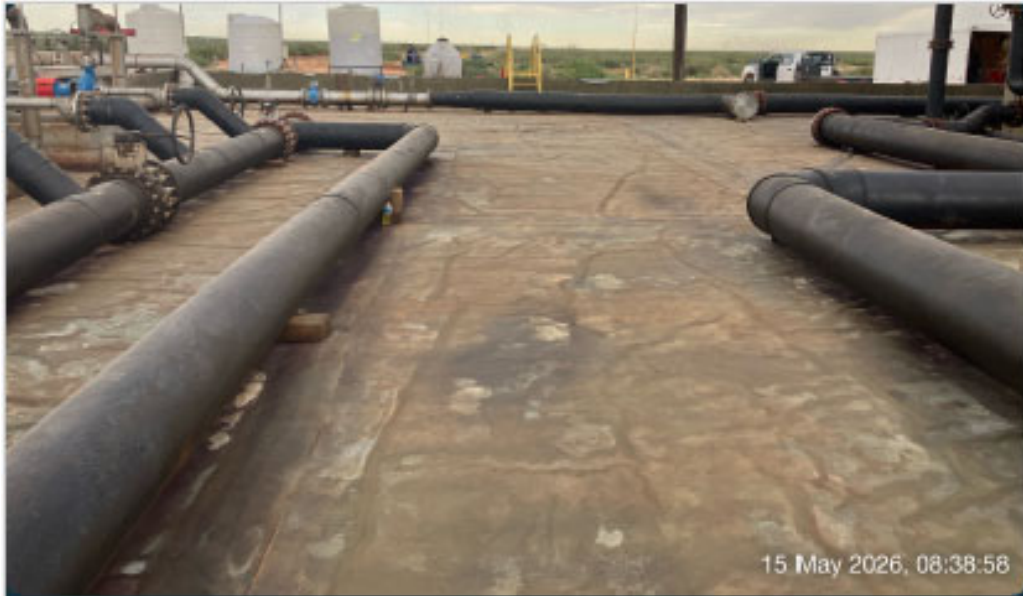
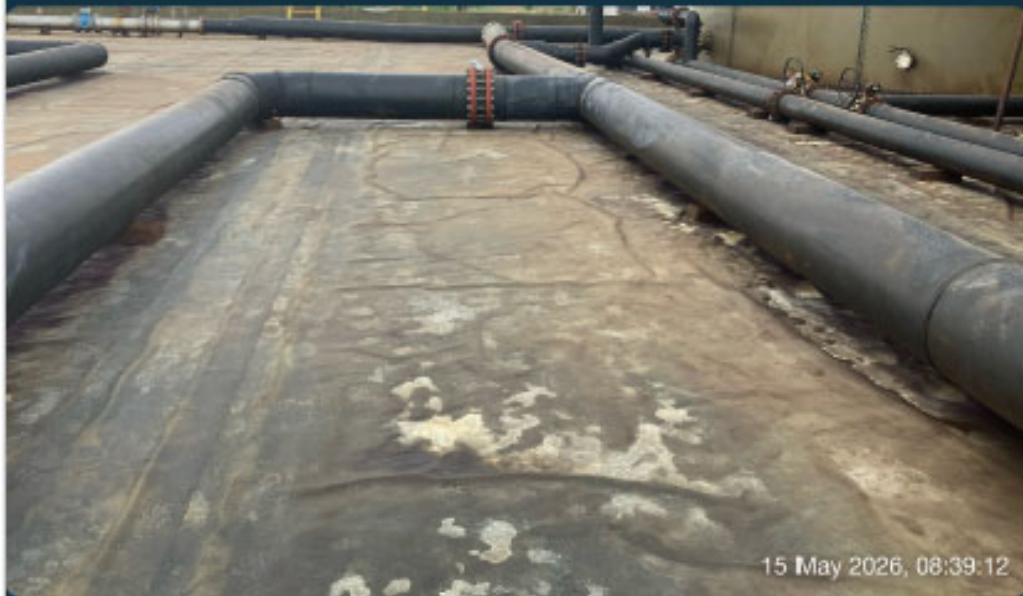
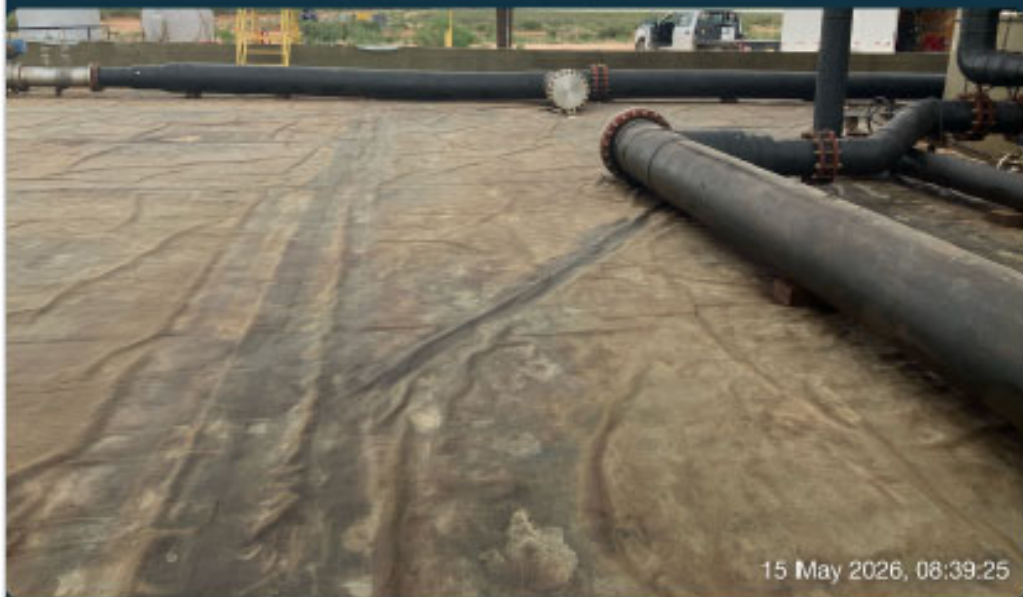
Photographic Documentation – Liner Inspection

On 05/04/2026, a C-141L was submitted and approved by the NMOCD. The liner inspection was canceled due to rain which prevented adequate visual inspection of liner integrity (submission ID: 581396). A second C-141L was submitted 5/13/2026 and approved by the NMOCD. The containment liner was visually inspected on 5/15/2026. Demonstration of liner integrity is documented in Appendix C. No deficiencies were identified during the inspection. In accordance with NMAC 19.15.29, soil samples were not required. Solaris Water Midstream LLC is requesting closure for incident nAPP2611849053.
