## Remediation Summary & Soil Closure Request

**Serrano Roll-Off Overflow**  
Lea County, New Mexico  
Unit Letter "C", Section 28, Township 23S, Range 35E  
Latitude 32.27997° North, Longitude 103.37313° West  
**NMOCD Reference No. nAPP2609314382**

**Etech Environmental & Safety Solutions, Inc.**  
6309 Indiana Ave., Ste. D  
Lubbock, Texas 79413

June 18, 2026

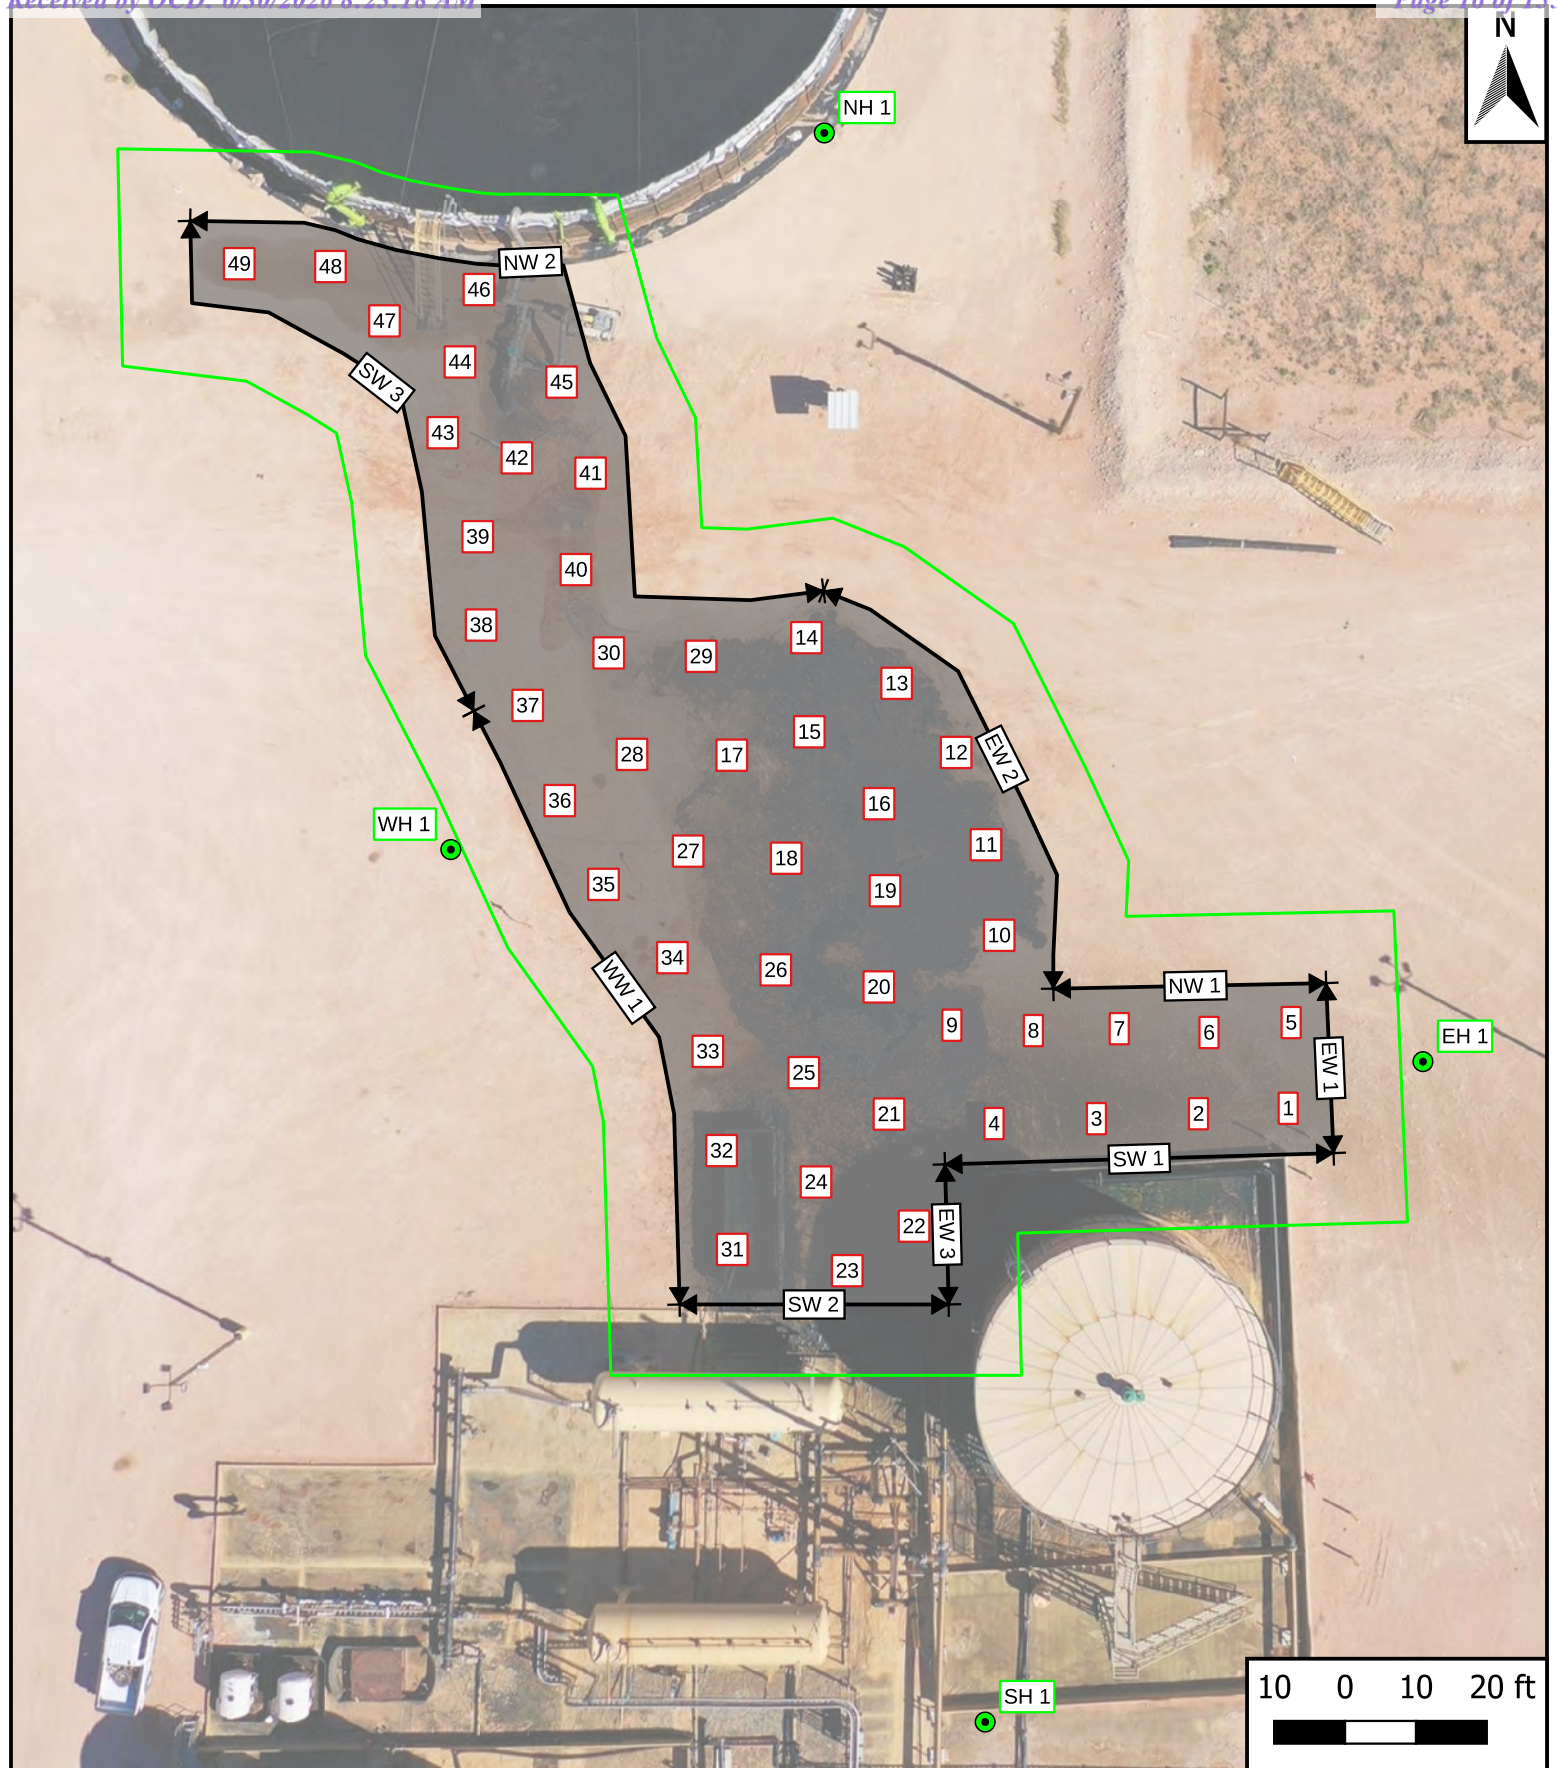
- Excavation Extent (~8,653 ft<sup>2</sup>)
- Area to be Reclaimed (~13,145 ft<sup>2</sup>)
- Composite Floor Sample
- ←
→
 Composite Wall Sample
- Delineation Sample Location

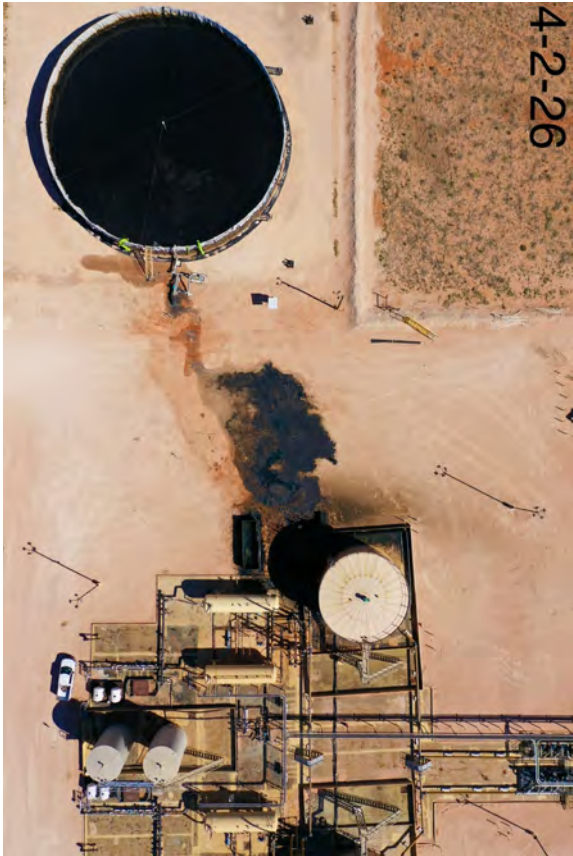
| <b>Photo Number:</b><br>1 | |

| <b>Photo Description:</b><br><br>Aerial view of the affected area. | |

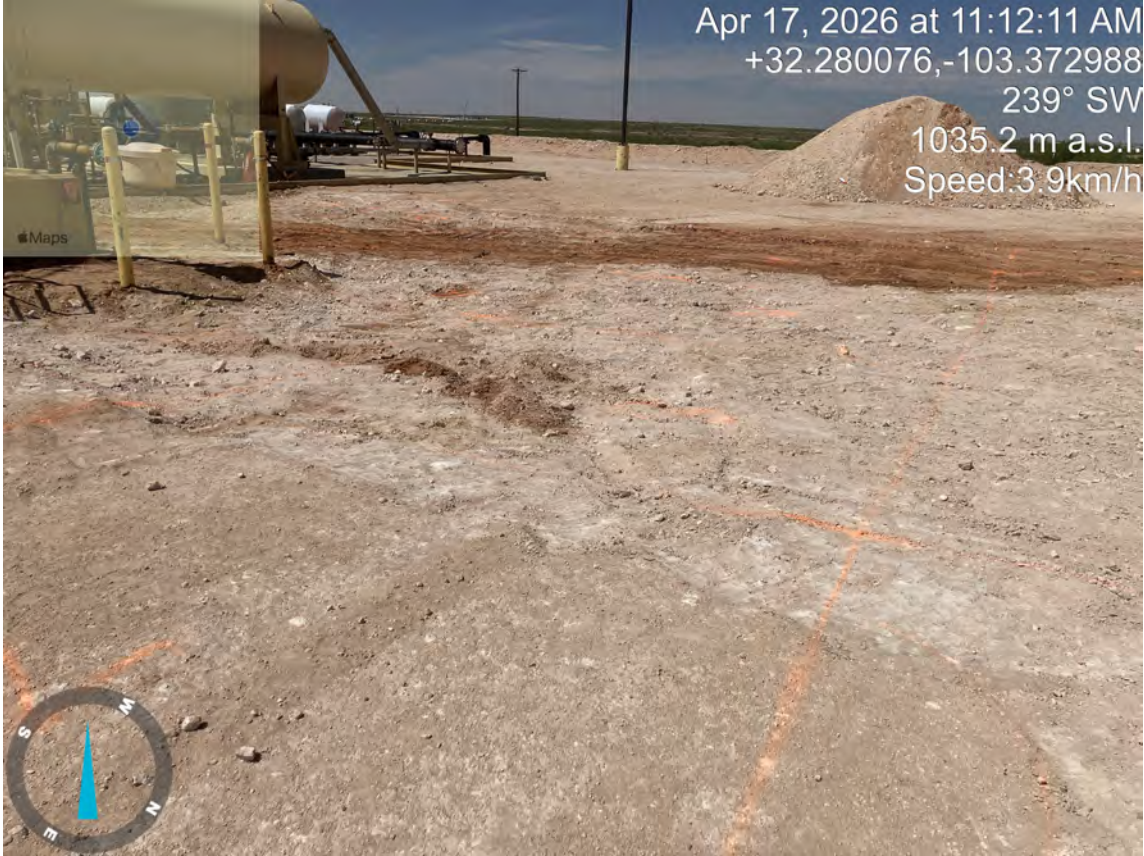
| <b>Photo Number:</b><br>2 | |

| <b>Photo Description:</b><br><br>View of the excavated area. | |

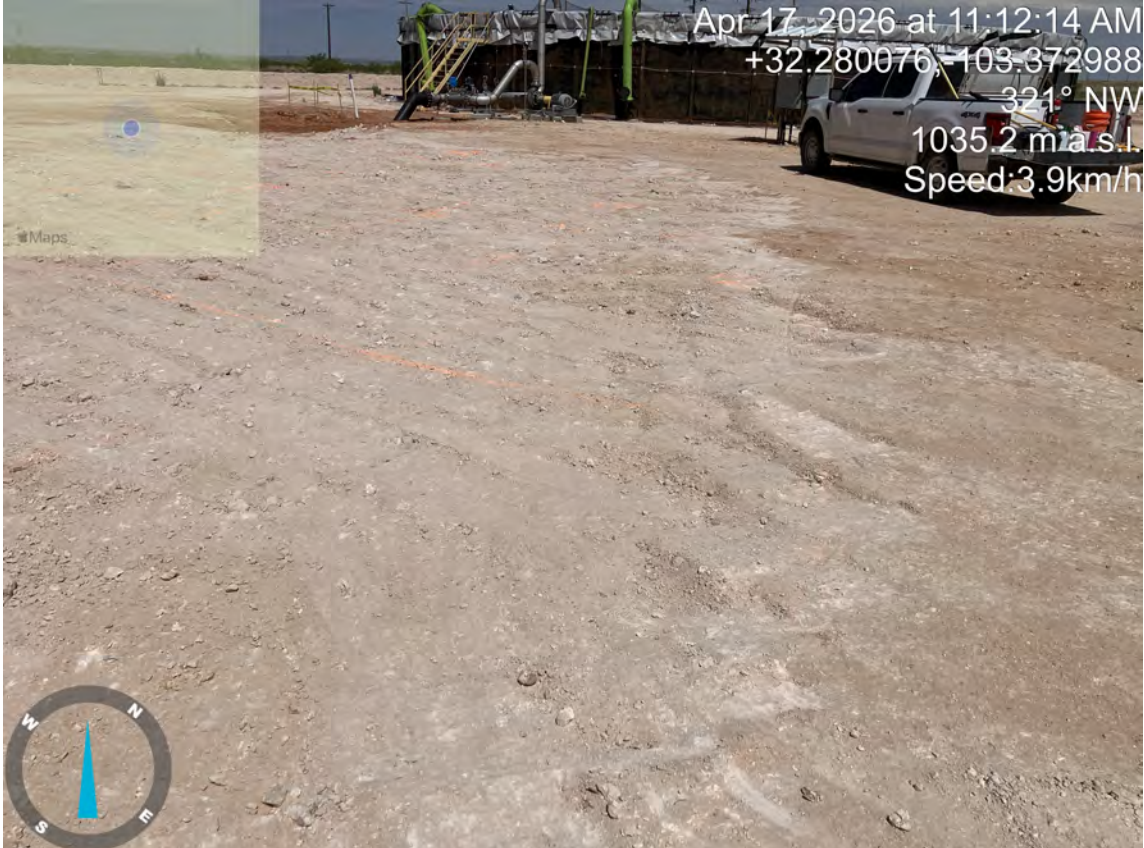
| <b>Photo Number:</b><br>3 | |

| <b>Photo Description:</b><br><br>View of the excavated area. | |

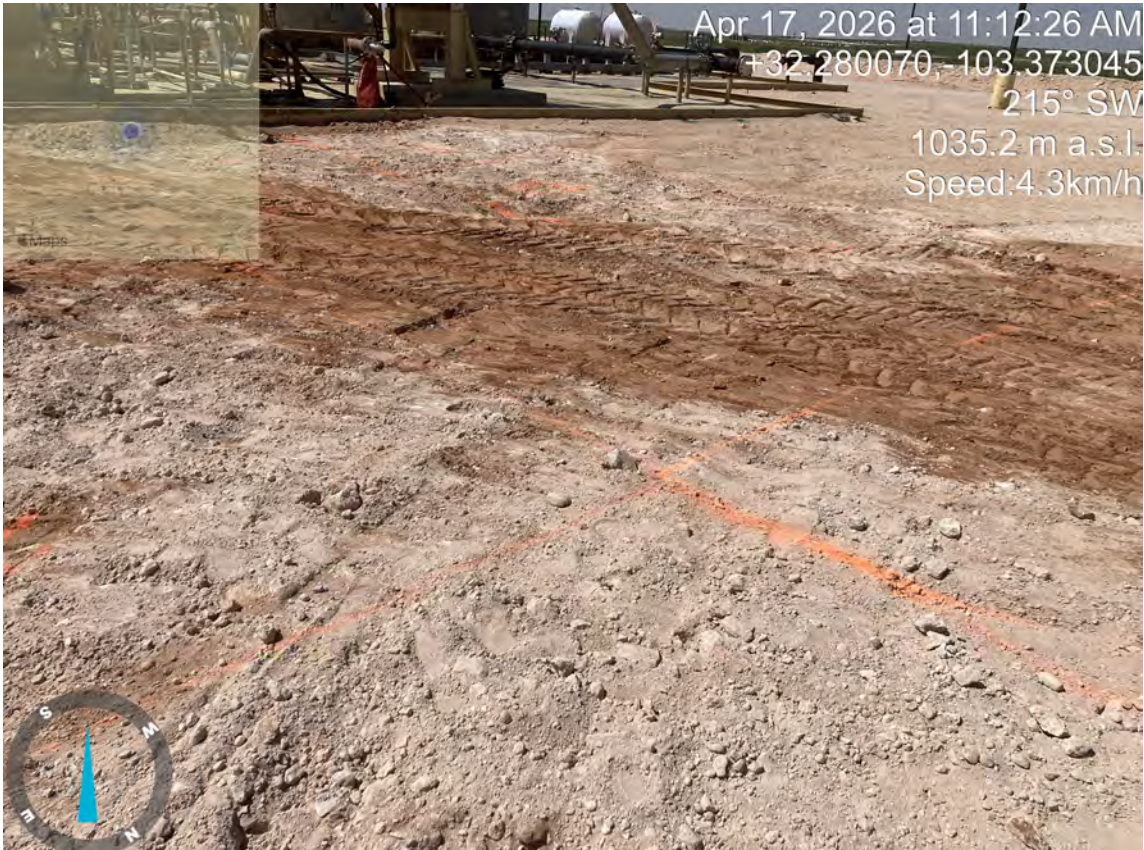
| <b>Photo Number:</b><br>4 | |

| <b>Photo Description:</b><br><br>View of the excavated area. | |

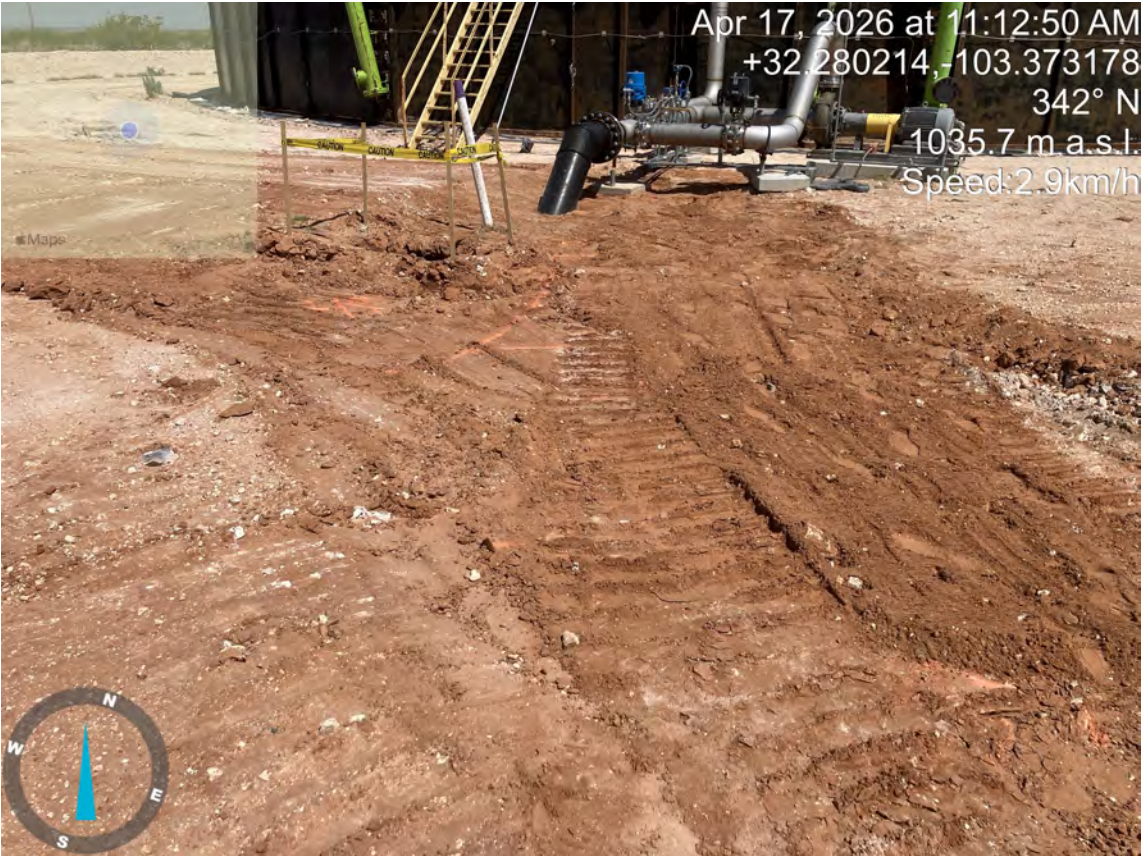
| <div>Photo Description:</div> <div>View of the excavated area.</div> | |

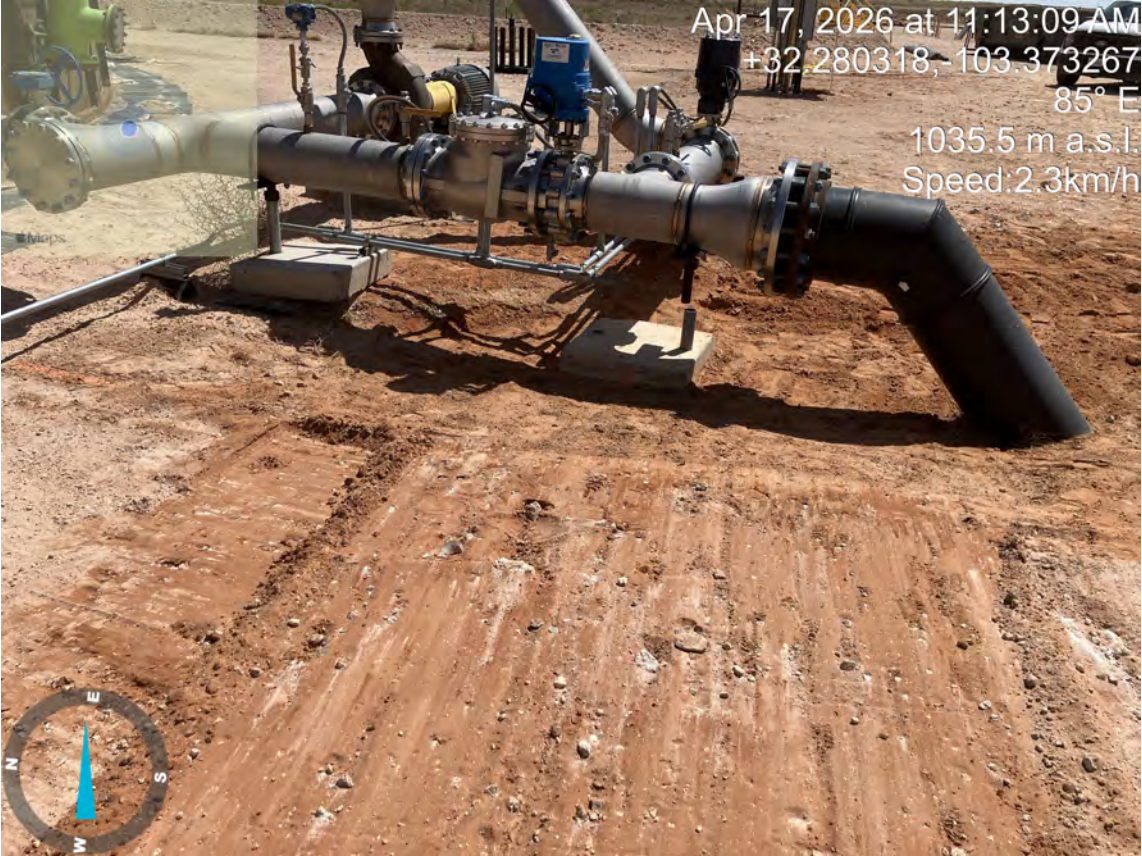
| <div>Photo Description:</div> <div>View of the excavated area.</div> | |

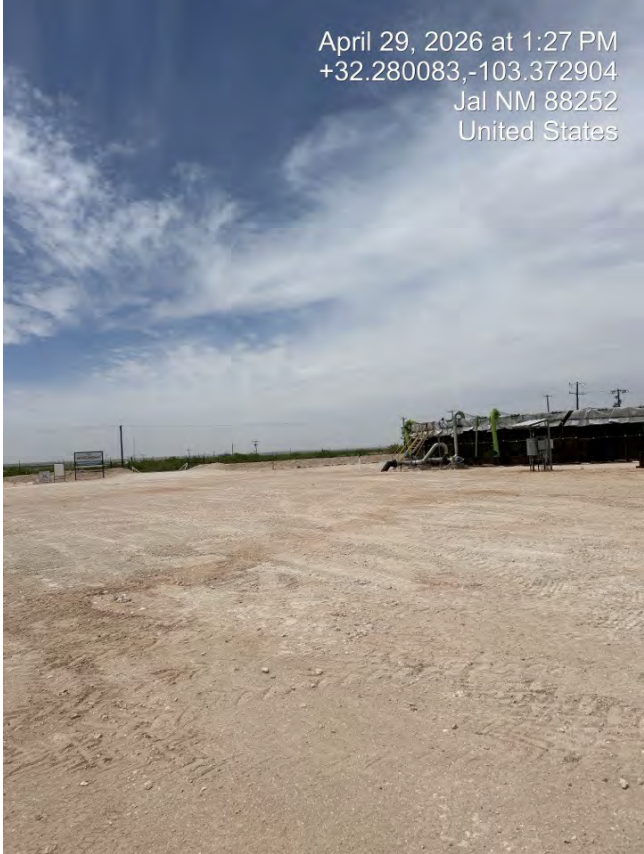
| <b>Photo Number:</b><br>7 | <p>April 29, 2026 at 1:27 PM<br/>+32.280083,-103.372904<br/>Jal NM 88252<br/>United States</p> |

| <b>Photo Description:</b><br><br>View of the remediated area following backfill and regrading. | |

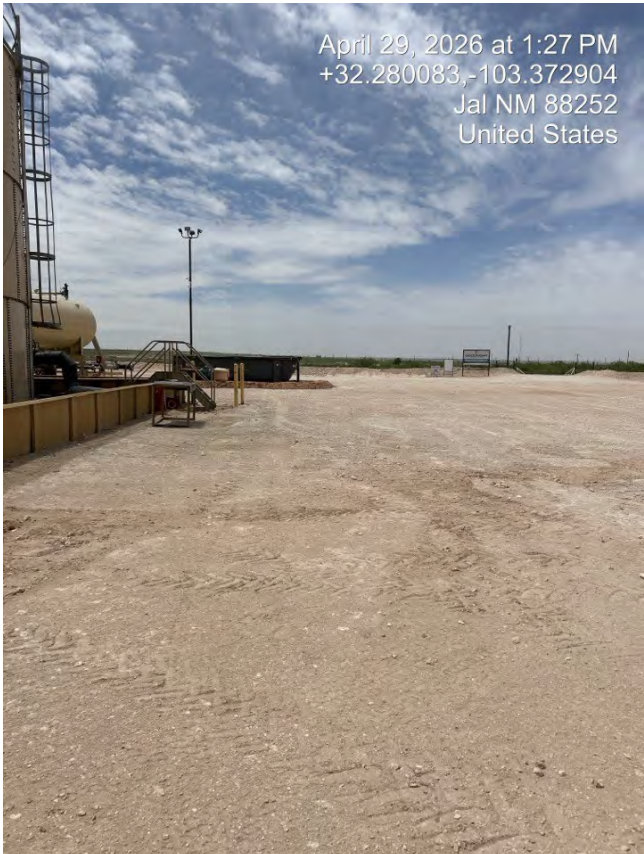
| <b>Photo Number:</b><br>8 | <p>April 29, 2026 at 1:27 PM<br/>+32.280083,-103.372904<br/>Jal NM 88252<br/>United States</p> |

| <b>Photo Description:</b><br><br>View of the remediated area following backfill and regrading. | |

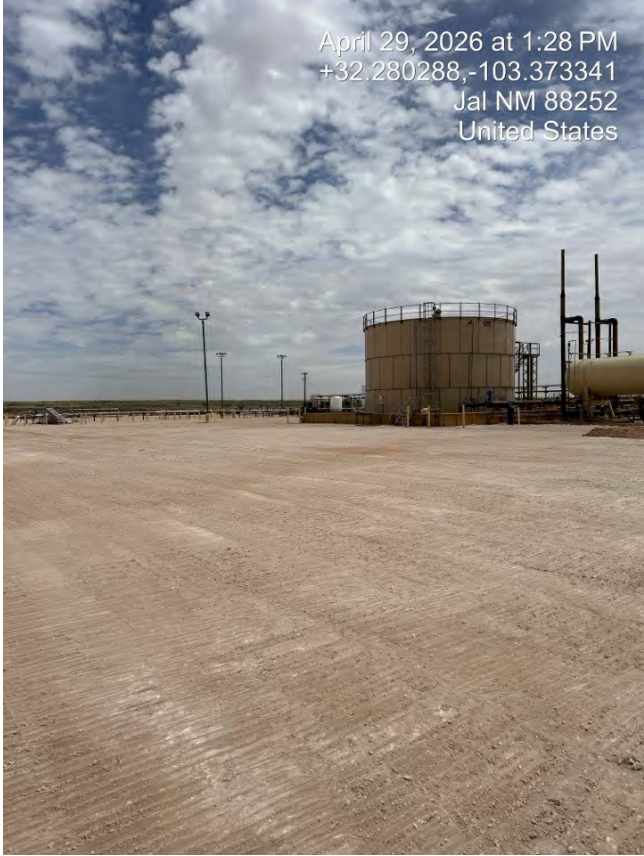
| <b>Photo Number:</b><br>9 | <p>April 29, 2026 at 1:28 PM<br/>+32.280288,-103.373341<br/>Jal NM 88252<br/>United States</p> |

| <b>Photo Description:</b><br><br>View of the remediated area following backfill and regrading. | |

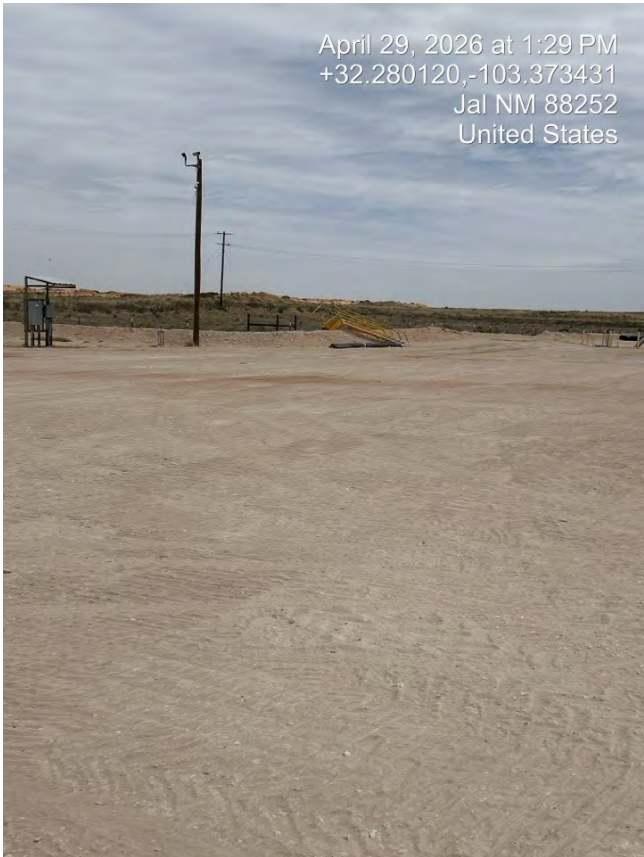
| <b>Photo Number:</b><br>10 | <p>April 29, 2026 at 1:29 PM<br/>+32.280120,-103.373431<br/>Jal NM 88252<br/>United States</p> |

| <b>Photo Description:</b><br><br>View of the remediated area following backfill and regrading. | |

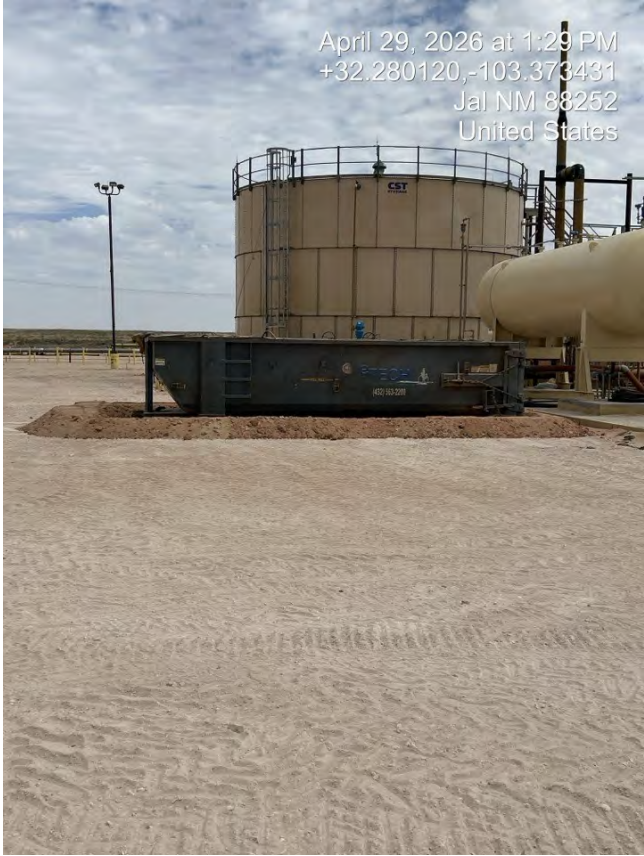
| <b>Photo Number:</b><br>11 | <p>April 29, 2026 at 1:29 PM<br/>+32.280120,-103.373431<br/>Jal NM 88252<br/>United States</p> |

| <b>Photo Description:</b><br><br>View of the remediated area following backfill and regrading. | |

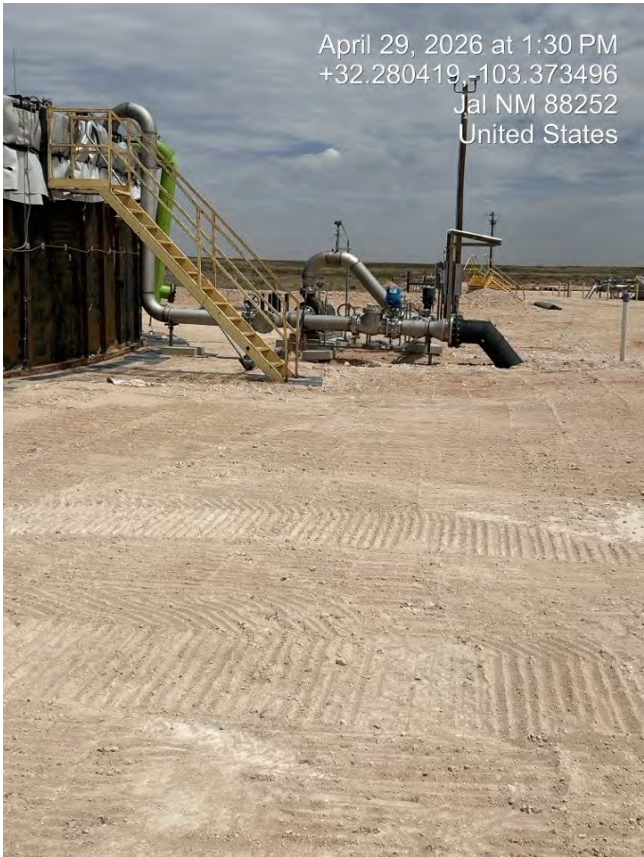
| <b>Photo Number:</b><br>12 | <p>April 29, 2026 at 1:30 PM<br/>+32.280419,-103.373496<br/>Jal NM 88252<br/>United States</p> |

| <b>Photo Description:</b><br><br>View of the remediated area following backfill and regrading. | |
