**RE: Right Meow 31 CTB 7 - Closure Request Report**

Incident Number: nAPP2525125732, nAPP2606434775, nAPP2613145609

Lea County, New Mexico

ESRR Project No. VP-7221, VP-9259, VP-9953

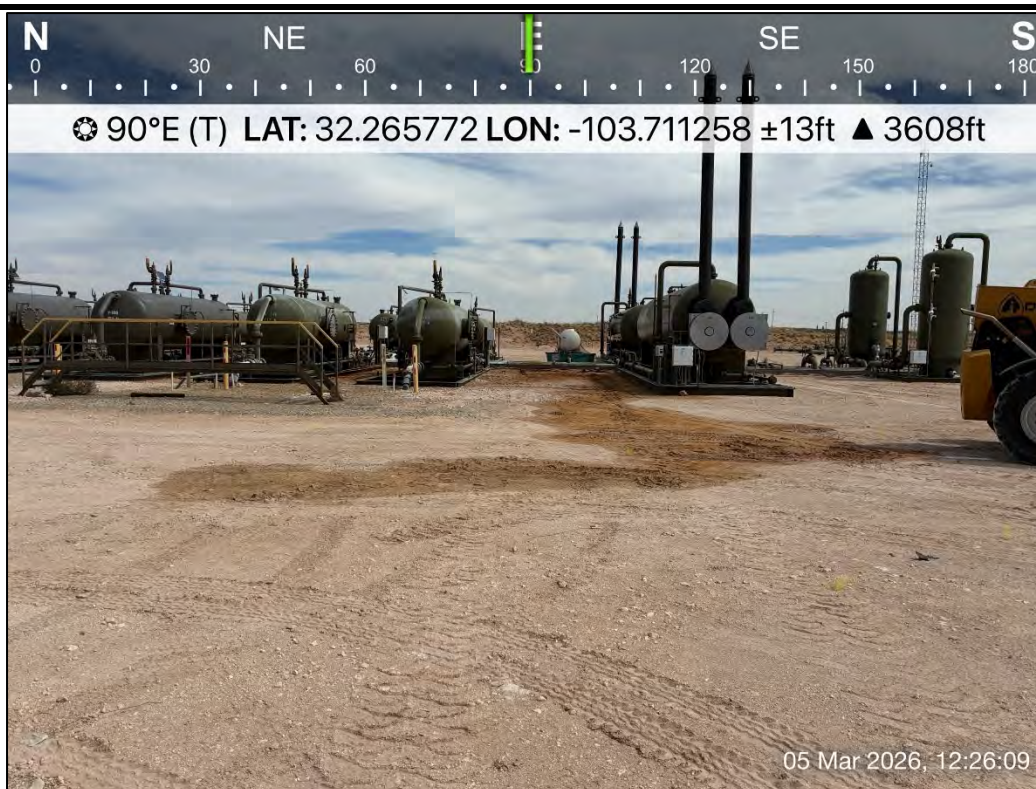
PHOTO 6: Eastern view during site assessment activities for nAPP2606434775. 3/5/2026

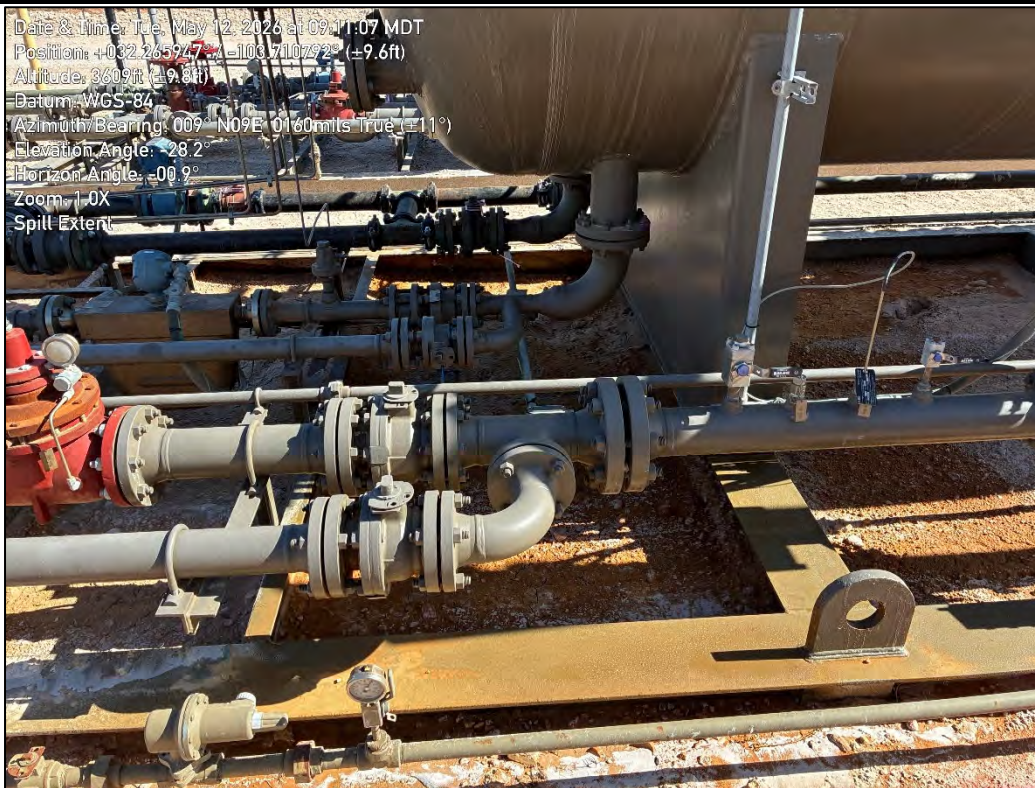
PHOTO 11: Southwestern view during site assessment activities for nAPP2613145609. 5/12/2026

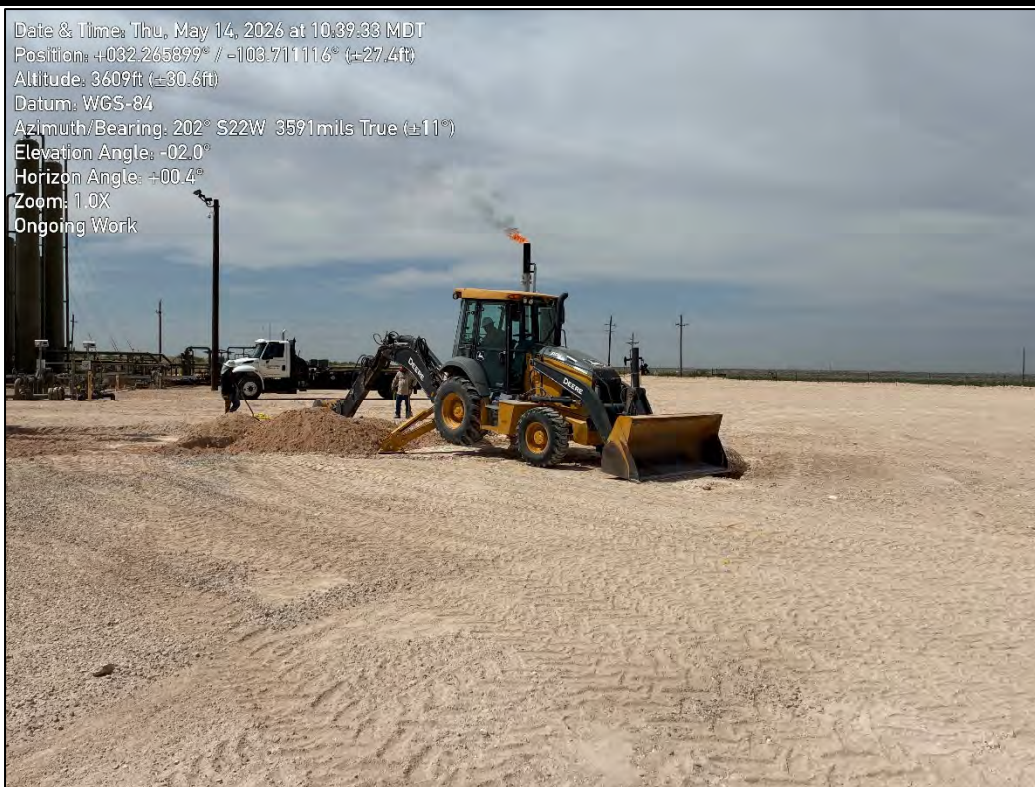
PHOTO 12: Southwestern view during excavation activities. 5/14/2026
