**RE: Right Meow 31 CTB 7 - Closure Request Report**

Incident Number: nAPP2525125732, nAPP2606434775, nAPP2613145609

ESRR Project No. VP-7221, VP-9259, VP-9953

Earth Systems Response and Restoration (ESRR), presents the following Closure Request Report (CRR) which details excavation activities and subsequent soil sampling events associated with three overlapping inadvertent produced water releases at the Right Meow 31 CTB 7 (Site). Based on completed remedial actions and laboratory analytical results from recent soil sampling events, Devon is requesting No Further Action (NFA) at the Site.

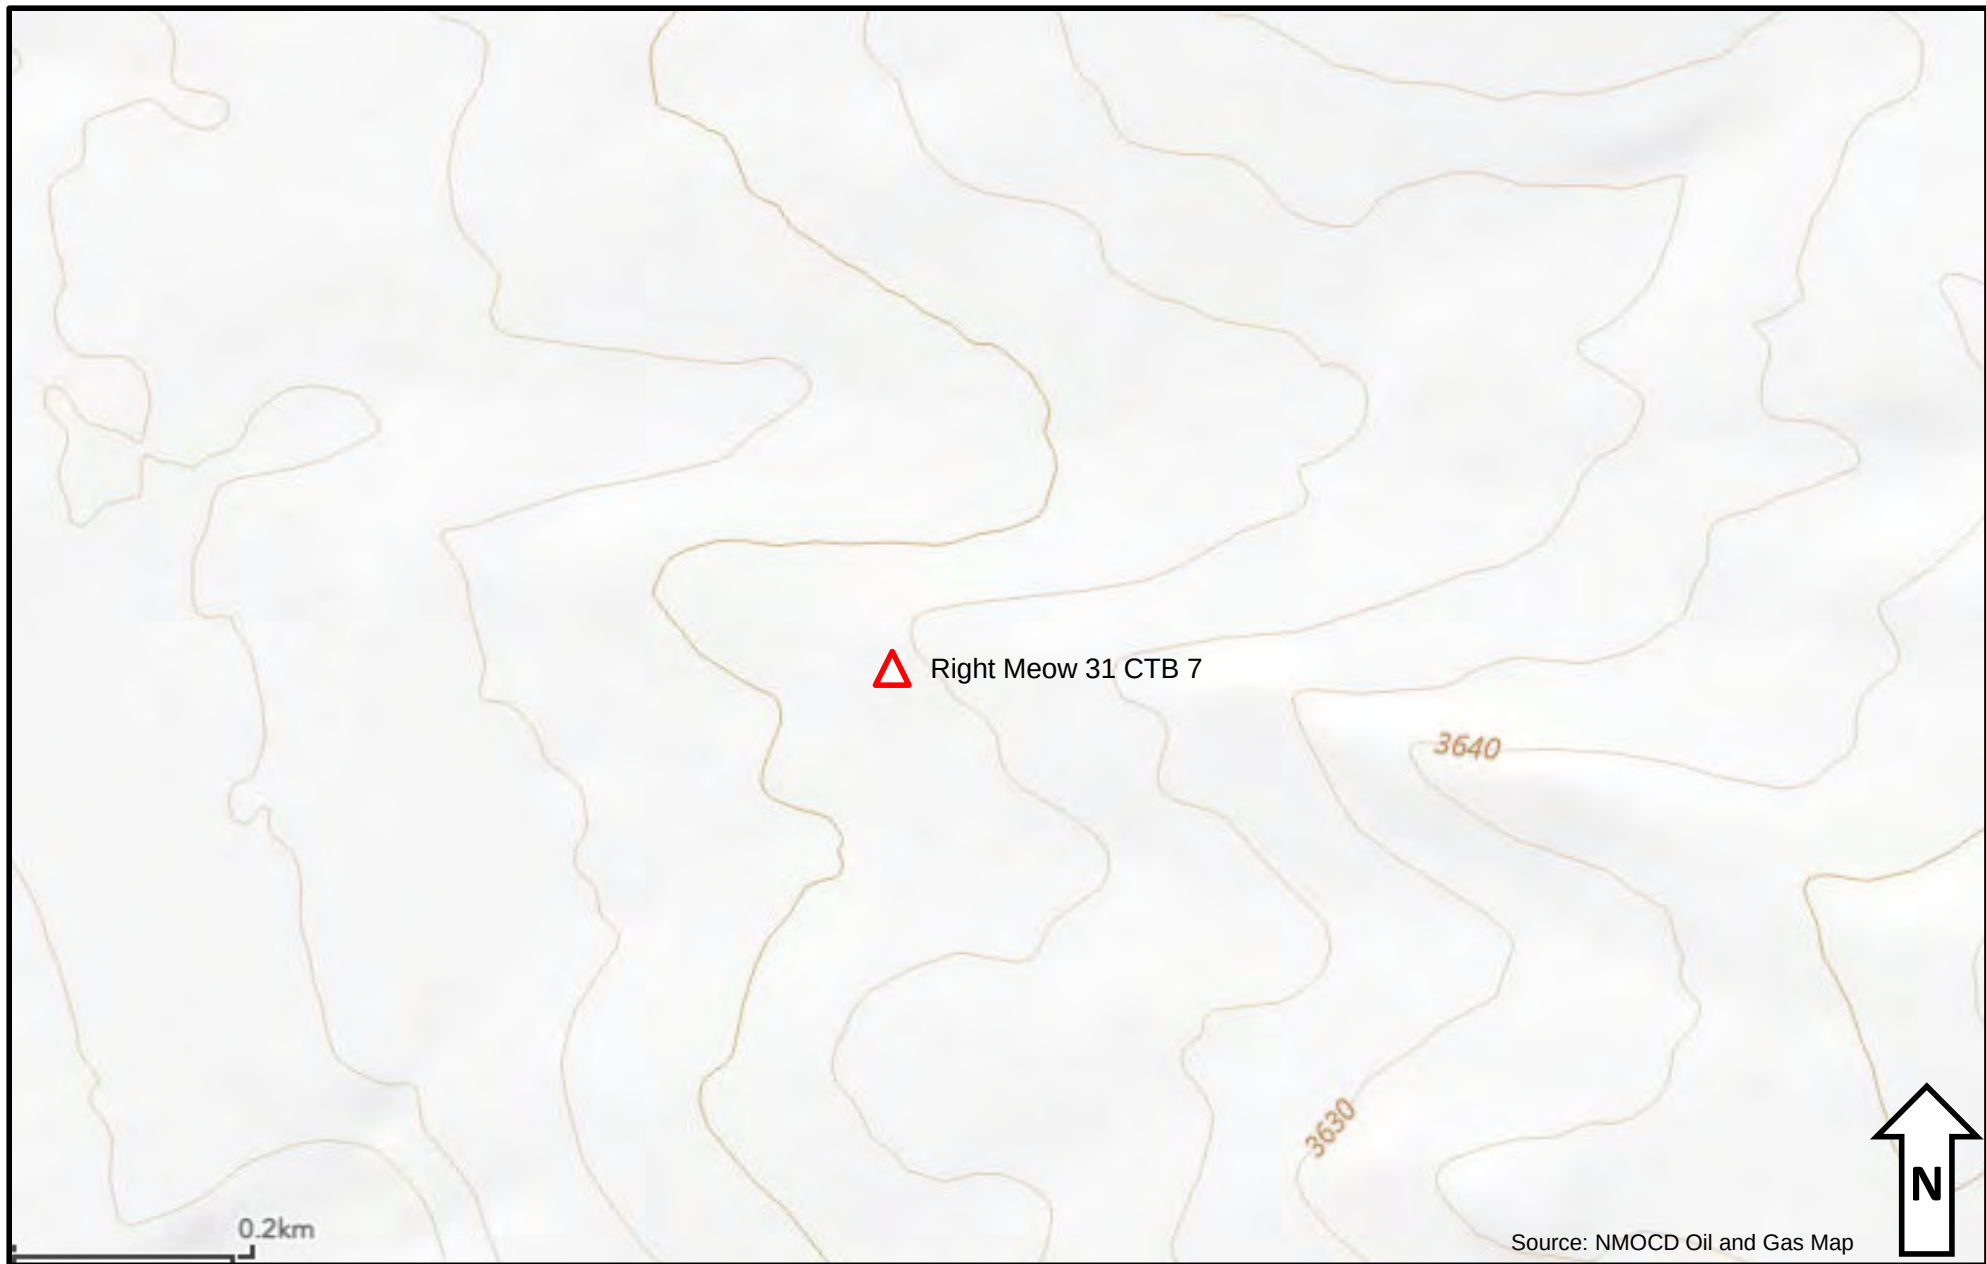
**Figure 1 – Site Map**

The Site is located in Unit B, Section 31, Township 23 South, Range 32 East, in Lea County, New Mexico (32.265538°, -103.710866°) and is associated with oil and gas exploration and production operations on Federal Land managed by the Bureau of Land Management (BLM) (**Figure 1**).

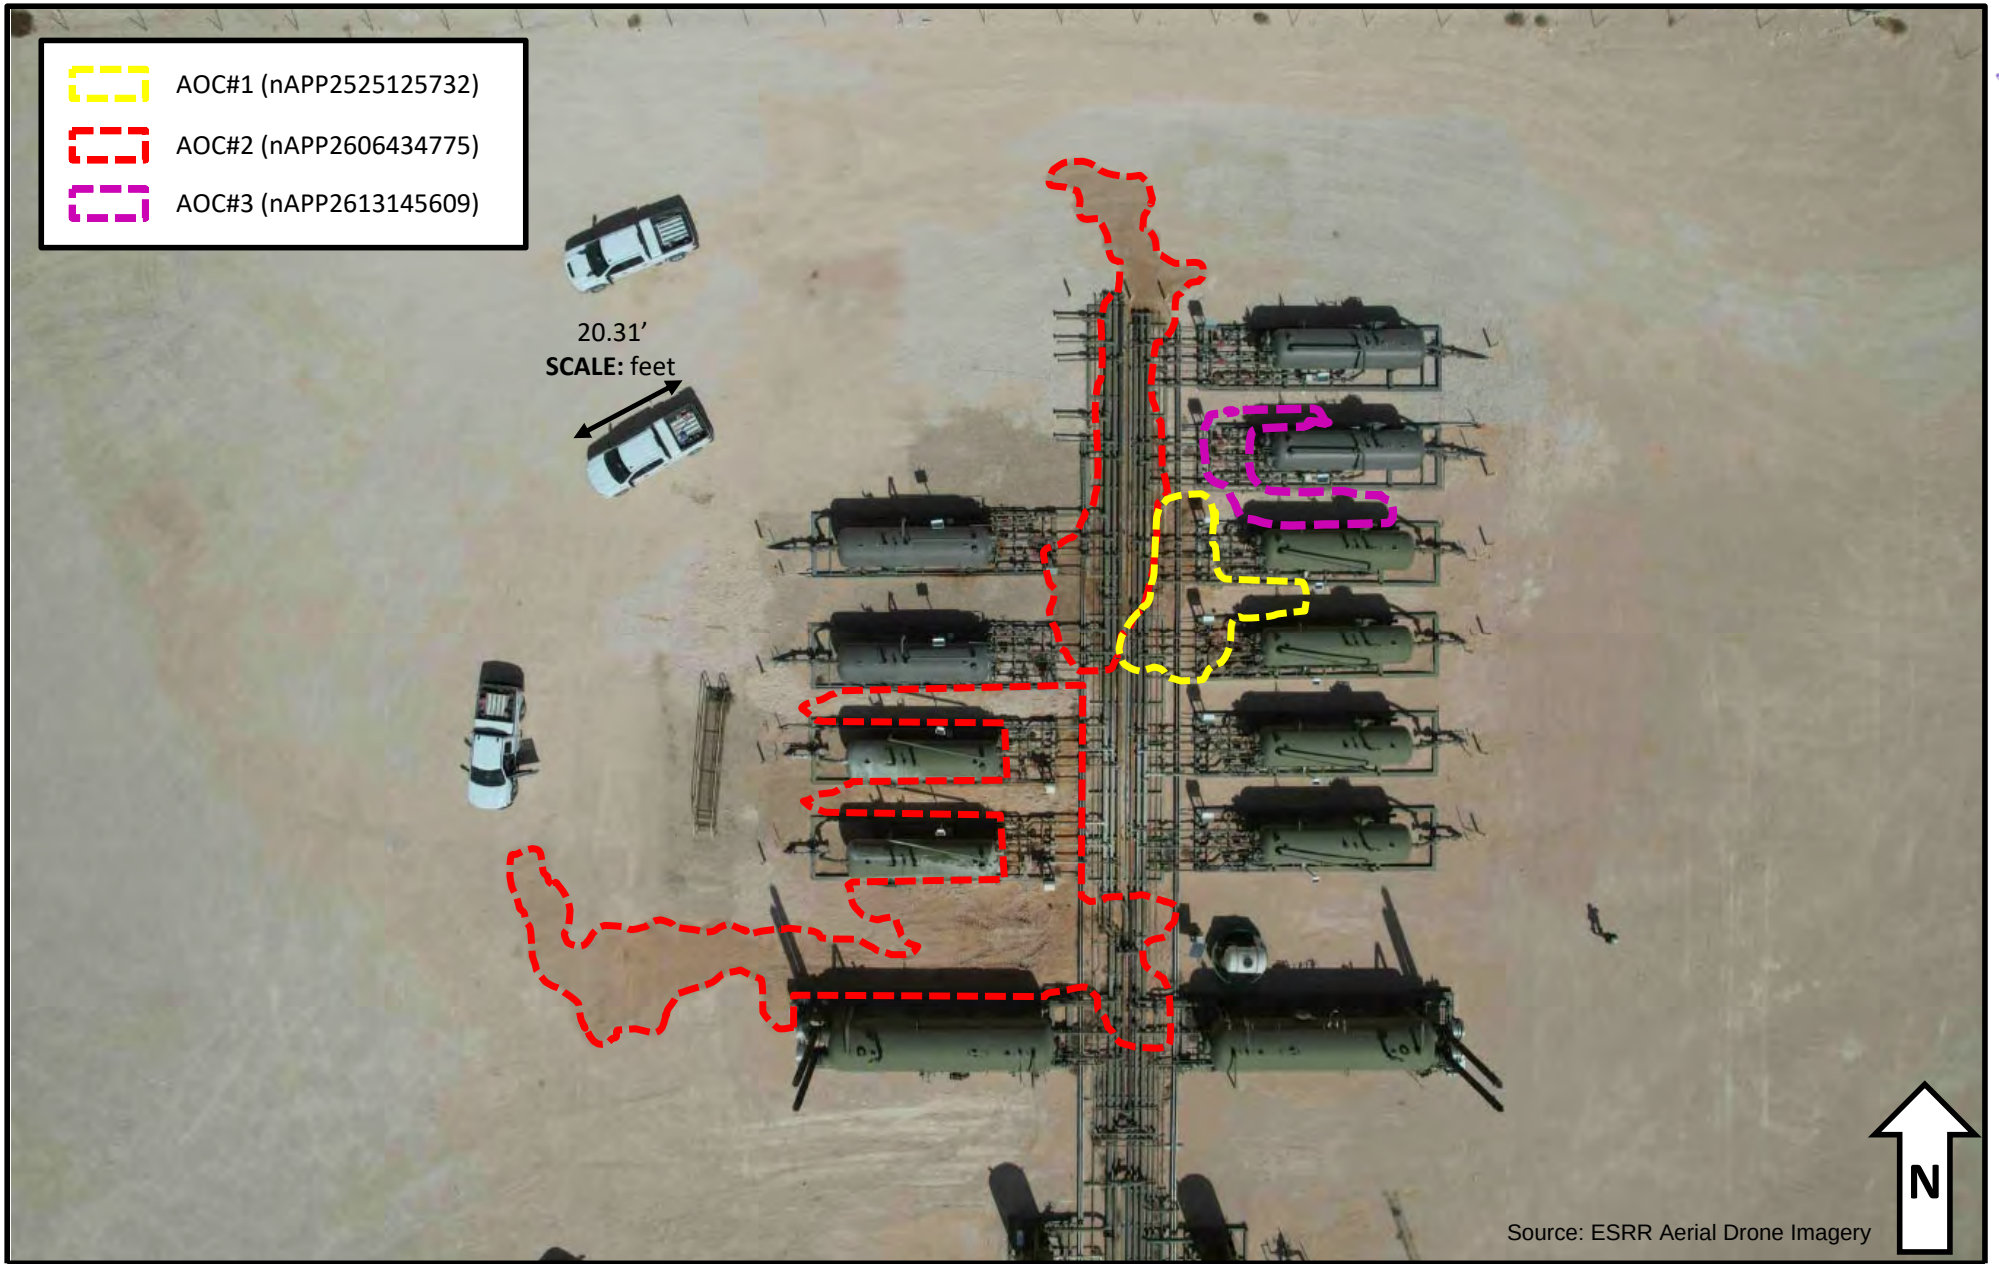
Figure 2 – Area of Concern

- **December 8, 2026** - ESRR conducted site assessment activities, mapping the observed release footprint, hereafter referred to as the AOC#1 (**Figure 2**). ESRR, on behalf of Devon, requested an extension of the December 8, 2025 deadline, to allow additional time to complete delineation and remediation activities. Devon was granted a 90-day extension by the NMOCD for March 9, 2026, for Incident Number **nAPP2525125732**.

- **March 5, 2026** - ESRR conducted initial site assessment activities and mapped the observed release footprint hereafter referred to as the AOC#2 (**Figure 2**). Devon gave notice to the NMOCD by NOR and was subsequently assigned Incident Number **nAPP2606434775**.

- **May 12, 2026** - ESRR conducted initial site assessment activities and mapped the observed release footprint hereafter referred to as the AOC#3 (**Figure 2**).

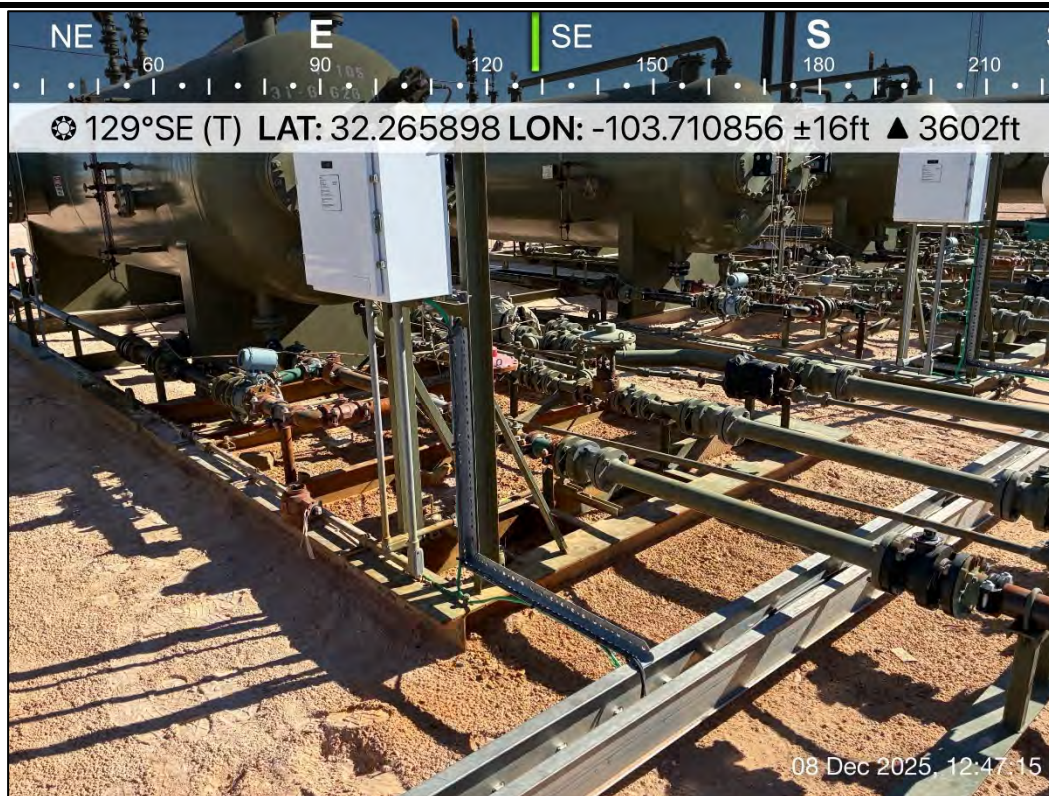
PHOTO 1: Southeastern view during site assessment activities for nAPP2525125732. 12/8/2025

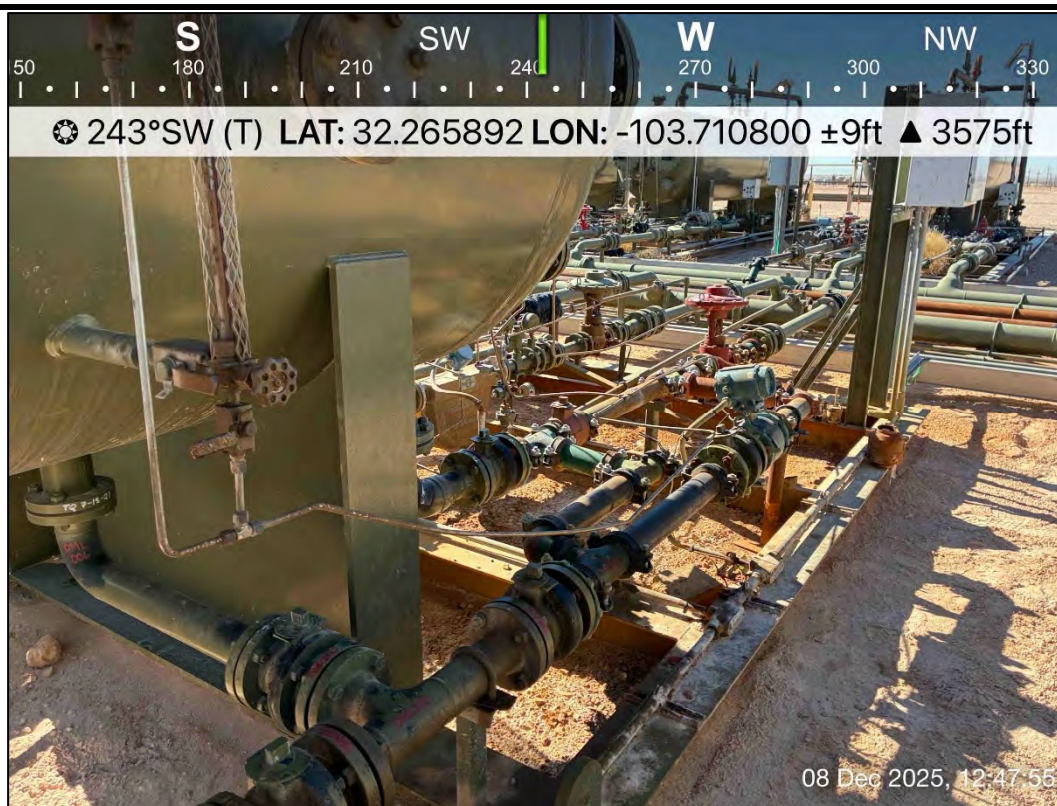
PHOTO 2: Southwestern view during site assessment activities for nAPP2525125732. 12/8/2025

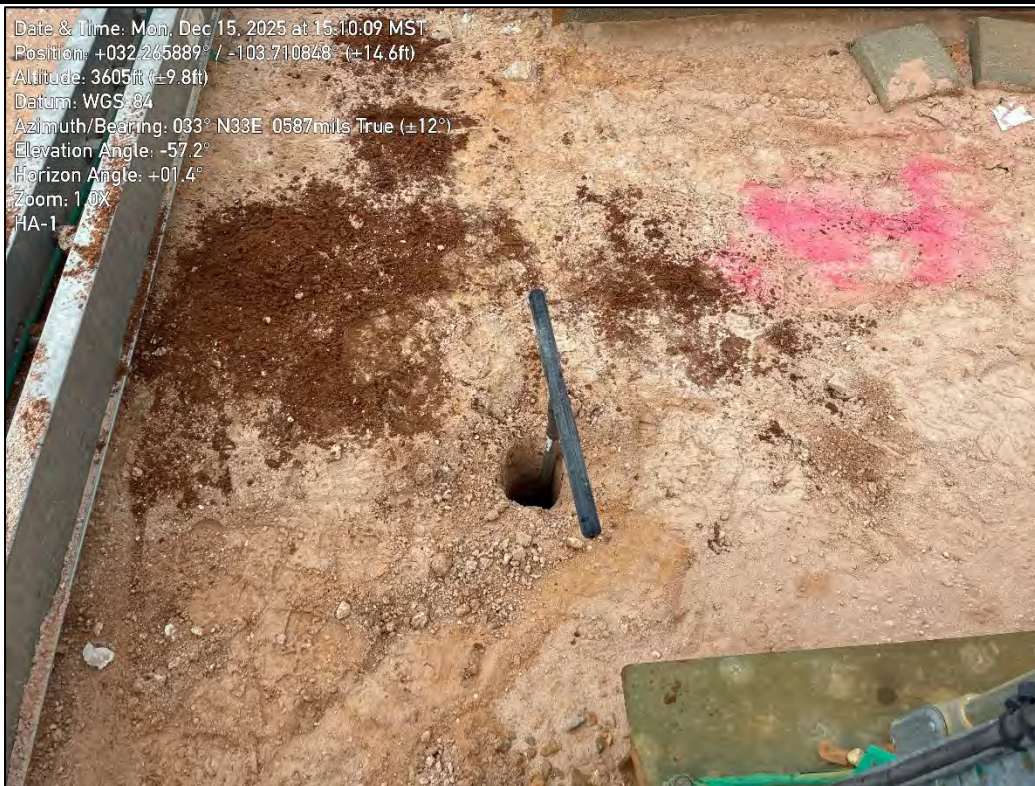
PHOTO 3: Northeastern view during delineation activities of nAPP2525125732. 12/15/2025

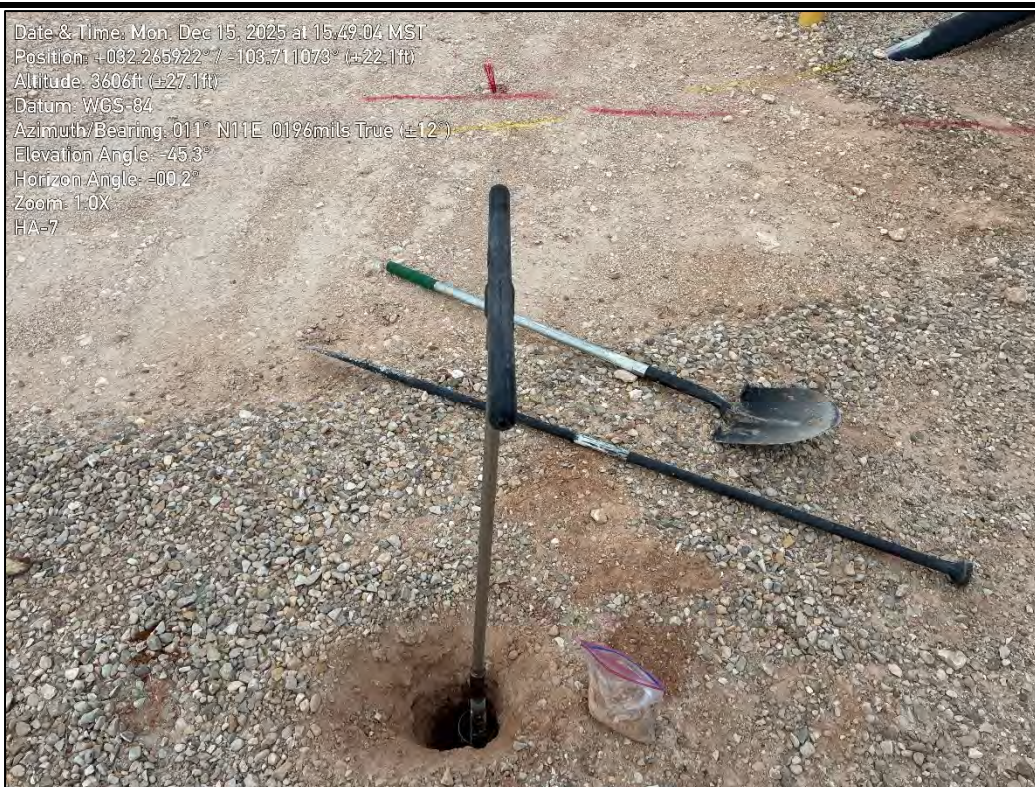
PHOTO 4: Northeastern view during delineation activities of nAPP2525125732. 12/15/2025

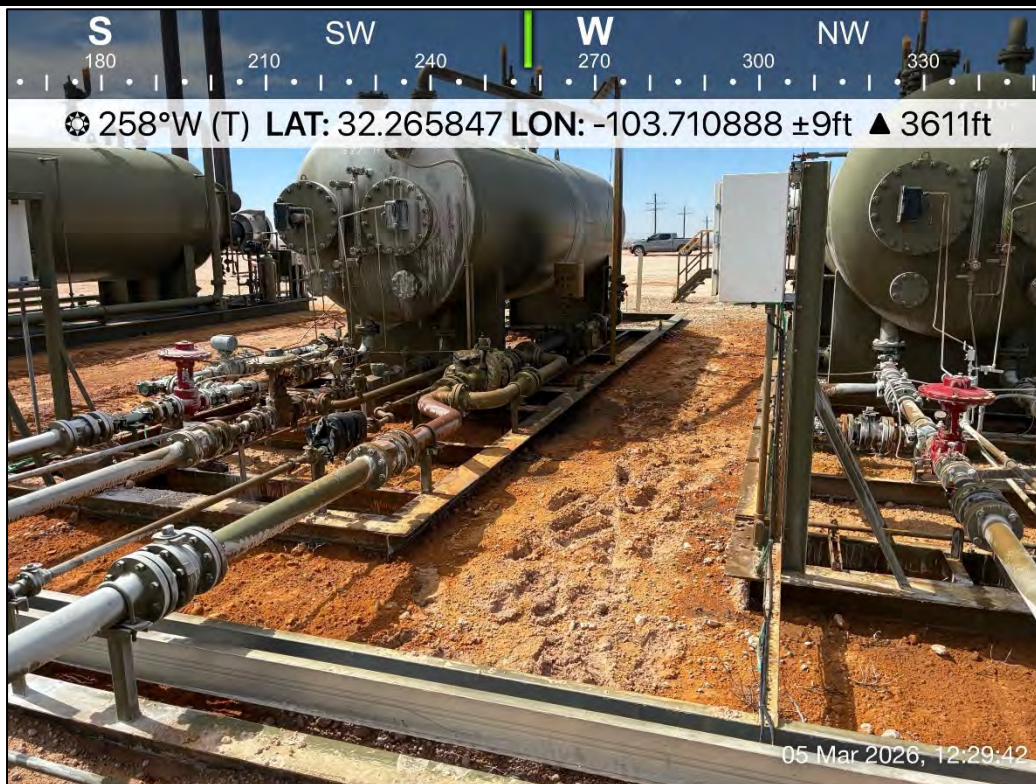
PHOTO 5: Southwestern view during site assessment activities for nAPP2606434775. 3/5/2026

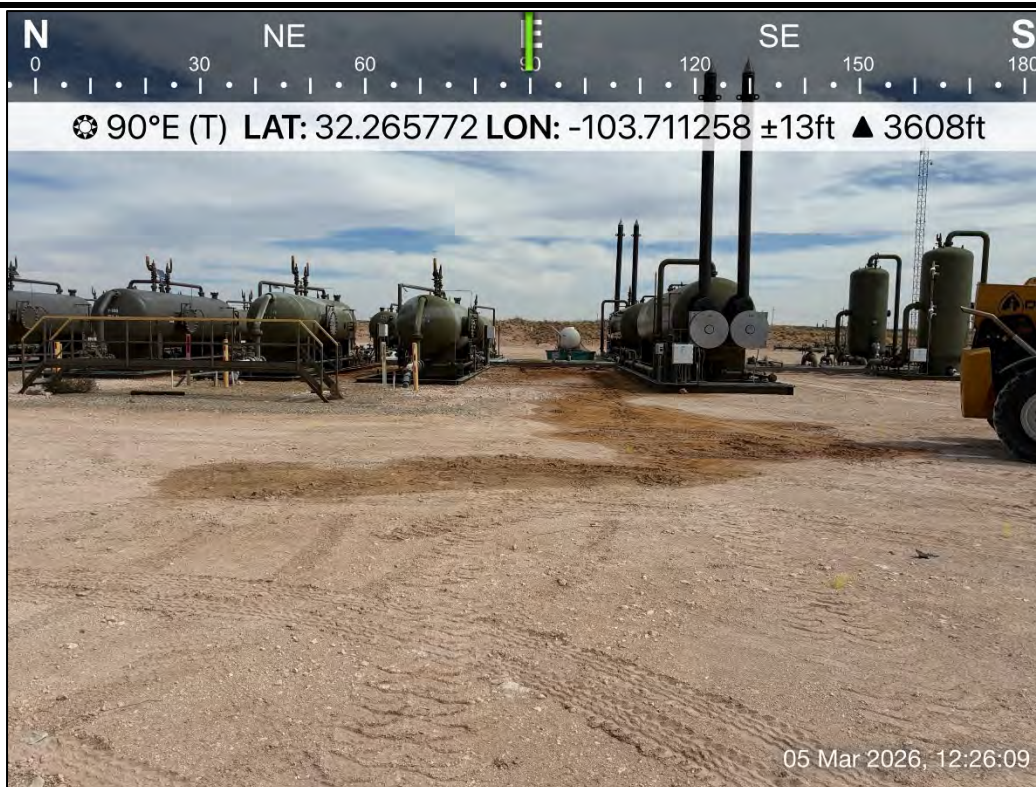
PHOTO 6: Eastern view during site assessment activities for nAPP2606434775. 3/5/2026

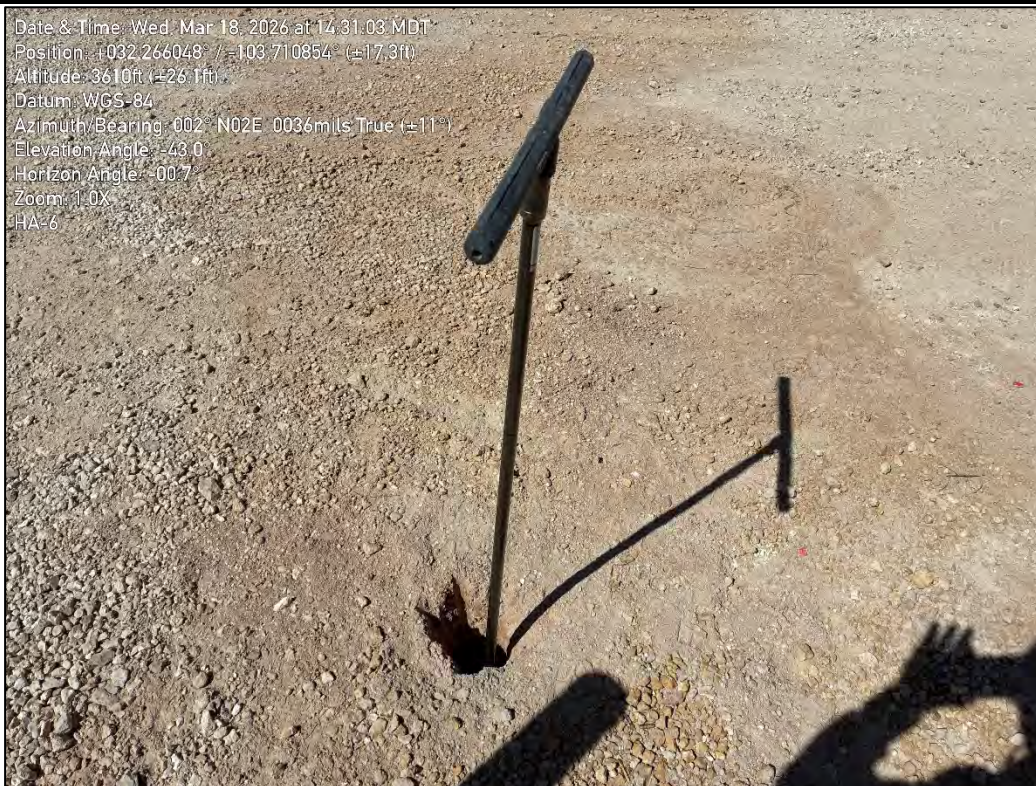
PHOTO 7: Northeastern view during delineation activities of nAPP2606434775. 3/18/2026

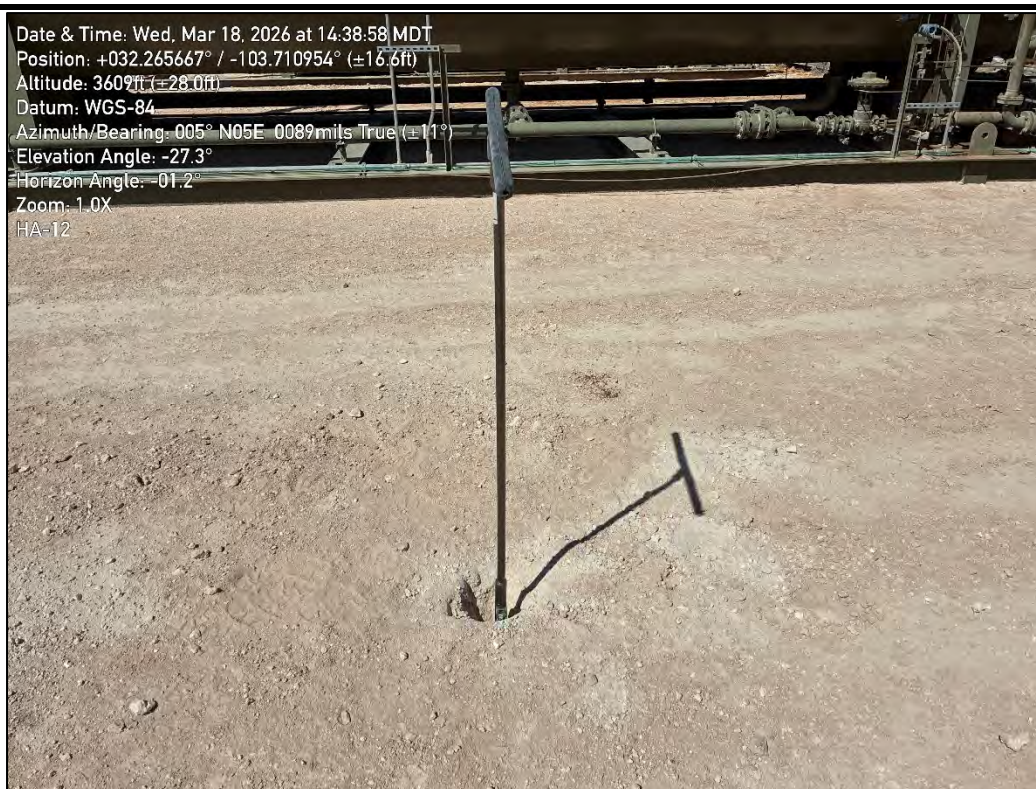
PHOTO 8: Northeastern view during delineation activities of nAPP2606434775. 3/18/2026

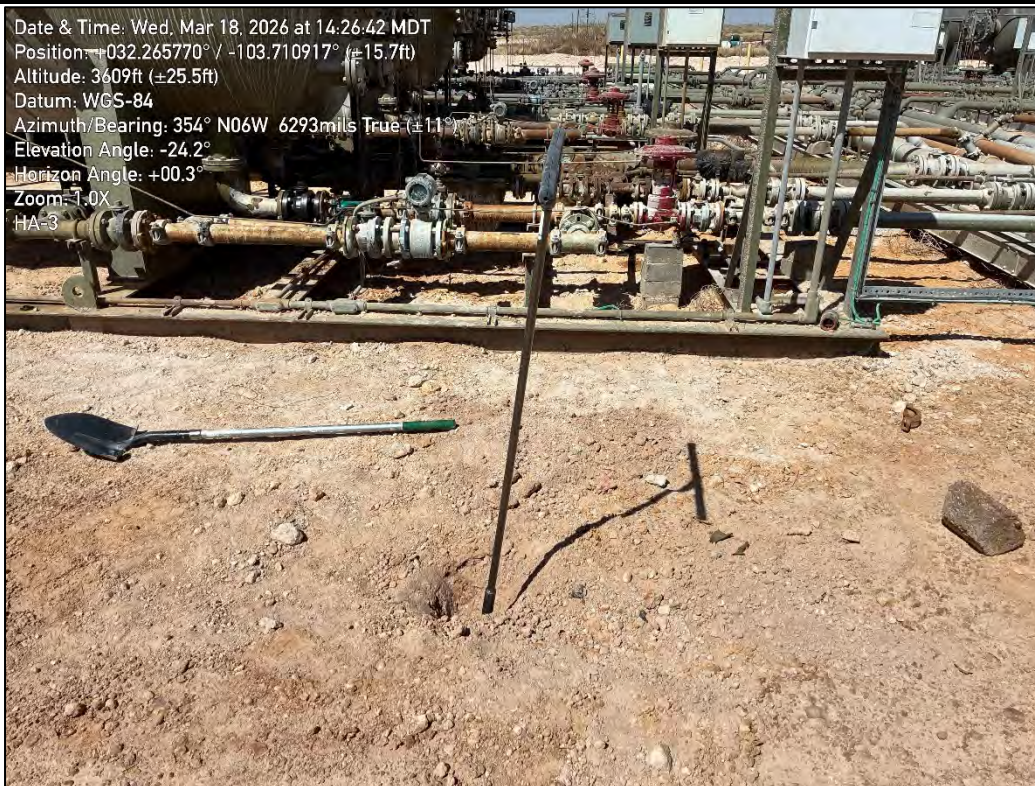
PHOTO 9: Northwestern view during delineation activities of nAPP2606434775. 3/18/2026

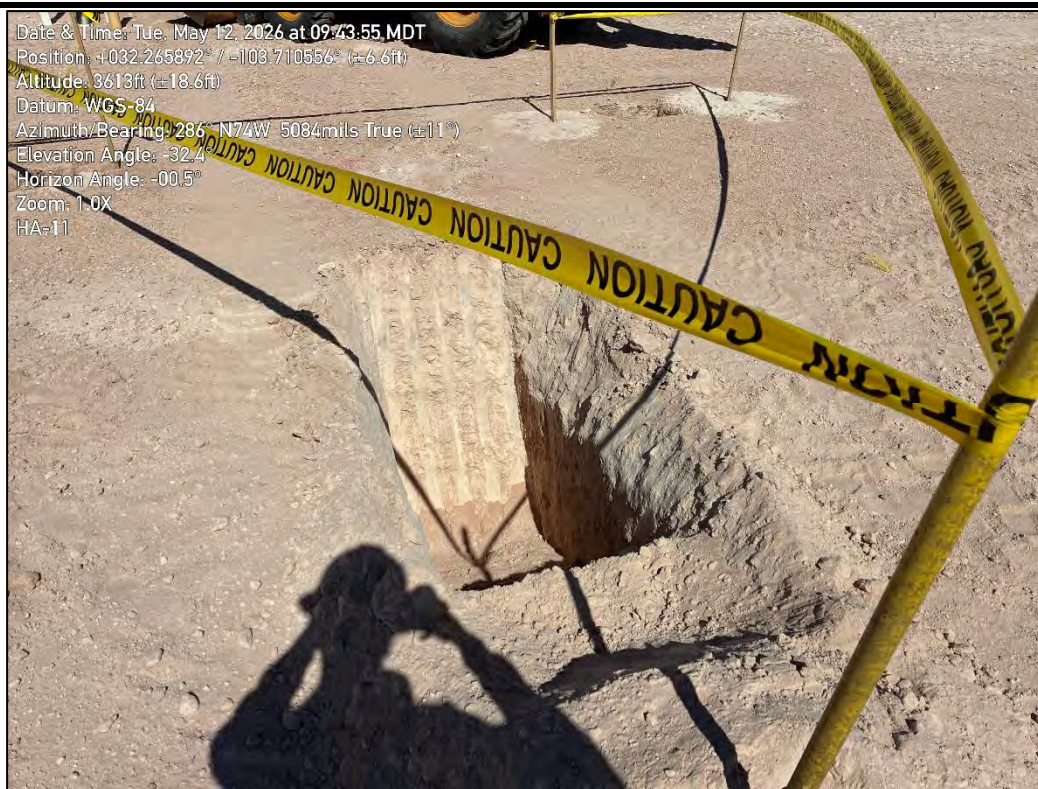
PHOTO 10: Northwestern view during continued delineation activities of nAPP2525125732. 5/12/2026

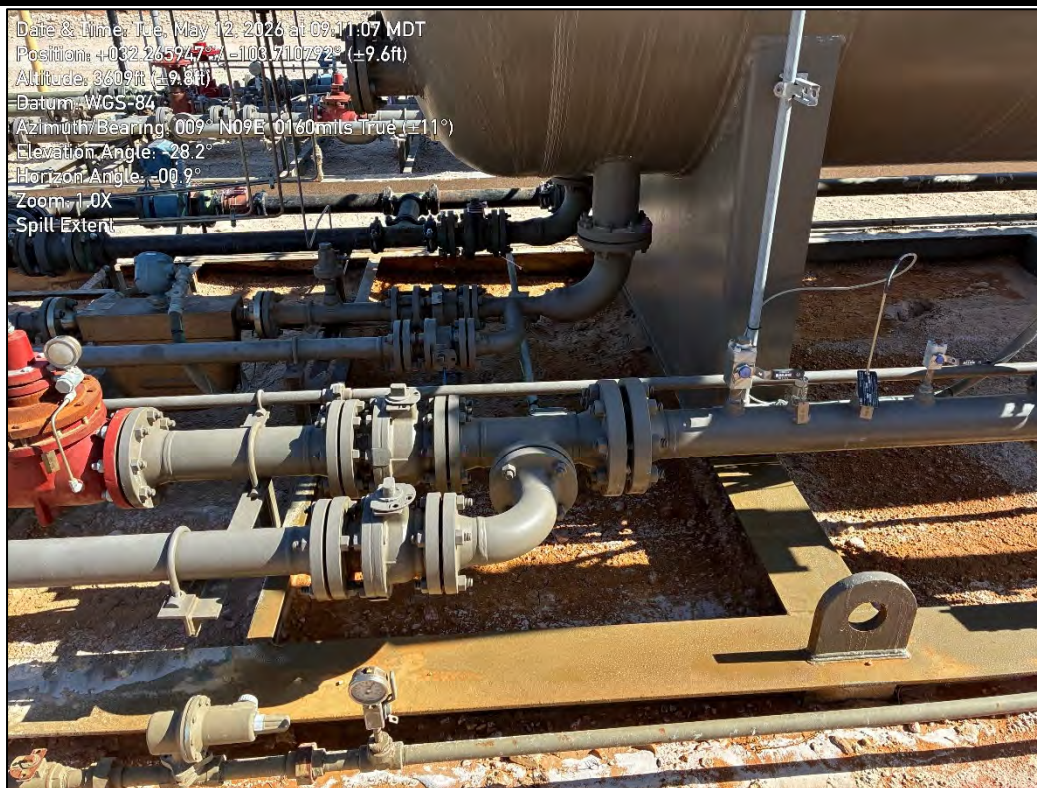
PHOTO 11: Southwestern view during site assessment activities for nAPP2613145609. 5/12/2026

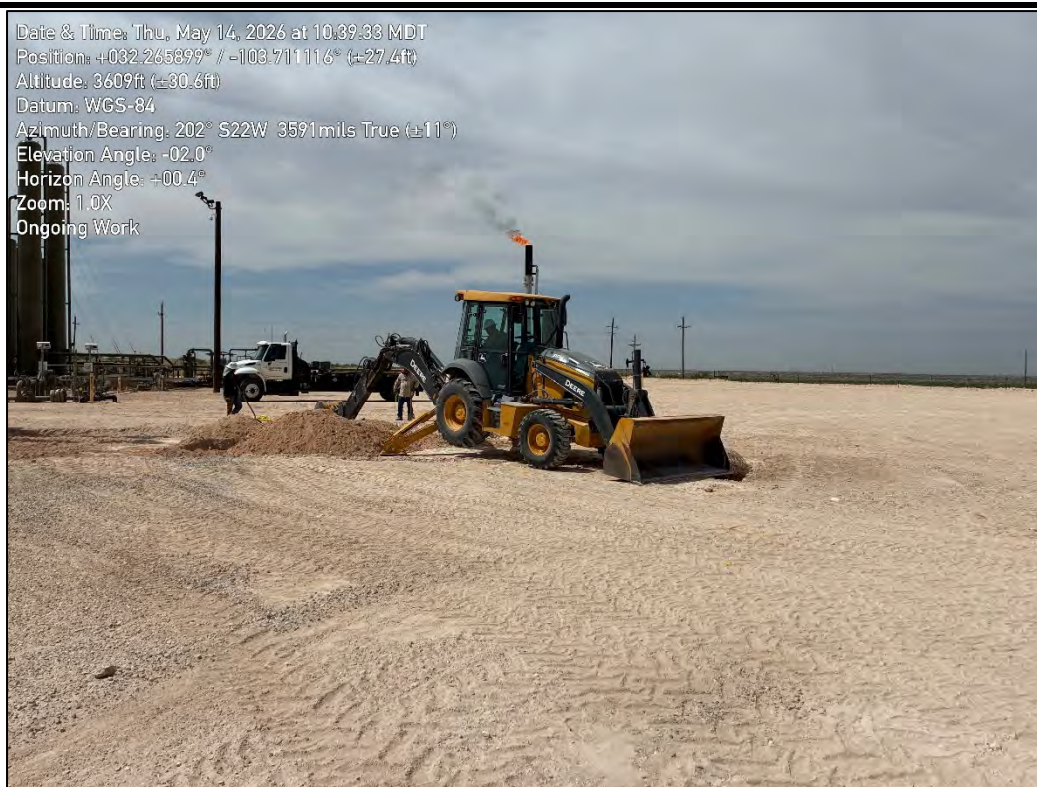
PHOTO 12: Southwestern view during excavation activities. 5/14/2026

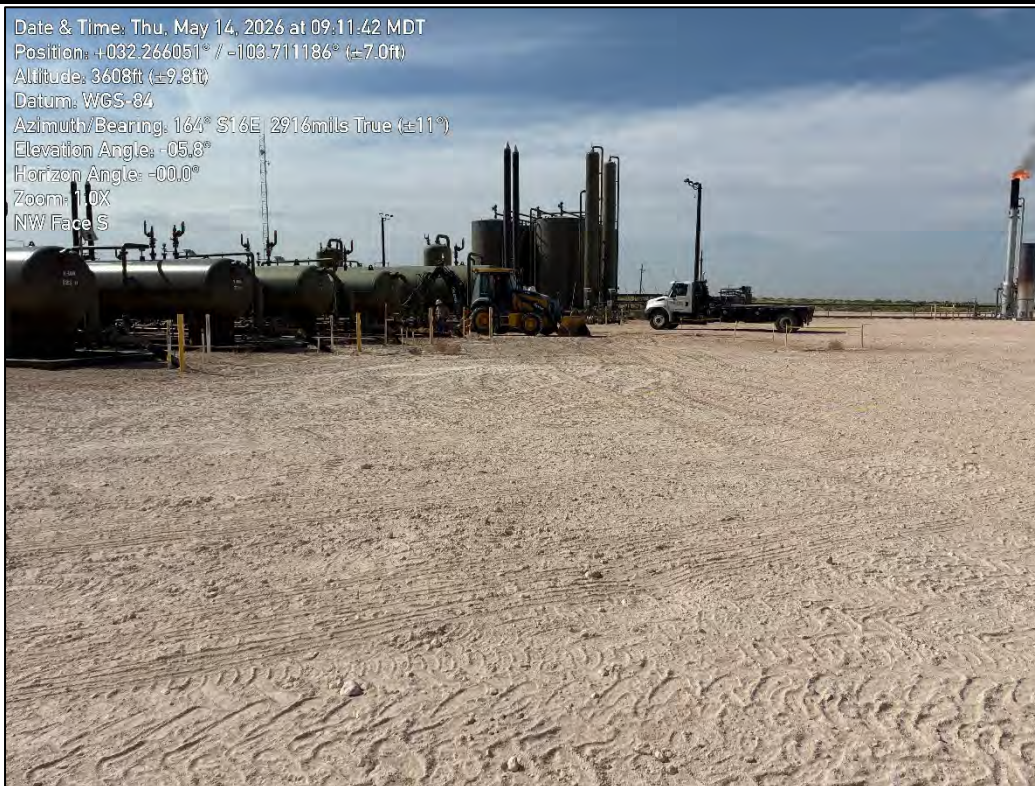
PHOTO 13: Southeastern view during excavation activities. 5/14/2026

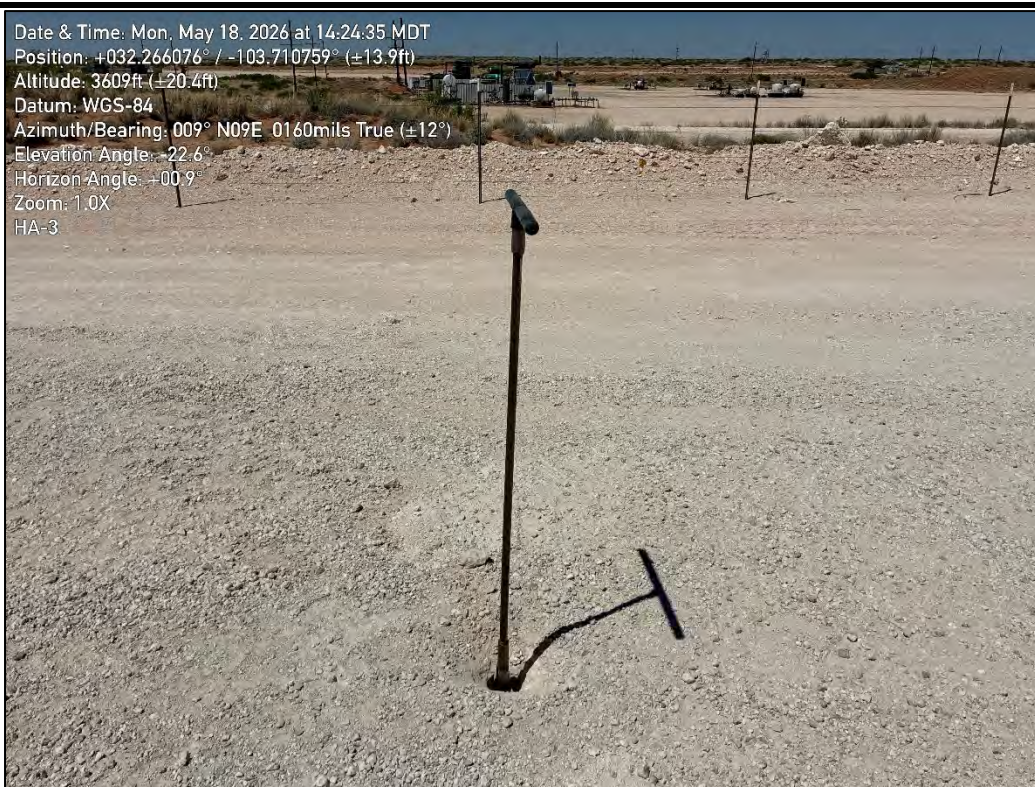
PHOTO 14: Northeastern view during delineation activities of nAPP2613145609. 5/18/2026

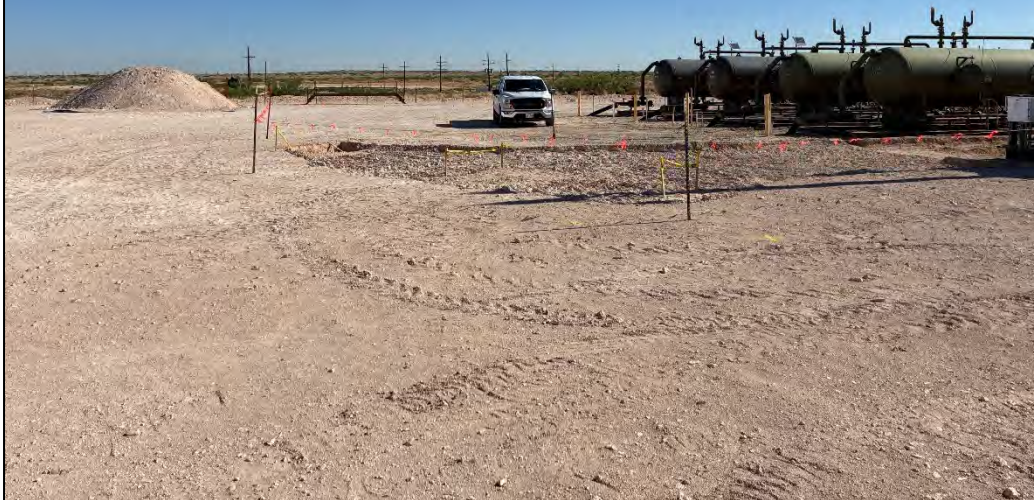
PHOTO 15: Northeastern view of excavation extent. 5/18/2026

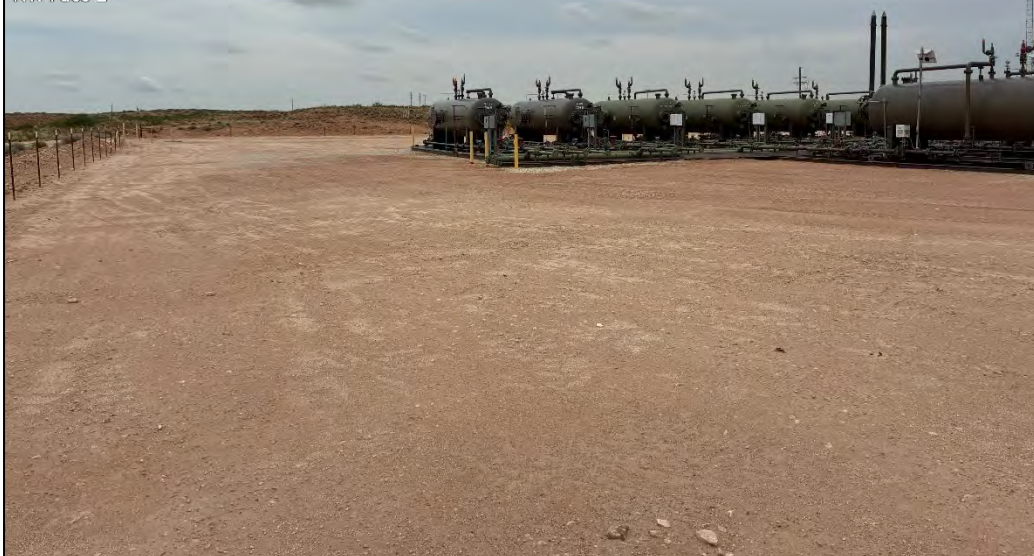
PHOTO 16: Southeastern view following restoration activities. 6/3/2026

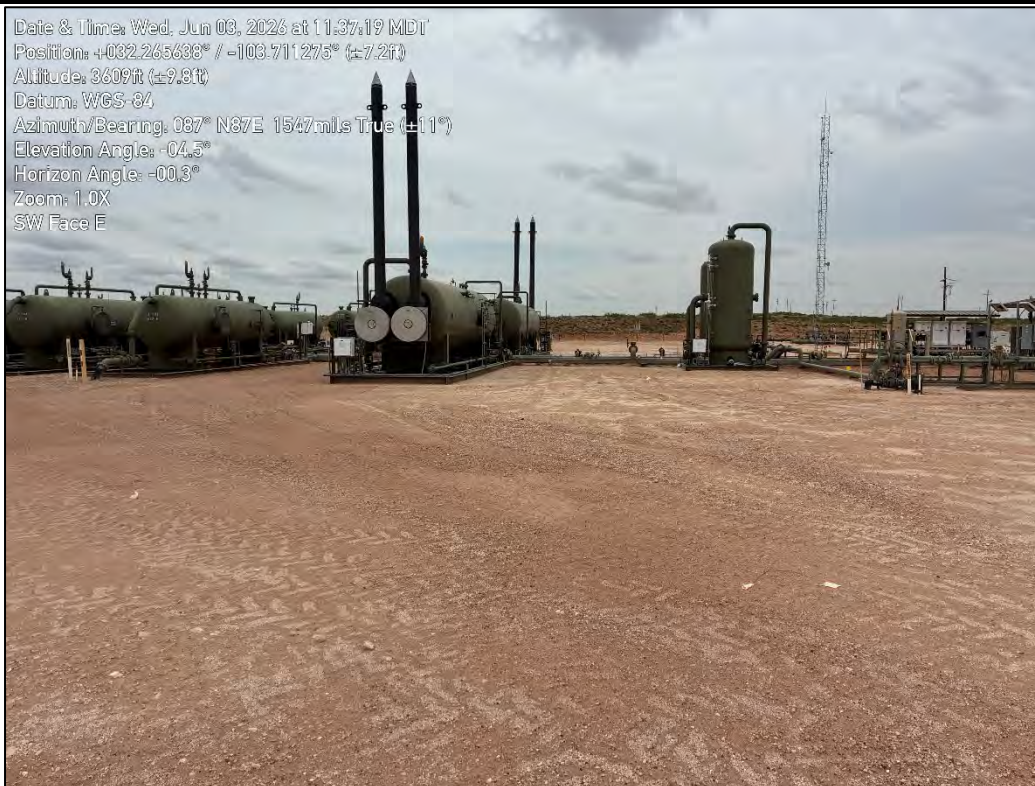
PHOTO 17: Northeastern view following restoration activities. 6/3/2026

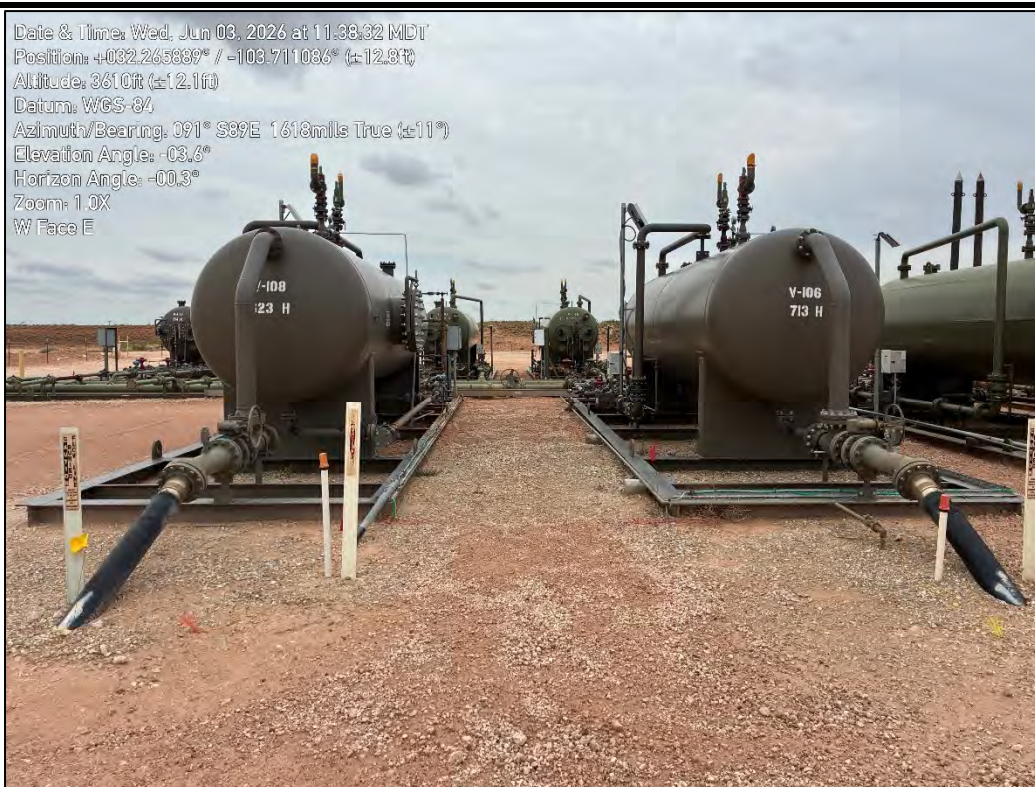
PHOTO 18: Southeastern view following restoration activities. 6/3/2026

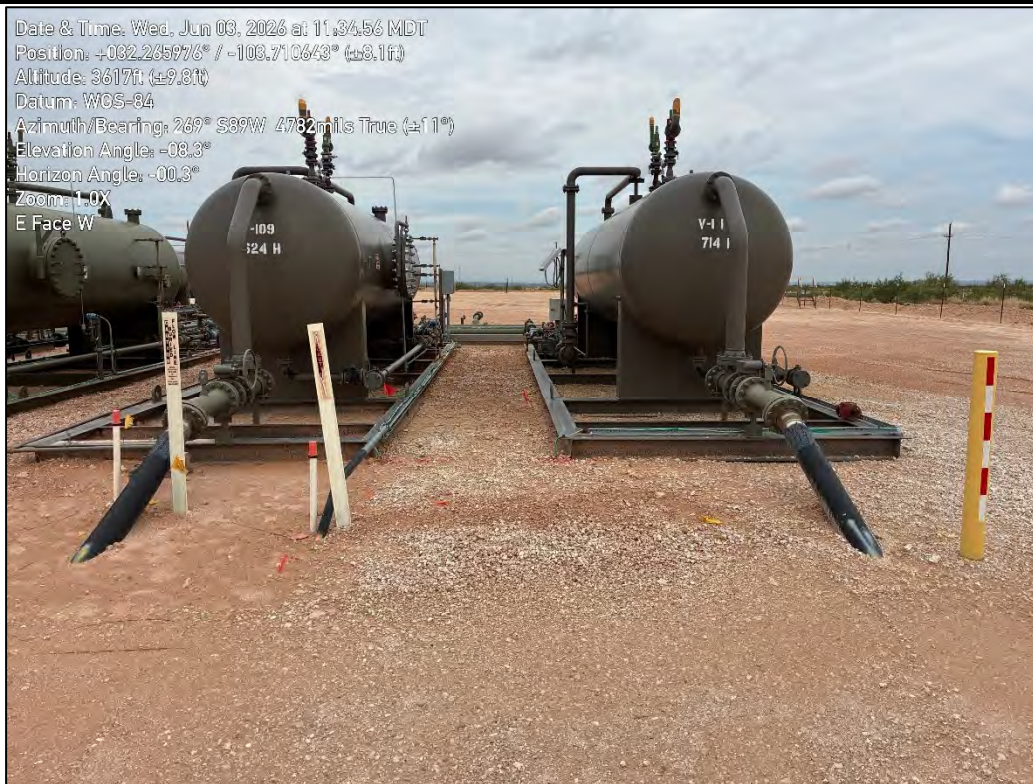
PHOTO 19: Southwestern view following restoration activities. 6/3/2026
