Pit, Closed-Loop System, Below-Grade Tank, or Proposed Alternative Method Permit or Closure Plan Application

From: Patricia Campbell
Sent: Tuesday, April 27, 2021 1:24 PM
To: OCD.Enviro@state.nm.us
Cc: CORY.SMITH@STATE.NM.US; Steven Moskal; Don Buller; Julie Best
Subject: SIMCOE LLC - Shane Gas Com 001 Below Grade Tank (BGT) Closure

BELOW-GRADE TANK CLOSURE PLAN

SHANE GAS COM #001Tank ID: A

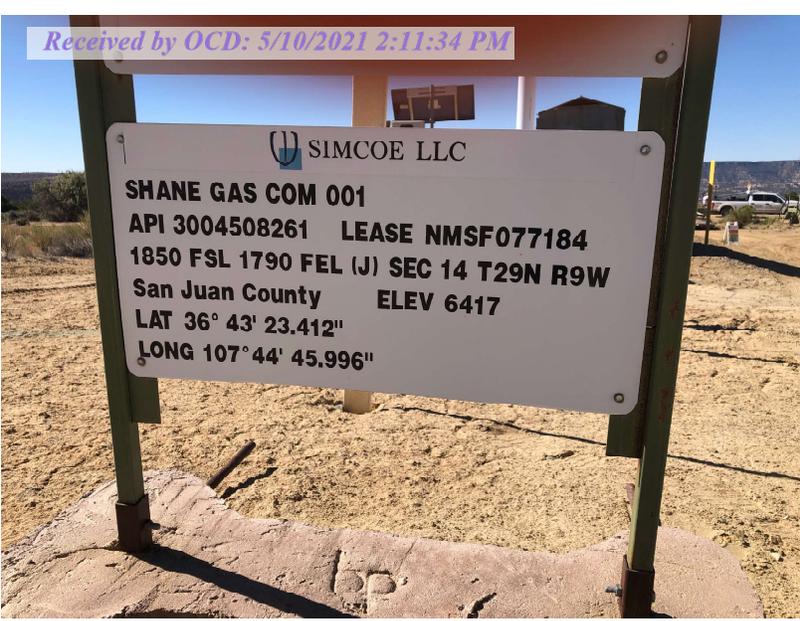
Well sign on March 30th, 2021

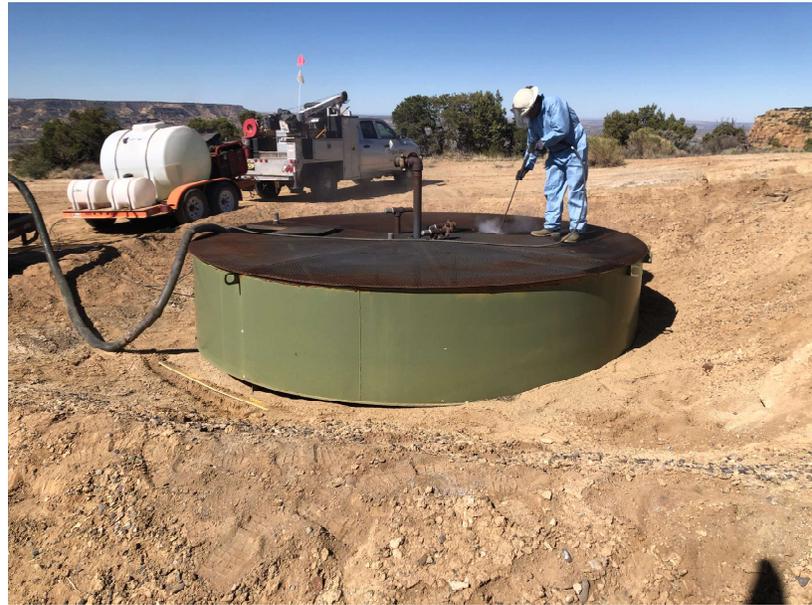
Below grade tank being cleaned prior to removal.

All liquids and/or sludge within the BGT were removed and sent to one of the above NMOCD approved facilities for disposal.

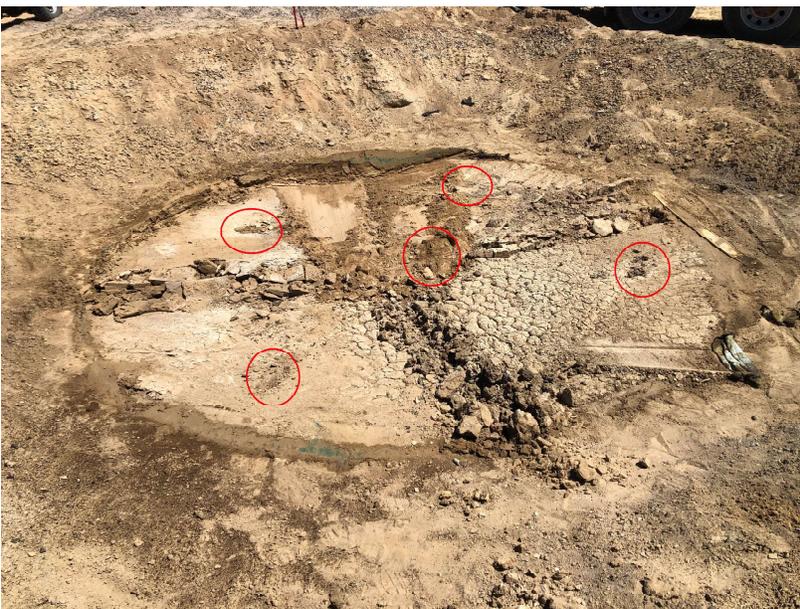
Five point composite sample location points

Constituents	Testing Method	Release Verification (mg/Kg)	Composite Results
Benzene	US EPA Method SW-846 8021B or 8260B	0.2	<0.024
Total BTEX	US EPA Method SW-846 8021B or 8260B	50	<0.098
TPH	US EPA Method SW-846 418.1	100	<47
Chlorides	US EPA Method 300.0 or 4500B	250 or background	190

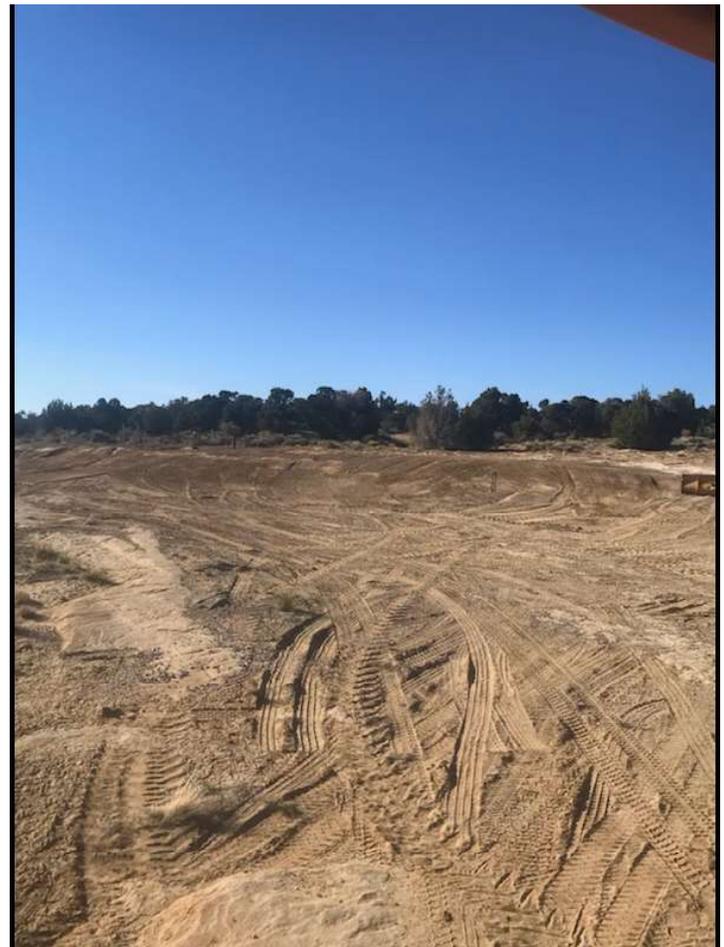
Area of BGT following backfilling.

10. SIMCOE shall reclaim the BGT location and all areas associated with the BGT including associated access roads to a safe and stable condition that blends with the surrounding undisturbed area. SIMCOE shall substantially restore the impacted surface area to the condition that existed prior to oil and gas operations by placement of the soil cover as provided in Subsection H of 19.15.17.13 NMAC, re-contour the location and associated areas to a contour that approximates the original contour and blends with the surrounding topography and re-vegetate according to Subsection I of 19.15.17.13 NMAC.
