Pit, Below-Grade Tank, or
Proposed Alternative Method Permit or Closure Plan Application

**Hilcorp Energy Company
San Juan Basin
Below Grade Tank Closure Report**

Lease Name: Hanks 10

API No.: 30-045-06764

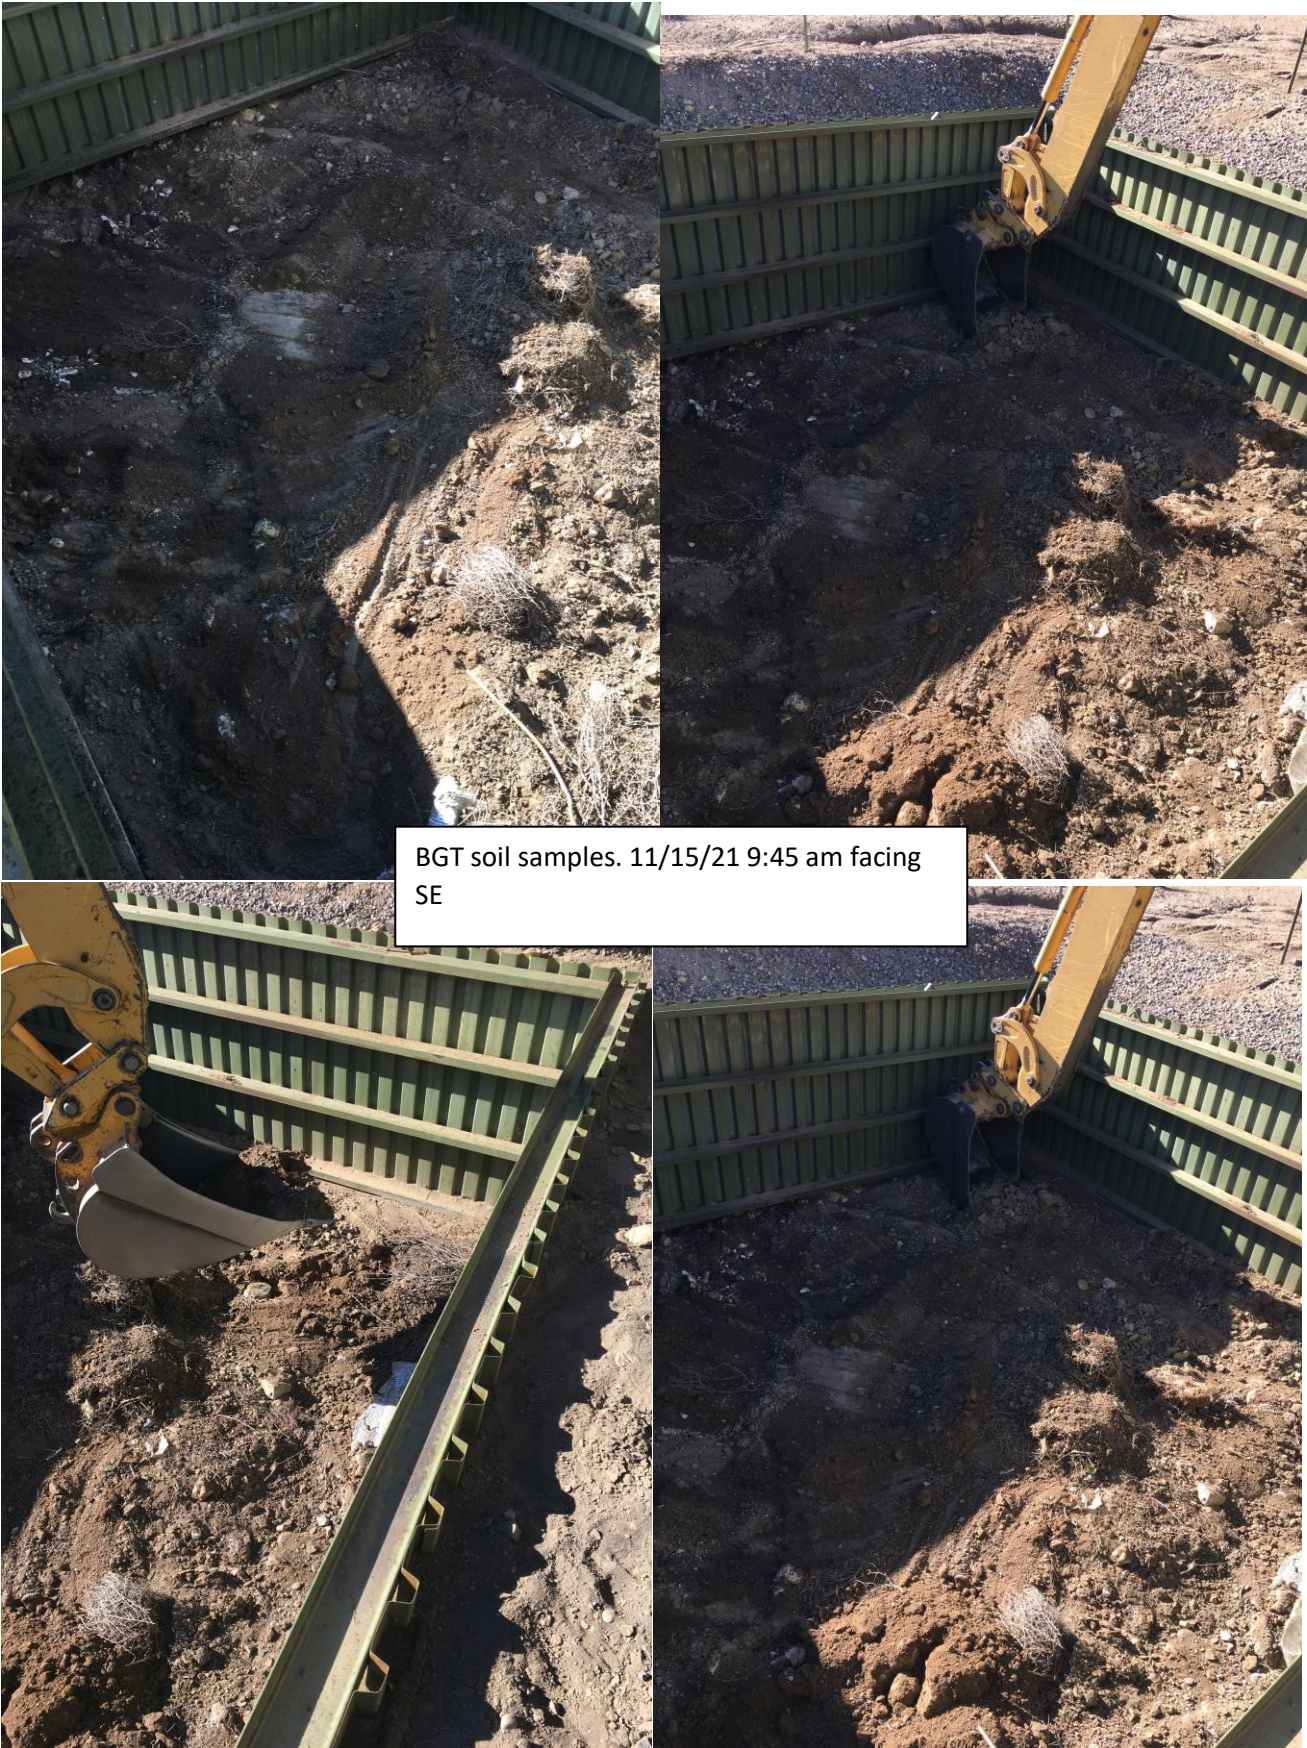
BGT before samples were taken. 11/15/21
9:20 am facing SE

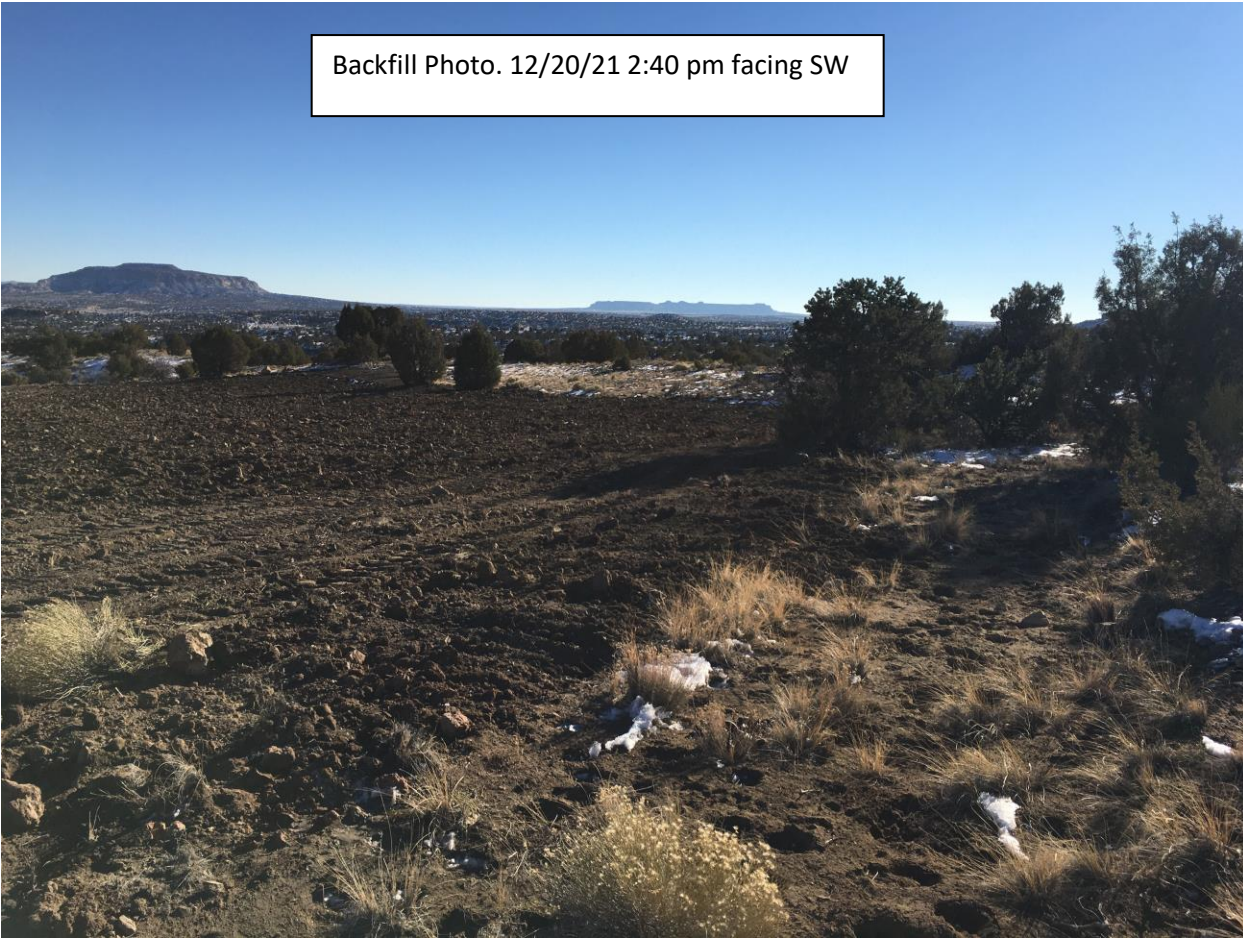
Backfill Photo. 12/20/21 2:40 pm facing SW

The below-grade tank area passed all requirements of Paragraph (4) of Subsection E of 19.15.17.13 NMAC and was backfilled with compacted, non-waste containing, earthen material.

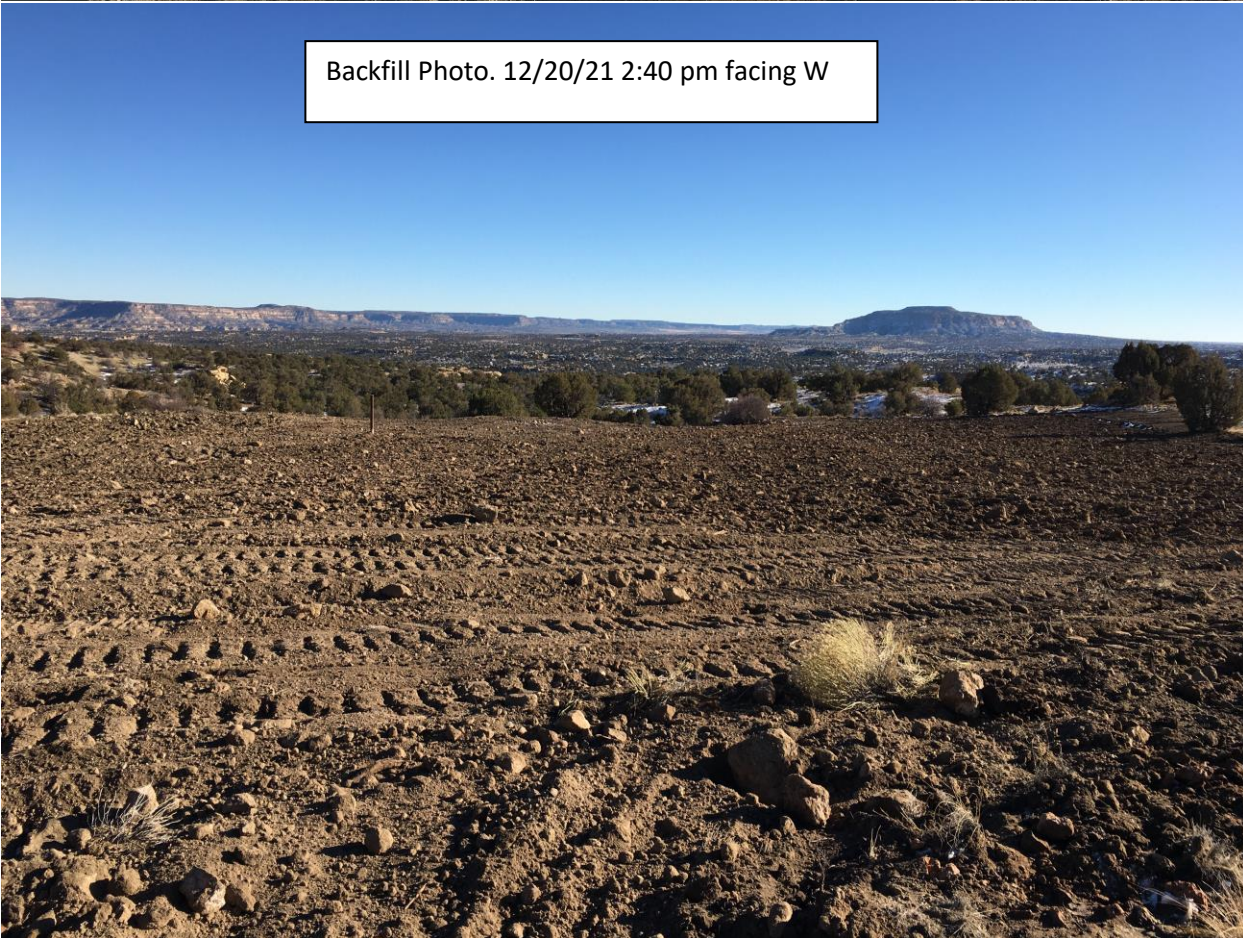
Backfill Photo. 12/20/21 2:40 pm facing W
