Pit, Below-Grade Tank, or
Proposed Alternative Method Permit or Closure Plan Application

1.
Operator: Hilcorp Energy Company OGRID #: 372171
Address: 382 Road 3100 Aztec, NM 87410
Facility or well name: Hughes 10
API Number: 30-045-06763 OCD Permit Number: _____
U/L or Qtr/Qtr N Section 3 Township 27N Range 9W County: San Juan
Center of Proposed Design: Latitude 36.59880 Longitude -107.77604 NAD27
Surface Owner: ☒ Federal ☐ State ☐ Private ☐ Tribal Trust or Indian Allotment

On August 21, 2020 Hilcorp Energy removed a below grade tank (BGT) at the Hughes 10 in accordance with NMAC 19.15.17.13 and the closure plan of the BGT permit for this facility. A five-point composite was taken and submitted to the laboratory for analysis.

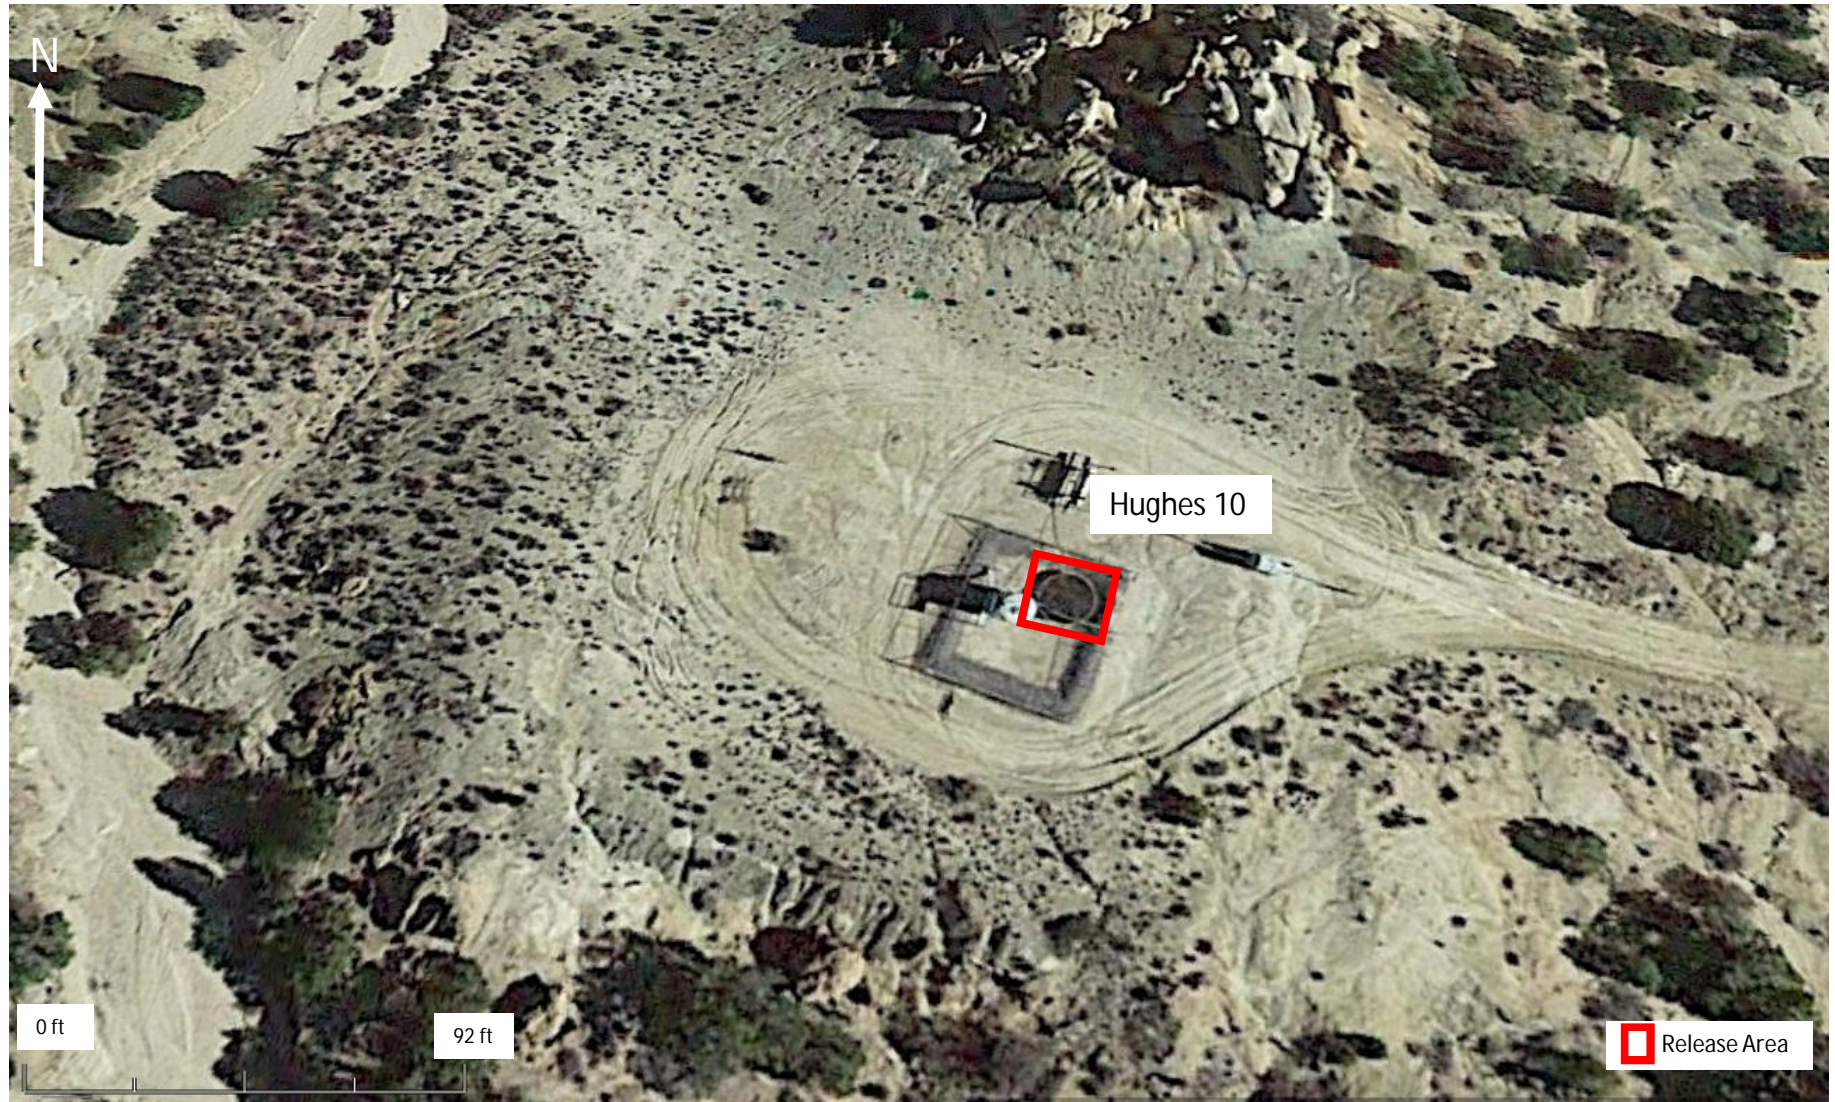
Pipelines in Area

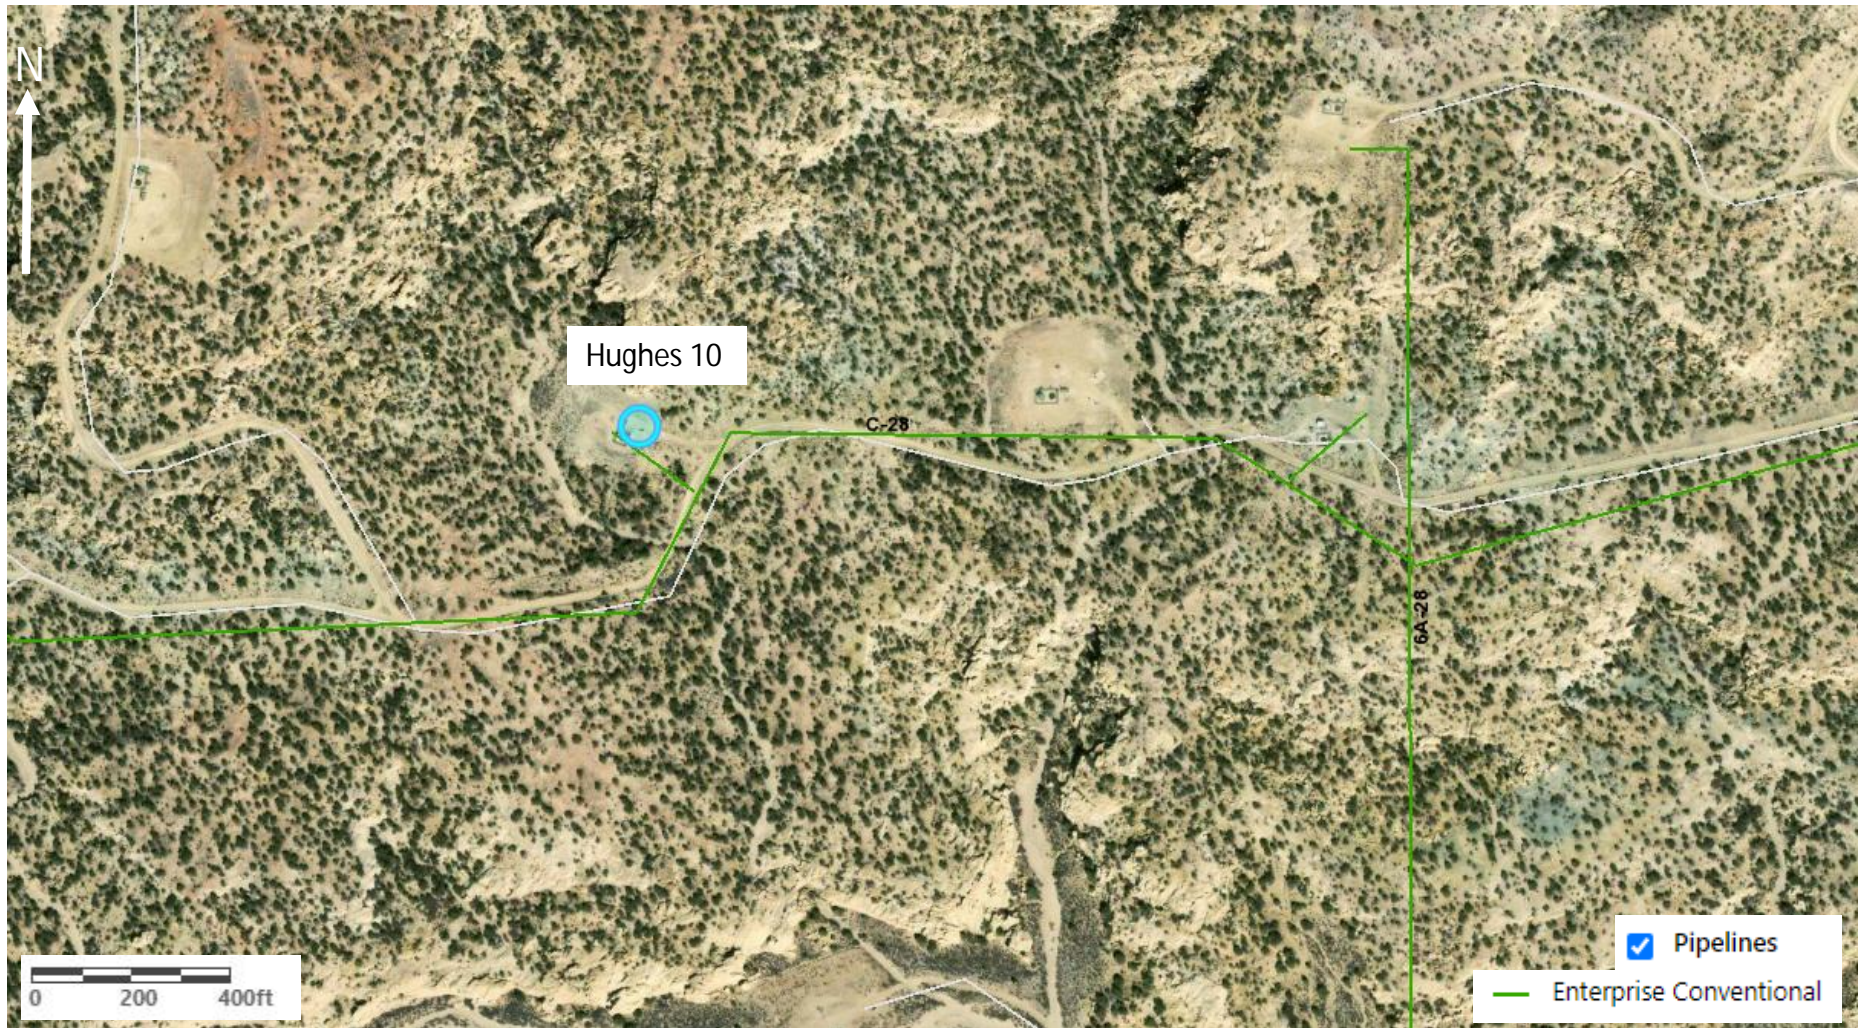
Distance to watercourse

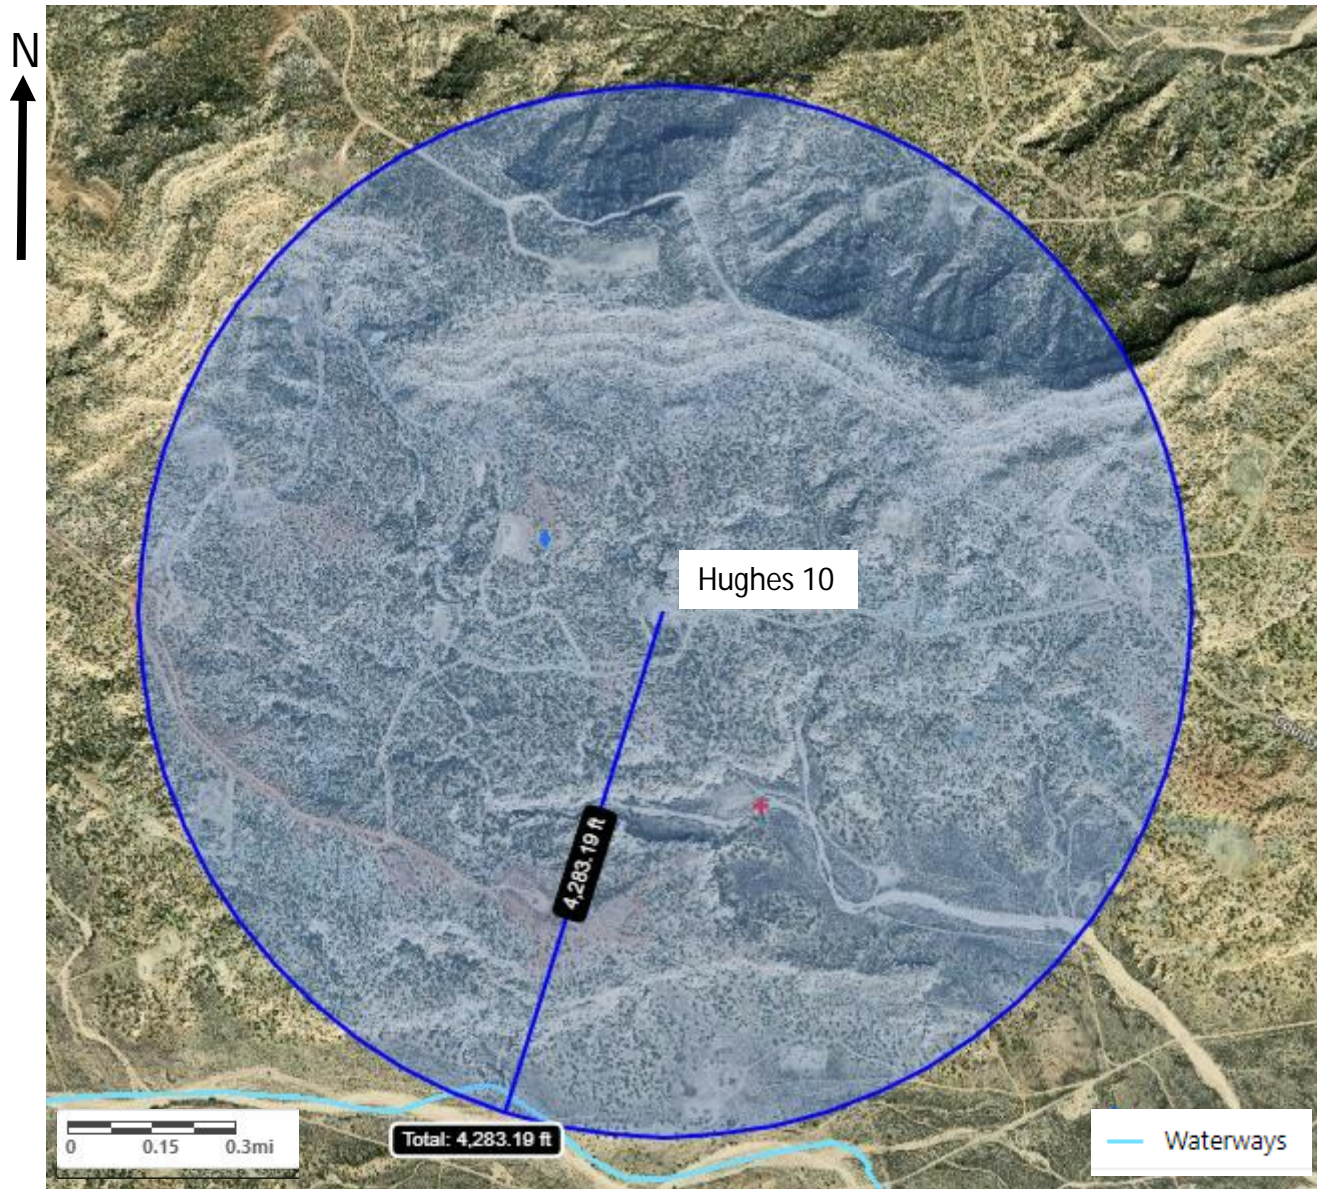
Distance to watercourse approximately 4,283 ft

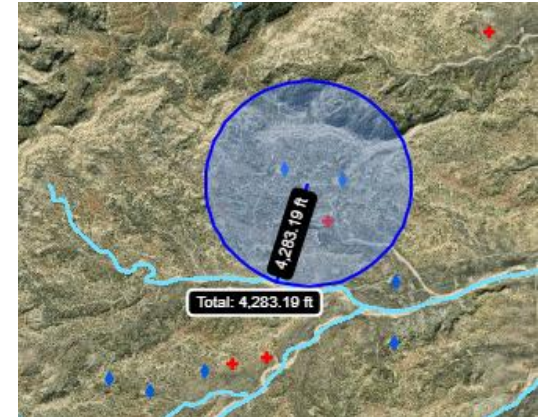
Water sources or courses within ½ mile

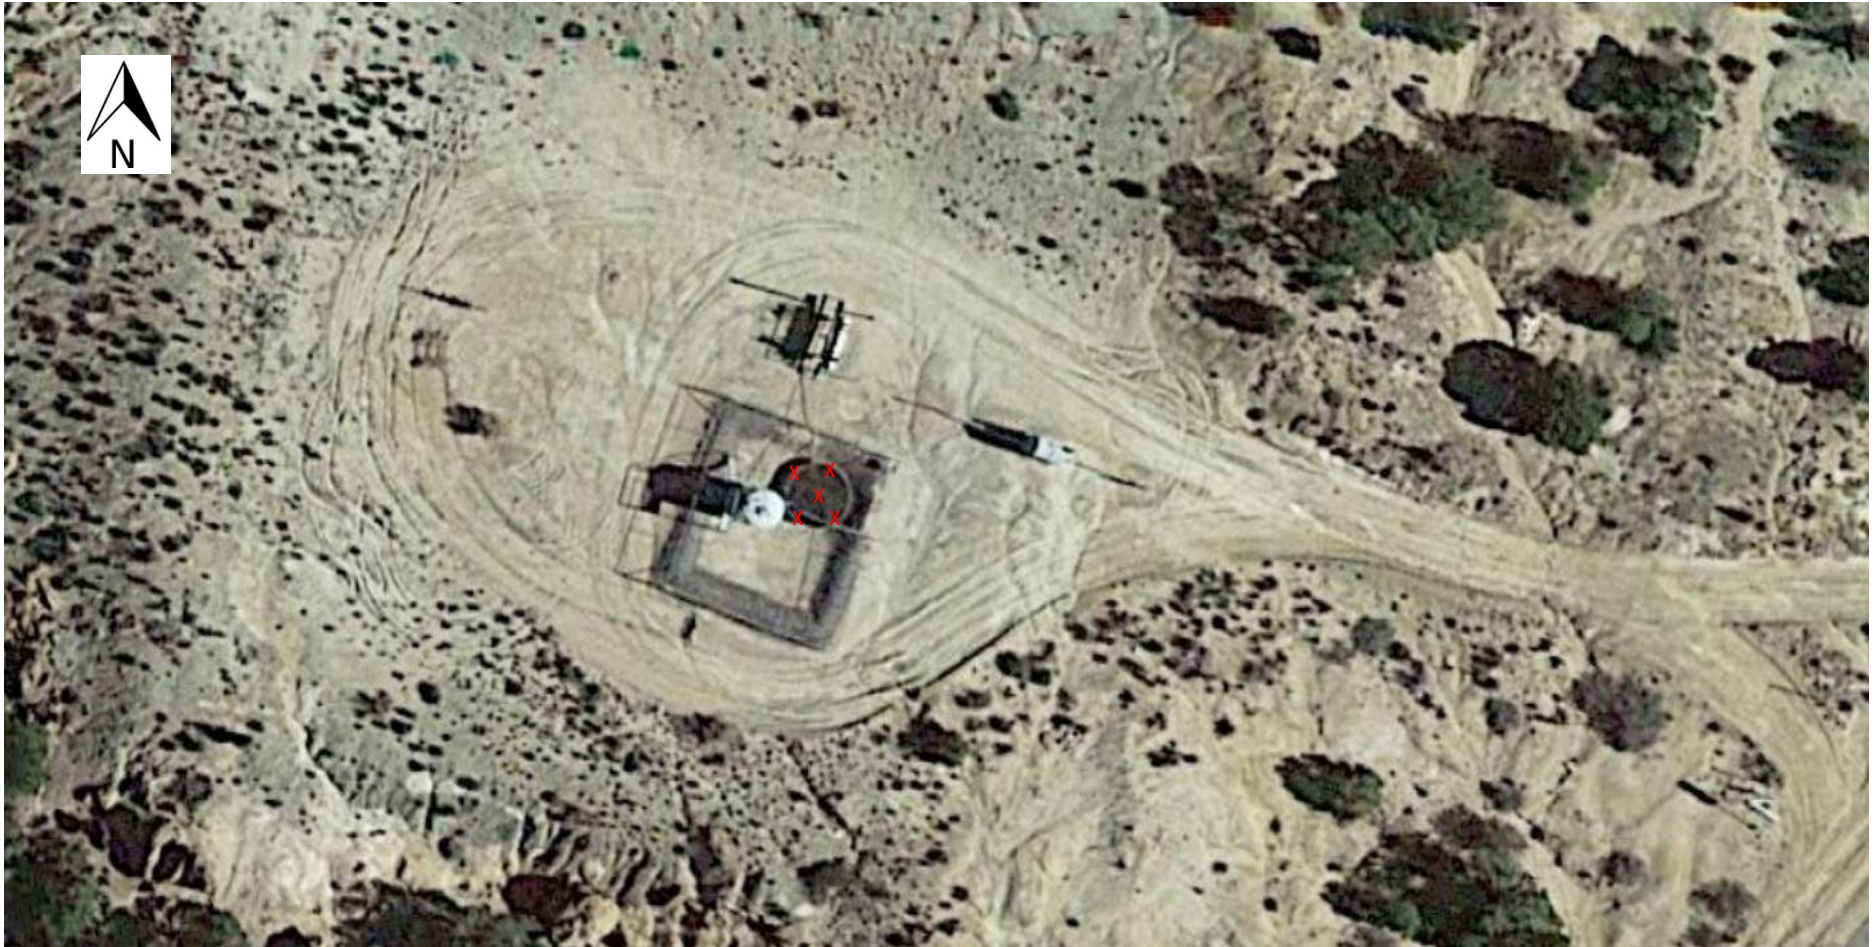
Sample locations/field notes

X Sample Locations

A five point composite sample was taken on 8/21/2020 in accordance with closure plan in the BGT permit application.

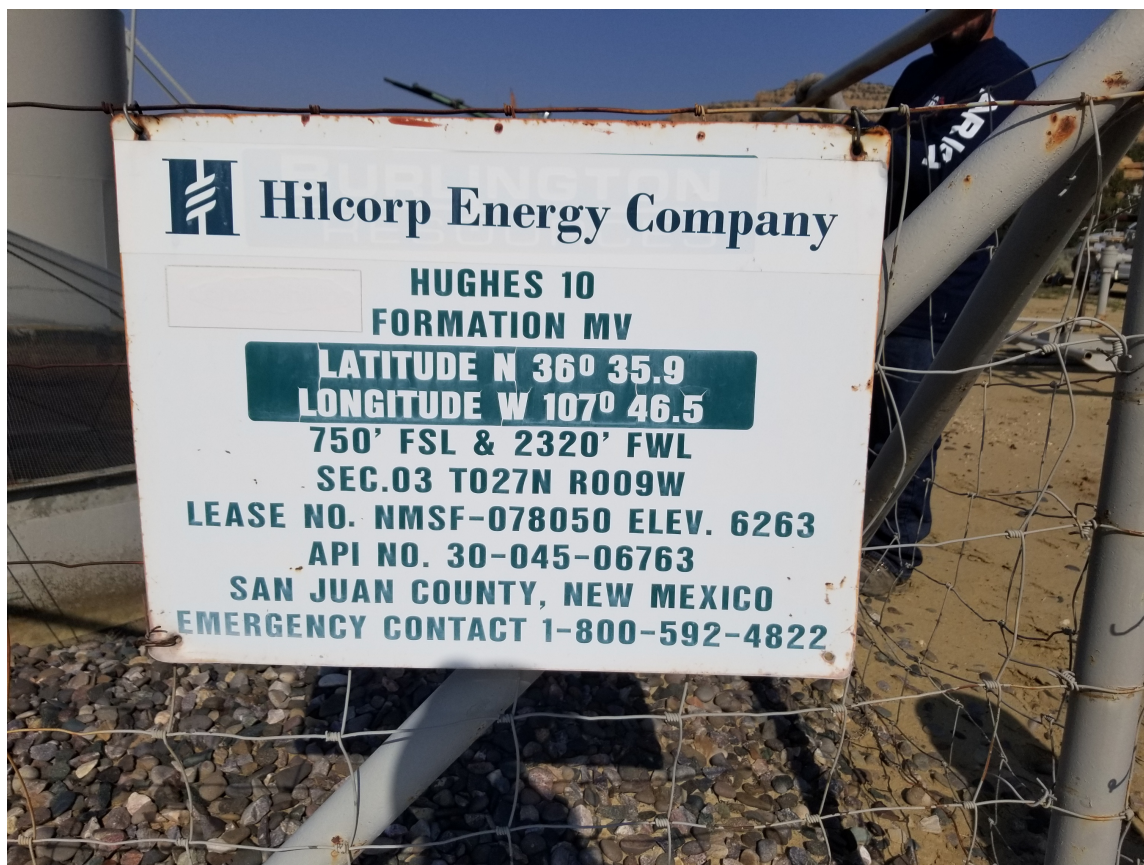
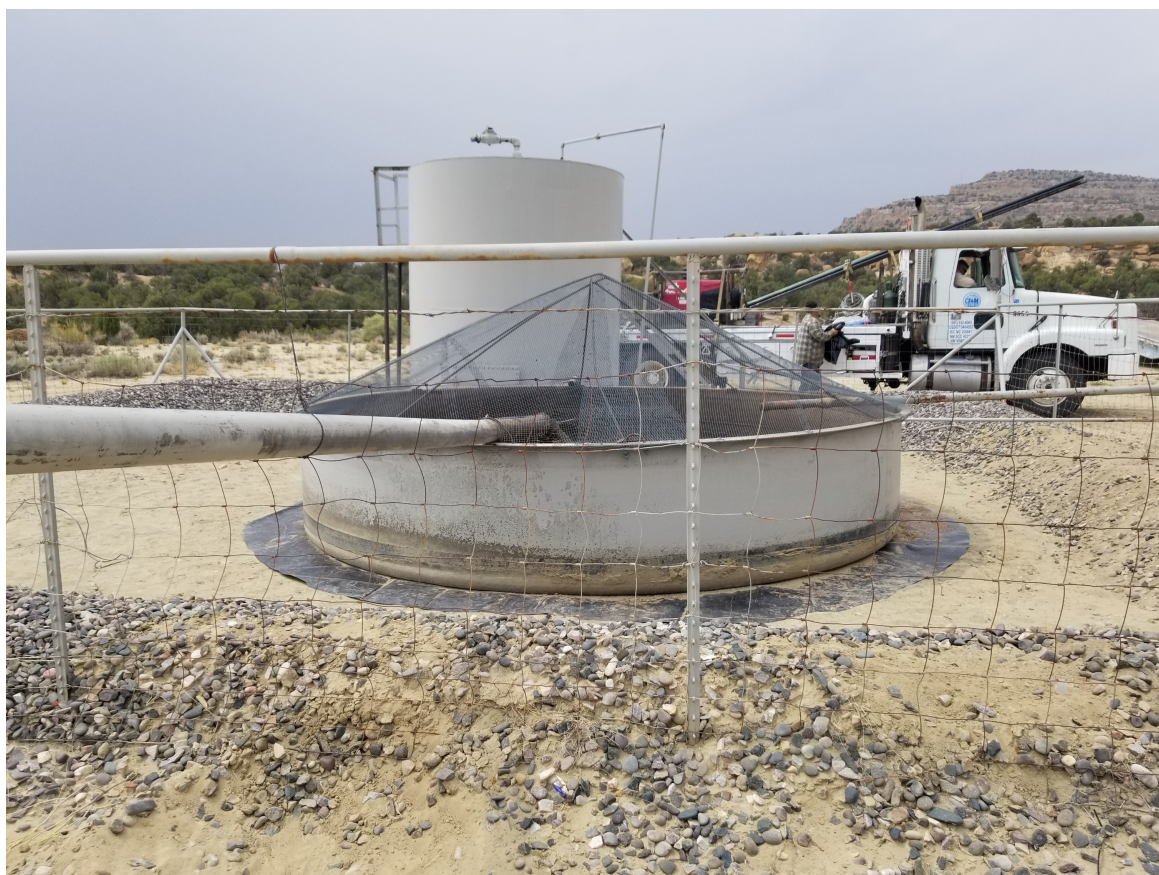
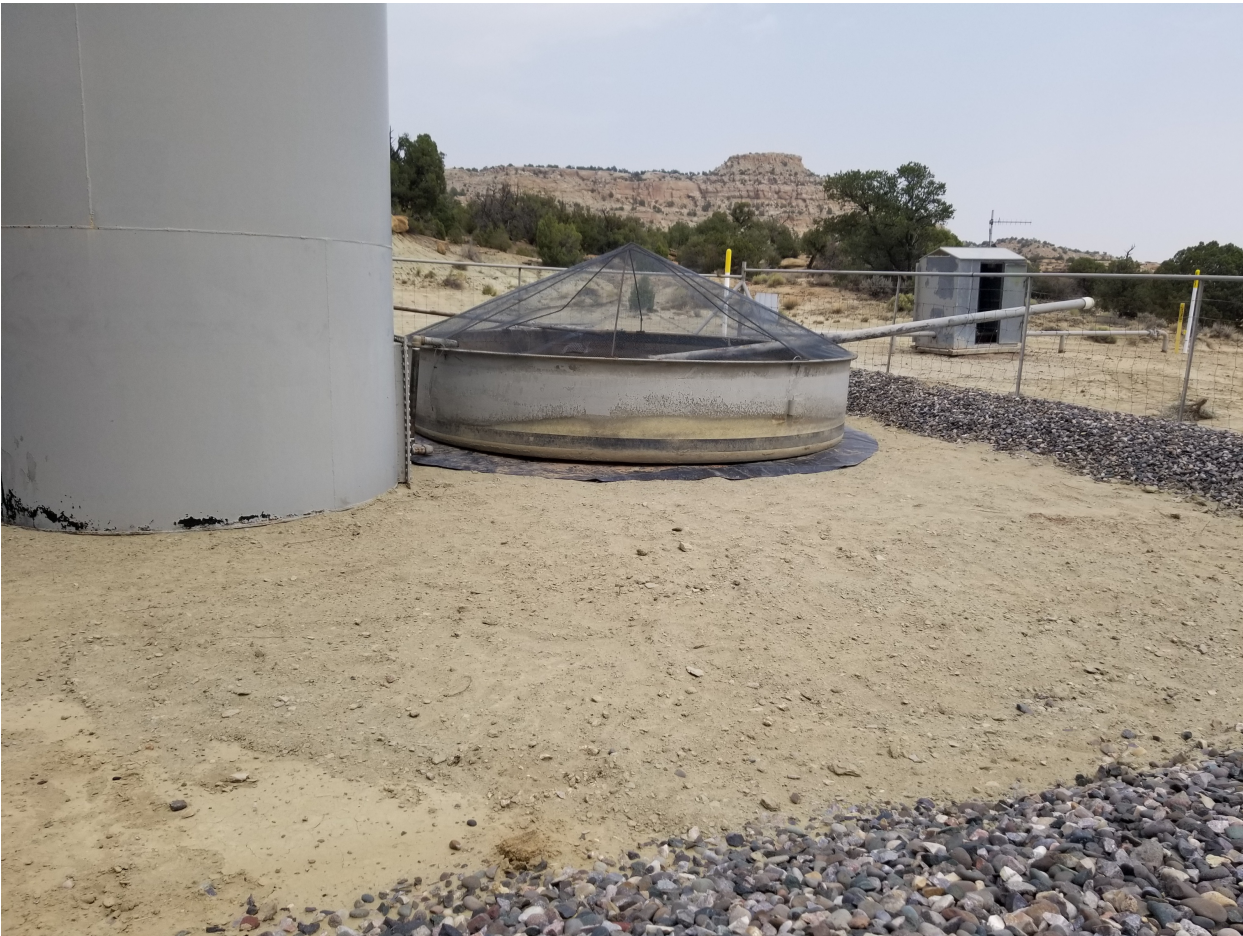
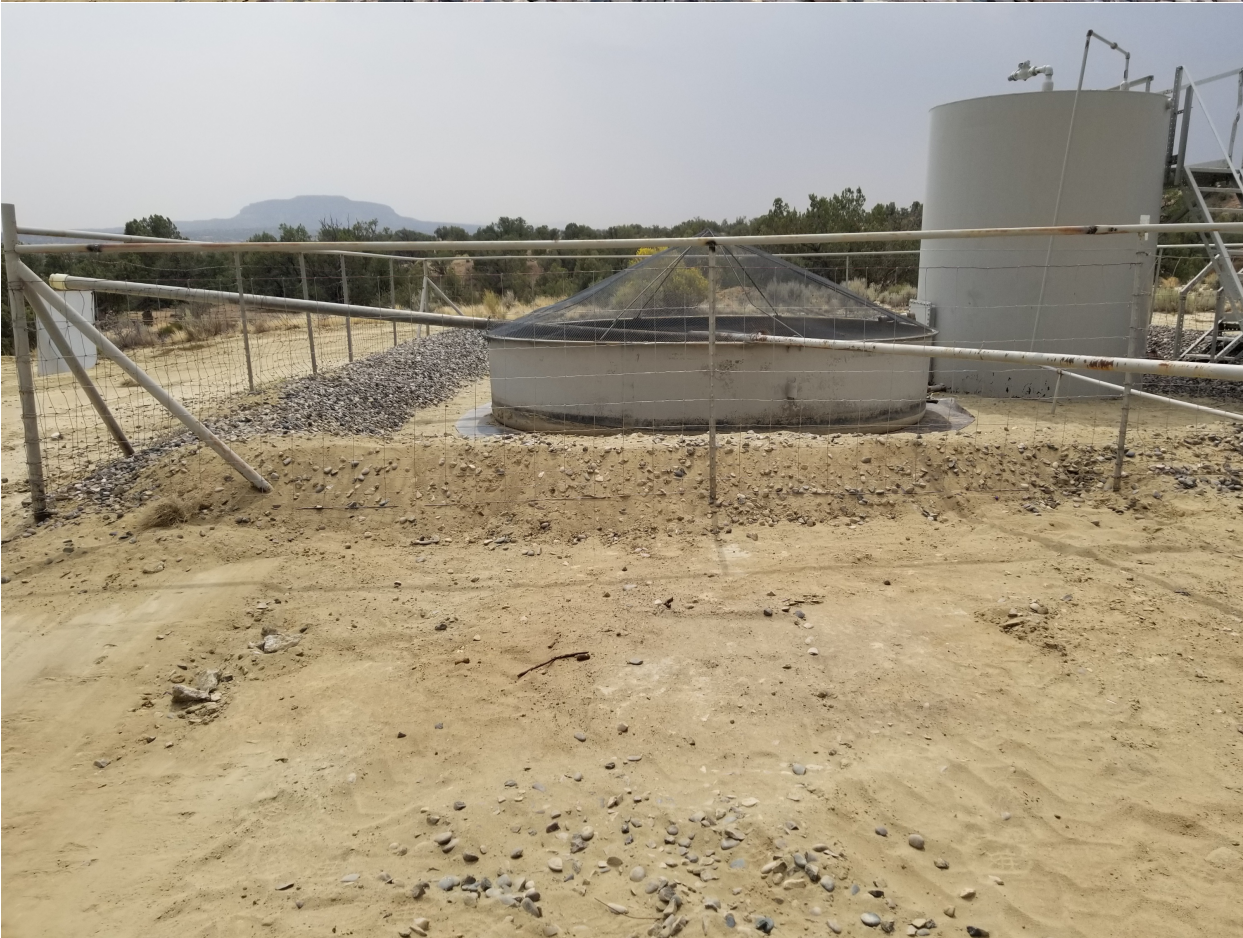
OCD Requested closure on the fiberglass BGT as it did not match 2008 metal BGT permit. BGT permit closed and fiberglass tank was reset as an AGT.
