SIMCOE, LLC SAN JUAN BASIN, NORTHWEST NEW MEXICO

Well Name: Hughes LS #017 Well API# 30-045-21152 Unit Letter H, Section 19, T29N, R8W

BELOW-GRADE TANK CLOSURE PLAN

Subject: SIMCOE, LLC Hughes LS 017 Below Grade Tank (BGT) Closure

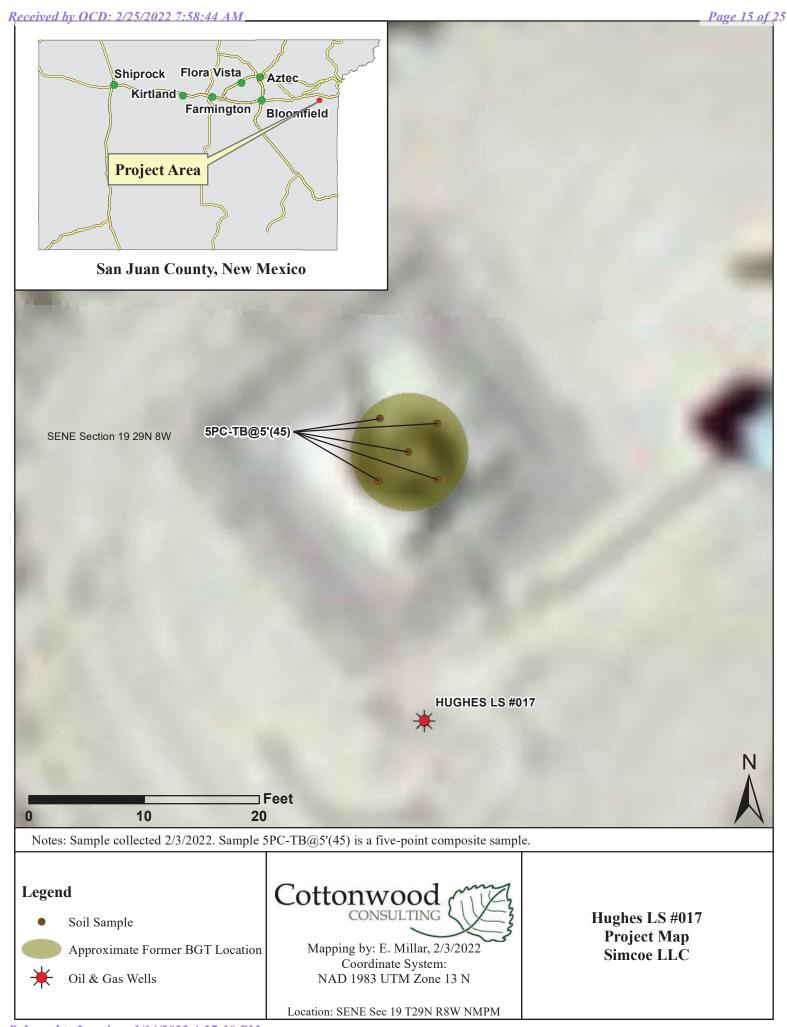
SITE SKETCH			I CALIB. READ. = 100 ppm RF=100						
	Bern PLOTPLAN CITCLE. all	♦ OVM	MISCELL. NOTES						
	SPC-TB@ 5'(45)								
	O Hughes LS #017 Wellhend	C Tai	Permit date(s): DCD Appr. date(s): OVM = Organic Vapor Meter ppm = parts per million BGT Sidewalls Visible: Y / N BGT Sidewalls Visible: Y / N						
BOTTOM; PBGTL = PREVIOUS BELOW-GRADE	SSION; B.G. = BELOW GRADE; B = BELOW; T.H. = TEST HOLE; ~ = APPROX.; W.H. = WELL HEAD; T.B. = TANK LOCATION; SPD = SAMPLE POINT DESIGNATION; R.W. = RETAINING WALL; NA - NOT APPL JUBLE WALL; SB - SINGLE BOTTOM; DB - DOUBLE BOTTOM.	LICABLE OR N	BGT Sidewalls Visible: Y / N Magnetic declination:						
NOTES:	ONGITE	2131	2.3

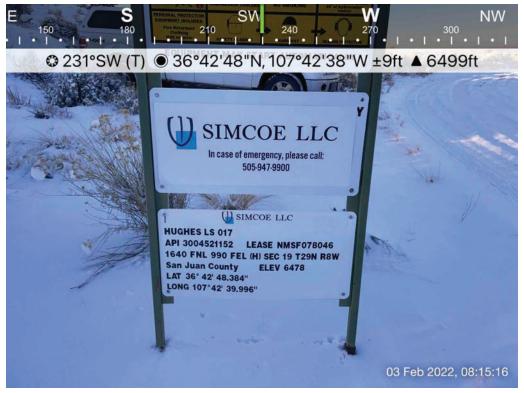
Photo 1: Hughes LS #017 well sign, 2/3/2022.

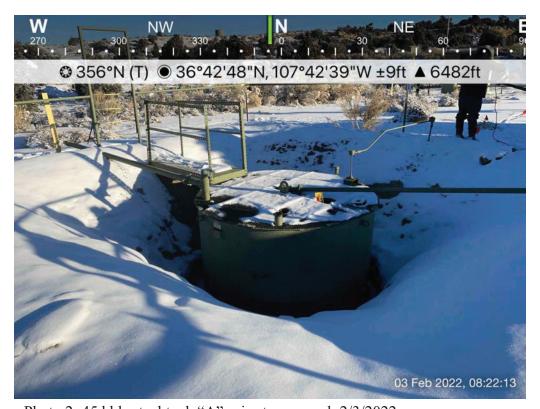
Photo 2: 45 bbls steel tank "A" prior to removal, 2/3/2022.

All liquids and/or sludge within the BGT were removed and sent to one of the above NMOCD approved facilities for disposal.

The BGT will be inspected and may be recycled, reused, or reclaimed.

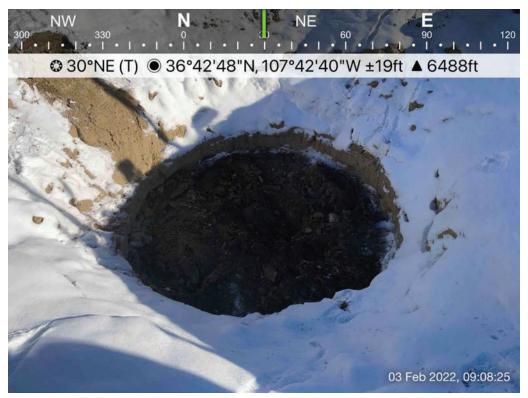
Photo 3: Former location of 45 bbls steel tank "A" following removal, 2/3/2022.

Soils beneath the BGT were sampled for TPH, BTEX, and chloride per the above requirements. BTEX, and chloride were all non-detect based on laboratory analytical results. TPH was detected above the laboratory detection limit but below the NMOCD standard.

Sampling results and field observations reveal no evidence of a release had occurred.

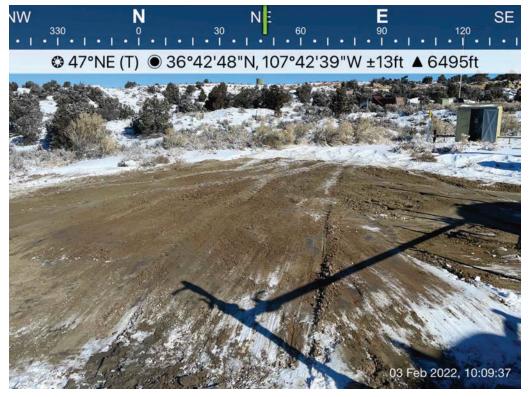
Photo 4: Former location of 45 bbls steel tank "A" following removal and regrading, 2/3/2022.

No evidence of a release. Area backfilled / regraded.

Area backfilled / regraded. No reclamation to be done at this time as former BGT location is located on well pad within area needed for production operations or subsequent drilling.
