Pit, Below-Grade Tank, or
Proposed Alternative Method Permit or Closure Plan Application

Hilcorp Energy Company
San Juan Basin: New Mexico Assets
Below Grade Tank Closure Report

Lease Name: Byrd Frost 1
API No.: 30-045-25533

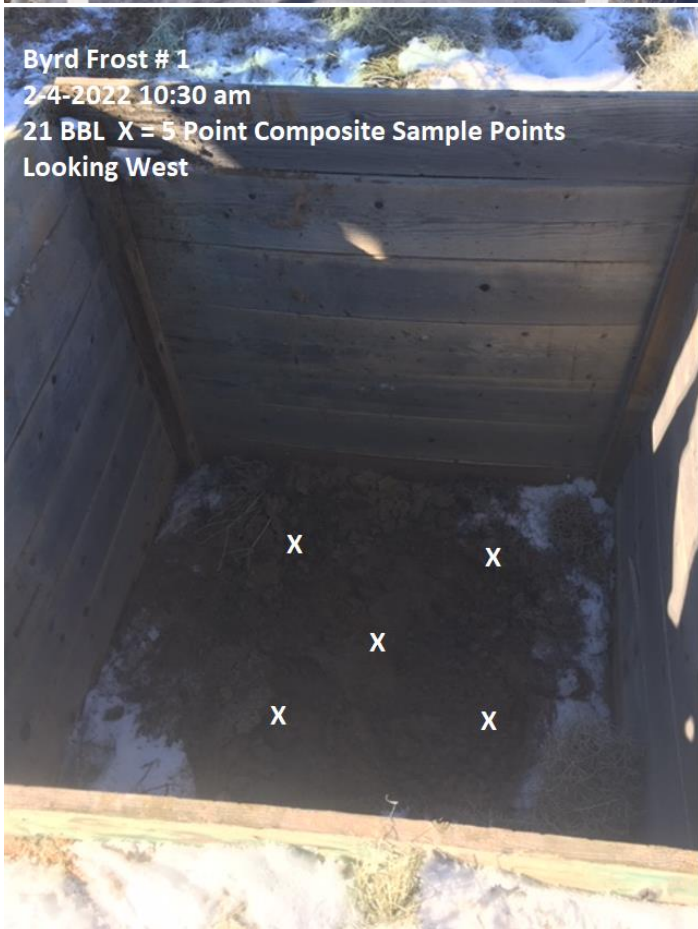
Byrd Frost # 1
2-4-2022 10:30 am
21 BBL X = 5 Point Composite Sample Points
Looking West

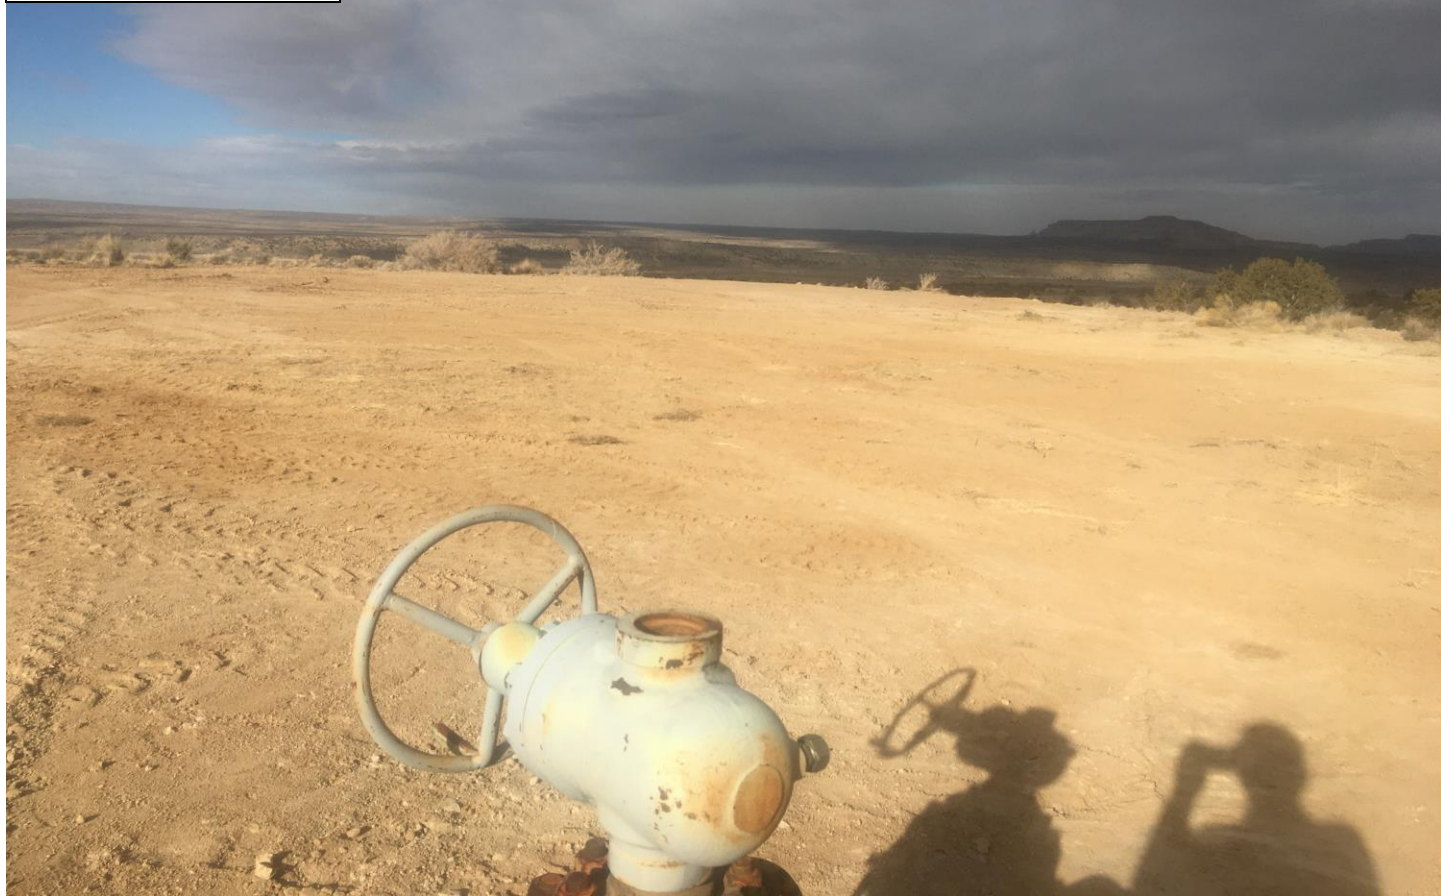
Byrd Frost #1
2/16/22, 8:58 am
21 bbl – Backfill photo
Looking West
