Pit, Below-Grade Tank, or
Proposed Alternative Method Permit or Closure Plan Application

1.
Operator: Simcoe, LLC OGRID #: 329736
Address: 1199 Main Ave., Suite 101, Durango, CO 81301
Facility or well name: NORTHEAST BLANCO UNIT #056A
API Number: 30-045-25369 OCD Permit Number: _____
U/L or Qtr/Qtr E Section 34 Township 31 Range 7 County: San Juan
Center of Proposed Design: Latitude 36.85834413 Longitude -107.565419 NAD83
Surface Owner: ☒ Federal ☐ State ☐ Private ☐ Tribal Trust or Indian Allotment

Northeast Blanco Unit #056A
Photographic Log
Simcoe, LLC

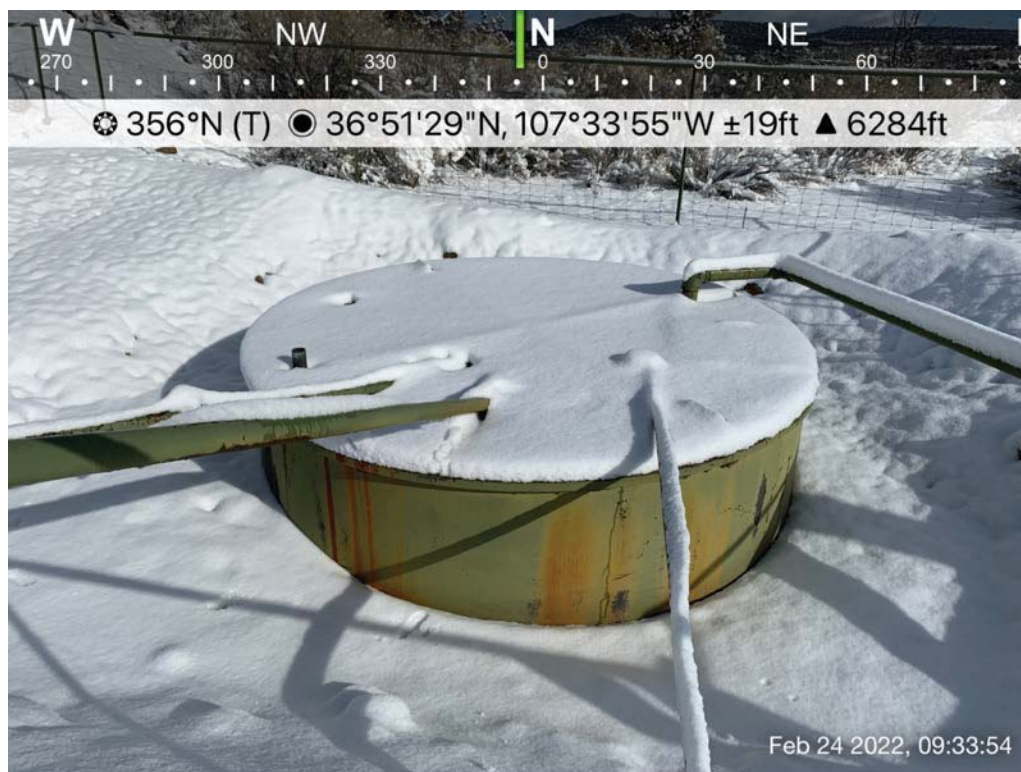
Photo 2: 40 bbls steel tank prior to removal, 2/24/2022.

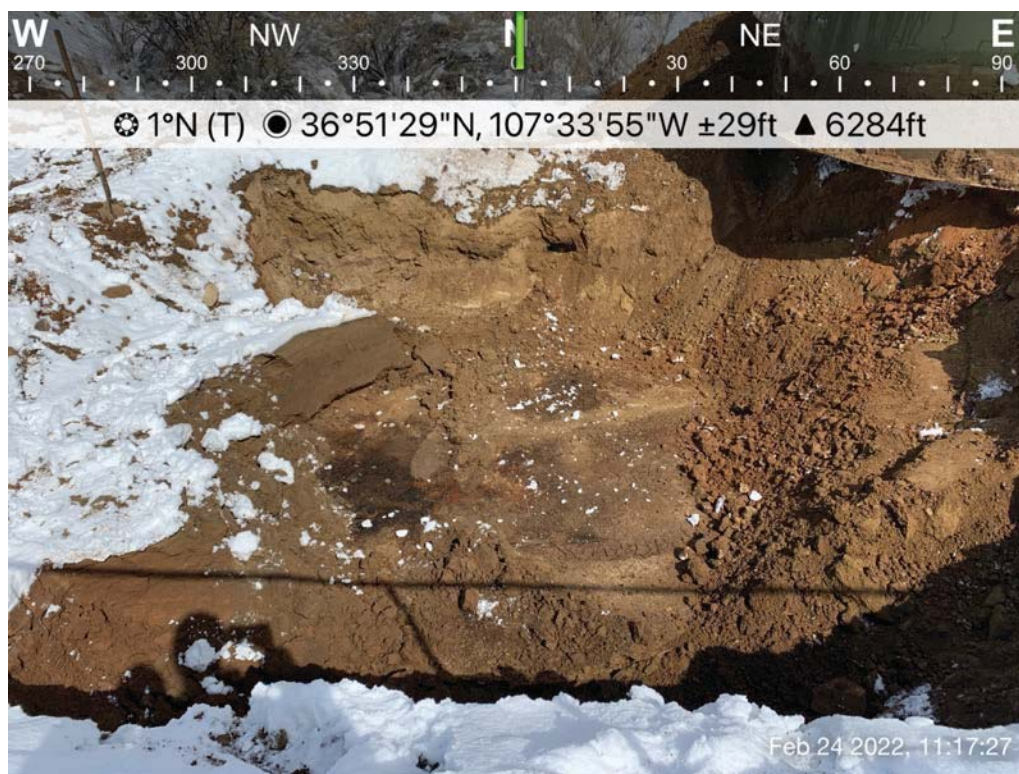
Photo 3: Former location of 40 bbls steel tank following removal, 2/24/2022.

Sampling results indicate that all concentrations were below the relevant closure criteria standards. The BGT was replaced.

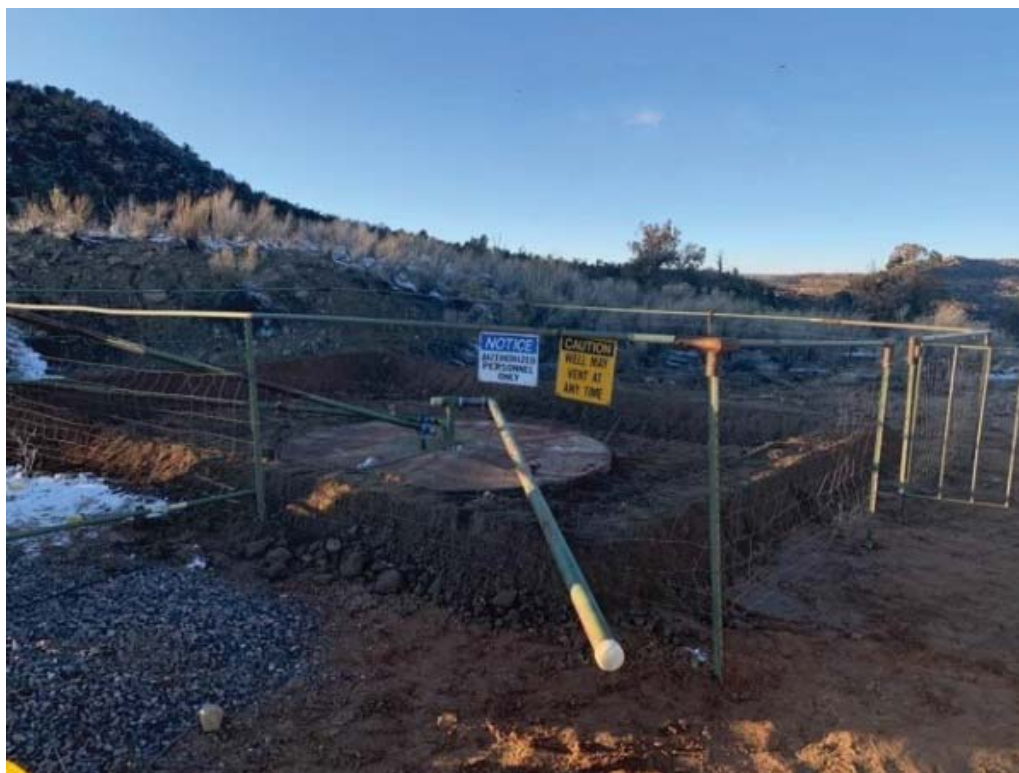
Photo 4: Replaced BGT, 2/24/2022.

The BGT was replaced and equipment remained on site.
