Pit, Below-Grade Tank, or  
Proposed Alternative Method Permit or Closure Plan Application

1.  
Operator: Simcoe, LLC OGRID #: 329736  
Address: 1199 Main Ave., Suite 101, Durango, CO 81301  
Facility or well name: NORTHEAST BLANCO UNIT #003R  
API Number: 30-045-26457 OCD Permit Number: \_\_\_\_\_  
U/L or Qtr/Qtr K Section 5 Township 30N Range 7W County: San Juan  
Center of Proposed Design: Latitude 36.83981275 Longitude -107.5975507 NAD83  
Surface Owner: ☒ Federal ☐ State ☐ Private ☐ Tribal Trust or Indian Allotment

Northeast Blanco Unit #003R  
Photographic Log  
Simcoe, LLC

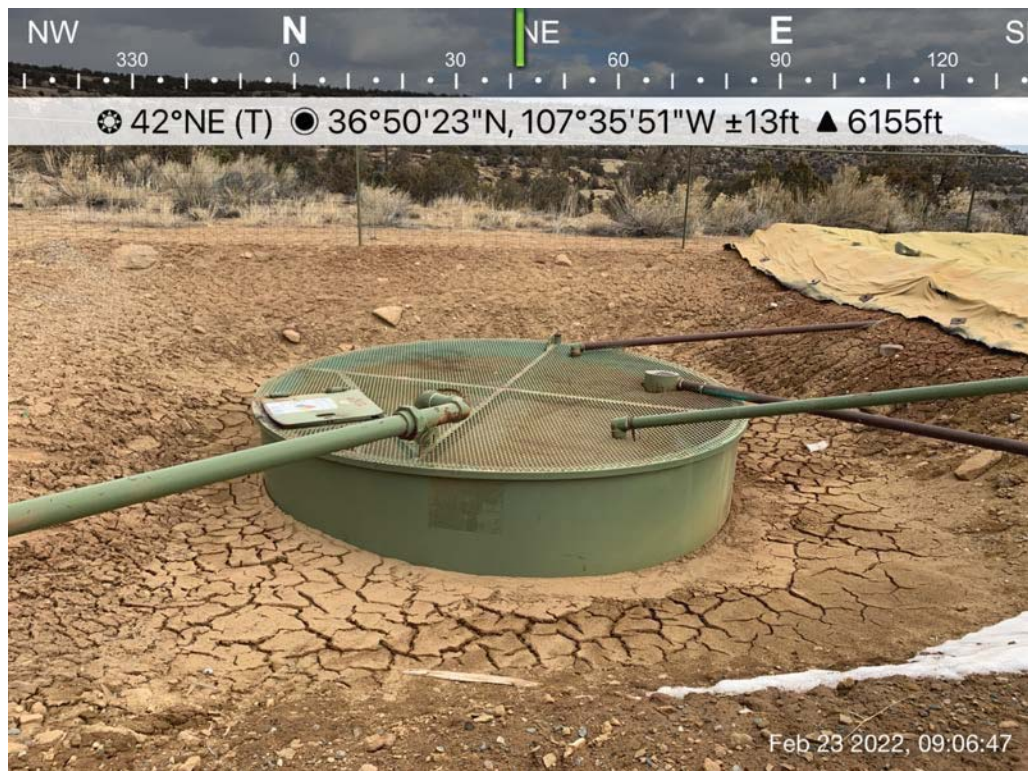
Photo 2: 40 bbls steel tank prior to removal, 2/23/2022.

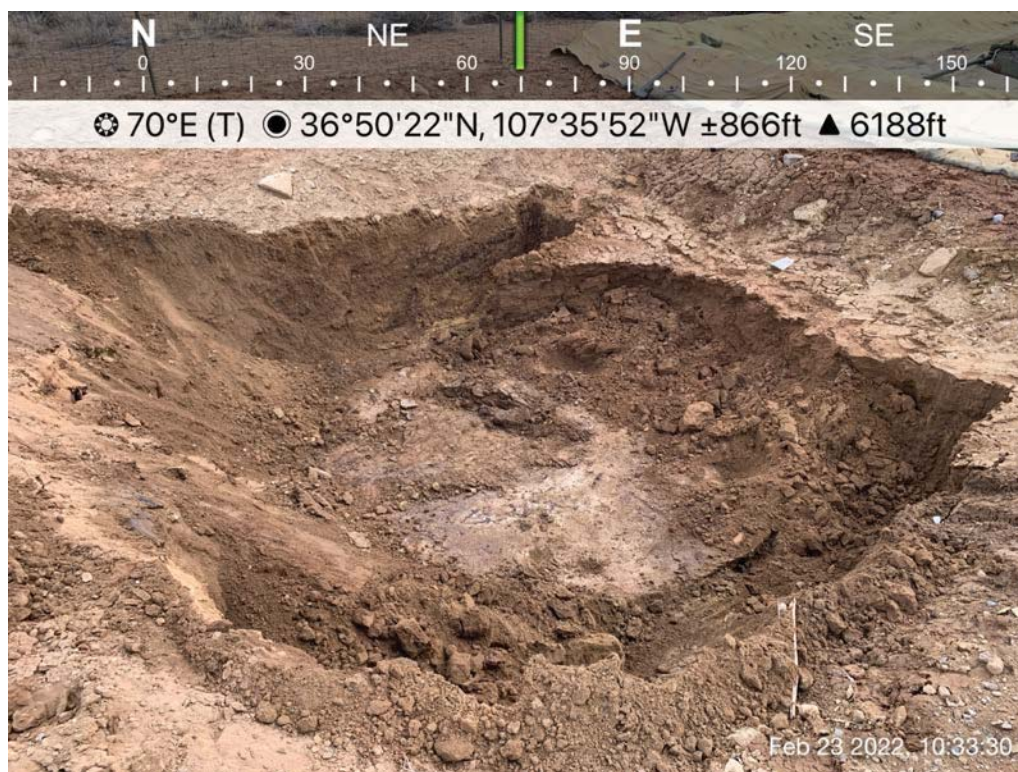
**No evidence of a release. The BGT was replaced.**

Photo 3: Former location of 40 bbls steel tank following removal, 2/23/2022.

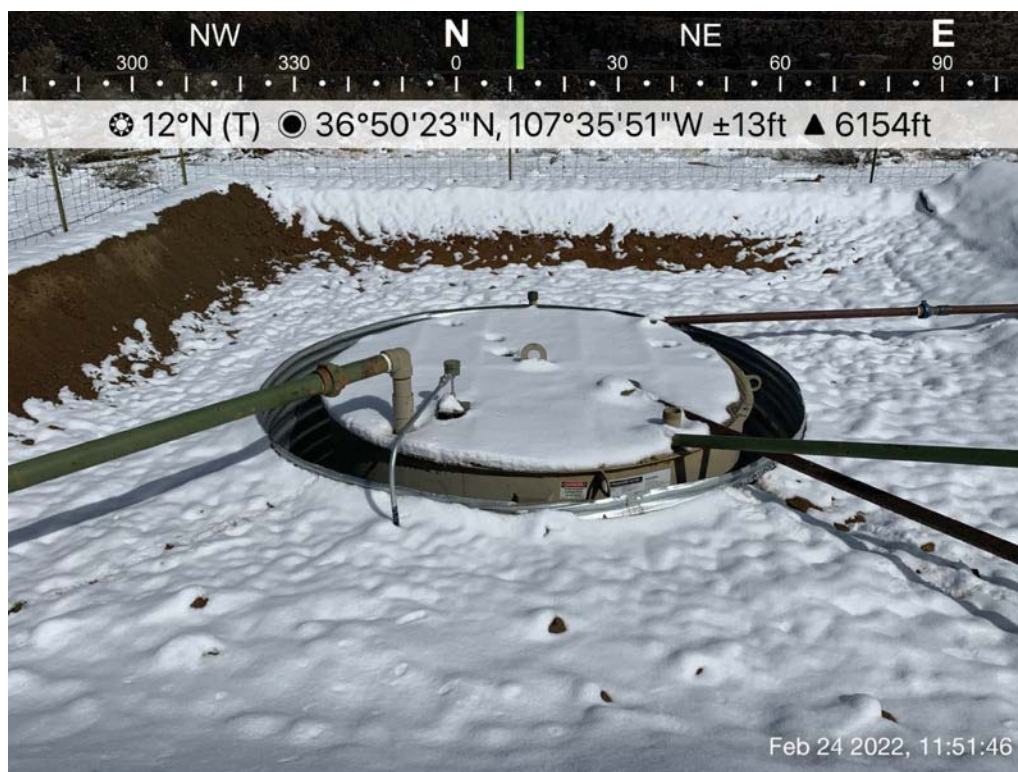
Photo 4: Replaced BGT with liner, 2/24/2022.

**The BGT was replaced and equipment remained on site.**
