Pit, Below-Grade Tank, or
Proposed Alternative Method Permit or Closure Plan Application

1.
Operator: Simcoe, LLC OGRID #: 329736
Address: 1199 Main Ave., Suite 101, Durango, CO 81301
Facility or well name: Roelofs LS #004
API Number: 30-045-20281 OCD Permit Number: _____
U/L or Qtr/Qtr P Section 22 Township 29N Range 8W County: San Juan
Center of Proposed Design: Latitude 36.7062912 Longitude -107.6577375 NAD83
Surface Owner: ☒ Federal ☐ State ☐ Private ☐ Tribal Trust or Indian Allotment

BELOW-GRADE TANK CLOSURE PLAN

**Roelofs LS #004
Photographic Log
Simcoe LLC**

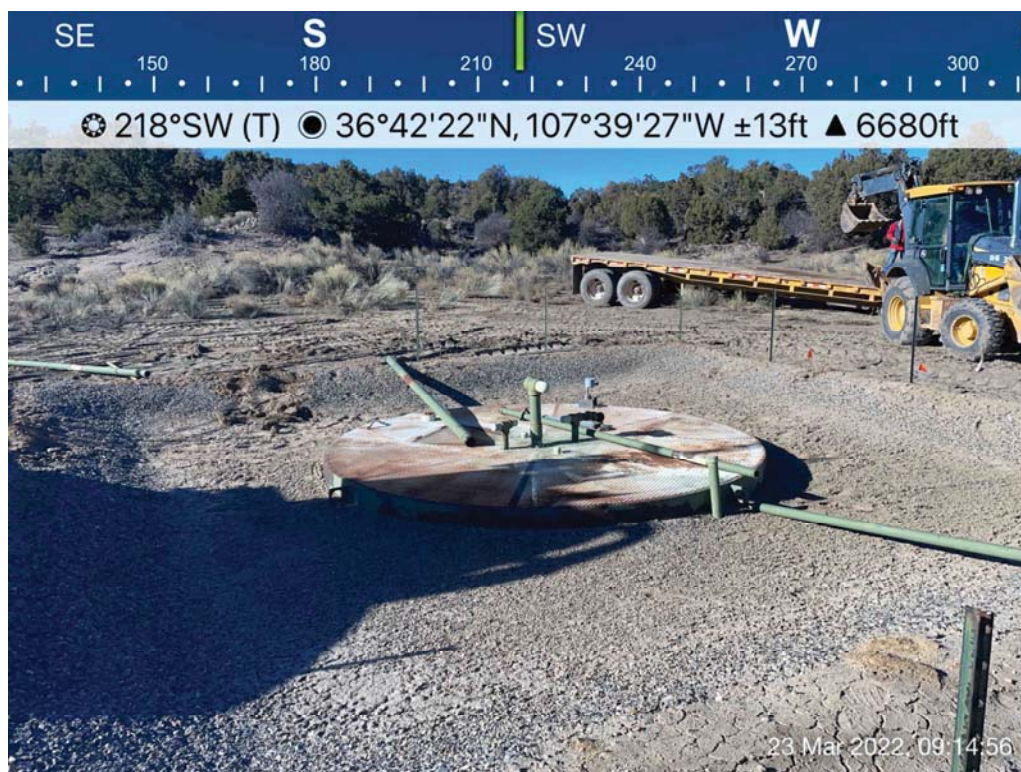
Photo 2: 95 bbls steel tank prior to removal, 3/23/2022.

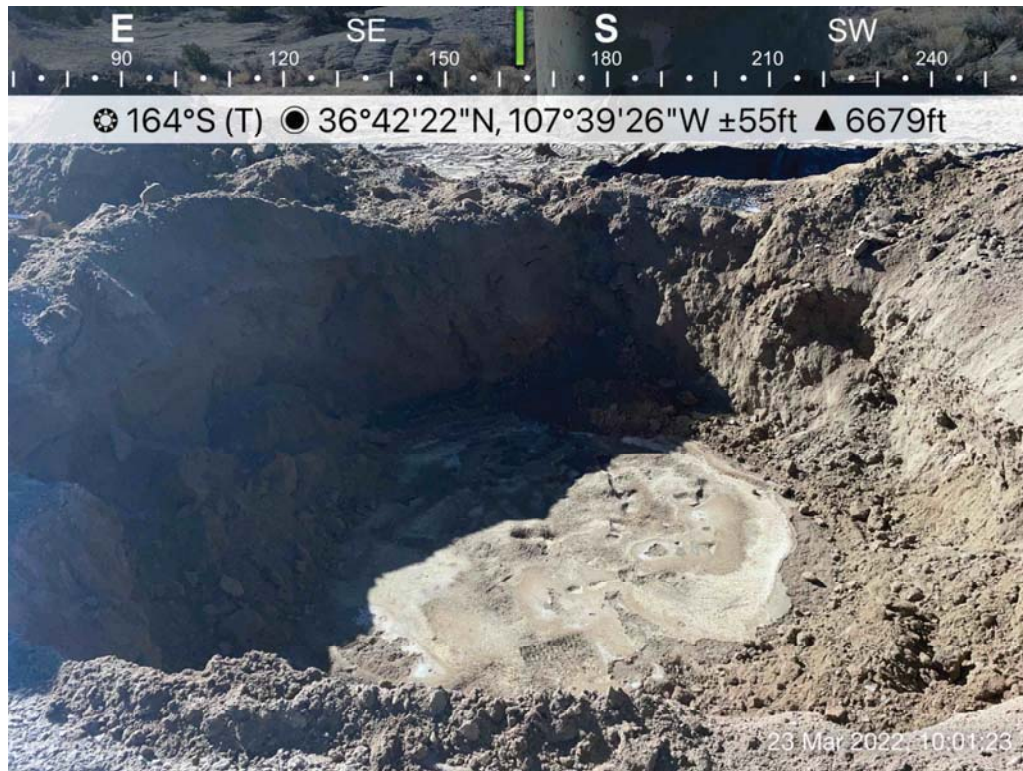
Photo 3: Former location of BGT following removal, 3/23/2022.

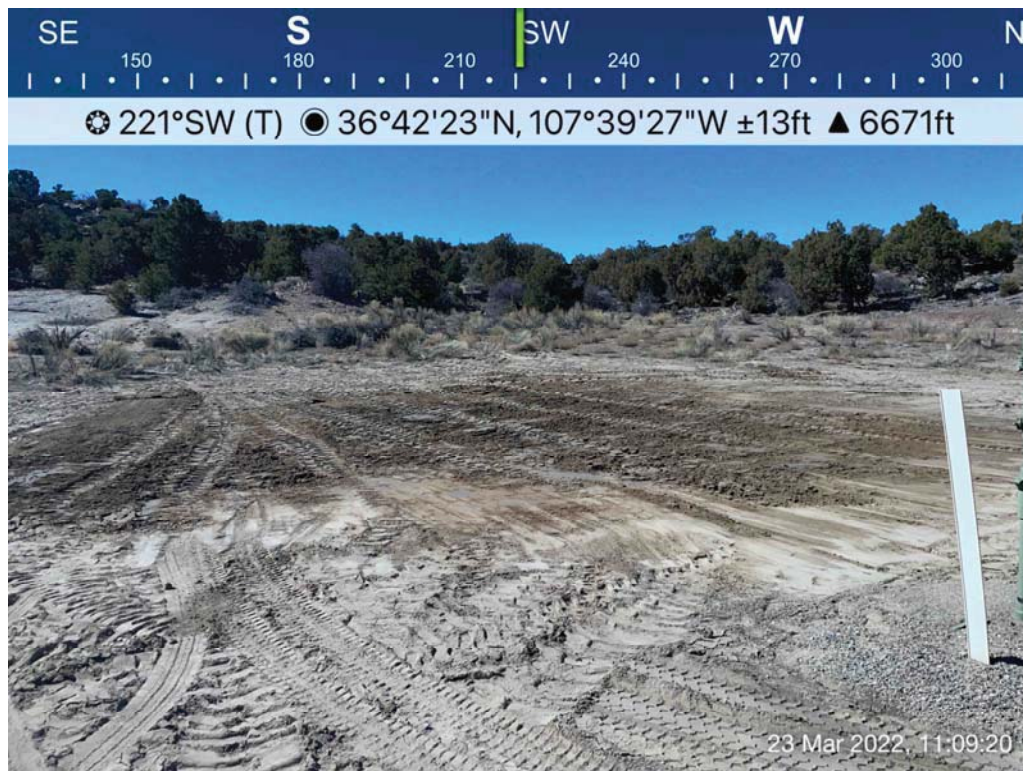
Photo 4: Former location of BGT following removal and re-grading, 3/23/2022.
