Pit, Below-Grade Tank, or
Proposed Alternative Method Permit or Closure Plan Application

1.
Operator: Simcoe, LLC OGRID #: 329736
Address: 1199 Main Ave., Suite 101, Durango, CO 81301
Facility or well name: NEBU #072A
API Number: 30-045-25360 OCD Permit Number: _____
U/L or Qtr/Qtr O Section 29 Township 31N Range 7W County: San Juan
Center of Proposed Design: Latitude 36.86436194 Longitude -107.5921916 NAD83
Surface Owner: ☒ Federal ☐ State ☐ Private ☐ Tribal Trust or Indian Allotment

Northeast Blanco Unit 072 A API# 30-045-25360 BGT Closure map 36.864367, -107.592367 Scheduled for closure on 4/4/2022 @ 9:30 AM

NEBU #072A
Photographic Log
Simcoe LLC

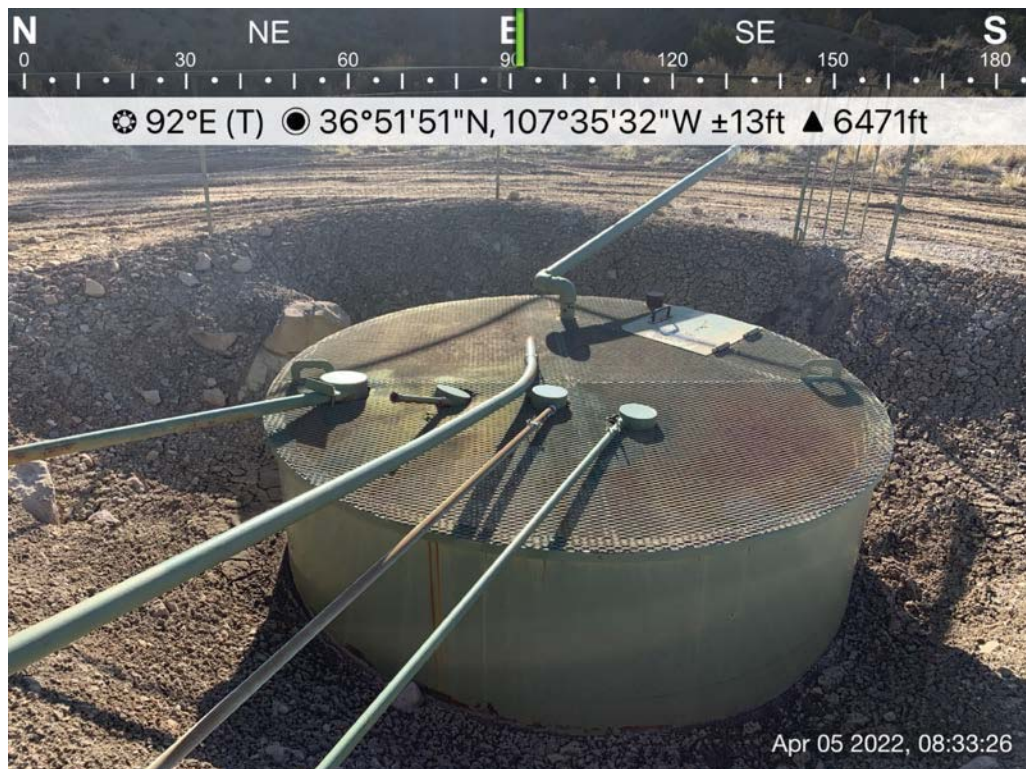
Photo 2: 40 bbls steel tank prior to removal, 4/5/2022.

The BGT was replaced and equipment remained on site.

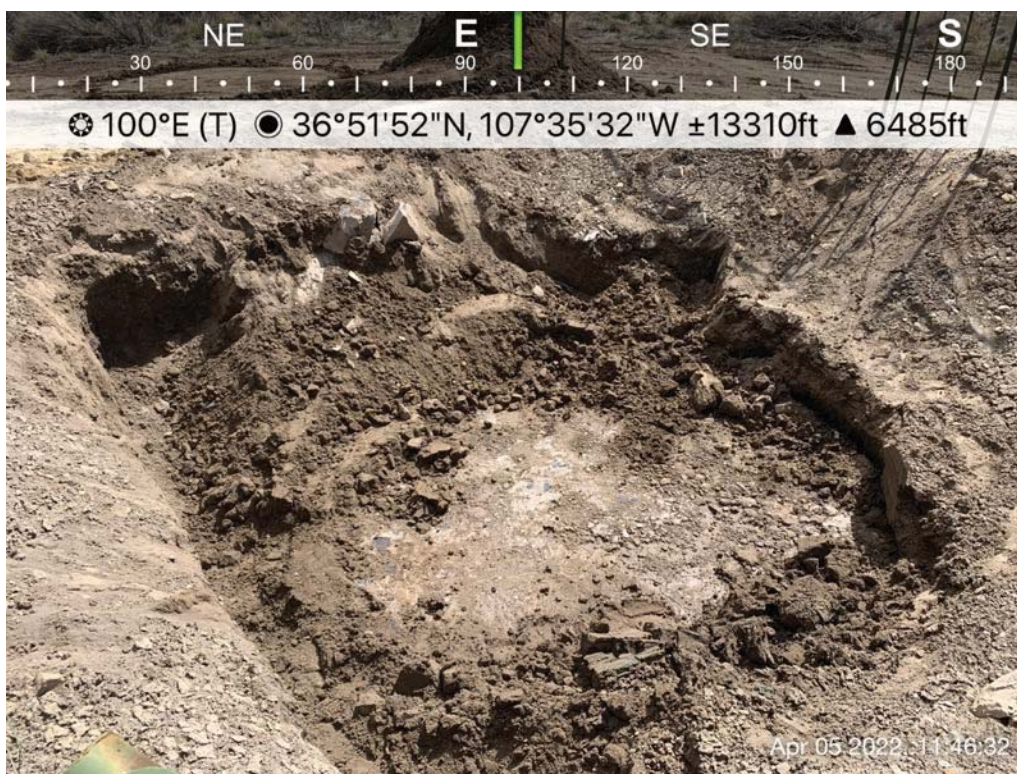
Photo 3: Former location of BGT following removal, 4/5/2022.

No evidence of a release. The BGT was replaced.

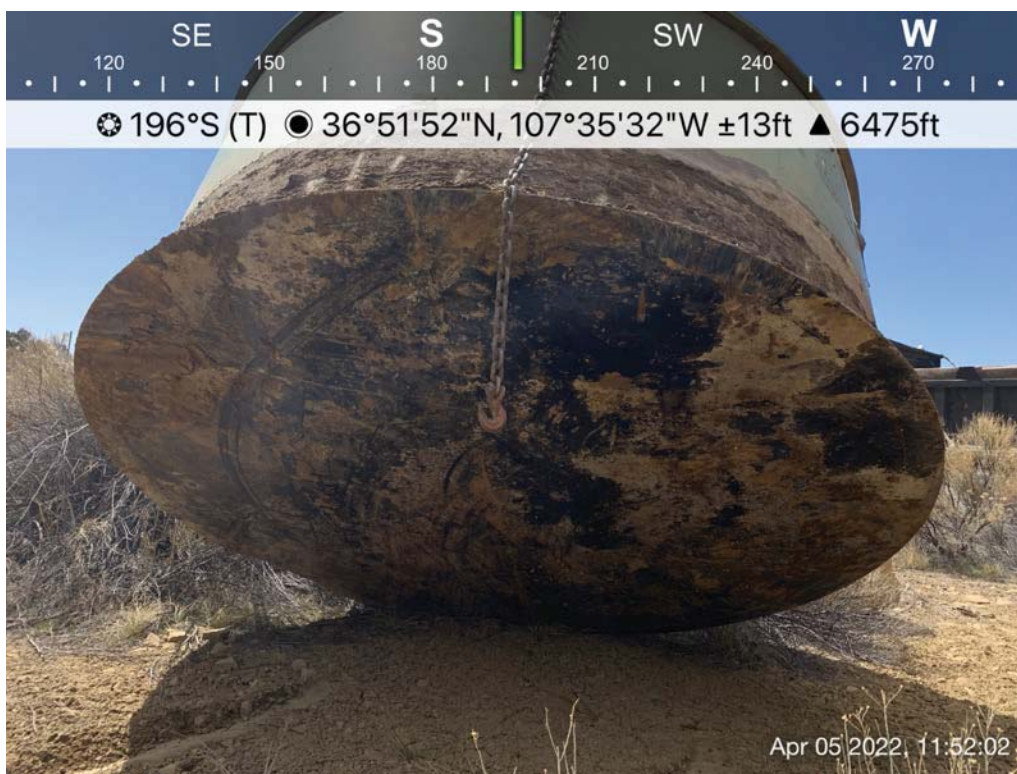
Photo 4: Bottom of BGT following removal, 4/5/2022.

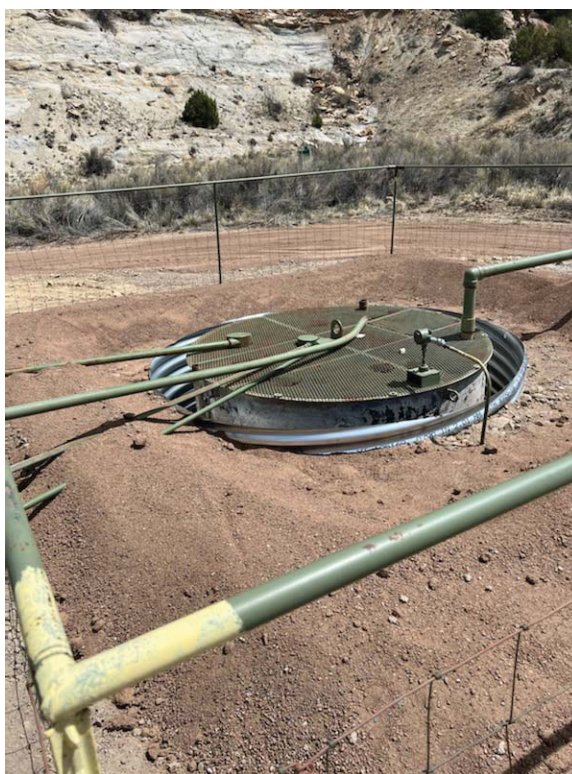
Photo 5: BGT following replacement, 4/5/2022.

The BGT was replaced. No reclamation to be done at this time as former BGT location is located on well pad within area needed for production operations or subsequent drilling.
