Pit, Below-Grade Tank, or
Proposed Alternative Method Permit or Closure Plan Application

SIMCOE, LLC
SAN JUAN BASIN, NORTHWEST NEW MEXICO

Well Name: Vandewart B #002E
Well API# 30-045-25847
Unit Letter B, Section 24, T29N, R8W

BELOW-GRADE TANK CLOSURE PLAN

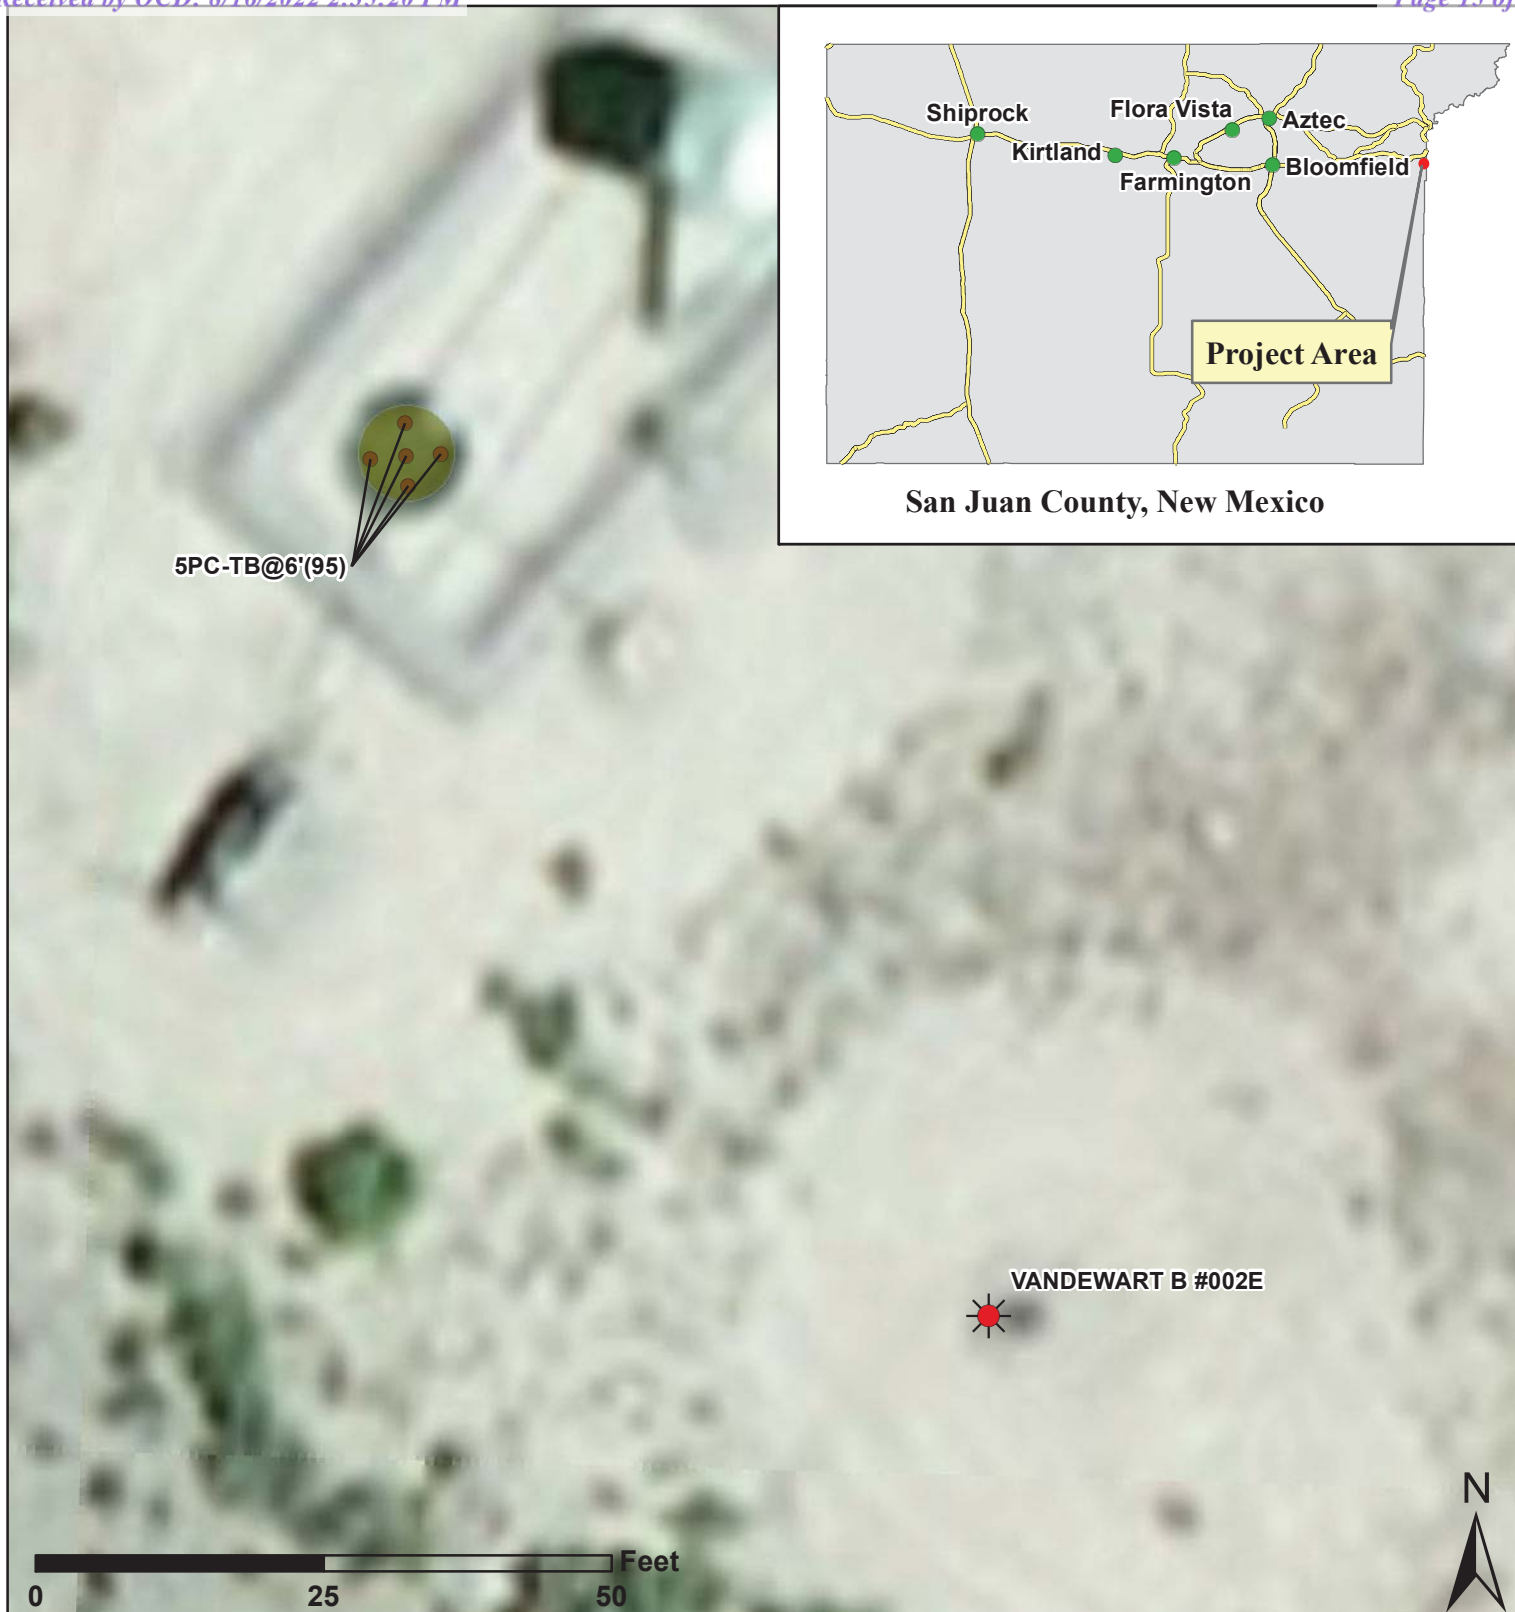
SITE OBSERVATIONS: LOST INTEGRITY OF EQUIPMENT: YES / <u>NO</u> EXPLANATION - APPARENT EVIDENCE OF A RELEASE OBSERVED AND/OR OCCURRED: YES / <u>NO</u> EXPLANATION: EQUIPMENT SET OVER RECLAIMED AREA: YES / <u>NO</u> EXPLANATION - <u>Area back-filled & graded</u> OTHER:		
EXCAVATION DIMENSION ESTIMATION: _____ ft. X _____ ft. X _____ ft. EXCAVATION ESTIMATION (Cubic Yards): _____ DEPTH TO GROUNDWATER: _____ NEAREST WATER SOURCE: _____ NEAREST SURFACE WATER: _____ NMOCD TPH CLOSURE STD: _____ ppm		
SITE SKETCH BGT Located: off / <u>on</u> site PLOT PLAN circle: <u>attached</u>		OVM CALIB. READ. = <u>100</u> ppm RF=1.00 OVM CALIB. GAS = <u>100</u> ppm TIME: <u>0820</u> @mpm DATE: <u>6/30/22</u>
		MISCELL. NOTES Permit date(s): OCD Appr. date(s): Tank ID: <u>A</u> OVM = Organic Vapor Meter ppm = parts per million BGT Sidewalls Visible: <u>Y / N</u> BGT Sidewalls Visible: <u>Y / N</u> BGT Sidewalls Visible: <u>Y / N</u> Magnetic declination:

NOTES: BGT = BELOW GRADE TANK; ED = EXCAVATION DEPRESSION; BG = BELOW GRADE; B = BELOW; T.H. = TEST HOLE; ~ = APPROX.; W.H. = WELL HEAD; T.B. = TANK BOTTOM; PBGTL = PREVIOUS BELOW-GRADE TANK LOCATION; SPD = SAMPLE POINT DESIGNATION; R.W. = RETAINING WALL; NA = NOT APPLICABLE OR NOT AVAILABLE; SW - SINGLE WALL; DW - DOUBLE WALL; SB - SINGLE BOTTOM; DB - DOUBLE BOTTOM.		
NOTES:		ONSITE:

Notes: All samples collected 6/30/2022. 5PC-TB@6'(95) collected as a 5-point composite sample.

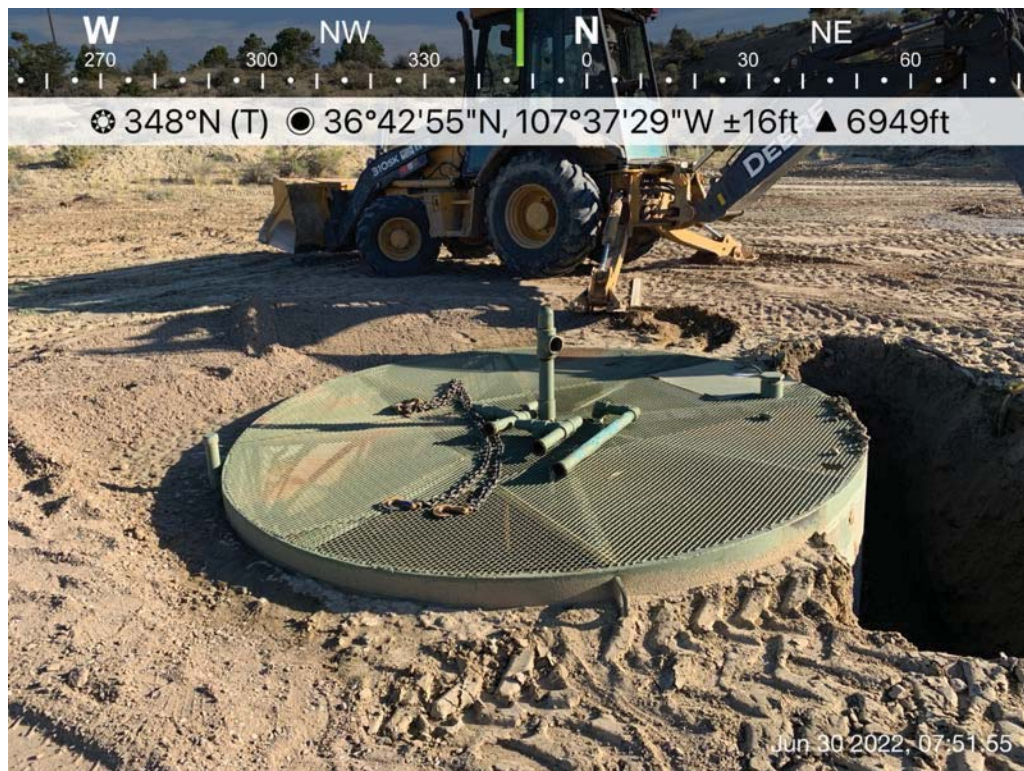
Photo 2: 95 bbls steel tank prior to removal, 6/30/2022.

The BGT was transported for recycling.

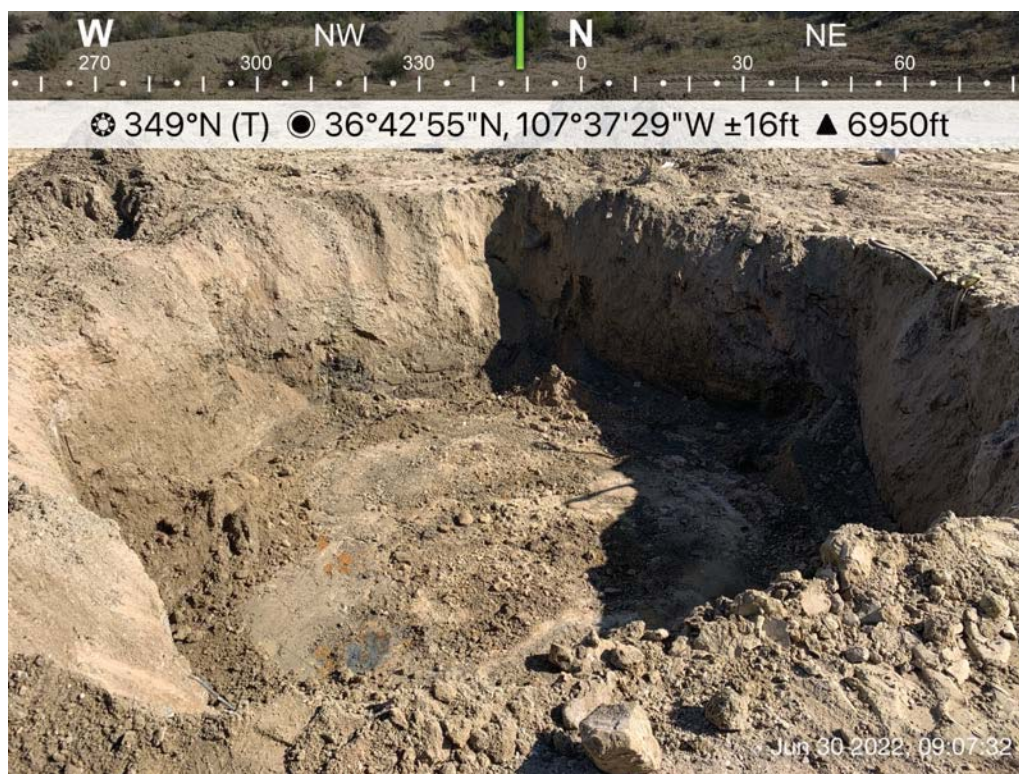
Photo 3: Former location of 95 bbls steel tank following removal, 6/30/2022.

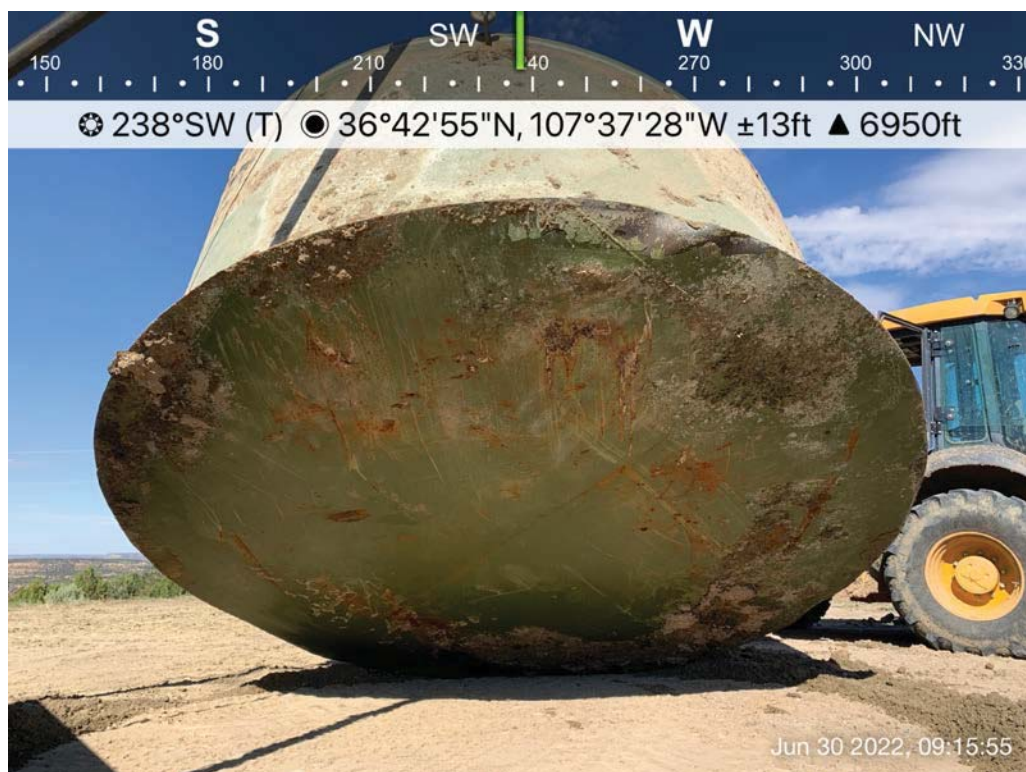
Photo 4: Bottom of steel tank following removal, 6/30/2022.

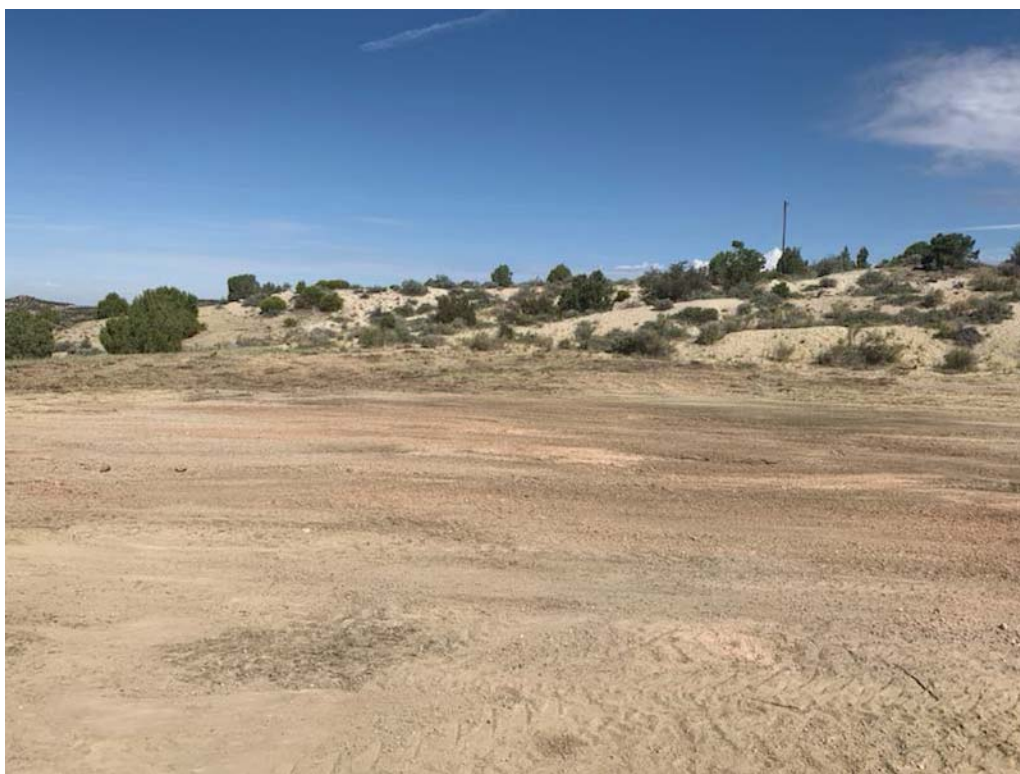
Photo 5: BGT following backfilling and grading, 6/30/2022.

10. Simcoe, LLC shall reclaim the BGT location, and all areas associated with the BGT including associated access roads to a safe and stable condition that blends with the surrounding undisturbed area. Simcoe, LLC shall substantially restore the impacted surface area to the condition that existed prior to oil and gas operations by placement of the soil cover as provided in Subsection H of 19.15.17.13 NMAC, re-contour the location and associated areas to a contour that approximates the original contour and blends
