Pit, Below-Grade Tank, or
Proposed Alternative Method Permit or Closure Plan Application

1.
Operator: Simcoe, LLC OGRID #: 329736
Address: 1199 Main Ave., Suite 101, Durango, CO 81301
Facility or well name: Isabel A #001
API Number: 30-045-28185 OCD Permit Number: _____
U/L or Qtr/Qtr G Section 30 Township 32 Range 09W County: San Juan
Center of Proposed Design: Latitude 36.956452 Longitude -107.817150 NAD83
Surface Owner: ☒ Federal ☐ State ☐ Private ☐ Tribal Trust or Indian Allotment

SIMCOE, LLC
SAN JUAN BASIN, NORTHWEST NEW MEXICO

BELOW-GRADE TANK CLOSURE PLAN

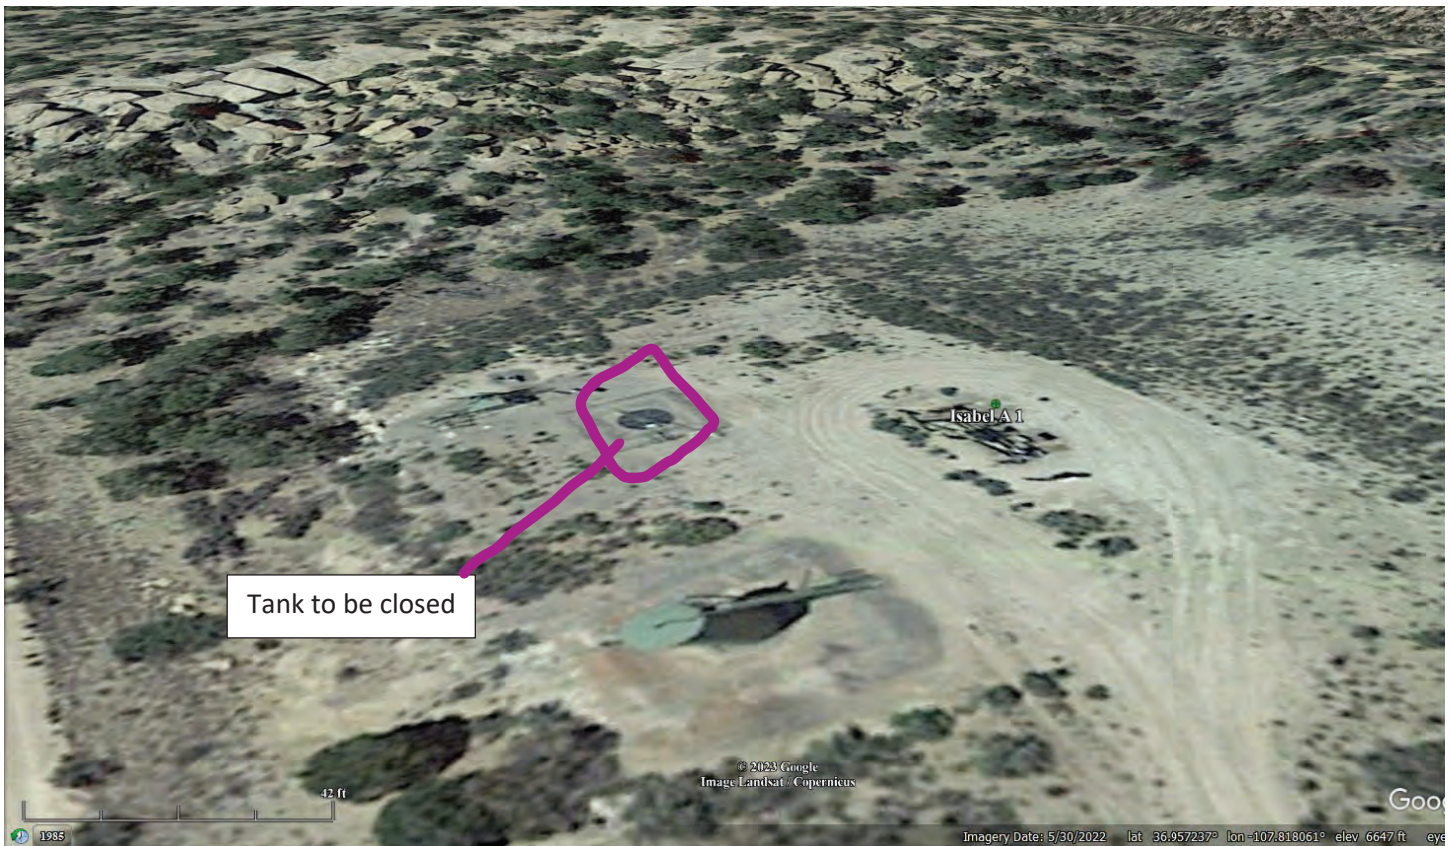
Above grade tank to be removed 95 bbl double wall/double bottom below grade tank sides not visible.

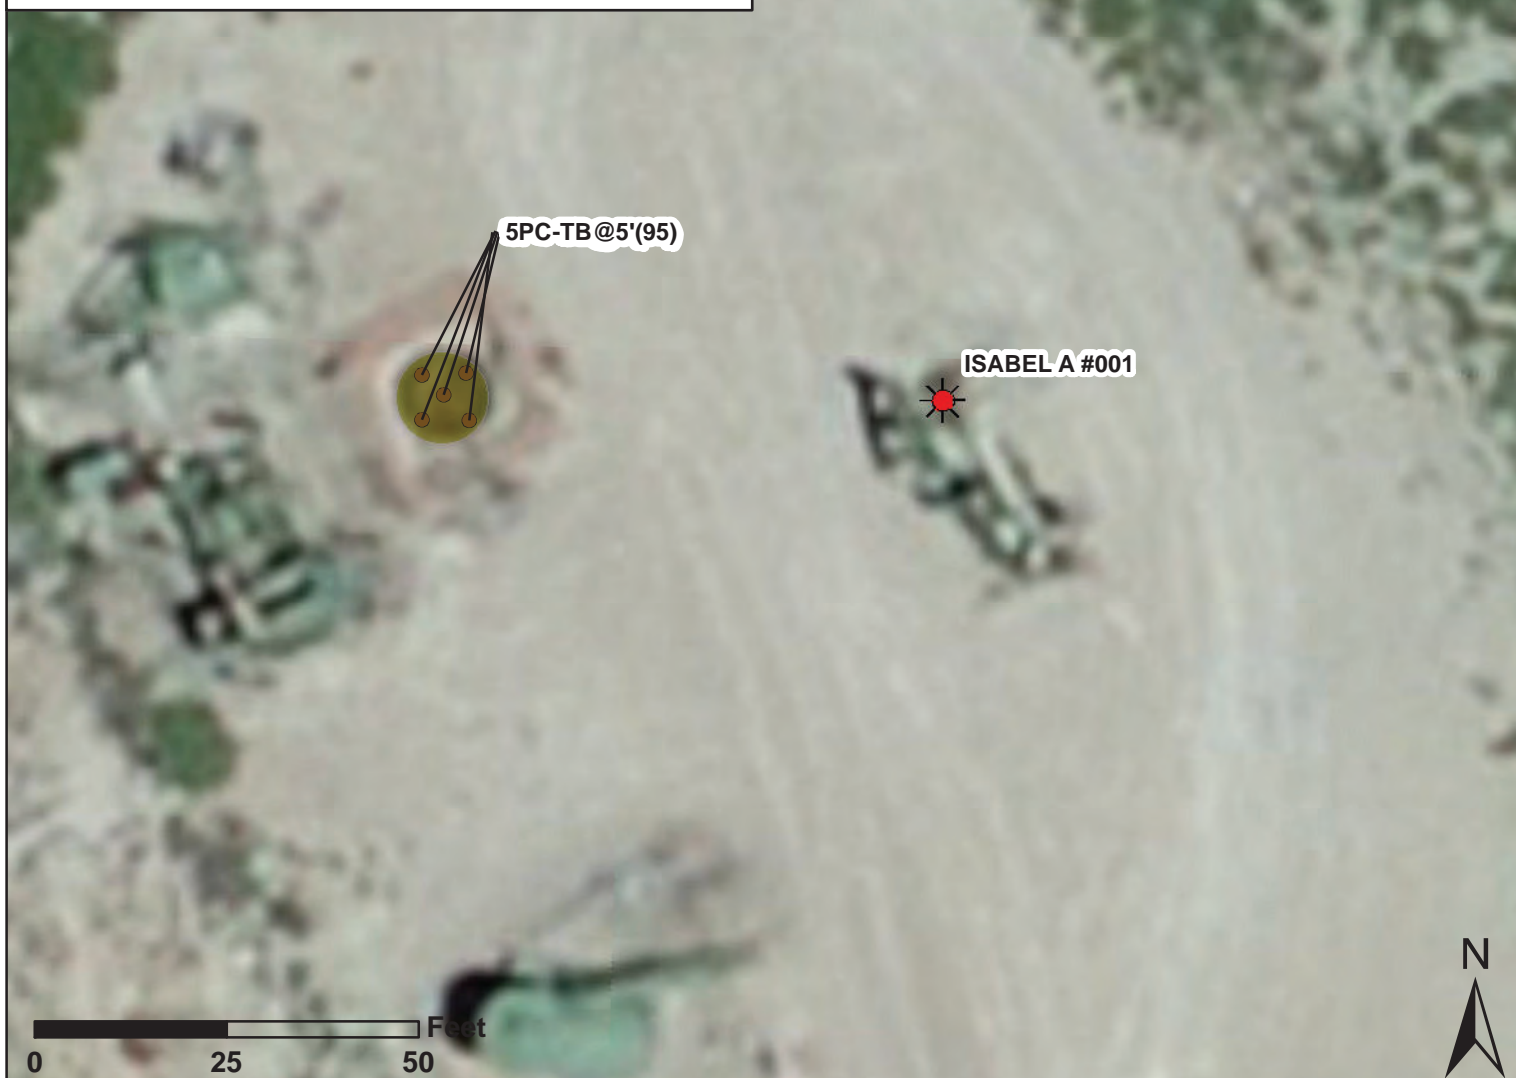
Notes: Sample collected 4/7/2023. 5PC-TB@5'(95) is a five point composite sample.

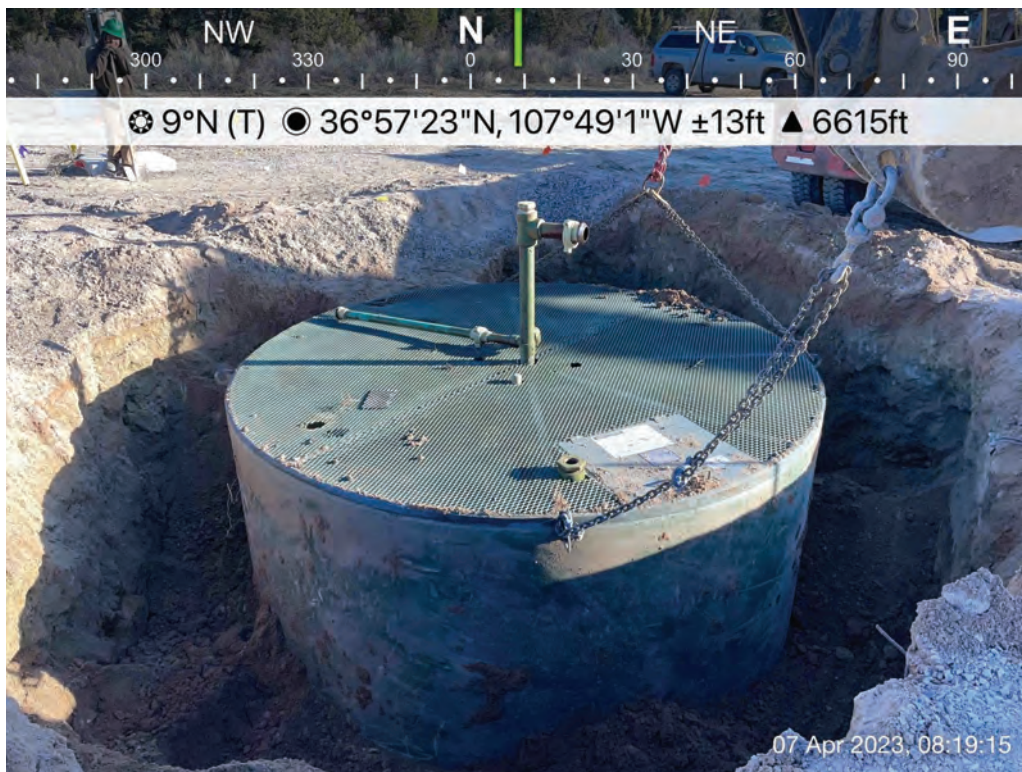
Photo 2: BGT prior to removal, 4/7/2023.

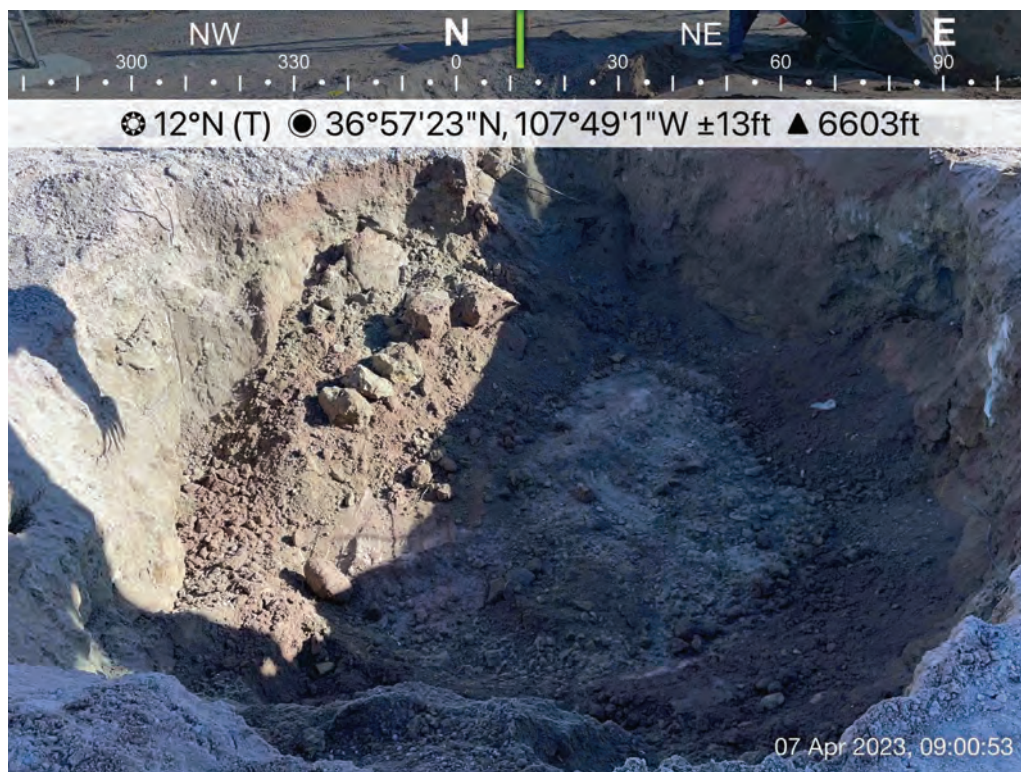
Photo 3: Location of BGT following removal, 4/7/2023.

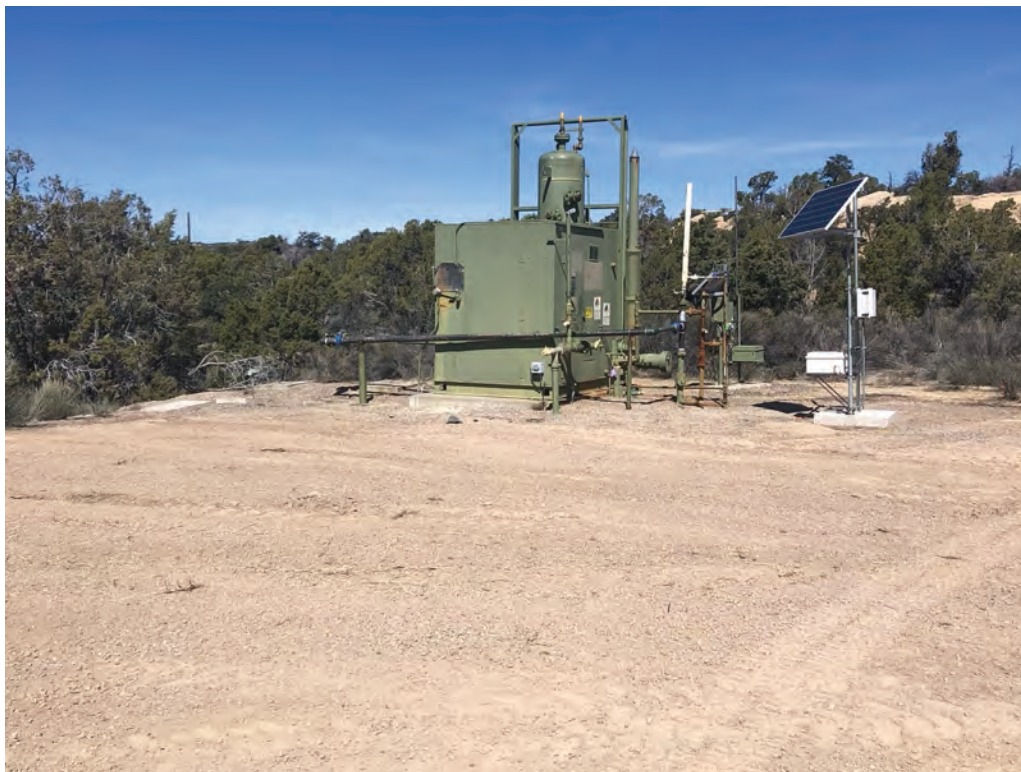
Photo 5: Former location of BGT following backfilling and grading,
4/7/2023.
