Pit, Below-Grade Tank, or  
Proposed Alternative Method Permit or Closure Plan Application

Hilcorp Energy Company  
San Juan Basin  
Below Grade Tank Closure Report

Lease Name: Hanks 4  
API No.: 30-045-06617

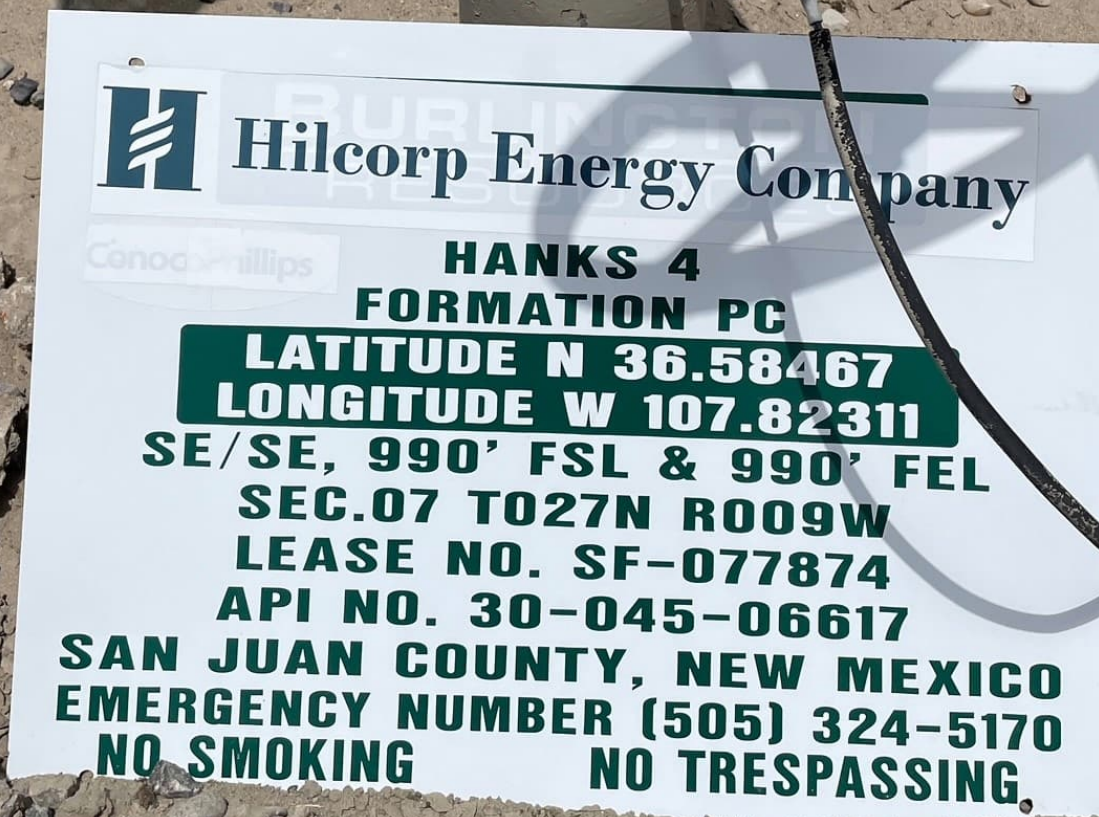
Hanks 4

Placard

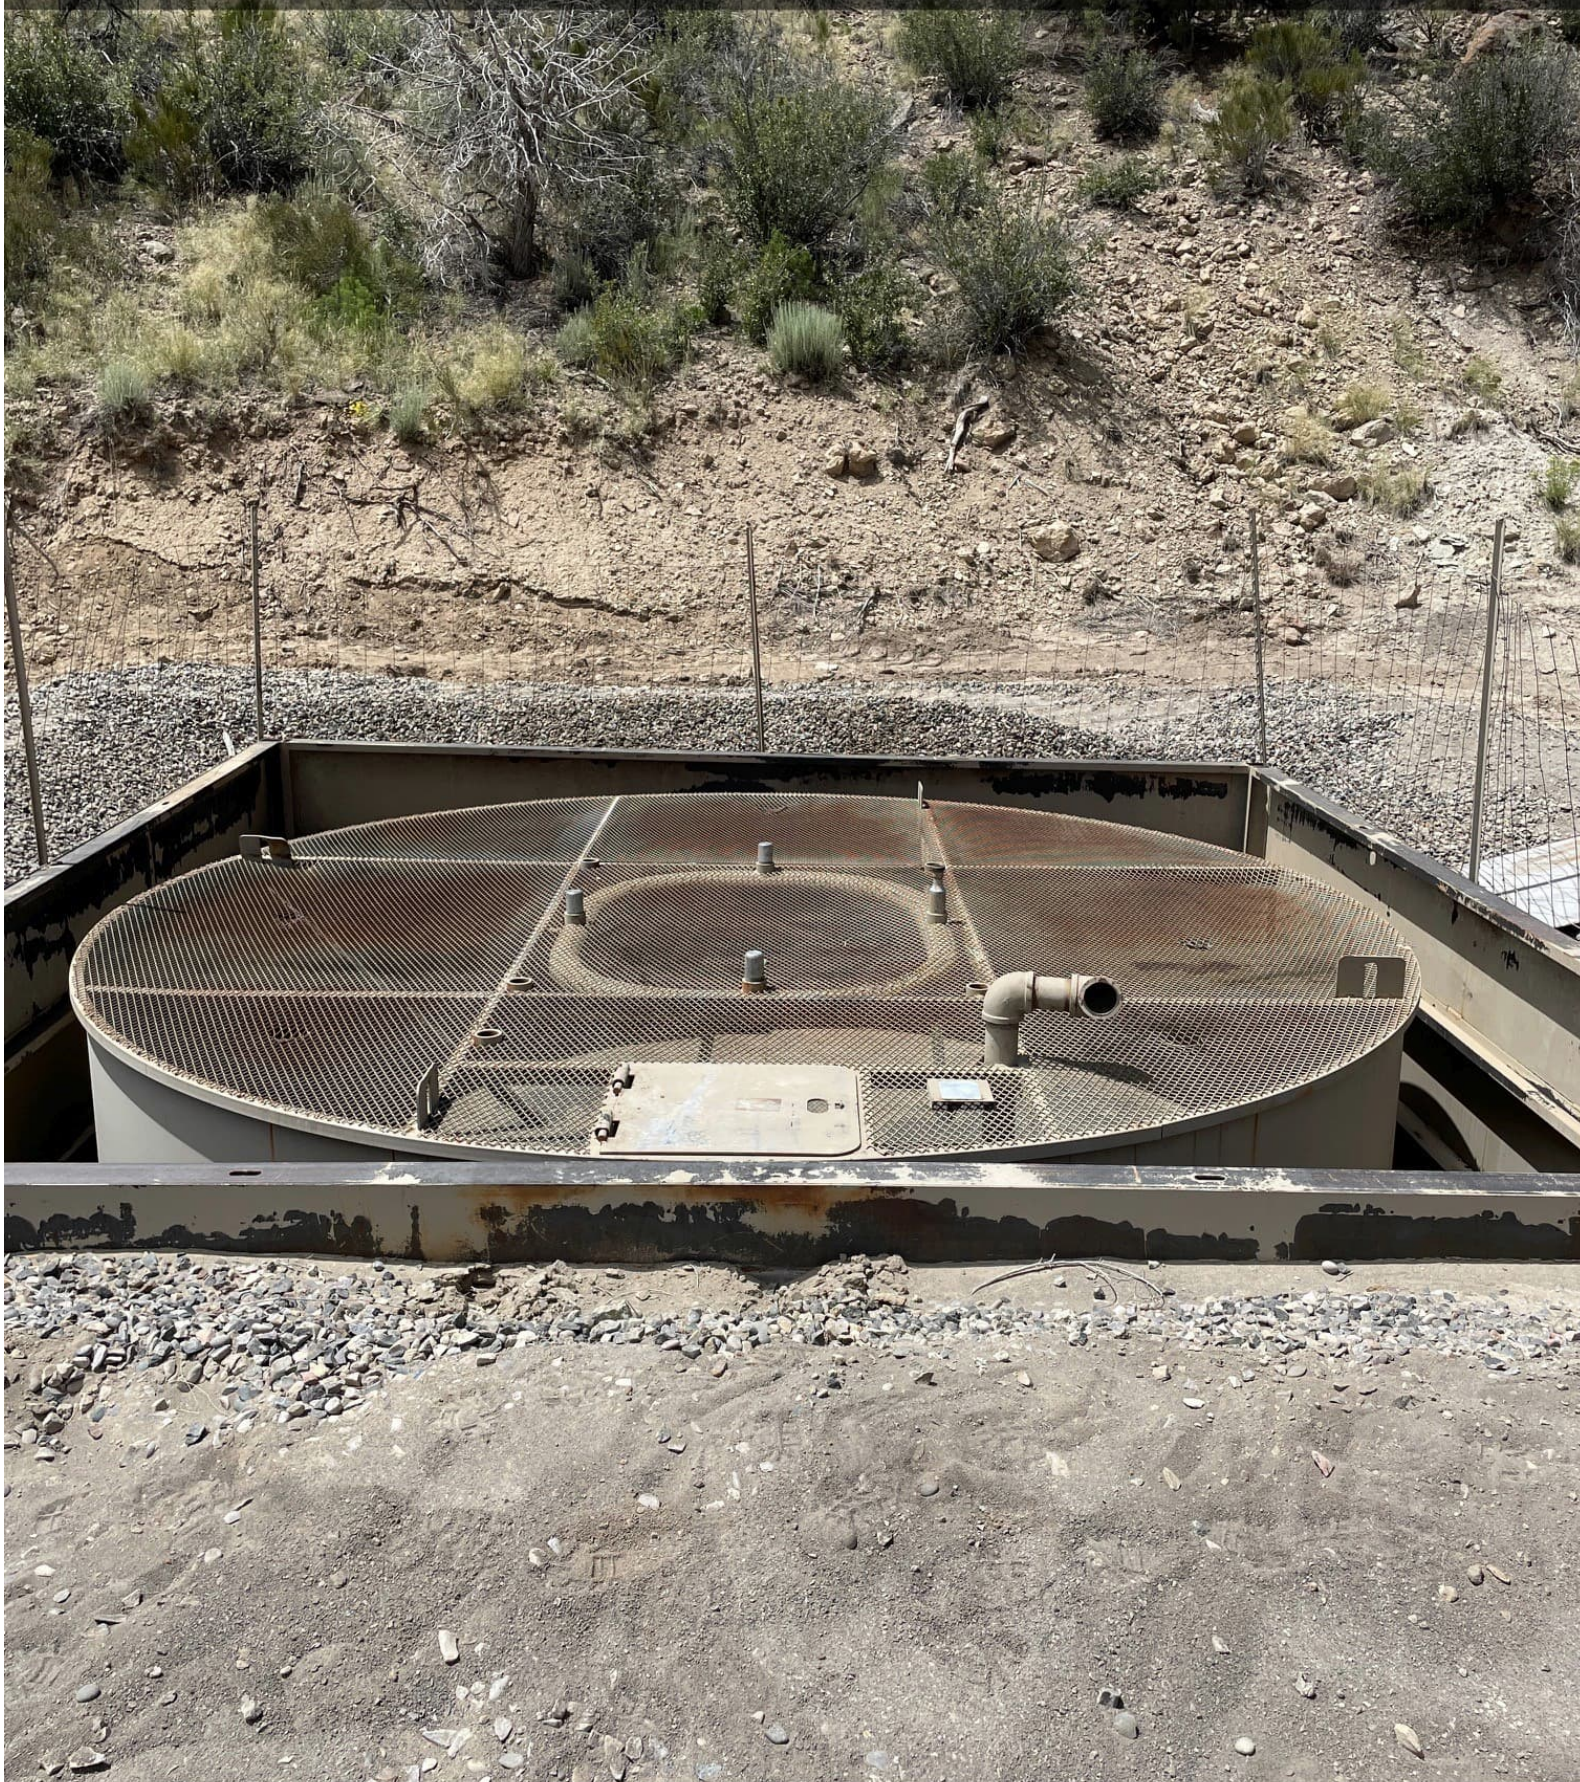
Hanks 4

Before Removal

The below-grade tank was disposed of in a division-approved manner.

All on-site equipment associated with the below-grade tank was removed.

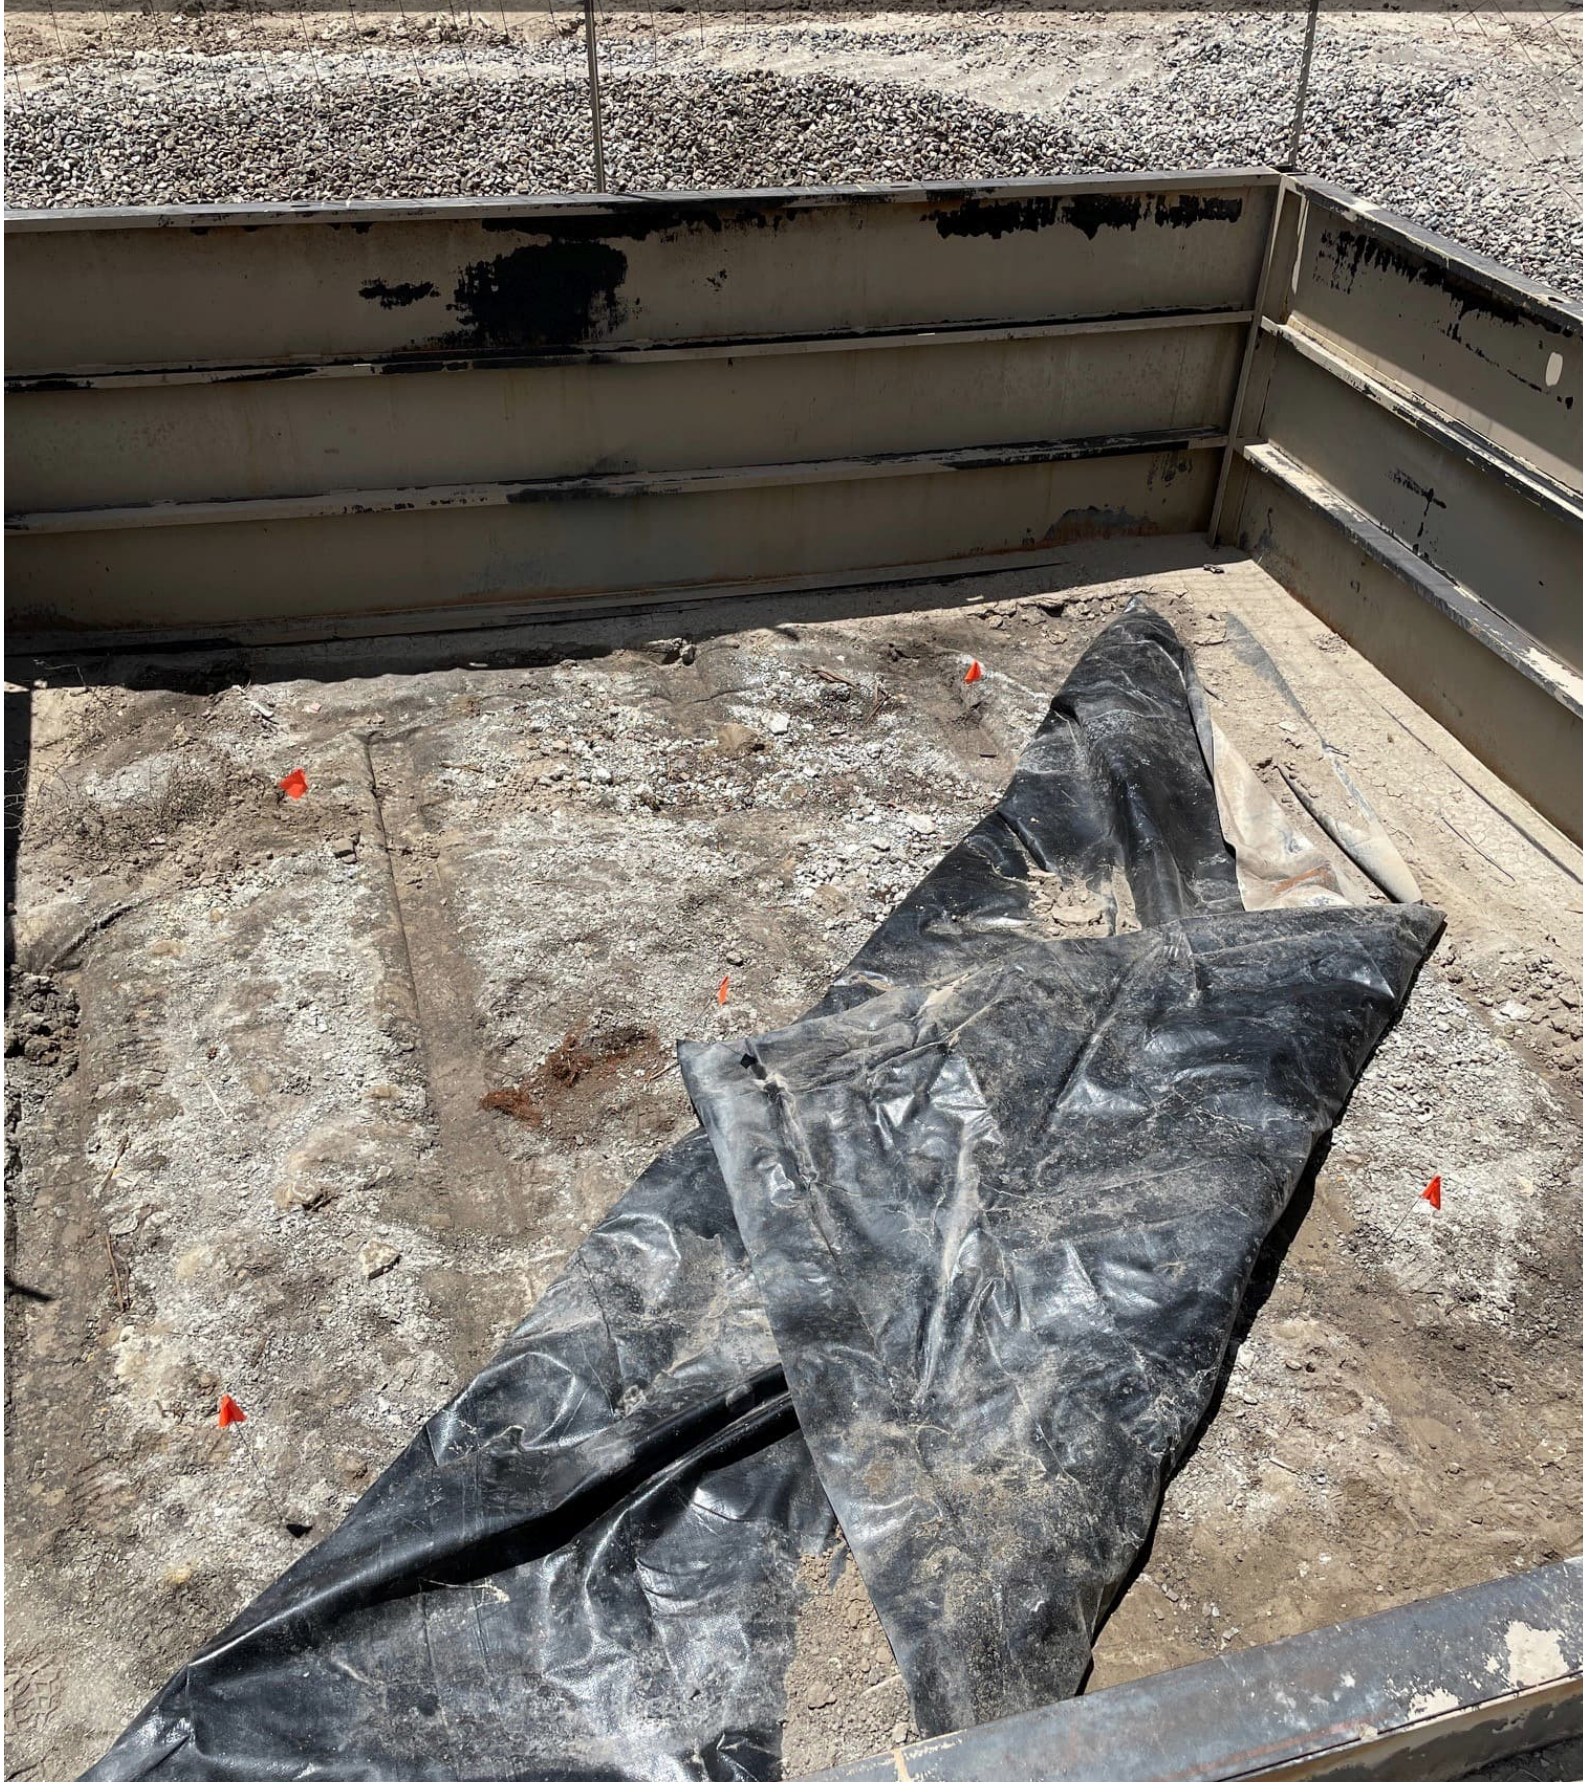
Hanks 4

After Removal  
with Composite  
Sample Points

A five point composite sample was taken of the below-grade tank using sampling tools and all samples tested per Subsection B of 19.15.17.1 3(B)(1)(b). (Sample results attached). Form C-141 is attached.

A release **was not** determined for the above referenced well.
