From: Hansen, Edward J., EMNRD
Sent: Thursday, April 19, 2012 10:06 AM
To: 'Hack Conder'
Cc: Leking, Geoffrey R, EMNRD; 'Katie Jones'; 'Laura Pena'; 'Scott Curtis'
Subject: Remediation Plan (1R425-13) Termination - ROC Vacuum Jct H-27 Site

RE: Termination Request
Vacuum Jct. H-27 (1R425-13): UL/H, Sec. 27, T17S, R35E
RICE Operating Company – Vacuum SWD System

**RICE OPERATING COMPANY
JUNCTION BOX FINAL REPORT**

Vacuum jct. H-27

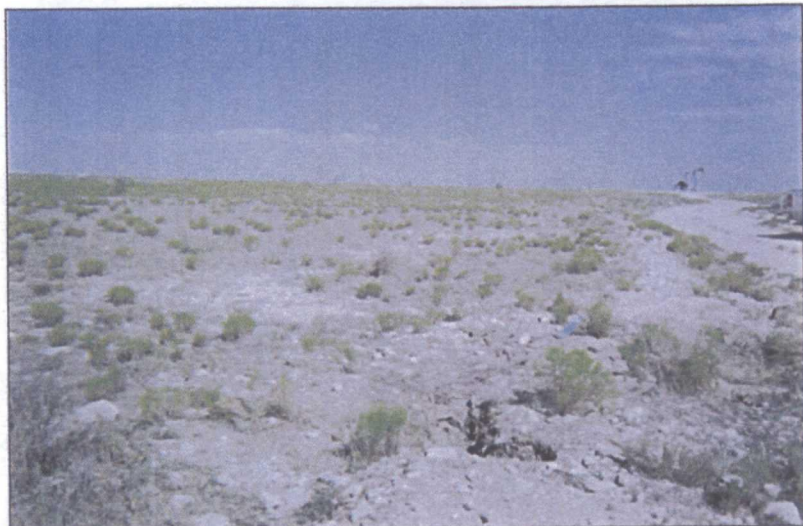
7/1/2005

before excavation; hole with box removed

This junction box was addressed as part of the Vacuum System Abandonment. After removing the box materials, a delineation trench was made with a backhoe at the junction while soil samples were collected every ft of depth to 7 ft BGS. Chloride field tests were performed on the samples and yielded low concentrations similar to background level. PID screenings were also performed and also exhibited low concentrations. A grab sample at 7 ft BGS was analyzed at a laboratory for confirmation of the field tests. TPH concentrations were below the lab's detection limits (<10.0 ppm), meeting NMOCD guidelines. The excavated soil was blended on site and then backfilled into the trench and contoured to the surrounding surface. The disturbed area was seeded with a blend of native vegetation and is expected to return to productive capacity at a normal rate.

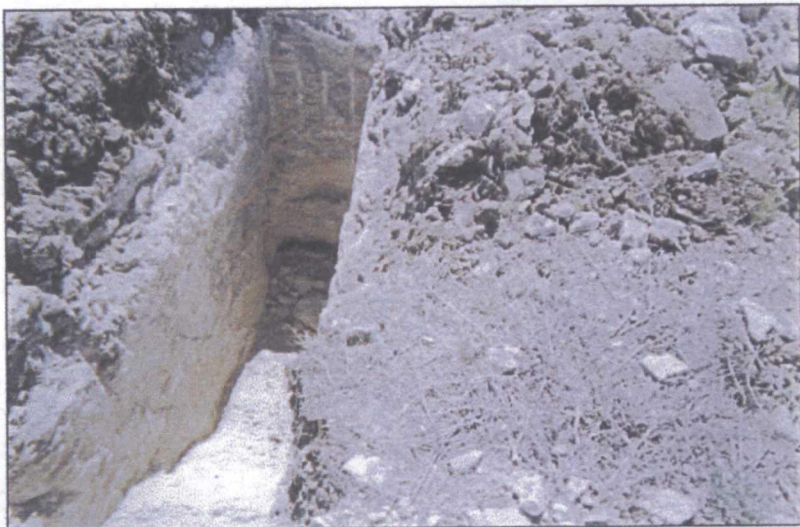
7/28/2005

delineation trench at former box site

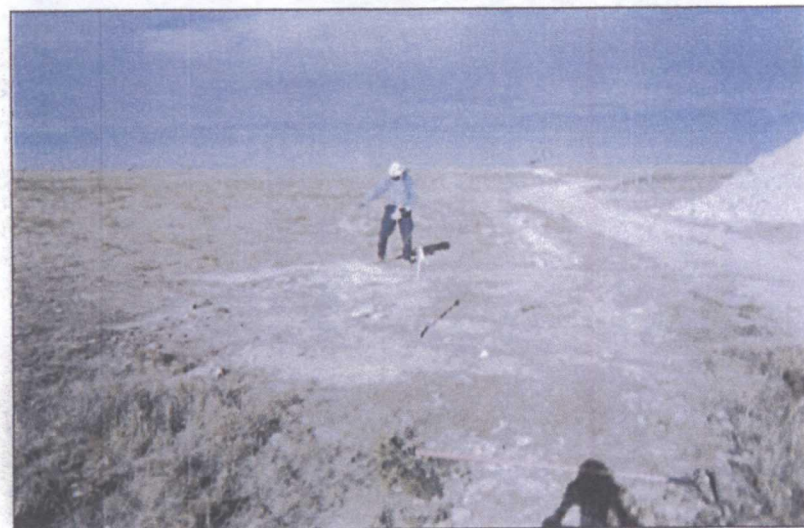
12/23/2005

seeding disturbed surface
