**From:** Hansen, Edward J., EMNRD  
**Sent:** Wednesday, May 16, 2012 3:17 PM  
**To:** Hack Conder (hconder@riceswd.com)  
**Cc:** Leking, Geoffrey R, EMNRD; Katie Jones <kjones@riceswd.com> (kjones@riceswd.com); Laura Pena (lpena@riceswd.com); Scott Curtis (scurtis@riceswd.com)  
**Subject:** Remediation Plan (1R425-49) Termination - ROC Vacuum I-32 Vent Boot Site

RE: Termination Request  
Vacuum I-32 vent boot (1R425-49): UL/I, Sec. 32, T17S, R35E  
RICE Operating Company – Vacuum SWD System

**RICE OPERATING COMPANY  
JUNCTION BOX FINAL REPORT**

## Vacuum vent I-32 boot

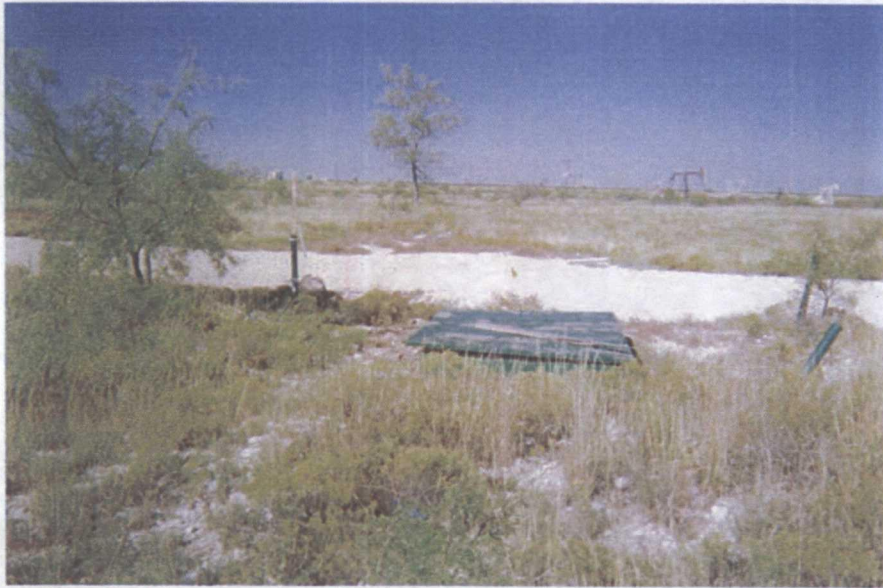
10/25/2005

undisturbed junction box, facing north

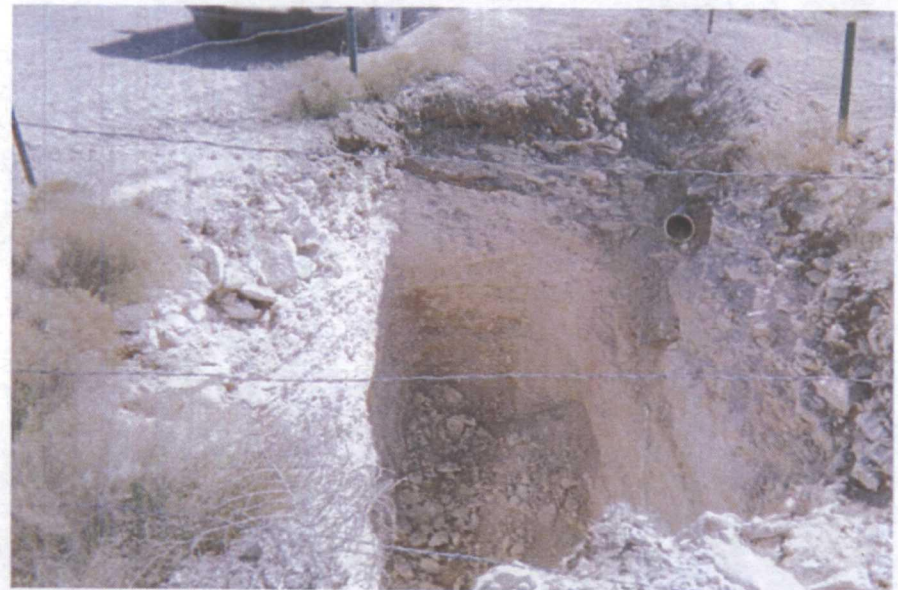
3/04/2008

delineation trench at former junction site

LOCATION	DEPTH	mg/kg
background	6"	73
vertical delineation trench at junction (source)	7'	127
	8'	173
	9'	126
	10'	103
	11'	179
	12'	103

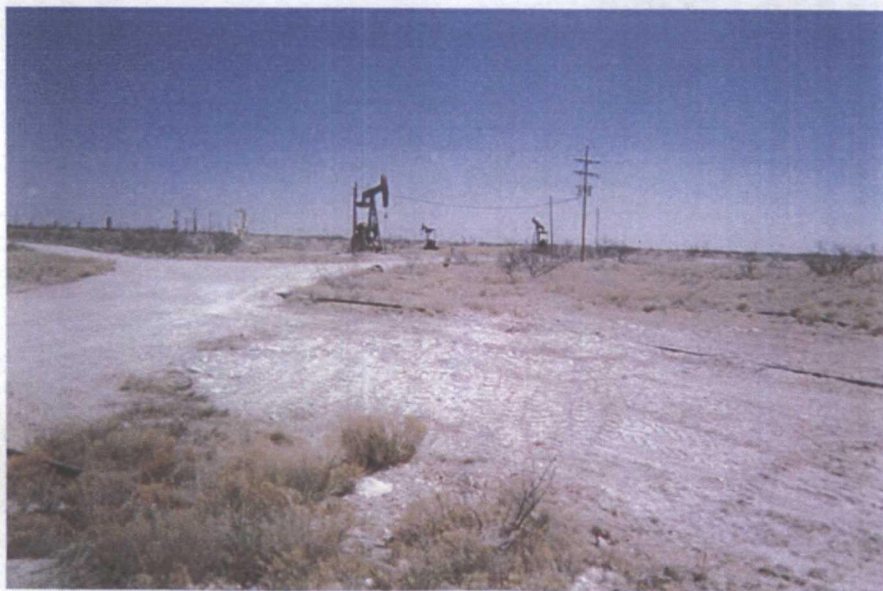
3/19/2008

backfilled site, facing east

**General Description of Remedial Action:** This junction was addressed under the Vacuum SWD System abandonment. After this junction was removed, an investigation was conducted using a backhoe to collect soil samples at regular intervals producing a 5x3x12-ft-deep hole. Chloride field tests were performed on each sample, which yielded low concentrations. Organic vapors were measured using a PID, which also yielded low concentrations. The deepest sample, 12 ft-BGS, was sent to a commercial laboratory for analysis of chloride and TPH, which confirmed low concentrations. The excavated soil was returned to the excavation and clean, imported soil was used as a top cap and to contour to the surrounding area. On 3/20/2008, the site was seeded with a blend of native vegetation and is expected to return to a productive capacity at a normal rate.

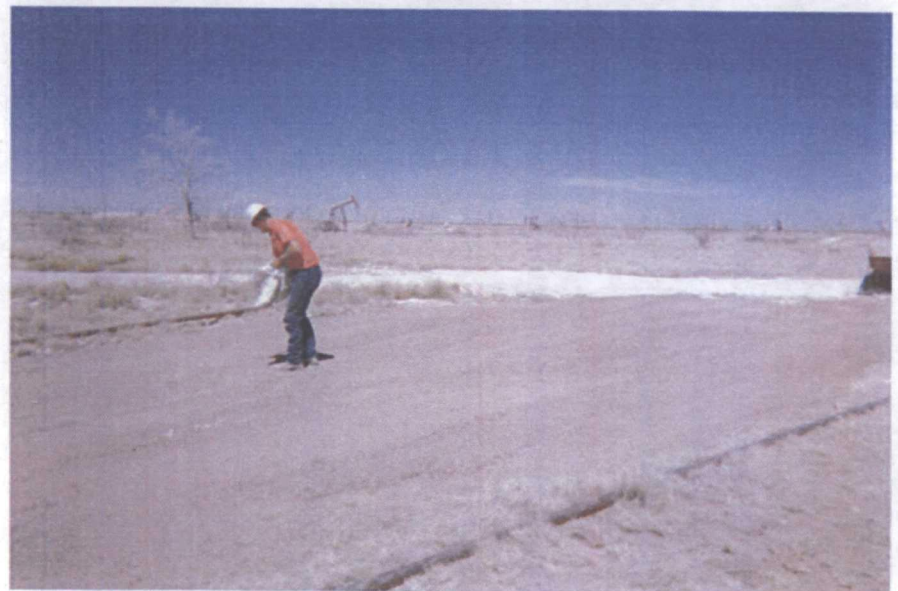
3/20/2008

seeding backfilled site, facing north
