**RE: Termination Request  
for the Rice Operating Company's  
Vacuum J-32 Vent Boot Site  
Unit Letter J, Section 32, T17S, R35E, NMPM, Lea County, New Mexico  
Remediation Plan (1R425-51) Termination**

RE: Termination Request  
Vacuum J-32 vent boot (1R425-51): UL/J, Sec. 32, T17S, R35E  
RICE Operating Company – Vacuum SWD System

**RICE OPERATING COMPANY  
JUNCTION BOX FINAL REPORT**

## Vacuum vent J-32 boot

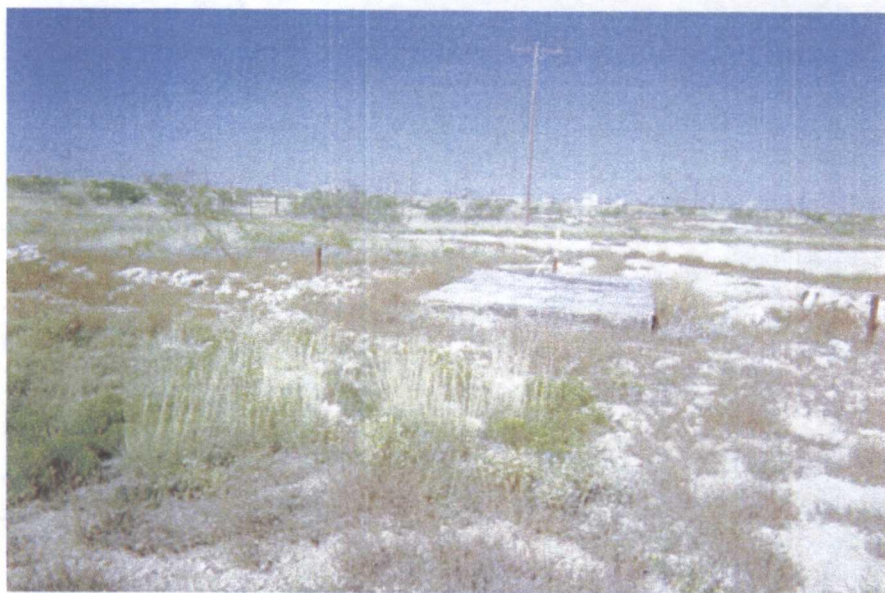
10/24/2005

undisturbed junction box, facing north

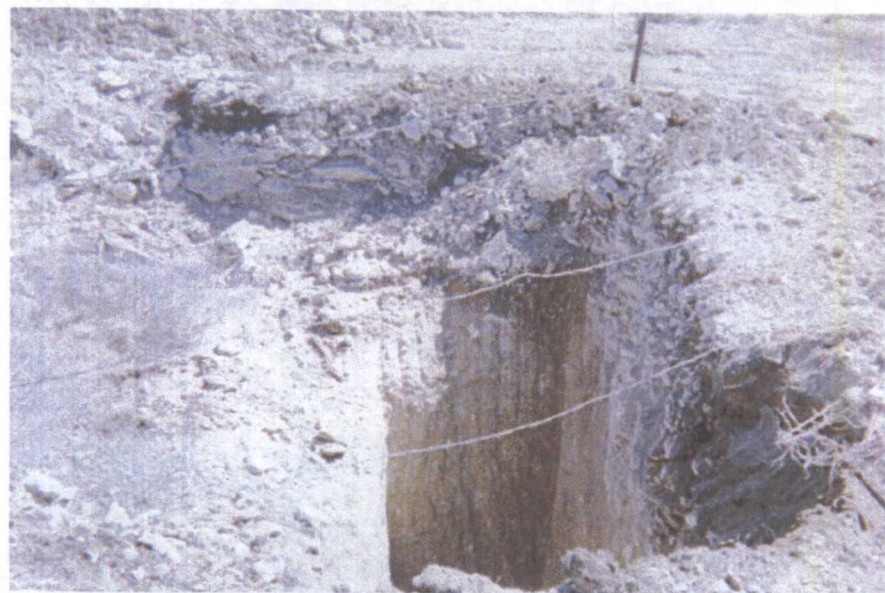
3/4/2008

delineation trench at former junction site

General Description of Remedial Action: This junction was addressed under the Vacuum SWD System abandonment. After this junction was removed, an investigation was conducted using a backhoe to collect soil samples at regular intervals producing a 5x3x12-ft-deep hole. Chloride field tests were performed on each sample, which yielded low concentrations. Organic vapors were measured using a PID, which also yielded low concentrations. The deepest sample, 12 ft BGS, was sent to a commercial laboratory for analysis of chloride and TPH, confirming low concentrations. The excavated soil was returned to the excavation and clean soil was imported and used to top cap and to contour the site to the surrounding area. On 3/20/2008, the site was seeded with a blend of native vegetation and is expected to return to a productive capacity at a normal rate.

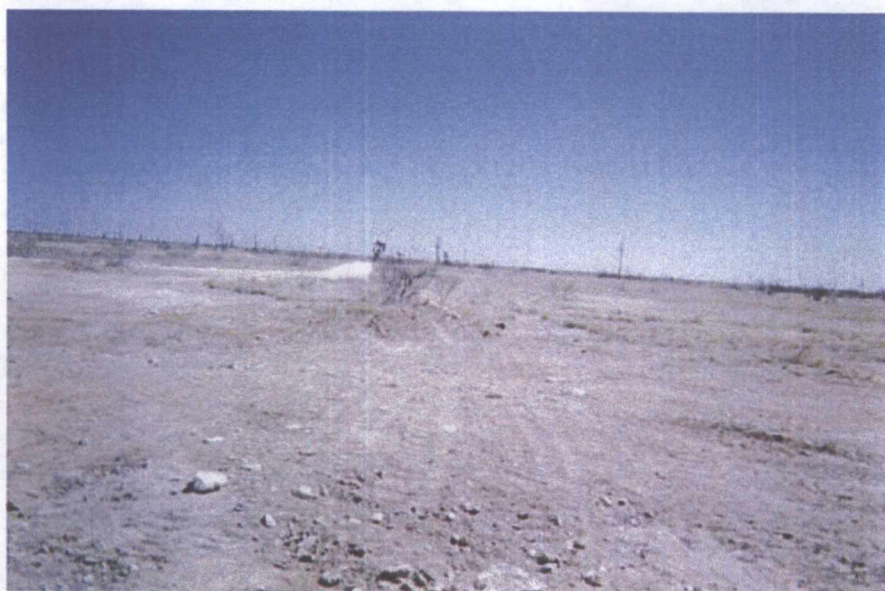
3/19/2008

backfilled site, facing east

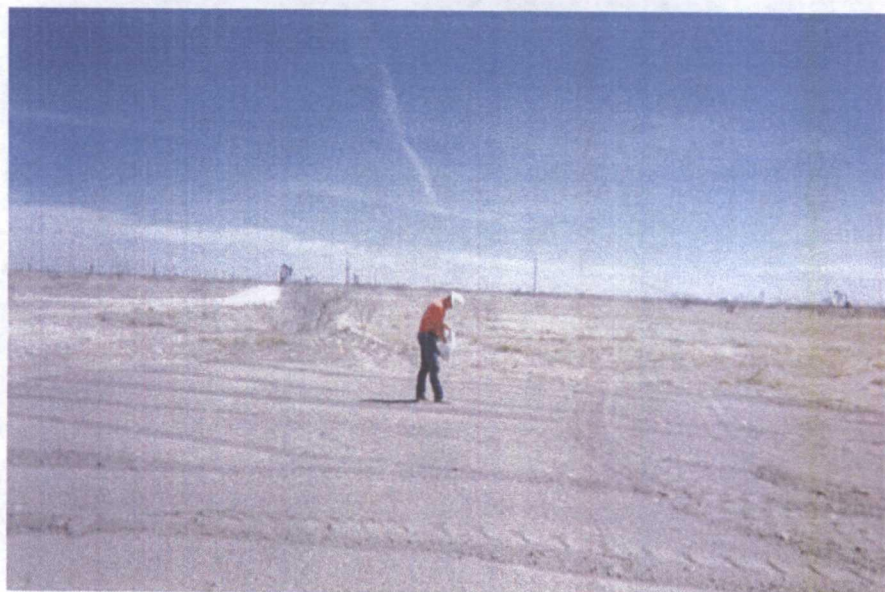
3/20/2008

seeding backfilled site, facing east
