**RE: Termination Request
for the Rice Operating Company's
EME C-17 EOL Site
Unit Letter C, Section 17, T21S, R36E, NMPM, Lea County, New Mexico
Remediation Plan (1R427-326) Termination**

RE: Termination Request
EME C-17 EOL (1R427-326): UL/C, Sec. 17, T21S, R36E
RICE Operating Company – Eunice Monument Eumont SWD System

EME C-17 EOL (1R427-326)

**RICE OPERATING COMPANY
JUNCTION BOX FINAL REPORT**

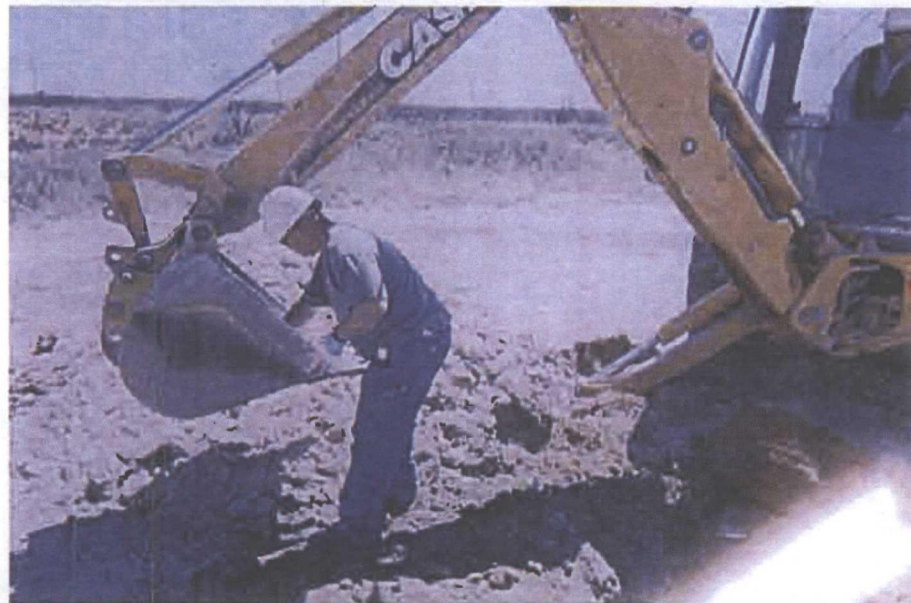
Collecting a soil sample 3/29/10

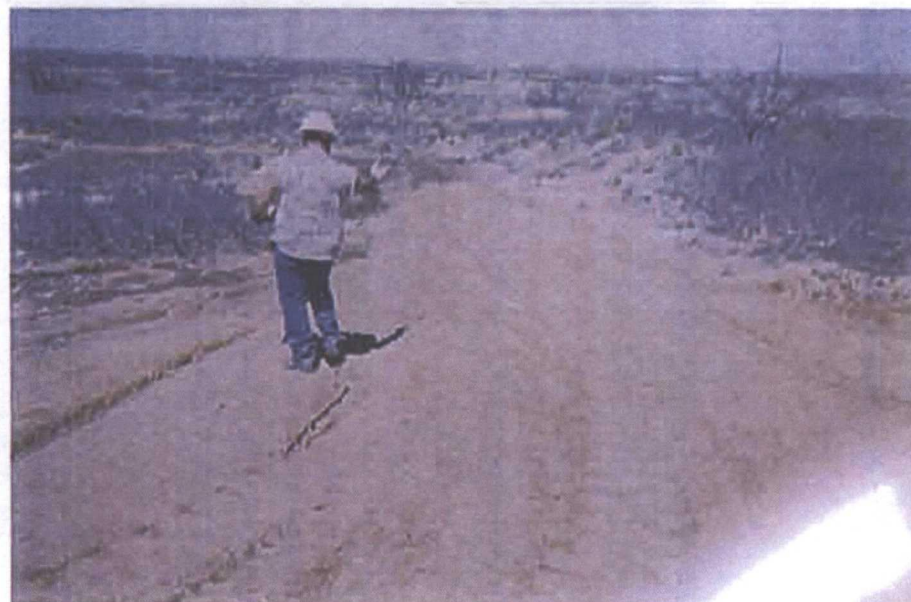
Seeding site 3/30/10

and contoured to the surrounding area. On 3/30/2010, site was seeded with a blend of native vegetation and is expected to return to

a productive capacity at a normal rate.

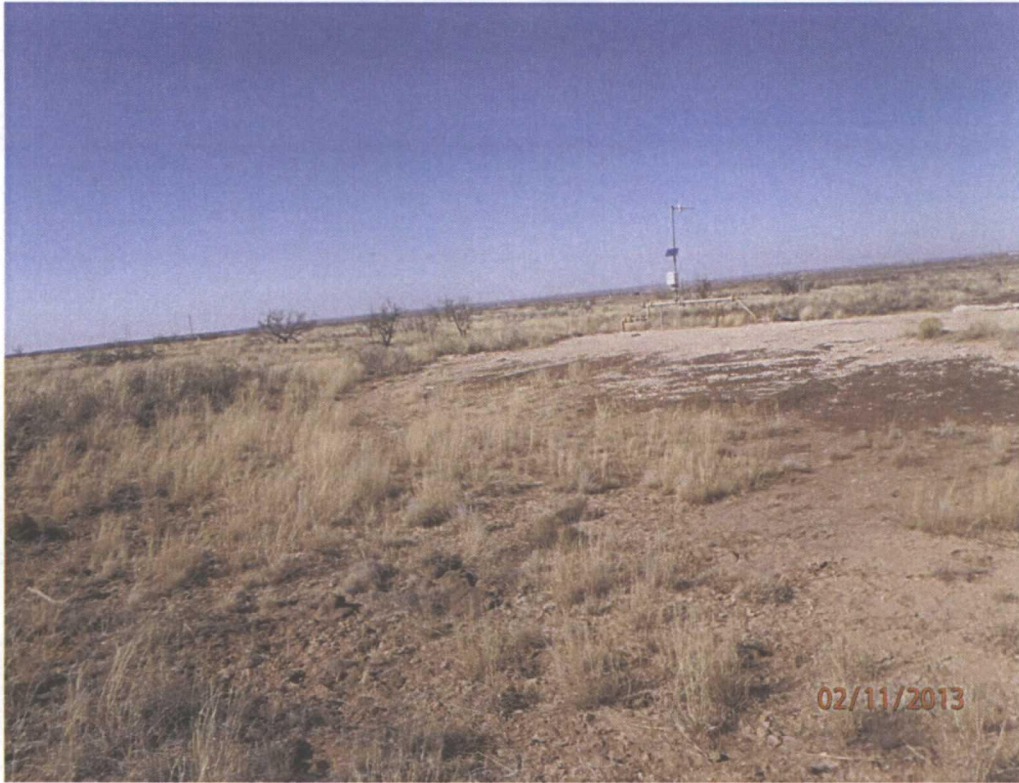
Facing north

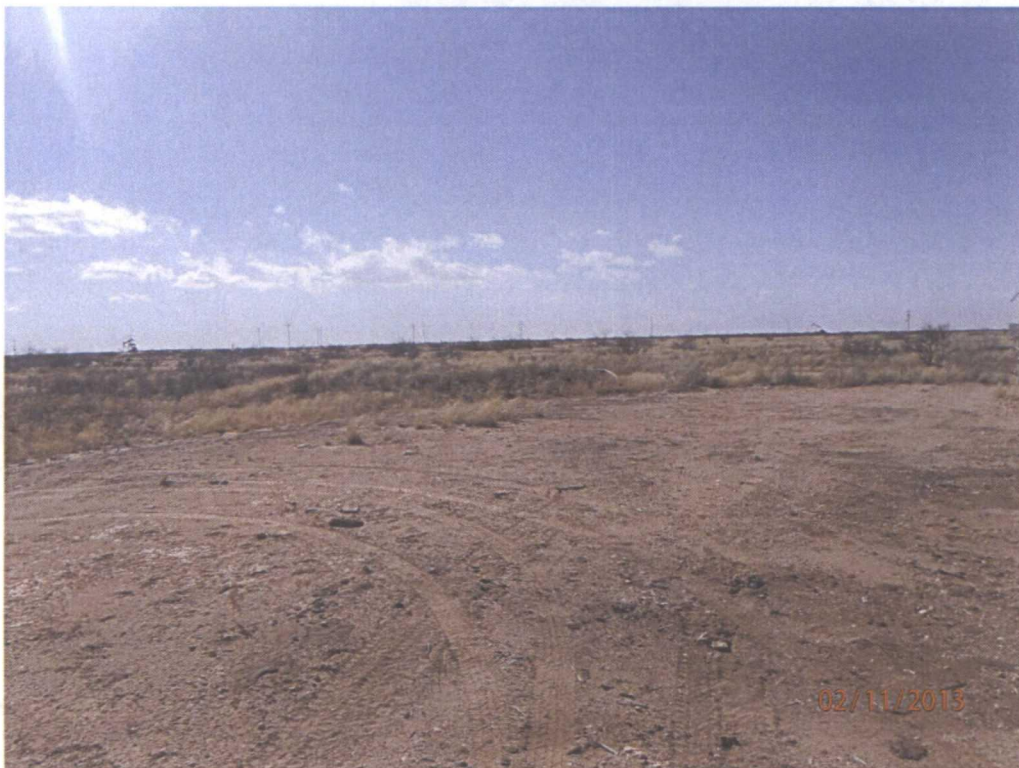
Facing west
